project
HAMPTON WATERWORKS

drawing title
EXISTING DOOR TYPES & SCHEDULE
RUSTON & WARD

drawing no. revision
1685-A-P051 A

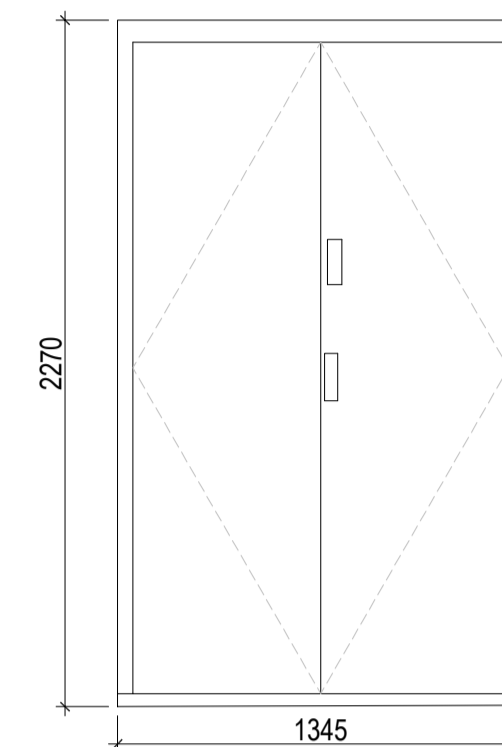
SCALE 1:25
TYPE 13 (DT-13)

D-04	TYPE 13/ DT-13	RUSTON & WARD ELEVATION 4	1345	2270	1345 x 2270	DOUBLE	N/A	WOOD	N/A	N	4	TIMBER, PAINT DEFECTS	REPLACED BY PROPOSED NEW WINDOW TYPE 34, W-103	N/A	-	D-04. REFER TO 1685-A-608	EARLY-TWENTIETH CENTURY
D-05	TYPE 14/ DT-14	RUSTON & WARD ELEVATION 4	2145	1775 / 1935	2145 X 1775 / 1935 (TOP OF ARCH)	DOUBLE	N/A	WOOD	SINGLE	N	4	TIMBER, PAINT DEFECTS	RETAINED / REPAIRED	N/A	-	D-05. REFER TO 1685-A-608	LATE-NINETEENTH CENTURY
OUT OF PROJECT SCOPE																	
D-07	TYPE 16/ DT-16	RUSTON & WARD ELEVATION 6	1745	2390	1745 X 2390 WITH ARCHED TRANSOM WINDOW OVER - 859MM HIGH - 3500MM O'ALL	DOUBLE	N/A	WOOD	SINGLE	N	4	TIMBER, PAINT DEFECTS	RETAINED / REPAIRED	N/A	-	D-07. REFER TO 1685-A-608	LATE-NINETEENTH CENTURY
D-08	TYPE 17/ DT-17	RUSTON & WARD ELEVATION 6	2460	2590	2460 X 2590 WITH ARCHED TRANSOM WINDOW OVER - 943MM HIGH - 3919MM O'ALL	DOUBLE	N/A	WOOD	TBC	N	4	TIMBER, PAINT DEFECTS	RETAINED / REPAIRED	N/A	-	D-08. REFER TO 1685-A-608	MID-NINETEENTH CENTURY
