project
HAMPTON WATERWORKS

drawing title
**FABRIC CONDITION DRAWING -
- KARSLAKE
ELEVATIONS 1 & 3**

drawing no. revision
1685-A-P055 A

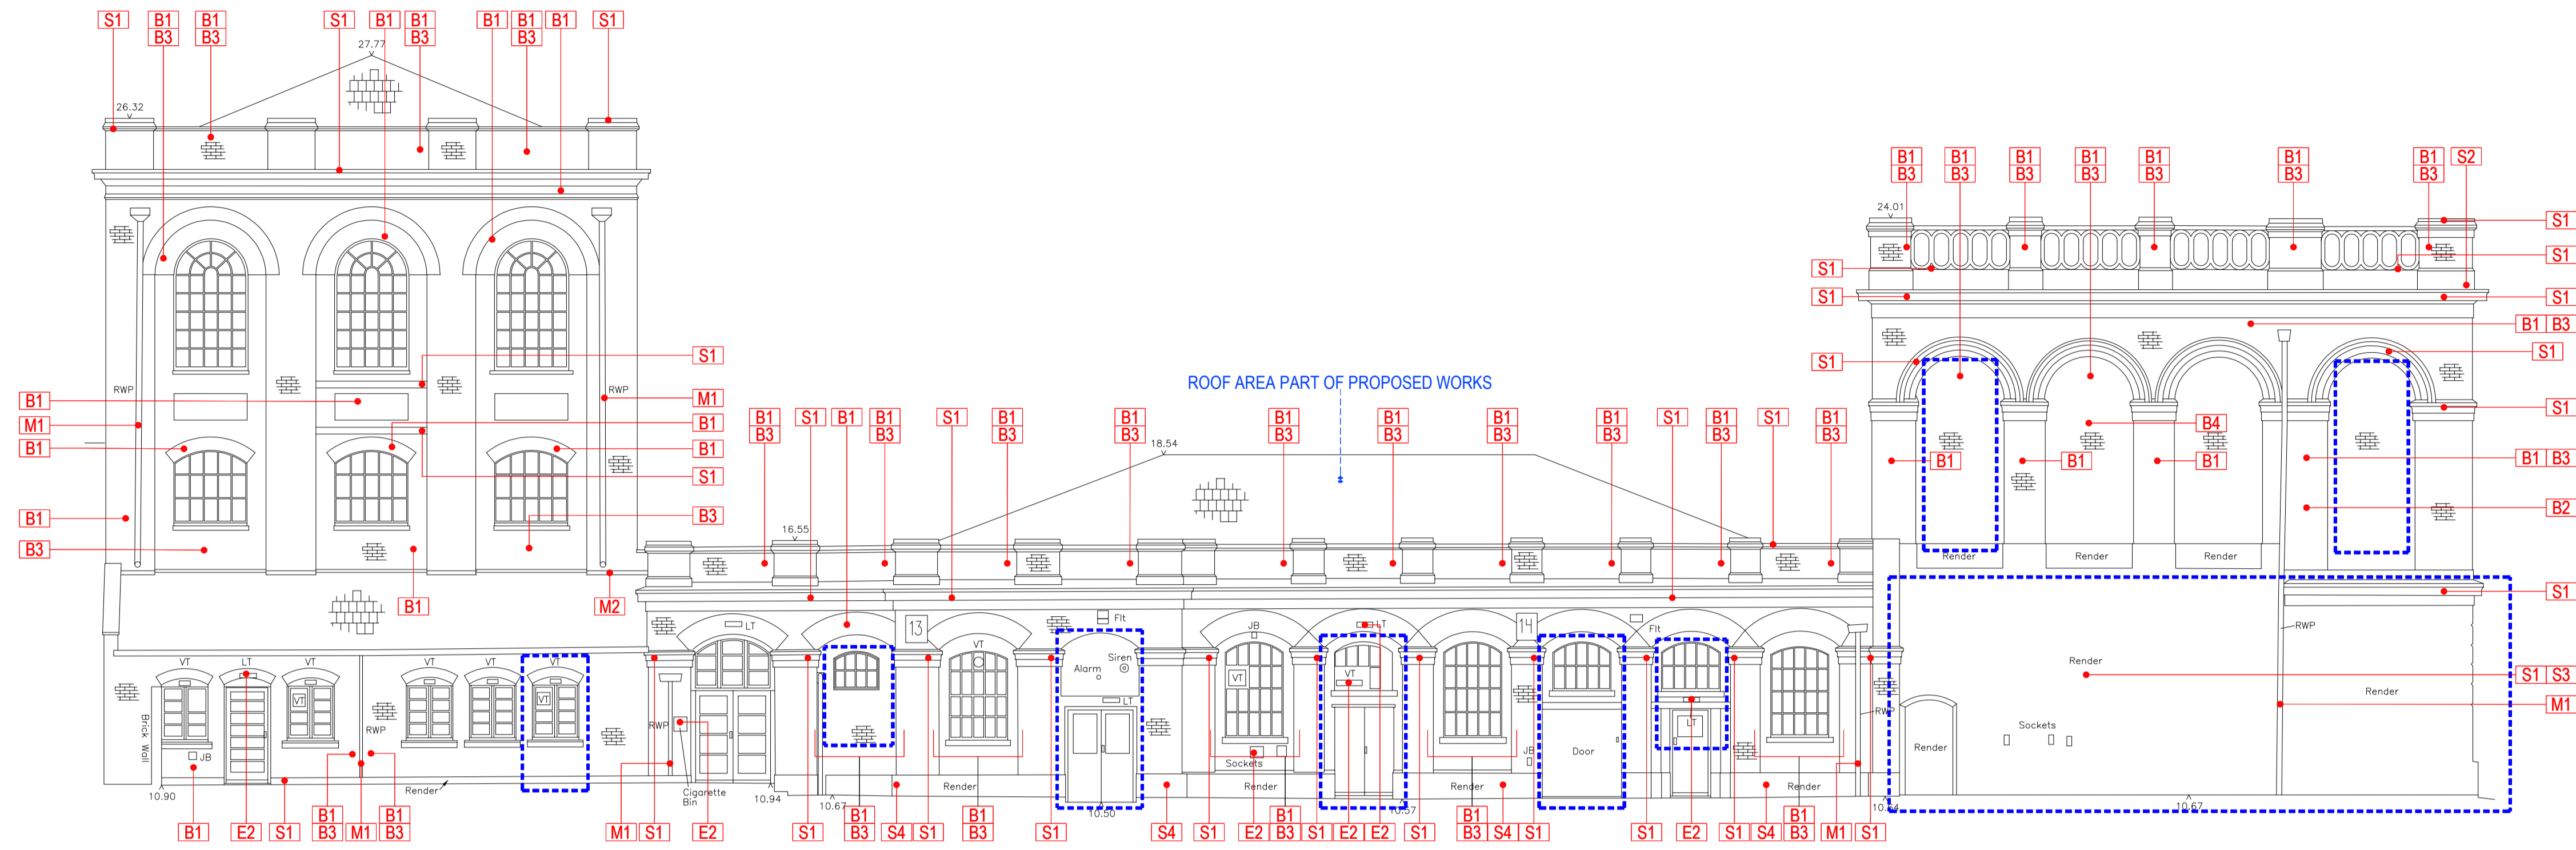
SCALE 1:100
KARSLAKE - ELEVATION 1 - EXISTING

1685 - HAMPTON WATERWORKS - CONDITION SURVEY & OUTLINE RESTORATION SCHEDULE		
REF.	CONDITION DESCRIPTION	REQUIRED ACTION
BRICKWORK		
B1	Discolouration & staining	Undertake cleaning of any brickwork with associated defects restored as required.
B2	Organic growth	Remove any plant growth within finish material and restore any associated damage/defects.
B3	Minor material failure	Re-pointing any areas of mortar failure.
B4	Extensive material failure	Substantial restoration works required such as replacing or repairing any decayed bricks and re-pointing.
B5	Incorrect material from historic works	Any areas of brickwork that varies from the predominant finish type should be re-finished or replaced if required.
STONEWORK/ RENDER/ PLASTER		
S1	Discolouration & staining	Undertake cleaning of any stonework, render or plaster with associated defects restored as required.
S2	Organic growth	Remove any plant growth within finish material and restore any associated damage/defects.

S3	Minor material failure	Re-finish any discoloured areas of stonework.
S4	Defective render	Re-finish any cracked or failed render or plaster.
S5	Window sill material failure or damage	Repair or replace.
ROOFING		
R1	Organic growth	Undertake cleaning and removal of any organic growth on or around any roof areas.
R2	Minor material failure	Re-finish any discoloured areas of roofing.
R3	Extensive material failure	Substantial restoration works required such as replacing or repairing any broken tiling or roof membranes.
METALWORK		
M1	Defective rainwater goods	Replace rainwater goods with new or restore if defect is only minimal such as organic growth blockages.
M2	Flashing failure	Replace rainwater goods with new or restore if defect is only minimal.
M3	Discoloured signs or features	Undertake restoration works of any existing features or signage to be retained.
M4	Pipe work removal	Removal of any defunct or unnecessary pipe work and make good.
