Condition Survey Photo Record

Schedule of Repairs – Karslake Windows

Client Waterfall Planning Ltd
Project Hampton Water Works
Subject Karslake Condition Survey - Window Photo Record
Date 26.05.2023
Revision A
Job no. 1685
Reference 1685-A-P605 Karslake Window Photo Record

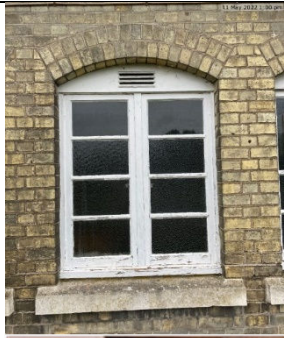
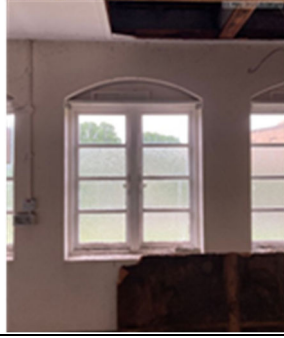
Reference:	W-04 (TYPE-01)

Location:	ELEVATION 1	
Description:	Timber, outward opening, single glazed, obscured	
Condition:	3	
Damage:	Timber, paint defects	
Proposal:	Replaced	
Comments:	NEW DOUBLE-GLAZED ALUMINIUM TO MATCH	
Heritage Comments:	Early-Twentieth Century

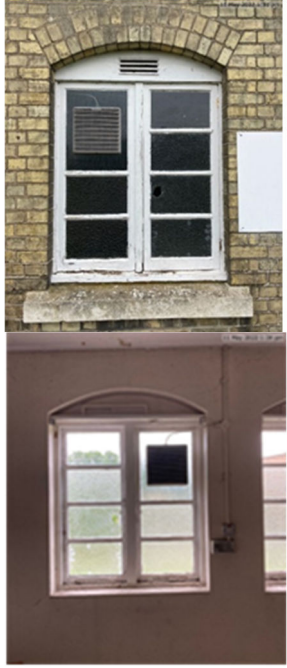
Reference:	W-05 (TYPE-01)	
Location:	ELEVATION 1	
Description:	Timber, outward opening, single glazed, obscured, vent	
Condition:	4 / 6	
Damage:	Timber, paint defects	
Proposal:	Replaced

Comments:	Replaced by proposed new door. Type 18, D-50

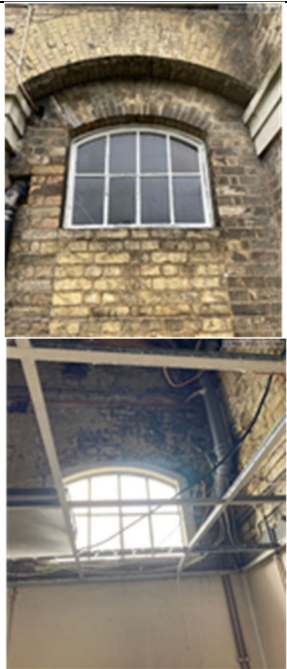
Reference:	W-06 (TYPE-02)

Location:	ELEVATION 1	
Description:	Metal, inward + outward opening, single glazed	
Condition:	3 / 6	
Damage:	Metal rusted, paint defects	
Proposal:	Replaced	
Comments:	Replaced by proposed new window Type 26, W-100	
Heritage Comments:	Early-Twentieth Century

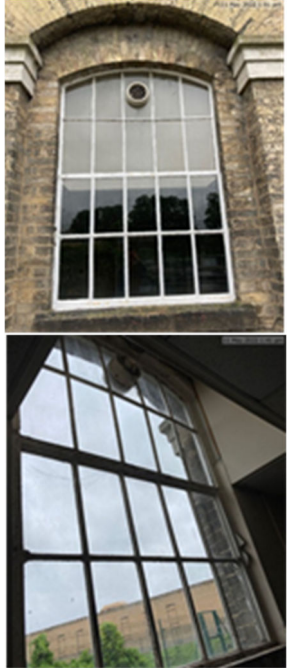
Reference:	W-07 (TYPE-03)	
Location:	ELEVATION 1	
Description:	Metal, inward + outward opening, single glazed, vent	
Condition:	3	
Damage:	Metal rusted, paint defects	
Proposal:	Retained / Repaired

Comments:	Remove vent & re-glaze to match. ADDITIONAL SECONDARY GLAZING REQUIRED

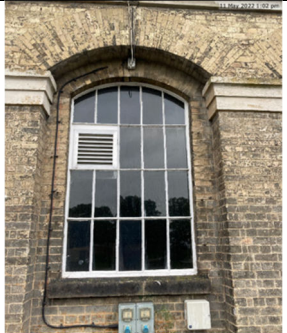
Reference:	W-08 (TYPE-04)

Location:	ELEVATION 1	
Description:	Metal, inward + outward opening, single glazed, vent	
Condition:	3	
Damage:	Metal rusted, paint defects	
Proposal:	Retained / Repaired	
Comments:	Remove vent & re-glaze to match. ADDITIONAL SECONDARY GLAZING REQUIRED	
Heritage Comments:	Mid-Nineteenth Century

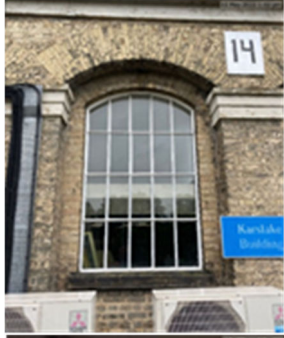
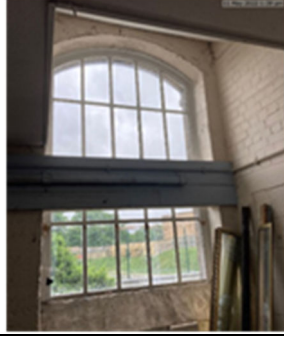
Reference:	W-09 (TYPE-04)	
Location:	ELEVATION 1	
Description:	Metal, inward + outward opening, single glazed	
Condition:	3	
Damage:	Metal rusted, paint defects	
Proposal:	Retained / Repaired

Comments:	ADDITIONAL SECONDARY GLAZING REQUIRED

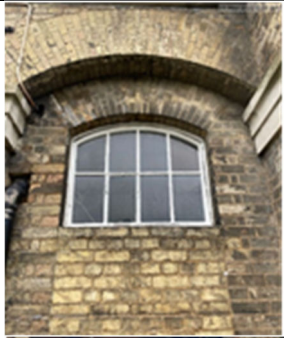
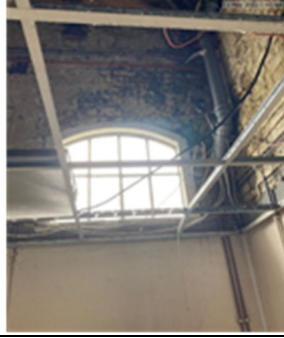
Reference:	W-10 (TYPE-05)

Location:	ELEVATION 1	
Description:	Metal, inward + outward opening, single glazed	
Condition:	3 / 6	
Damage:	Metal rusted, paint defects	
Proposal:	Replaced	
Comments:	New door Type 19, D-53 & new window Type 27, W-101	
Heritage Comments:	Early-Twentieth Century

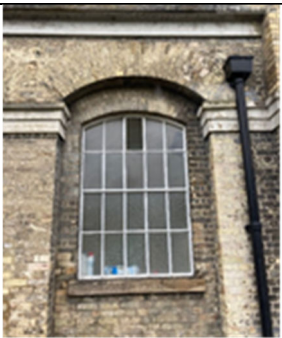
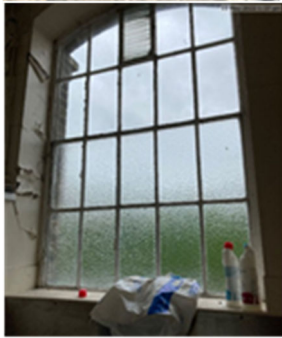
Reference:	W-11 (TYPE-03)	
Location:	ELEVATION 1	
Description:	Metal, inward + outward opening, single glazed, obscured, vent	
Condition:	3	
Damage:	Metal rusted, paint defects	
Proposal:	Retained / Repaired

Comments:	Remove vent & re-glaze to match. ADDITIONAL SECONDARY GLAZING REQUIRED

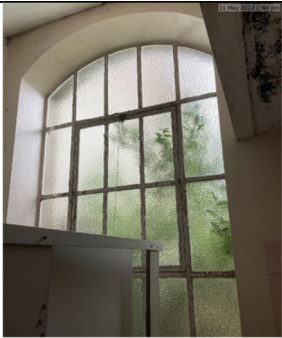
Reference:	W-12 (TYPE-06)

Location:	ELEVATION 2	
Description:	Metal, inward + outward opening, single glazed	
Condition:	3 / 6	
Damage:	Metal rusted, paint defects	
Proposal:	Replaced	
Comments:	Demolished for proposed extension	
Heritage Comments:	Early-Twentieth Century

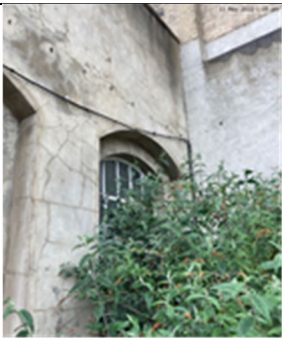
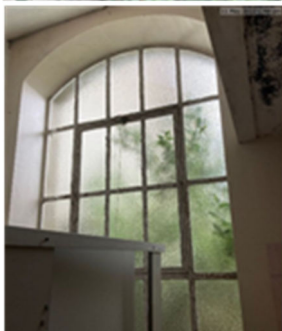
Reference:	W-13 (TYPE-06)

Location:	ELEVATION 2	
Description:	Metal, inward + outward opening, single glazed, obscured	
Condition:	4 / 6	
Damage:	Metal rusted, paint defects	
Proposal:	Replaced	
Comments:	Demolished for proposed extension

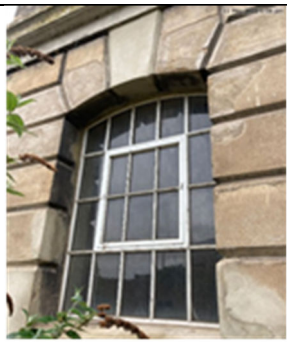
Reference:	W-14 (TYPE-07)

Location:	ELEVATION 2	
Description:	Metal, UPVC, inward + outward opening, single glazed	
Condition:	2	
Damage:	None	
Proposal:	Replaced	
Comments:	NEW DOUBLE-GLAZED ALUMINIUM / CRITTALL WINDOW TO MATCH	
Heritage Comments:	Early-Twentieth Century

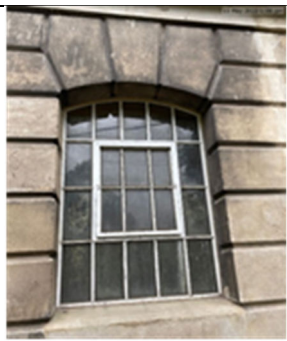
Reference:	W-15 (TYPE-07)

Location:	ELEVATION 3	
Description:	Metal, UPVC, inward + outward opening, single glazed	
Condition:	2	
Damage:	None	
Proposal:	Replaced	
Comments:	NEW DOUBLE-GLAZED ALUMINIUM / CRITTALL WINDOW TO MATCH	
Heritage Comments:	Early-Twentieth Century

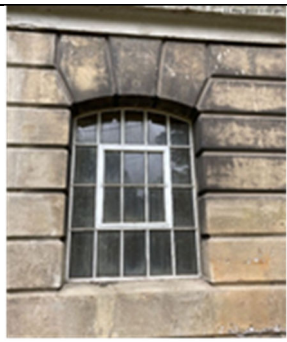
Reference:	W-16 (TYPE-07)

Location:	ELEVATION 3	
Description:	Metal, UPVC, inward + outward opening, single glazed	
Condition:	2	
Damage:	None	
Proposal:	Replaced	
Comments:	NEW DOUBLE-GLAZED ALUMINIUM / CRITTALL WINDOW TO MATCH	
Heritage Comments:	Early-Twentieth Century

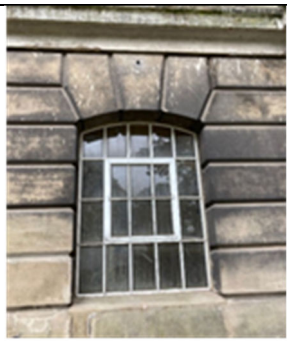
Reference:	W-17 (TYPE-07)

Location:	ELEVATION 3	
Description:	Metal, UPVC, inward + outward opening, single glazed	
Condition:	2	
Damage:	None	
Proposal:	Replaced	
Comments:	NEW DOUBLE-GLAZED ALUMINIUM / CRITTALL WINDOW TO MATCH	
Heritage Comments:	Early-Twentieth Century

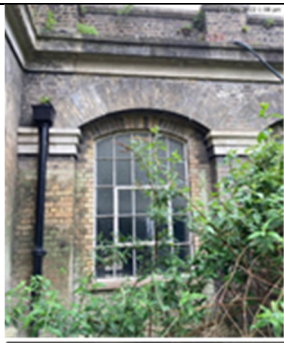
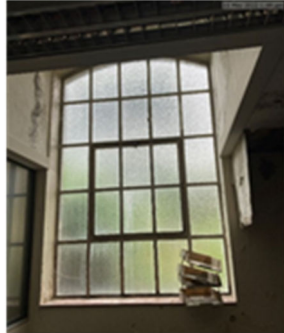
Reference:	W-18 (TYPE-08)

Location:	ELEVATION 3	
Description:	Metal, inward + outward opening, single glazed, obscured, external metal grille	
Condition:	3	
Damage:	Metal rusted, paint defects	
Proposal:	Replaced	
Comments:	NEW DOUBLE-GLAZED ALUMINIUM / CRITTALL WINDOW TO MATCH	
Heritage Comments:	Early-Twentieth Century

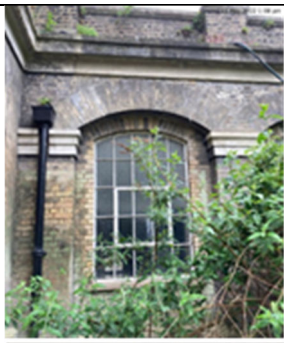
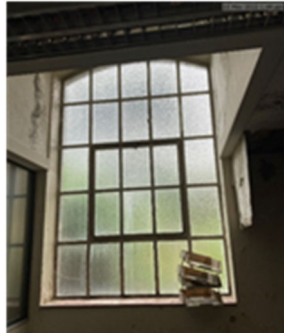
Reference:	W-19 (TYPE-08)

Location:	ELEVATION 3	
Description:	Metal, inward + outward opening, single glazed, obscured, external metal grille	
Condition:	3 / 6	
Damage:	Metal rusted, paint defects	
Proposal:	Replaced	
Comments:	Replaced by proposed new door. Type 21, D-55	
Heritage Comments:	Early-Twentieth Century

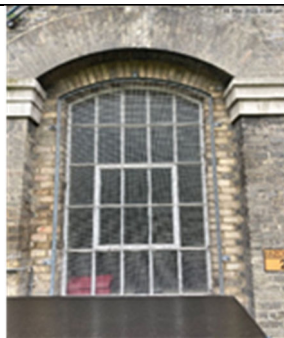
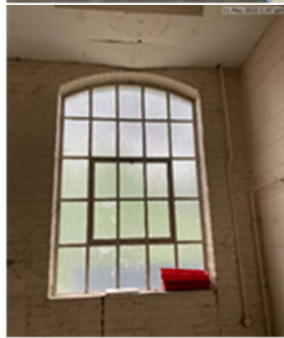
Reference:	W-21 (TYPE-08)

Location:	ELEVATION 3	
Description:	Metal, inward + outward opening, single glazed, obscured, external metal grille	
Condition:	3 / 6	
Damage:	Metal rusted, paint defects	
Proposal:	Replaced	
Comments:	Replaced by proposed new door. Type 21, D-56	
Heritage Comments:	Early-Twentieth Century

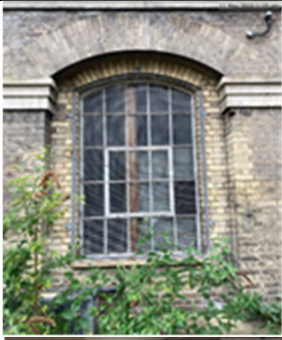
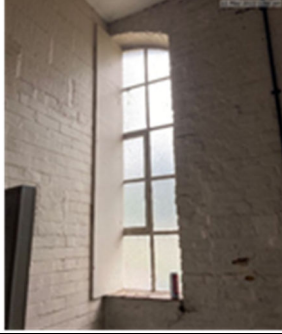
Reference:	W-23 (TYPE-08)

Location:	ELEVATION 3	
Description:	Metal, inward + outward opening, single glazed, obscured, external metal grille	
Condition:	3	
Damage:	Metal rusted, paint defects	
Proposal:	Replaced	
Comments:	NEW DOUBLE-GLAZED ALUMINIUM / CRITTALL WINDOW TO MATCH	
Heritage Comments:	Early-Twentieth Century

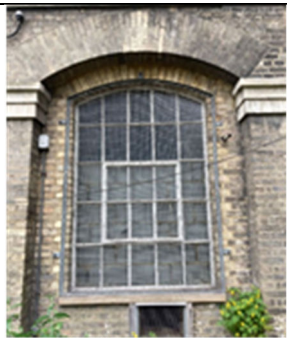
Reference:	W-24 (TYPE-08)	
Location:	ELEVATION 3	
Description:	Metal, inward + outward opening, single glazed, obscured, external metal grille	
Condition:	3	
Damage:	Metal rusted, paint defects	
Proposal:	Replaced

Comments:	NEW DOUBLE-GLAZED ALUMINIUM / CRITTALL WINDOW TO MATCH

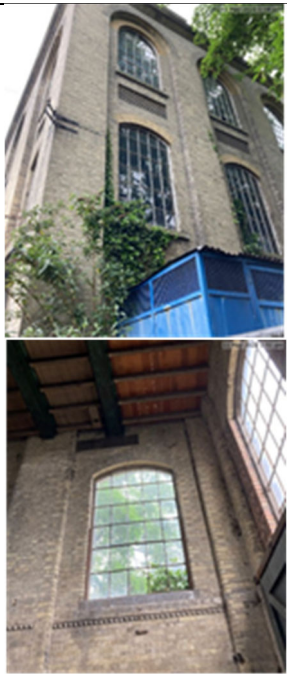
Reference:	W-25 (TYPE-09)

Location:	ELEVATION 3	
Description:	Metal / Timber, inward + outward opening, single glazed	
Condition:	4	
Damage:	Metal rusted, timber, paint defects	
Proposal:	Retained / Repaired	
Comments:	ADDITIONAL SECONDARY GLAZING REQUIRED	
Heritage Comments:	Late-Nineteenth Century

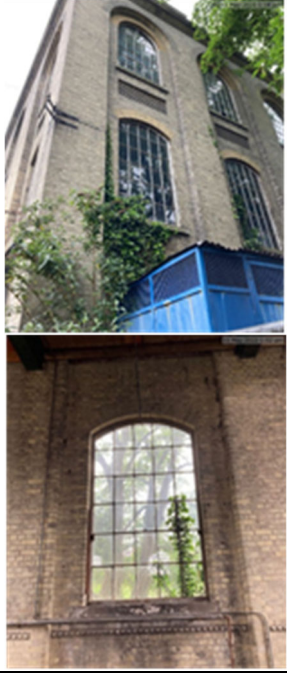
Reference:	W-26 (TYPE-09)	
Location:	ELEVATION 3	
Description:	Metal / Timber, inward + outward opening, single glazed	
Condition:	4	
Damage:	Metal rusted, timber, paint defects	
Proposal:	Retained / Repaired	
Comments:	ADDITIONAL SECONDARY GLAZING REQUIRED

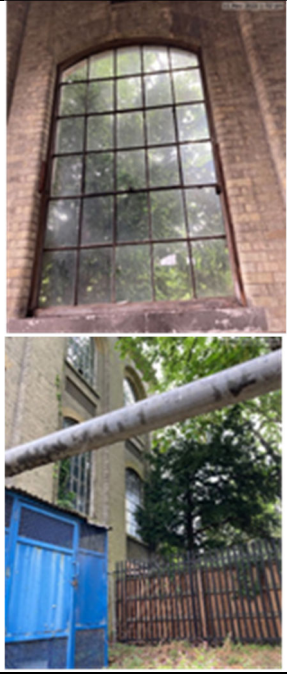
Reference:	W-27 (TYPE-09)

Location:	ELEVATION 3	
Description:	Metal / Timber, inward + outward opening, single glazed	
Condition:	4	
Damage:	Metal rusted, timber, paint defects	
Proposal:	Retained / Repaired	
Comments:	ADDITIONAL SECONDARY GLAZING REQUIRED	
Heritage Comments:	Late-Nineteenth Century

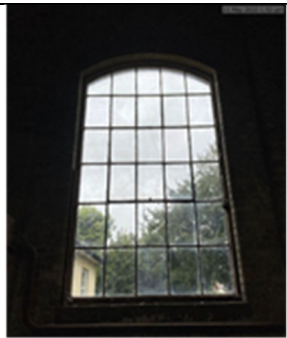
Reference:	W-28 (TYPE-09)	
Location:	ELEVATION 4	
Description:	Metal / Timber, inward + outward opening, single glazed	
Condition:	4	
Damage:	Metal rusted, timber, paint defects	
Proposal:	Retained / Repaired

Comments:	ADDITIONAL SECONDARY GLAZING REQUIRED

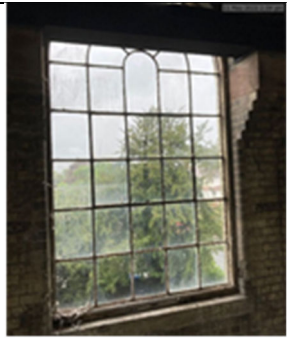
Reference:	W-29 (TYPE-10)

Location:	ELEVATION 4	
Description:	Metal / Timber, inward + outward opening, single glazed	
Condition:	4	
Damage:	Metal rusted, timber, paint defects	
Proposal:	Retained / Repaired	
Comments:	ADDITIONAL SECONDARY GLAZING REQUIRED	
Heritage Comments:	Late-Nineteenth Century

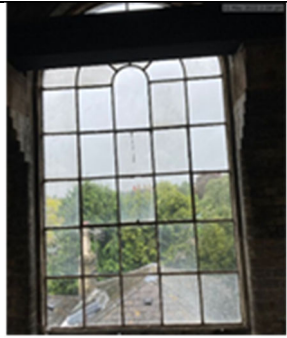
Reference:	W-30 (TYPE-10)

Location:	ELEVATION 4	
Description:	Metal / Timber, inward + outward opening, single glazed	
Condition:	4	
Damage:	Metal rusted, timber, paint defects	
Proposal:	Retained / Repaired	
Comments:	ADDITIONAL SECONDARY GLAZING REQUIRED	
Heritage Comments:	Late-Nineteenth Century

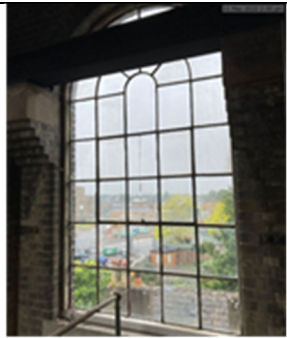
Reference:	W-31 (TYPE-10)

Location:	ELEVATION 4	
Description:	Metal / Timber, inward + outward opening, single glazed	
Condition:	4	
Damage:	Metal rusted, timber, paint defects	
Proposal:	Retained / Repaired	
Comments:	ADDITIONAL SECONDARY GLAZING REQUIRED	
Heritage Comments:	Late-Nineteenth Century

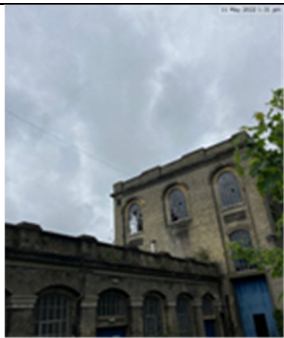
Reference:	W-32 (TYPE-10)	
Location:	ELEVATION 5

Condition:	5 / 6	
Damage:	Metal rusted, timber, paint defects	
Proposal:	Replaced	
Comments:	Demolished to become internal opening. glazed link to extension.	
Heritage Comments:	Late-Nineteenth Century

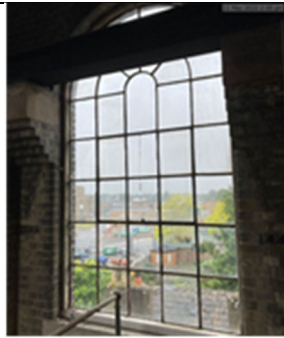
Reference:	W-33 (TYPE-10)

Location:	ELEVATION 5	
Description:	Metal / Timber, inward + outward opening, single glazed	
Condition:	5	
Damage:	Metal rusted, glazing, timber, paint defects	
Proposal:	Retained / Repaired	
Comments:	ADDITIONAL SECONDARY GLAZING REQUIRED	
Heritage Comments:	Late-Nineteenth Century

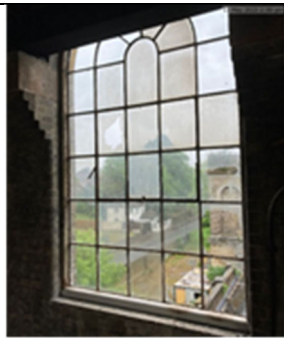
Reference:	W-34 (TYPE-10)

Location:	ELEVATION 5	
Description:	Metal / Timber, inward + outward opening, single glazed	
Condition:	5	
Damage:	Metal rusted, glazing, timber, paint defects	
Proposal:	Retained / Repaired	
Comments:	ADDITIONAL SECONDARY GLAZING REQUIRED	
Heritage Comments:	Late-Nineteenth Century

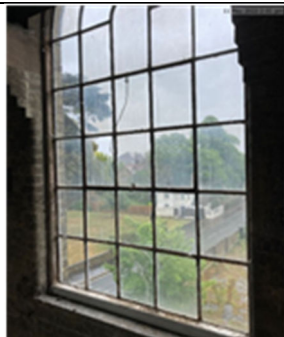
Reference:	W-35 (TYPE-10)

Location:	ELEVATION 5	
Description:	Metal / Timber, inward + outward opening, single glazed	
Condition:	5	
Damage:	Metal rusted, glazing, timber, paint defects	
Proposal:	Retained / Repaired	
Comments:	ADDITIONAL SECONDARY GLAZING REQUIRED	
Heritage Comments:	Late-Nineteenth Century

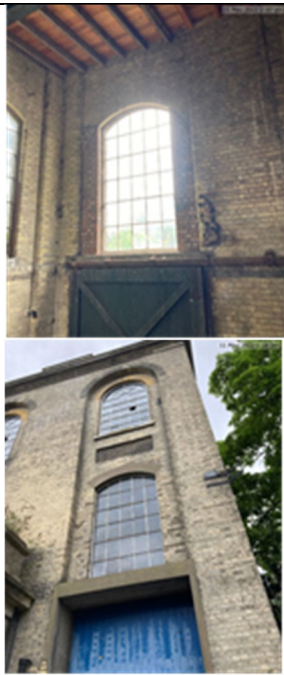
Reference:	W-36 (TYPE-09)	
Location:	ELEVATION 5

Condition:	5	
Damage:	Metal rusted, glazing, timber, paint defects	
Proposal:	Retained / Repaired	
Comments:	ADDITIONAL SECONDARY GLAZING REQUIRED	
Heritage Comments:	Late-Nineteenth Century

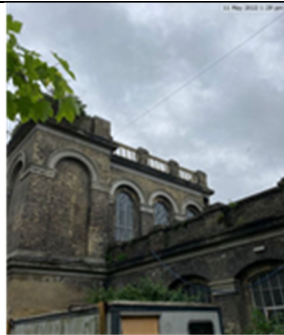
Reference:	W-37 (TYPE-12)

Location:	ELEVATION 6	
Description:	Metal, inward + outward opening, single glazed	
Condition:	2	
Damage:	None	
Proposal:	Retained / Repaired	
Comments:	ADDITIONAL SECONDARY GLAZING REQUIRED	
Heritage Comments:	Early-Twentieth Century

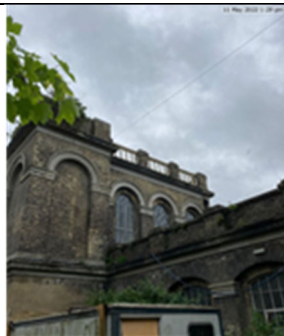
Reference:	W-38 (TYPE-12)

Location:	ELEVATION 6	
Description:	Metal, inward + outward opening, single glazed	
Condition:	2	
Damage:	None	
Proposal:	Retained / Repaired	
Comments:	ADDITIONAL SECONDARY GLAZING REQUIRED	
Heritage Comments:	Early-Twentieth Century

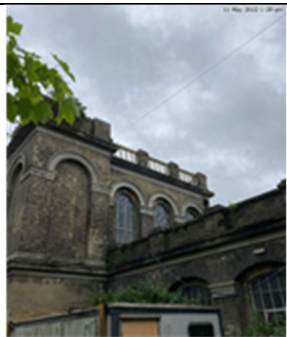
Reference:	W-39 (TYPE-12)	
Location:	ELEVATION 6	
Description:	Metal, UPVC, inward + outward opening, single glazed	
Condition:	2 / 6

Damage:	None

Proposal:	Replaced	
Comments:	Replaced by proposed new window Type 26, W-120	
Heritage Comments:	Early-Twentieth Century

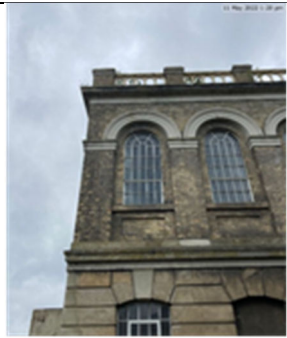
Reference:	W-40 (TYPE-12)

Location:	ELEVATION 2	
Description:	Metal, inward + outward opening, single glazed	
Condition:	2	
Damage:	None	
Proposal:	Retained / Repaired	
Comments:	ADDITIONAL SECONDARY GLAZING REQUIRED	
Heritage Comments:	Early-Twentieth Century

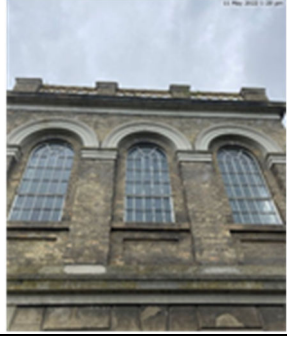
Reference:	W-41 (TYPE-12)

Location:	ELEVATION 2	
Description:	Metal, inward + outward opening, single glazed	
Condition:	2	
Damage:	None	
Proposal:	Retained / Repaired	
Comments:	ADDITIONAL SECONDARY GLAZING REQUIRED	
Heritage Comments:	Early-Twentieth Century

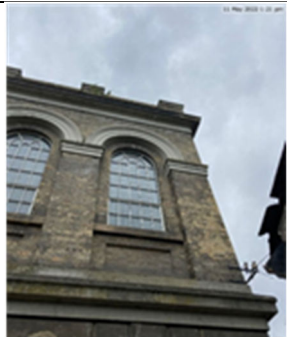
Reference:	W-42 (TYPE-12)

Location:	ELEVATION 2	
Description:	Metal, inward + outward opening, single glazed	
Condition:	2	
Damage:	None	
Proposal:	Retained / Repaired	
Comments:	ADDITIONAL SECONDARY GLAZING REQUIRED	
Heritage Comments:	Early-Twentieth Century

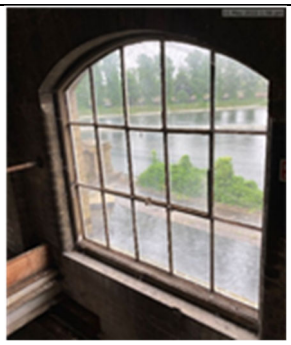
Reference:	W-44 (TYPE-11)

Location:	ELEVATION 1	
Description:	Metal / Timber, inward + outward opening, single glazed	
Condition:	5	
Damage:	Metal rusted, glazing, timber, paint defects	
Proposal:	Retained / Repaired	
Comments:	ADDITIONAL SECONDARY GLAZING REQUIRED	
Heritage Comments:	Late-Nineteenth Century

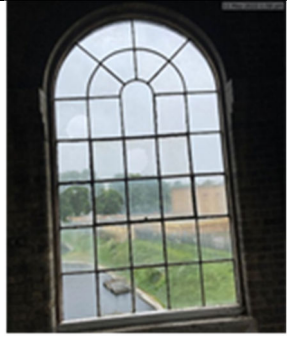
Reference:	W-46 (TYPE-10)

Location:	ELEVATION 1	
Description:	Metal / Timber, inward + outward opening, single glazed	
Condition:	5	
Damage:	Metal rusted, glazing, timber, paint defects	
Proposal:	Retained / Repaired	
Comments:	ADDITIONAL SECONDARY GLAZING REQUIRED	
Heritage Comments:	Late-Nineteenth Century

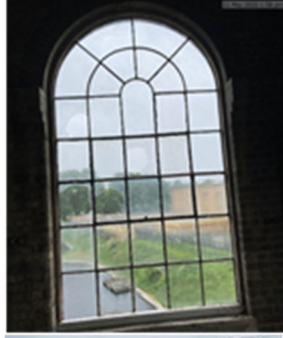
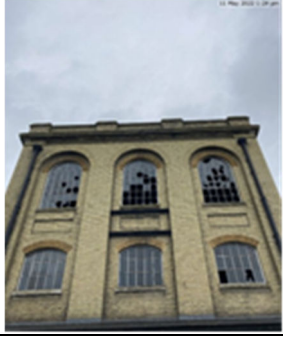
Reference:	W-47 (TYPE-10)	
Location:	ELEVATION 1	
Description:	Metal / Timber, inward + outward opening, single glazed	
Condition:	5	
Damage:	Metal rusted, glazing, timber, paint defects	
Proposal:	Retained / Repaired

Comments:	ADDITIONAL SECONDARY GLAZING REQUIRED

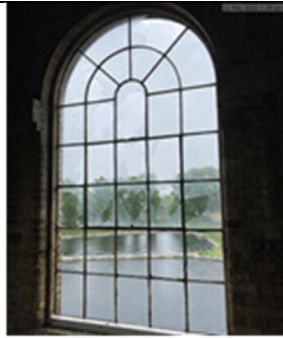
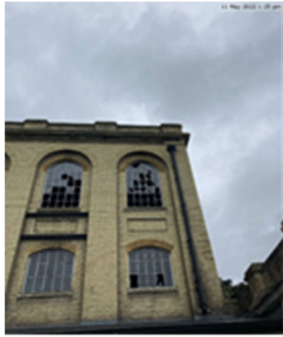
Reference:	W-48 (TYPE-10)

Location:	ELEVATION 1	
Description:	Metal / Timber, inward + outward opening, single glazed	
Condition:	5	
Damage:	Metal rusted, glazing, timber, paint defects	
Proposal:	Retained / Repaired	
Comments:	ADDITIONAL SECONDARY GLAZING REQUIRED	
Heritage Comments:	Late-Nineteenth Century

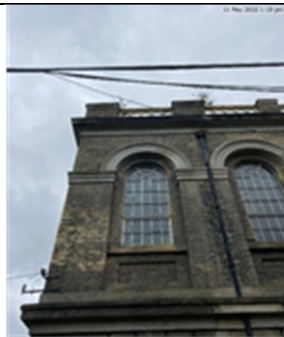
Reference:	W-49 (TYPE-12)	
Location:	ELEVATION 3	
Description:	Metal, inward + outward opening, single glazed	
Condition:	2	
Damage:	None	
Proposal:	Retained / Repaired

Comments:	ADDITIONAL SECONDARY GLAZING REQUIRED

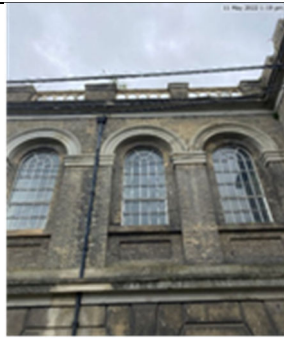
Reference:	W-50 (TYPE-12)

Location:	ELEVATION 3	
Description:	Metal, inward + outward opening, single glazed	
Condition:	2	
Damage:	None	
Proposal:	Retained / Repaired	
Comments:	ADDITIONAL SECONDARY GLAZING REQUIRED	
Heritage Comments:	Early-Twentieth Century

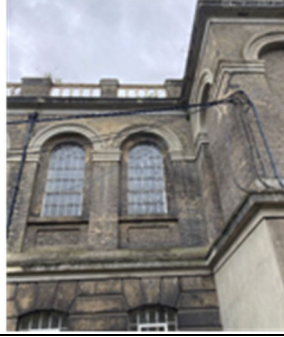
Reference:	W-51 (TYPE-12)

Location:	ELEVATION 3	
Description:	Metal, inward + outward opening, single glazed	
Condition:	2	
Damage:	None	
Proposal:	Retained / Repaired	
Comments:	ADDITIONAL SECONDARY GLAZING REQUIRED	
Heritage Comments:	Early-Twentieth Century

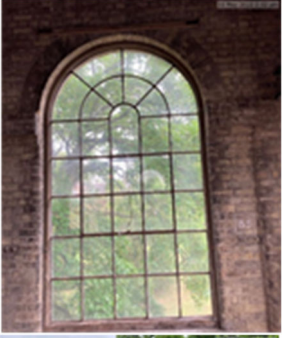
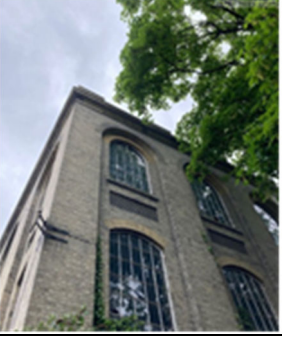
Reference:	W-52 (TYPE-10)	
Location:	ELEVATION 3	
Description:	Metal / Timber, inward + outward opening, single glazed	
Condition:	5	
Damage:	Metal rusted, glazing, timber, paint defects	
Proposal:	Retained / Repaired

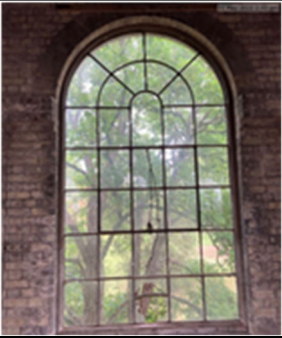
Reference:	W-53 (TYPE-10)

Location:	ELEVATION 3	
Description:	Metal / Timber, inward + outward opening, single glazed	
Condition:	5	
Damage:	Metal rusted, glazing, timber, paint defects	
Proposal:	Retained / Repaired	
Comments:		
Heritage Comments:	Late-Nineteenth Century

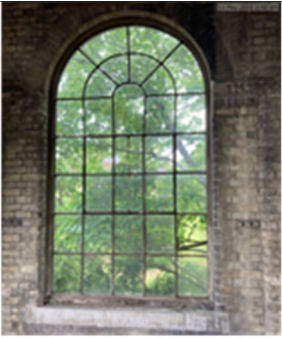
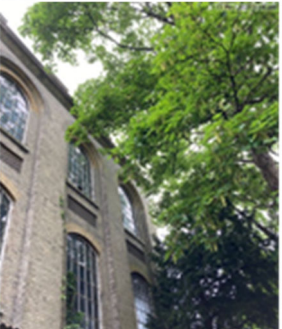
Reference:	W-54 (TYPE-10)

Location:	ELEVATION 3	
Description:	Metal / Timber, inward + outward opening, single glazed	
Condition:	5	
Damage:	Metal rusted, glazing, timber, paint defects	
Proposal:	Retained / Repaired	
Comments:
