Condition Survey Photo Record Schedule of Repairs – Ruston & Ward Windows

Client Waterfall Planning Ltd
Project Hampton Water Works
Subject Ruston & Ward Condition Survey - Window Photo Record
Date 26.05.2023
Revision A
Job no. 1685
Reference 1685-A-P606 Ruston & Ward Window Photo Record

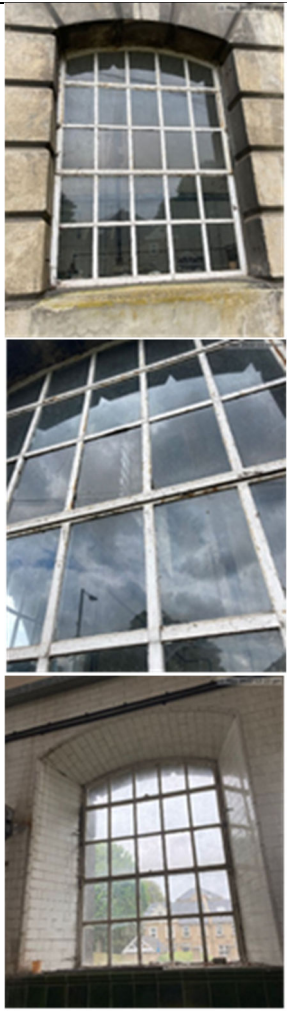
Reference:	W-01 (TYPE-13)

Location:	ELEVATION 1	
Description:	Metal, inward + outward opening, single glazed	
Condition:	3	
Damage:	Metal rusted, paint defects	
Proposal:	Replaced	
Comments:	NEW DOUBLE-GLAZED ALUMINIUM / CRITTALL WINDOW TO MATCH	
Heritage Comments:	Early-Twentieth Century

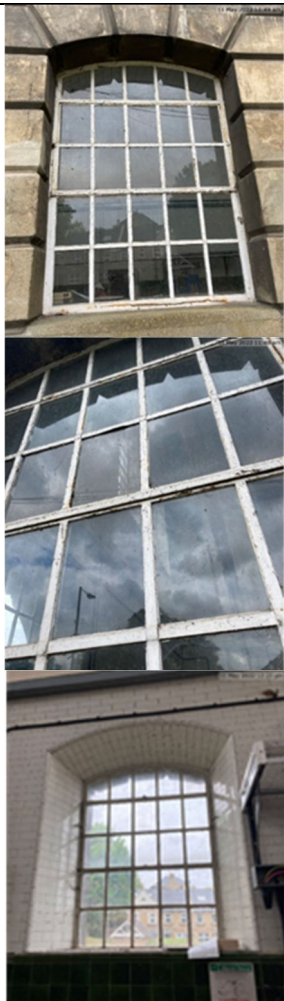
Reference:	W-02 (TYPE-13)	
Location:	ELEVATION 1	
Description:	Metal, inward + outward opening, single glazed	
Condition:	3	
Damage:	Metal rusted, paint defects	
Proposal:	Replaced

Comments:	NEW DOUBLE-GLAZED ALUMINIUM / CRITTALL WINDOW TO MATCH

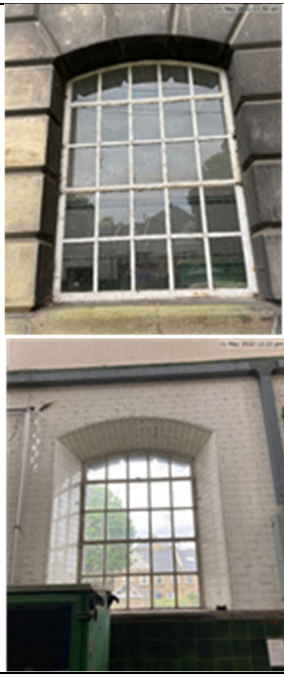
Reference:	W-03 (TYPE-13)

Location:	ELEVATION 1	
Description:	Metal, inward + outward opening, single glazed	
Condition:	3	
Damage:	Metal rusted, paint defects	
Proposal:	Replaced	
Comments:	NEW DOUBLE-GLAZED ALUMINIUM / CRITTALL WINDOW TO MATCH	
Heritage Comments:	Early-Twentieth Century

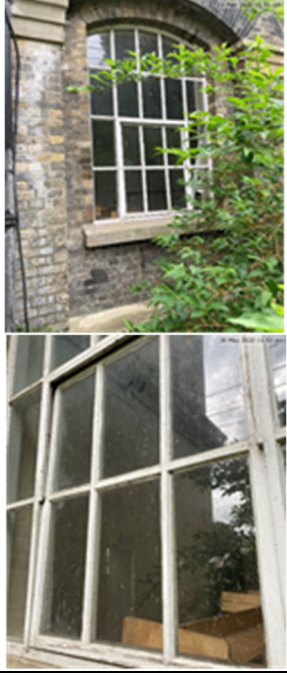
Reference:	W-04 (TYPE-14)

Location:	ELEVATION 1	
Description:	Timber, inward + outward opening, single glazed	
Condition:	2 / 6	
Damage:	Paint defects	
Proposal:	Replaced	
Comments:	Replaced by proposed new door. Type 21, D-50	
Heritage Comments:	Early-Twentieth Century

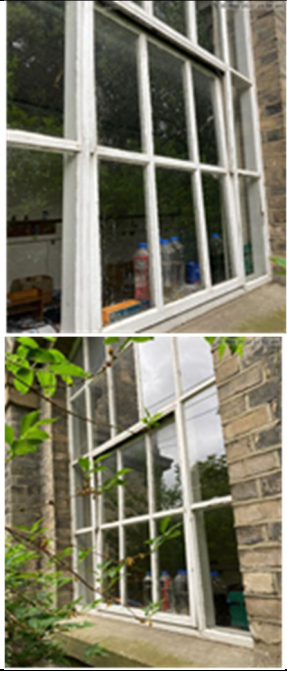
Reference:	W-05 (TYPE-14)

Location:	ELEVATION 1	
Description:	Timber, inward + outward opening, single glazed	
Condition:	2	
Damage:	Paint defects	
Proposal:	Replaced	
Comments:	NEW DOUBLE-GLAZED ALUMINIUM / CRITTALL WINDOW TO MATCH	
Heritage Comments:	Early-Twentieth Century

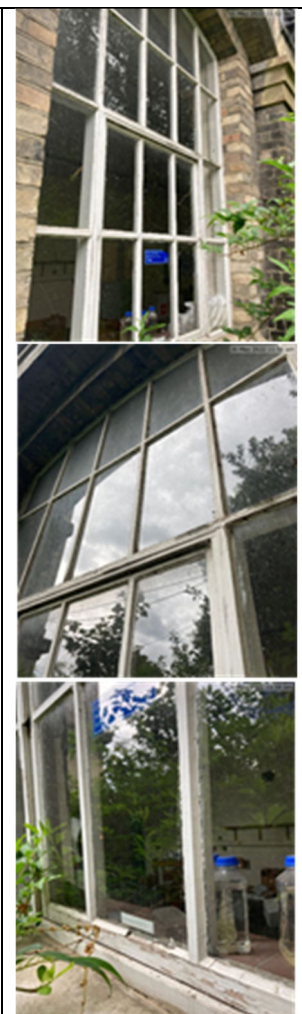
Reference:	W-06 (TYPE-14)	
Location:	ELEVATION 1	
Description:	Timber, inward + outward opening, single glazed	
Condition:	3 / 6	
Damage:	Timber, paint defects	
Proposal:	Replaced

Comments:	Replaced by proposed new door. Type 21, D-51

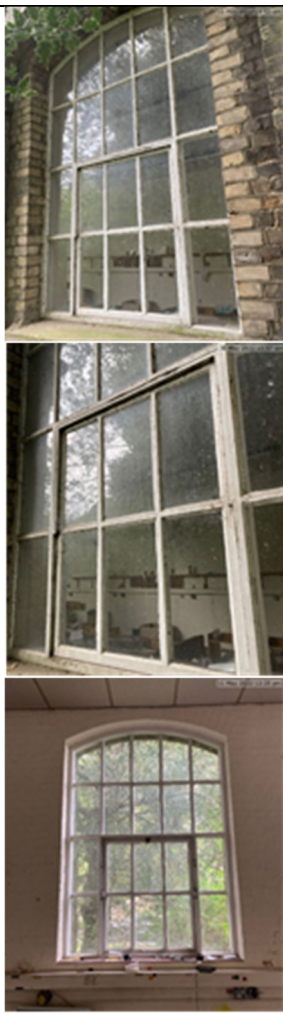
Reference:	W-07 (TYPE-14)	
Location:	ELEVATION 1	
Description:	Timber, inward + outward opening, single glazed	
Condition:	2	
Damage:	Paint defects	
Proposal:	Replaced

Comments:	NEW DOUBLE-GLAZED ALUMINIUM / CRITTALL WINDOW TO MATCH

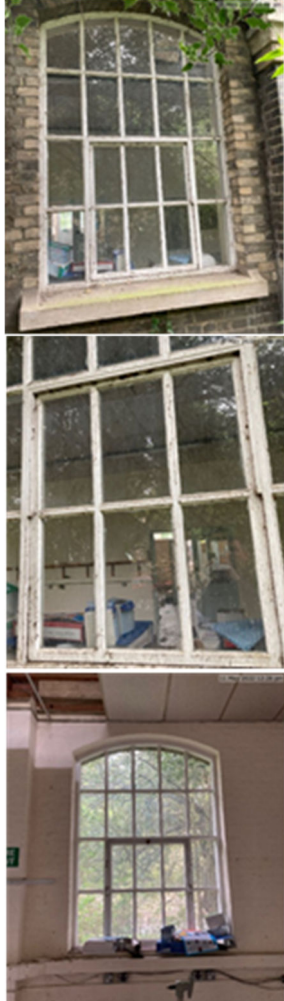
Reference:	W-08 (TYPE-14)	
Location:	ELEVATION 1	
Description:	Timber, inward + outward opening, single glazed	
Condition:	2/ 6	
Damage:	Paint defects	
Proposal:	Replaced

Comments:	Replaced by proposed new door. Type 21, D-52

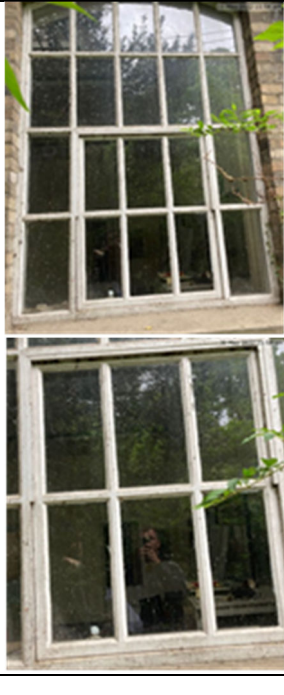
Reference:	W-09 (TYPE-14)

Location:	ELEVATION 1	
Description:	Timber, inward + outward opening, single glazed	
Condition:	2	
Damage:	Paint defects	
Proposal:	Replaced	
Comments:	NEW DOUBLE-GLAZED ALUMINIUM / CRITTALL WINDOW TO MATCH	
Heritage Comments:	Early-Twentieth Century

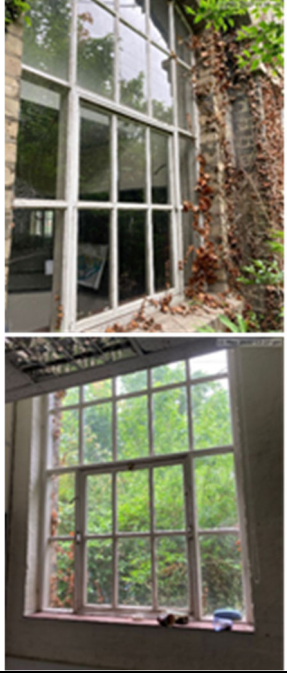
Reference:	W-10 (TYPE-14)

Location:	ELEVATION 1	
Description:	Timber, inward + outward opening, single glazed	
Condition:	2	
Damage:	Paint defects	
Proposal:	Replaced	
Comments:	NEW DOUBLE-GLAZED ALUMINIUM / CRITTALL WINDOW TO MATCH	
Heritage Comments:	Early-Twentieth Century

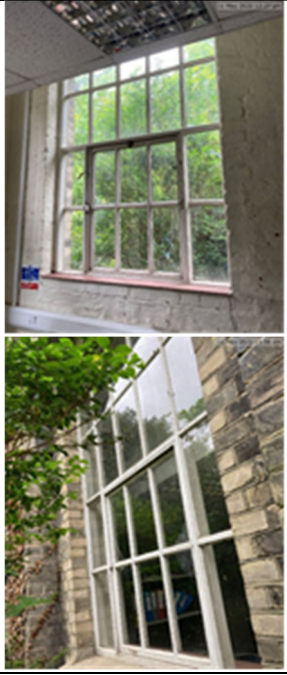
Reference:	W-11 (TYPE-14)

Location:	ELEVATION 1	
Description:	Timber, inward + outward opening, single glazed	
Condition:	2	
Damage:	Paint defects	
Proposal:	Replaced	
Comments:	NEW DOUBLE-GLAZED ALUMINIUM / CRITTALL WINDOW TO MATCH	
Heritage Comments:	Early-Twentieth Century

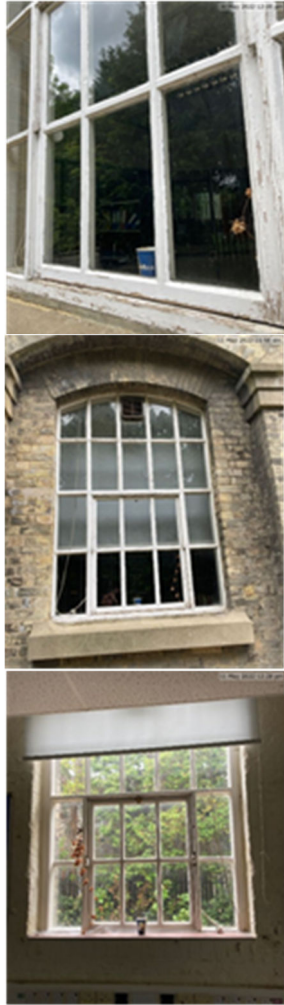
Reference:	W-12 (TYPE-15)	
Location:	ELEVATION 2	
Description:	Timber, inward + outward opening, single glazed	
Condition:	3	
Damage:	Timber, paint defects	
Proposal:	Replaced

Comments:	NEW DOUBLE-GLAZED ALUMINIUM / CRITTALL WINDOW TO MATCH

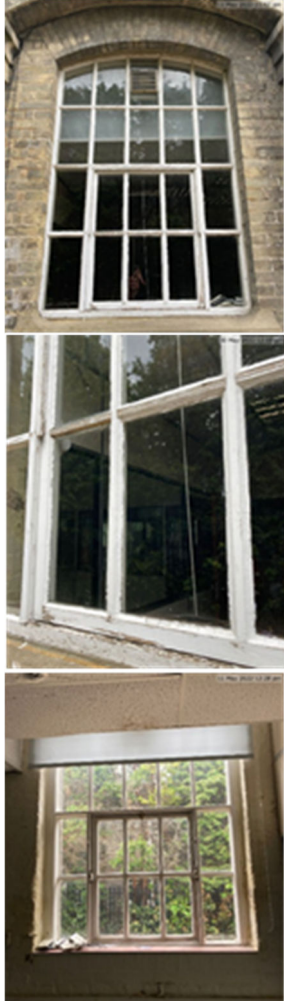
Reference:	W-13 (TYPE-15)	
Location:	ELEVATION 2	
Description:	Timber, inward + outward opening, single glazed	
Condition:	3	
Damage:	Timber, paint defects	
Proposal:	Replaced

Comments:	NEW DOUBLE-GLAZED ALUMINIUM / CRITTALL WINDOW TO MATCH

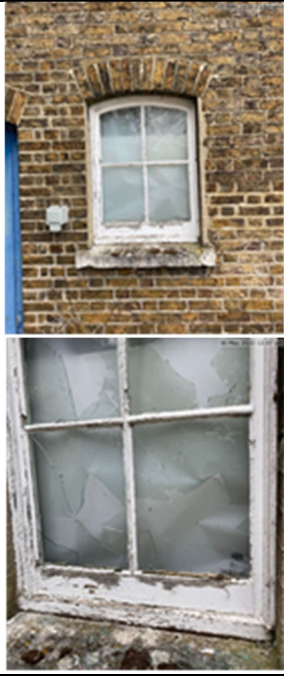
Reference:	W-14 (TYPE-16)

Location:	ELEVATION 2	
Description:	Timber, fixed, single glazed	
Condition:	5	
Damage:	Timber, paint defects	
Proposal:	Replaced	
Comments:	NEW DOUBLE-GLAZED ALUMINIUM / CRITTALL WINDOW TO MATCH	
Heritage Comments:	Early-Twentieth Century

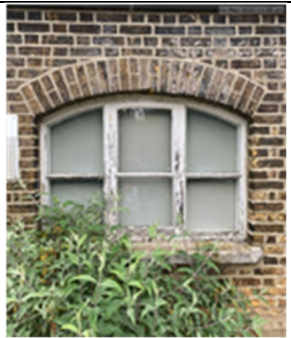
Reference:	W-16 (TYPE-18)

Location:	ELEVATION 3	
Description:	Timber, outward opening, single glazed	
Condition:	5	
Damage:	Timber, paint defects	
Proposal:	Replaced	
Comments:	NEW DOUBLE-GLAZED ALUMINIUM / CRITTALL WINDOW TO MATCH	
Heritage Comments:	Early-Twentieth Century

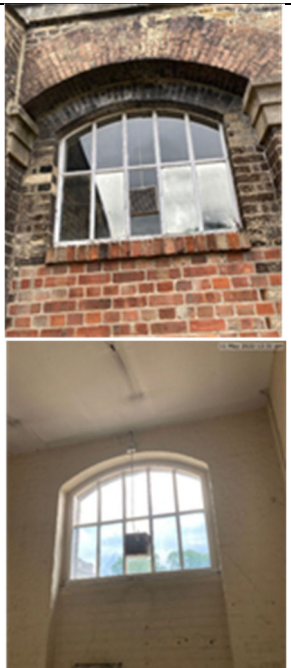
Reference:	W-17 (TYPE-05)

Location:	ELEVATION 3	
Description:	Timber, fixed, single glazed, vent	
Condition:	4 / 6	
Damage:	Timber, paint defects	
Proposal:	Replaced	
Comments:	Replaced by proposed new window. Type 35,W-101

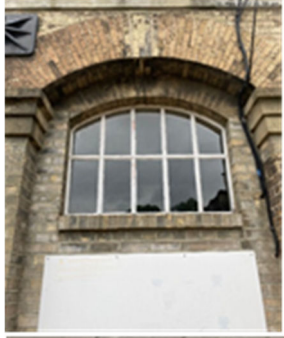
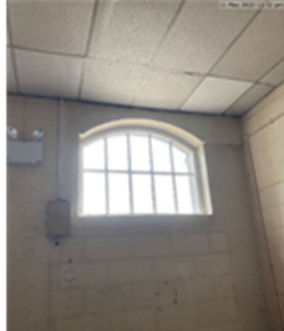
Reference:	W-18 (TYPE-05)

Location:	ELEVATION 3	
Description:	Timber, fixed, single glazed	
Condition:	3 / 6	
Damage:	Timber, paint defects	
Proposal:	Replaced	
Comments:	replaced by proposed new window. Type 35,W-102	
Heritage Comments:	Early-Twentieth Century

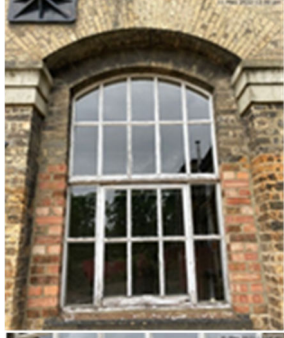
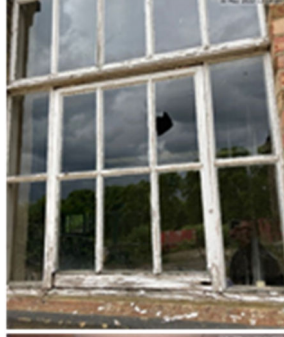
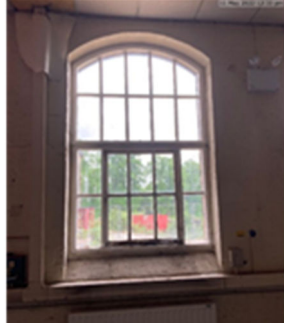
Reference:	W-19 (TYPE-17)

Location:	ELEVATION 3	
Description:	Timber, inward + outward opening, single glazed	
Condition:	4	
Damage:	Timber, paint defects	
Proposal:	Replaced	
Comments:	NEW DOUBLE-GLAZED ALUMINIUM / CRITTALL WINDOW TO MATCH	
Heritage Comments:

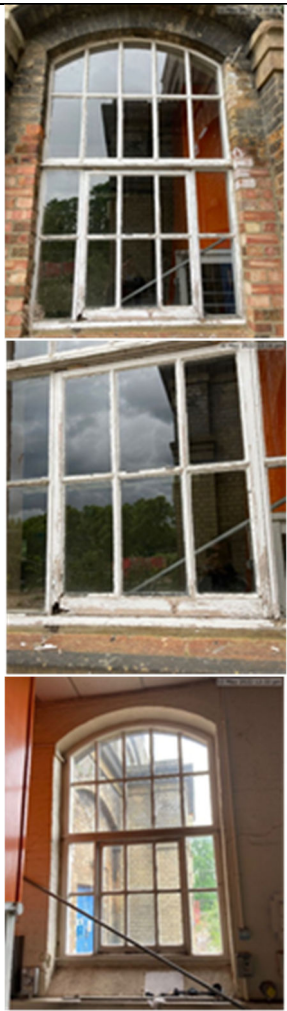
Reference:	W-20 (TYPE-17)

Location:	ELEVATION 3	
Description:	Timber, inward + outward opening, single glazed	
Condition:	4	
Damage:	Timber, paint defects	
Proposal:	Replaced	
Comments:	NEW DOUBLE-GLAZED ALUMINIUM / CRITTALL WINDOW TO MATCH	
Heritage Comments:	Early-Twentieth Century

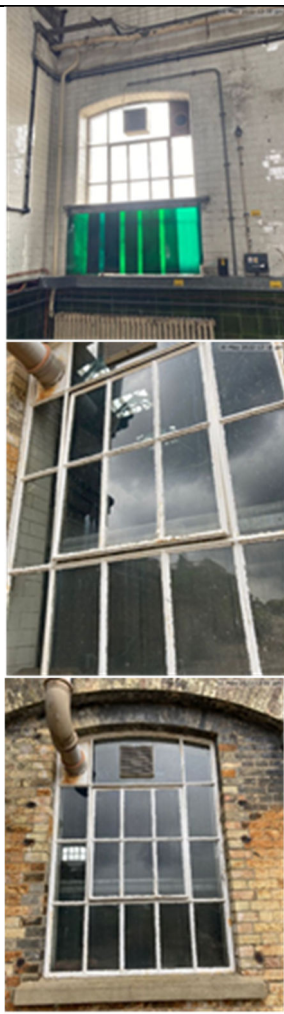
Reference:	W-21 (TYPE-17)	
Location:	ELEVATION 4	
Description:	Metal, inward + outward opening, single glazed, vent, flue	
Condition:	3	
Damage:	Metal rusted, paint defects	
Proposal:	Retained / Repaired

Comments:	Retained - vent & flue removed. re-glazed. ADDITIONAL SECONDARY GLAZING REQUIRED

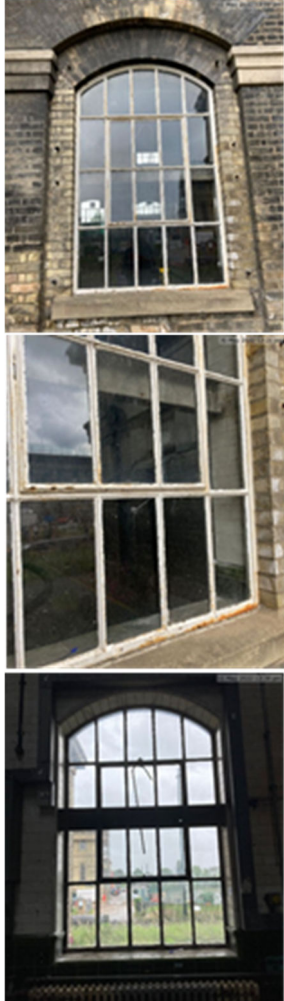
Reference:	W-36 (TYPE-22)	
Location:	ELEVATION 6	
Description:	Metal, inward + outward opening, single glazed	
Condition:	3	
Damage:	Metal rusted, paint defects	
Proposal:	Retained / Repaired

Comments:	ADDITIONAL SECONDARY GLAZING REQUIRED

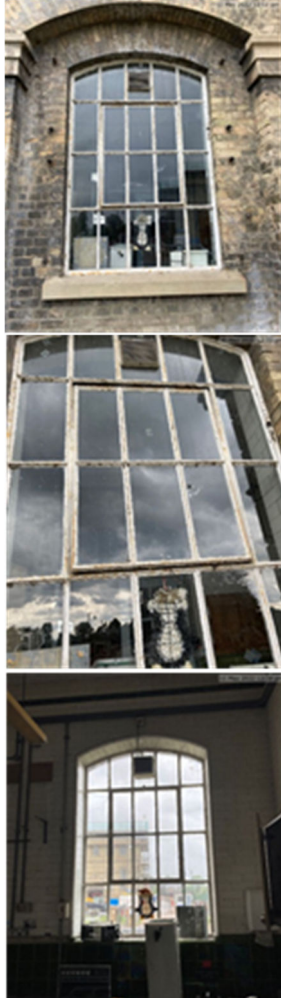
Reference:	W-37 (TYPE-23)	
Location:	ELEVATION 6	
Description:	Metal, inward + outward opening, single glazed, vent	
Condition:	3	
Damage:	Metal rusted, paint defects	
Proposal:	Retained / Repaired

Comments:	Retained - vent removed & re-glazed. ADDITIONAL SECONDARY GLAZING REQUIRED

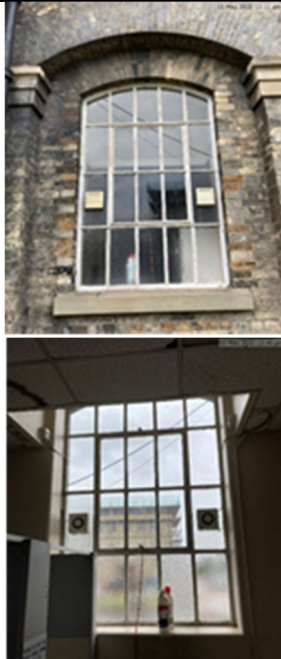
Reference:	W-38 (TYPE-23)

Location:	ELEVATION 6	
Description:	Metal, inward + outward opening, single glazed, vents	
Condition:	3	
Damage:	Metal rusted, paint defects	
Proposal:	Retained / Repaired	
Comments:	Retained - vent removed & re-glazed. ADDITIONAL SECONDARY GLAZING REQUIRED	
Heritage Comments:	Late-Nineteenth Century

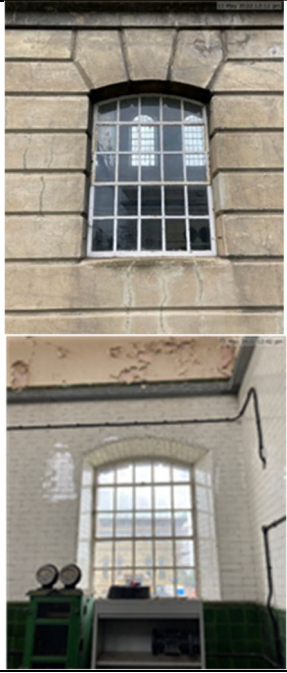
Reference:	W-39 (TYPE-13)

Location:	ELEVATION 6	
Description:	Metal, inward + outward opening, single glazed	
Condition:	3	
Damage:	Metal rusted, paint defects	
Proposal:	Replaced	
Comments:	NEW DOUBLE-GLAZED ALUMINIUM / CRITTALL WINDOW TO MATCH	
Heritage Comments:	Early-Twentieth Century

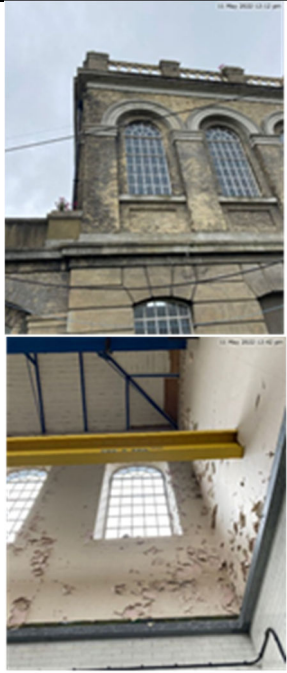
Reference:	W-40 (TYPE-24)

Location:	ELEVATION 6	
Description:	Metal, inward + outward opening, single glazed	
Condition:	3	
Damage:	Metal rusted, timber, paint defects	
Proposal:	Replaced	
Comments:	NEW DOUBLE-GLAZED ALUMINIUM / CRITTALL WINDOW TO MATCH	
Heritage Comments:	Early-Twentieth Century

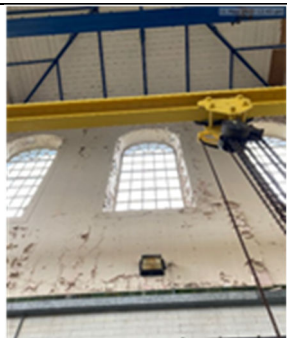
Reference:	W-41 (TYPE-24)	
Location:	ELEVATION 6	
Description:	Metal, inward + outward opening, single glazed	
Condition:	3	
Damage:	Metal rusted, paint defects	
Proposal:	Replaced

Comments:	NEW DOUBLE-GLAZED ALUMINIUM / CRITTALL WINDOW TO MATCH

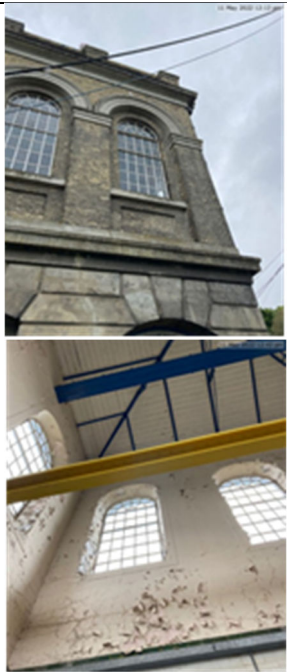
Reference:	W-42 (TYPE-24)

Location:	ELEVATION 6	
Description:	Metal, inward + outward opening, single glazed	
Condition:	3	
Damage:	Metal rusted, paint defects	
Proposal:	Replaced	
Comments:	NEW DOUBLE-GLAZED ALUMINIUM / CRITTALL WINDOW TO MATCH	
Heritage Comments:	Early-Twentieth Century

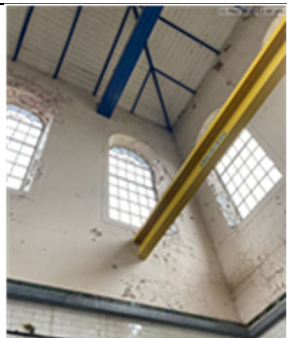
Reference:	W-43 (TYPE-24)

Location:	ELEVATION 1	
Description:	Metal, inward + outward opening, single glazed	
Condition:	3	
Damage:	Metal rusted, paint defects	
Proposal:	Replaced	
Comments:	NEW DOUBLE-GLAZED ALUMINIUM / CRITTALL WINDOW TO MATCH	
Heritage Comments:	Early-Twentieth Century

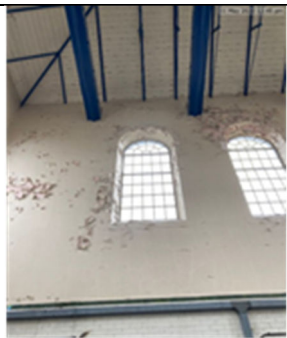
Reference:	W-45 (TYPE-24)

Location:	ELEVATION 1	
Description:	Metal, inward + outward opening, single glazed	
Condition:	3	
Damage:	Metal rusted, paint defects	
Proposal:	Replaced	
Comments:	NEW DOUBLE-GLAZED ALUMINIUM / CRITTALL WINDOW TO MATCH	
Heritage Comments:	Early-Twentieth Century

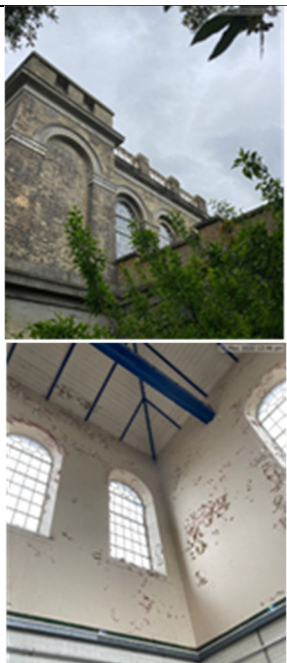
Reference:	W-46 (TYPE-24)

Location:	ELEVATION 7	
Description:	Metal, inward + outward opening, single glazed	
Condition:	3	
Damage:	Metal rusted, paint defects	
Proposal:	Replaced	
Comments:	NEW DOUBLE-GLAZED ALUMINIUM / CRITTALL WINDOW TO MATCH

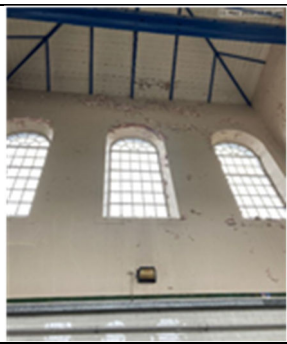
Reference:	W-47 (TYPE-24)

Location:	ELEVATION 7	
Description:	Metal, inward + outward opening, single glazed	
Condition:	3	
Damage:	Metal rusted, paint defects	
Proposal:	Retained / Repaired	
Comments:	ADDITIONAL SECONDARY GLAZING REQUIRED	
Heritage Comments:	Early-Twentieth Century

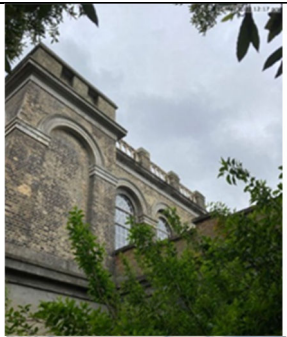
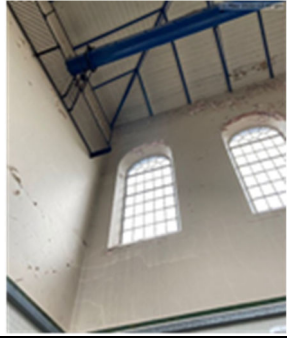
Reference:	W-48 (TYPE-24)

Location:	ELEVATION 7	
Description:	Metal, inward + outward opening, single glazed	
Condition:	3 / 6	
Damage:	Metal rusted, paint defects	
Proposal:	Replaced	
Comments:	replaced by proposed new window. Type 33,W-105	
Heritage Comments:	Early-Twentieth Century

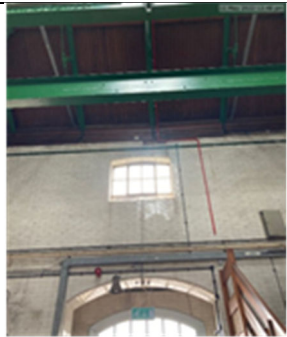
Reference:	W-49 (TYPE-25)

Location:	ELEVATION 4	
Description:	Metal, inward + outward opening, single glazed	
Condition:	3	
Damage:	Metal rusted, paint defects	
Proposal:	Retained / Repaired	
Comments:	ADDITIONAL SECONDARY GLAZING REQUIRED	
Heritage Comments:	Late-Nineteenth Century

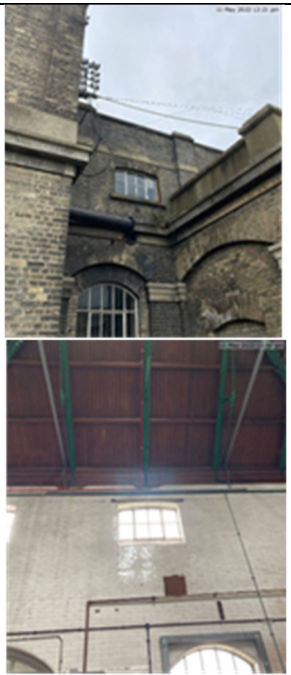
Reference:	W-50 (TYPE-25)	
Location:	ELEVATION 6	
Description:	Metal, inward + outward opening, single glazed

Condition:	3

Damage:	Metal rusted, paint defects	
Proposal:	Retained / Repaired	
Comments:	ADDITIONAL SECONDARY GLAZING REQUIRED	
Heritage Comments:	Late-Nineteenth Century

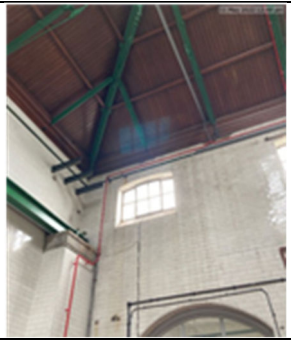
Reference:	W-51 (TYPE-25)

Location:	ELEVATION 6	
Description:	Metal, inward + outward opening, single glazed	
Condition:	3	
Damage:	Metal rusted, paint defects	
Proposal:	Retained / Repaired	
Comments:	ADDITIONAL SECONDARY GLAZING REQUIRED	
Heritage Comments:	Late-Nineteenth Century
