Condition Survey Photo Record

Schedule of Repairs – Karslake Doors

Client Waterfall Planning Ltd
Project Hampton Water Works
Subject Karslake Condition Survey - Door Photo Record
Date 26.05.2023
Revision A
Job no. 1685
Reference 1685-A-P607 Karslake Door Photo Record

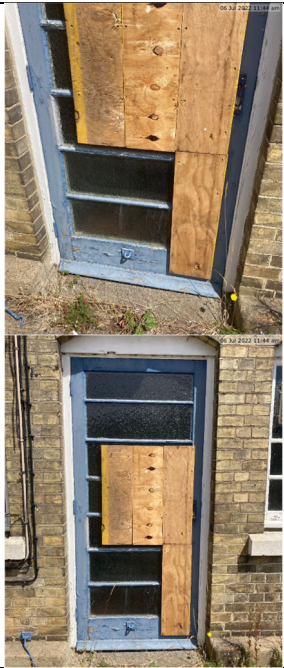
Reference:	D-01 (TYPE-01)

Location:	ELEVATION 1	
Description:	Timber, single leaf, single glazed panes	
Condition:	4	
Damage:	Timber, paint defects, glazing	
Proposal:	Replaced	
Comments:		
Heritage Comments:	Early-Twentieth Century

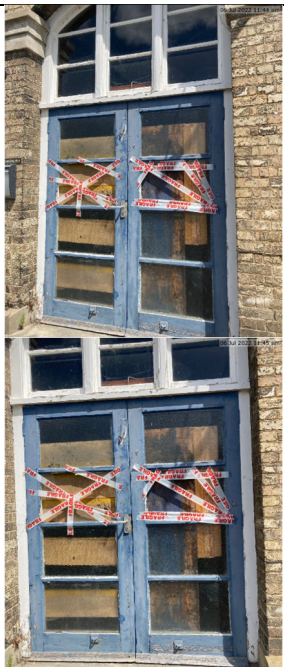
Reference:	D-02 (TYPE-02)

Location:	ELEVATION 1	
Description:	Timber, double leaf, glazed panes	
Condition:	4	
Damage:	Timber, paint defects, glazing	
Proposal:	Replaced	
Comments:		
Heritage Comments:	Early-Twentieth Century

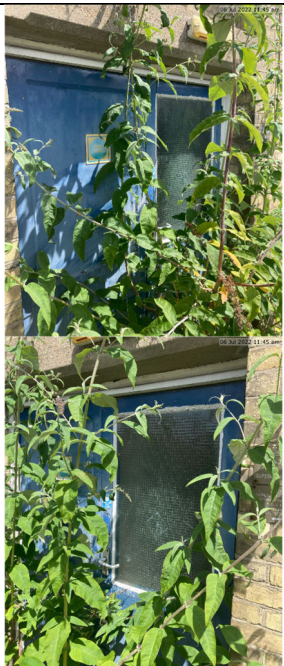
Reference:	D-03 (TYPE-03)	
Location:	ELEVATION 1	
Description:	Timber, double leaf	
Condition:	4	
Damage:	Timber, paint defects	
Proposal:	Replaced

Heritage Comments:	Early-Twentieth Century

Comments:	Replaced by proposed new door & window. Door Type 19, D-51 & Window Type 27, W-101

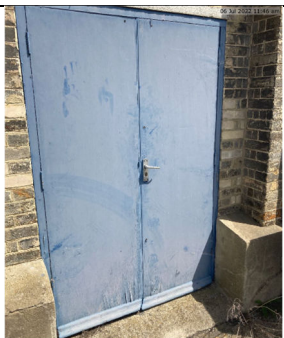
Reference:	D-04 (TYPE-04)

Location:	ELEVATION 1	
Description:	Timber, double leaf, vent	
Condition:	4	
Damage:	Timber, paint defects	
Proposal:	Replaced	
Comments:	Replaced by proposed new door & window. Door Type 19, D-52 & Window Type 27, W-102	
Heritage Comments:	Early-Twentieth Century

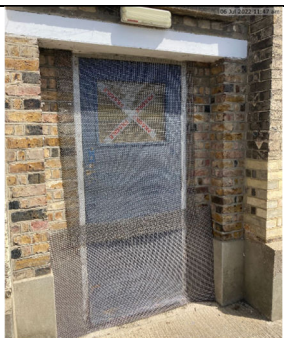
Reference:	D-05 (TYPE-05)

Location:	ELEVATION 1	
Description:	Timber, single leaf, glazed pane	
Condition:	4	
Damage:	Timber, paint defects, glazing	
Proposal:	Replaced	
Comments:	Replaced by proposed new door & window. Door Type 19, D-53 & Window Type 27, W-103	
Heritage Comments:	Early-Twentieth Century

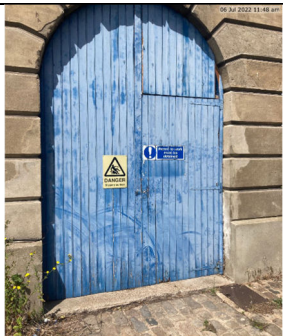
Reference:	D-06 (TYPE-06)	
Location:	ELEVATION 2	
Description:	Timber, single leaf, large opening	
Condition:	4	
Damage:	Timber, paint defects

Proposal:	Replaced

Comments:	Replaced by proposed new window Type 31, W-117	
Heritage Comments:	Early-Twentieth Century

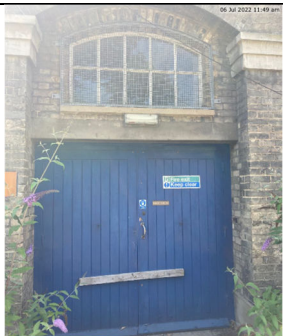
Reference:	D-07 (TYPE-07)

Location:	ELEVATION 3	
Description:	Timber, double leaf	
Condition:	3	
Damage:	Paint defects	
Proposal:	Replaced	
Comments:	Replaced by proposed new door Type 22, D-57	
Heritage Comments:	Early-Twentieth Century

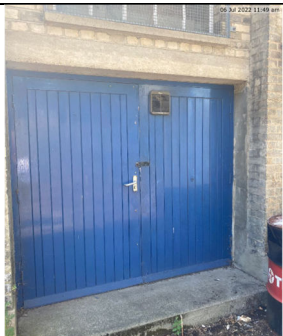
Reference:	D-08 (TYPE-08)

Location:	ELEVATION 4	
Description:	Timber, single leaf	
Condition:	2	
Damage:	Paint defects	
Proposal:	Replaced	
Comments:	Demolished and opening in-filled with matching brickwork	
Heritage Comments:	Early-Twentieth Century

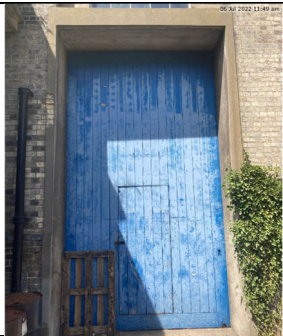
Reference:	D-09 (TYPE-09)

Location:	ELEVATION 5	
Description:	Single leaf, large opening, wood TBC	
Condition:	4	
Damage:	Timber, paint defects	
Proposal:	Replaced	
Comments:	Replaced by proposed new door Type 22, D-59	
Heritage Comments:
