Condition Survey Photo Record Schedule of Repairs – Ruston & Ward Doors

Client Waterfall Planning Ltd
Project Hampton Water Works
Subject Ruston & Ward Condition Survey - Door Photo Record
Date 26.05.2023
Revision A
Job no. 1685
Reference 1685-A-P608 Ruston & Ward Door Photo Record

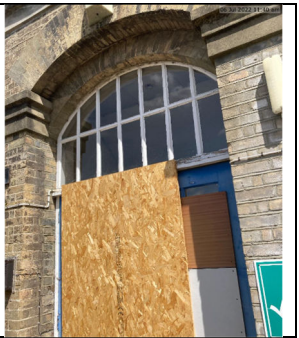
Reference:	D-03 (TYPE-12)	
Location:	ELEVATION 3	
Description:	Timber, double leaf	
Condition:	4	
Damage:	Timber, paint defects, glazing	
Proposal:	Replaced	
Comments:		
Heritage Comments:

Heritage Comments:	Early-Twentieth Century

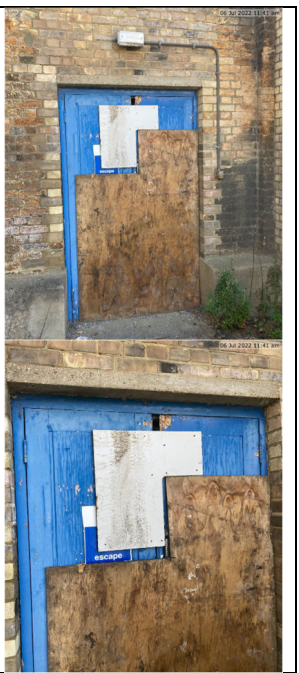
Reference:	D-04 (TYPE-13)

Location:	ELEVATION 4	
Description:	Timber, double leaf	
Condition:	4	
Damage:	Timber, paint defects	
Proposal:	Replaced	
Comments:	Replaced by proposed new window. Window Type 34, W-103	
Heritage Comments:	Early-Twentieth Century

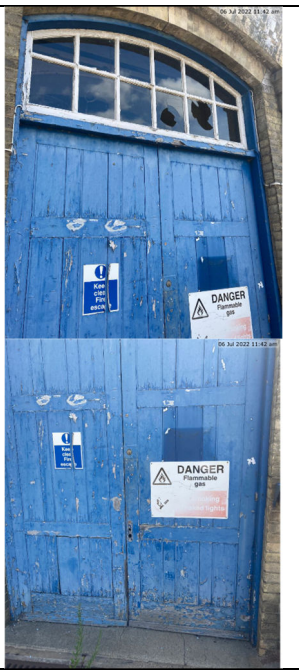
Reference:	D-05 (TYPE-14)

Location:	ELEVATION 4	
Description:	Timber, double leaf	
Condition:	4	
Damage:	Timber, paint defects	
Proposal:	Retained / Repair	
Comments:

Heritage Comments:	Late-Nineteenth Century	
--------------------	-------------------------	--

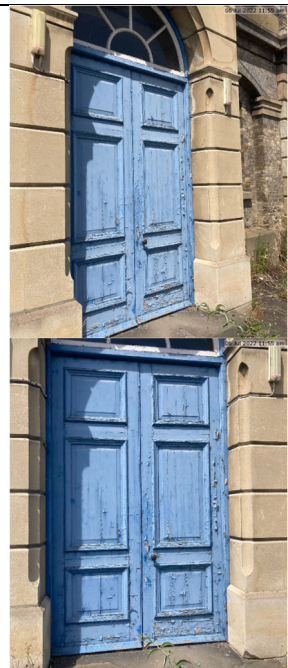
Reference:	D-07 (TYPE-16)

Location:	ELEVATION 6	
Description:	Timber, double leaf	
Condition:	4	
Damage:	Timber, paint defects	
Proposal:	Retained / Repair	
Comments:		
Heritage Comments:	Late-Nineteenth Century

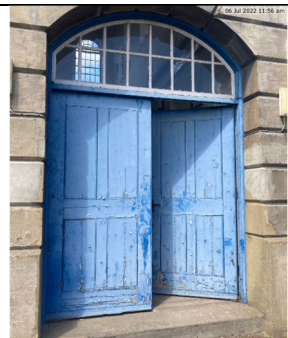
Reference:	D-08 (TYPE-17)

Location:	ELEVATION 6	
Description:	Timber, double leaf	
Condition:	4	
Damage:	Timber, paint defects	
Proposal:	Retained / Repair	
Comments:		
Heritage Comments:	Mid-Nineteenth Century
