# Condition Survey Photo Record Schedule of Repairs – Ruston & Ward Interior

**Client** Waterfall Planning Ltd  
**Project** Hampton Water Works  
**Subject** Ruston & Ward Condition Survey Photo Record – Schedule of Repairs  
**Date** 26.05.2023  
**Revision** A  
**Job no.** 1685  
**Reference** 1685-A-P611 Ruston & Ward Condition Survey – Schedule of Repairs

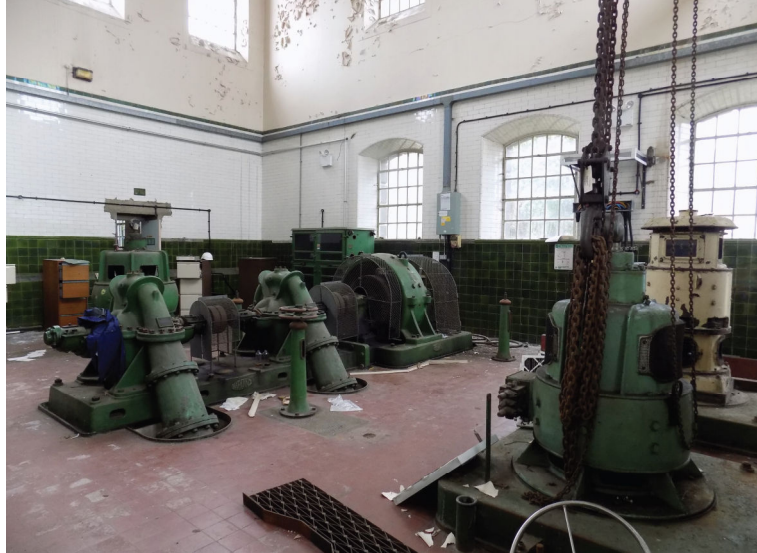
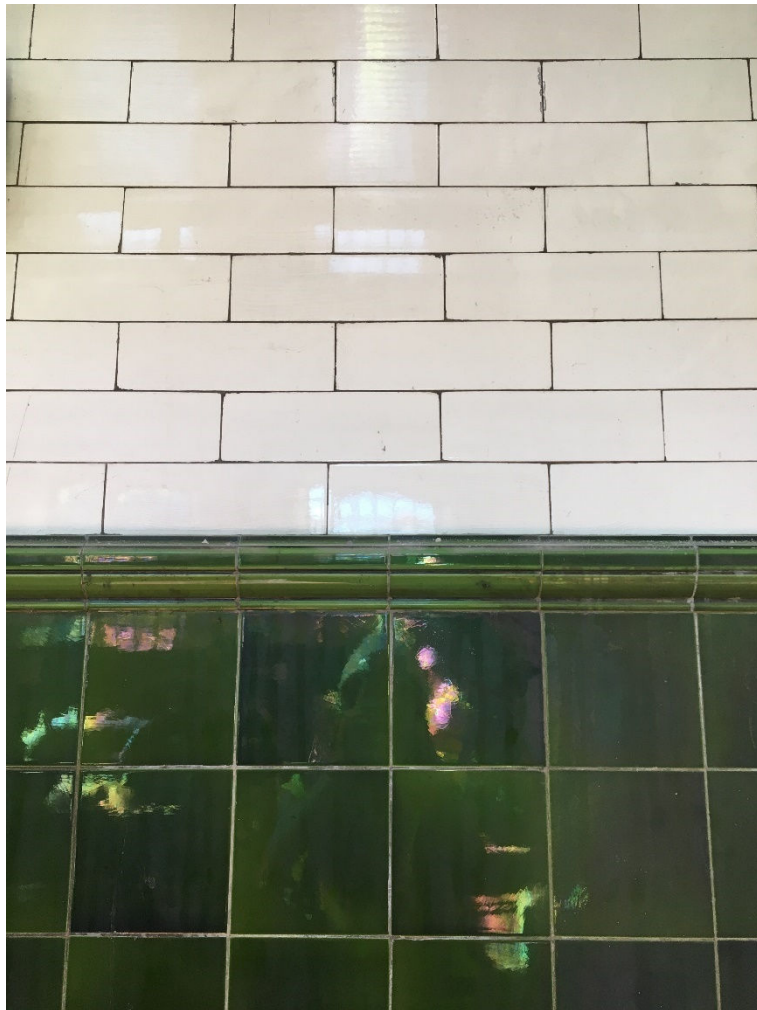
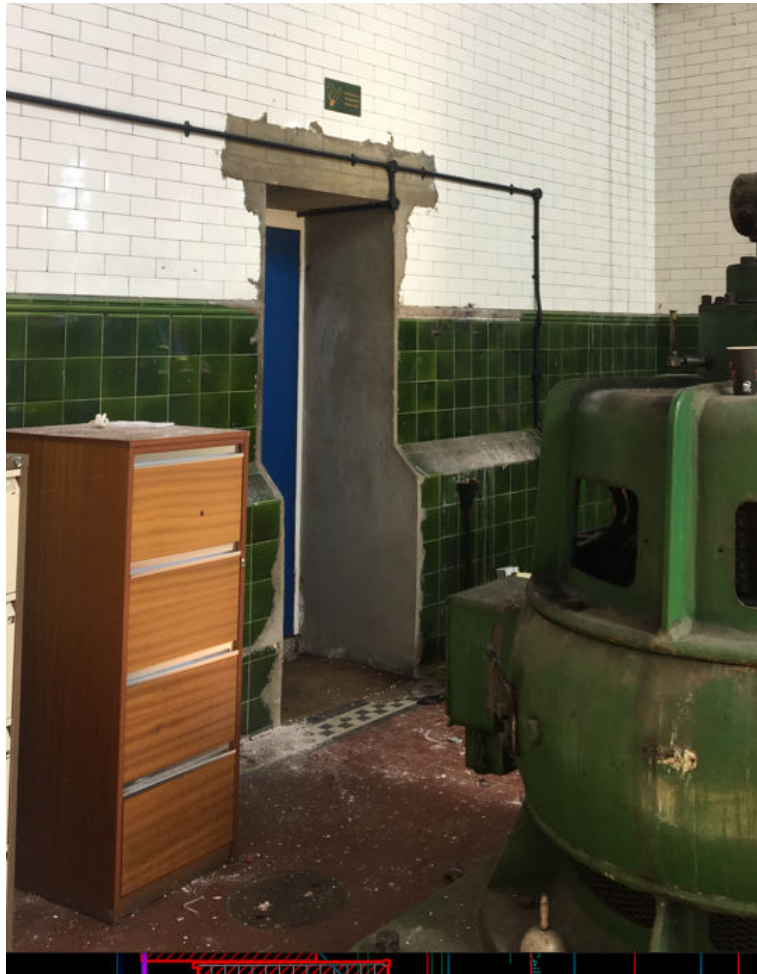
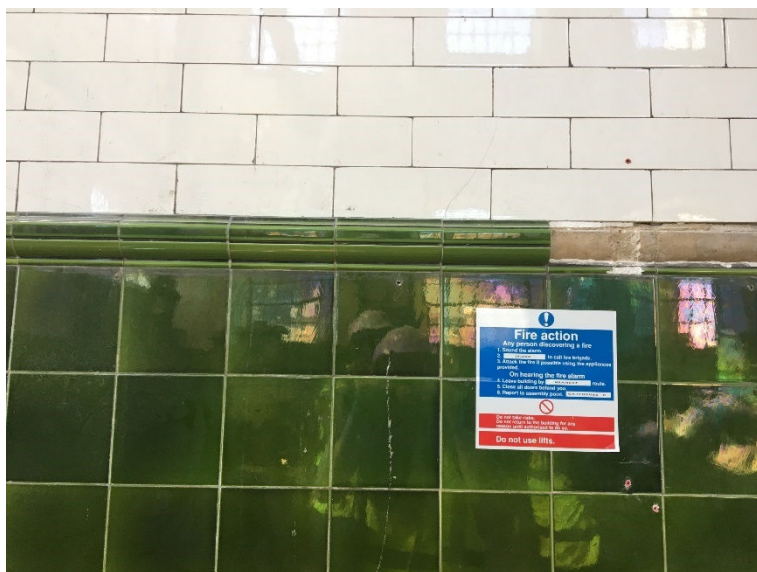
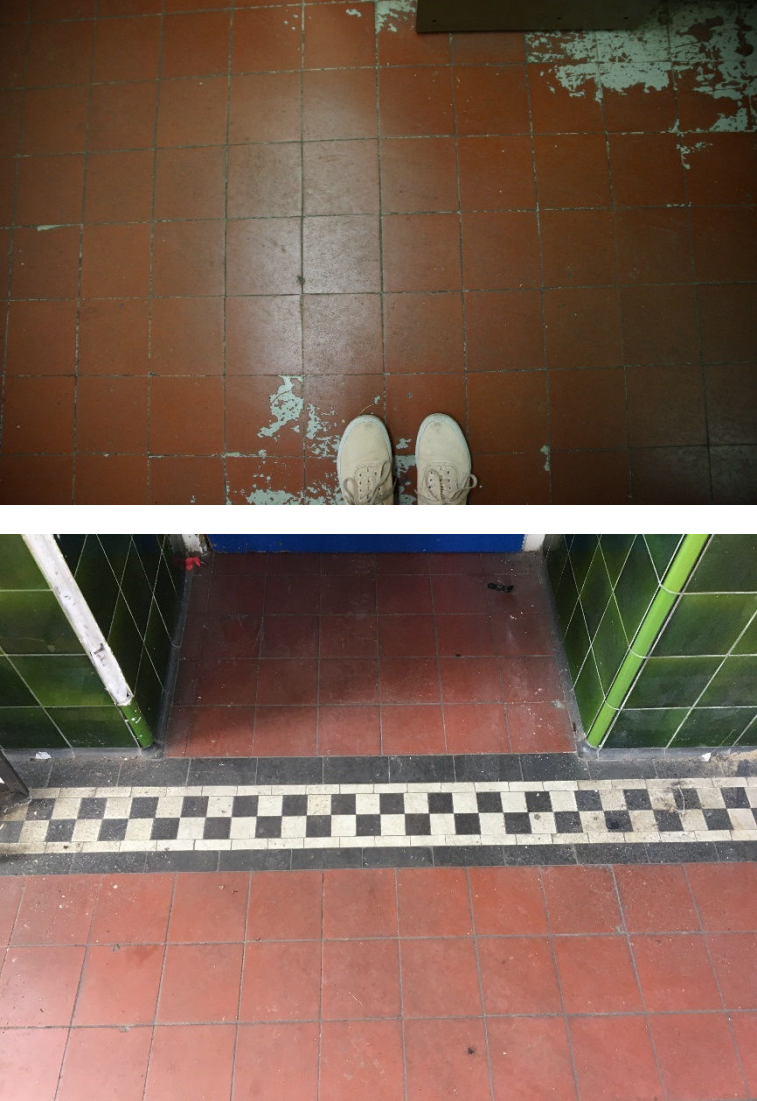
**Figure 1 – Wall tiles / Floor tiles**

Location:	<b>Ruston &amp; Ward - Bull Engine House</b>
Description:	Ruston Ward former Bull engine house with electric pumps installed ca. 1936, with associated flooring and ceramic wall tiles. (Low-medium significance). It is considered that the machinery has a low-medium level of interest and would tolerate relocation and preservation ex situ for interpretation purposes.
Condition:	3
Damage:	Ceramic glazed wall & floor tile defects
Proposal:	Retain in situ and relocate. Retain part in situ and part relocated, replace broken tiles to match existing ceramic wall tiles. Retain and reuse ceramic floor tiles to new location.
Methodology:	Tbc by condition.
Heritage Comments:	<b>LS/MS</b> Low-Medium significance

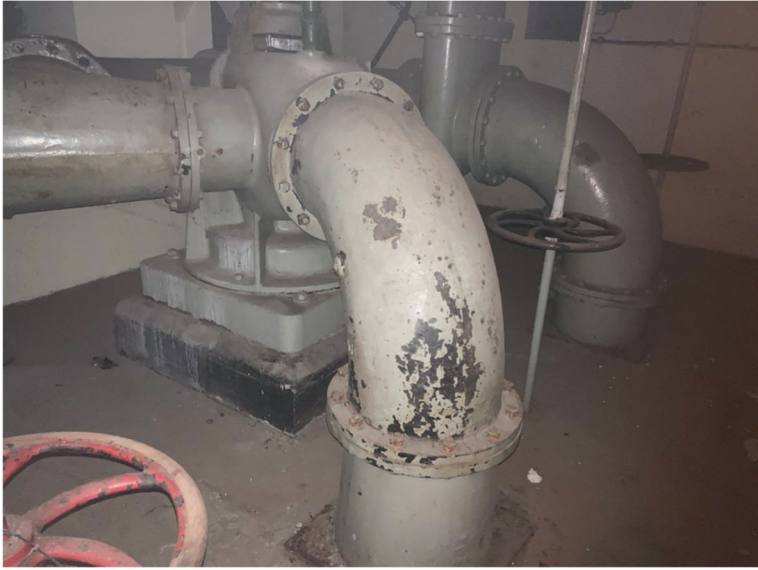
Reference:	<b>Figure 2 – Centrifugal pumps</b>
------------	-------------------------------------

Location:	<b>Ruston &amp; Ward - Bull Engine House</b>
Description:	Pipework for 1932 Harland electric centrifugal pumps below ground floor level, accessed below ground floor level, Ruston & Ward Engine House.
Condition:	<b>3</b>
Damage:	Unknown
Proposal:	Retain and relocate on site. Relocate electric centrifugal pumps with associated machinery and control cabinets
Methodology:	Tbc by condition.
Heritage Comments:	<b>LS/MS</b> Low-Medium significance

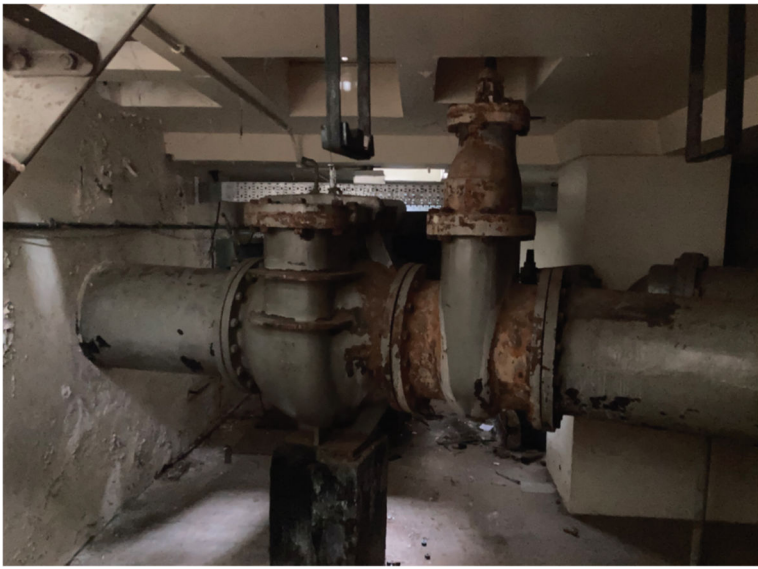
Reference:	<b>Figure 3 - Centrifugal pumps</b>

Location:	<b>Ruston &amp; Ward - Bull Engine House</b>
Description:	Pipework for 1932 Harland electric centrifugal pumps below ground floor level, accessed below ground floor level, Ruston & Ward Engine House.
Condition:	<b>3</b>
Damage:	Unknown

Proposal:	Retain and relocate on site. Relocate electric centrifugal pumps with associated machinery and control cabinets
Methodology:	Tbc by condition.
Heritage Comments:	<b>LS/MS</b> Low-Medium significance

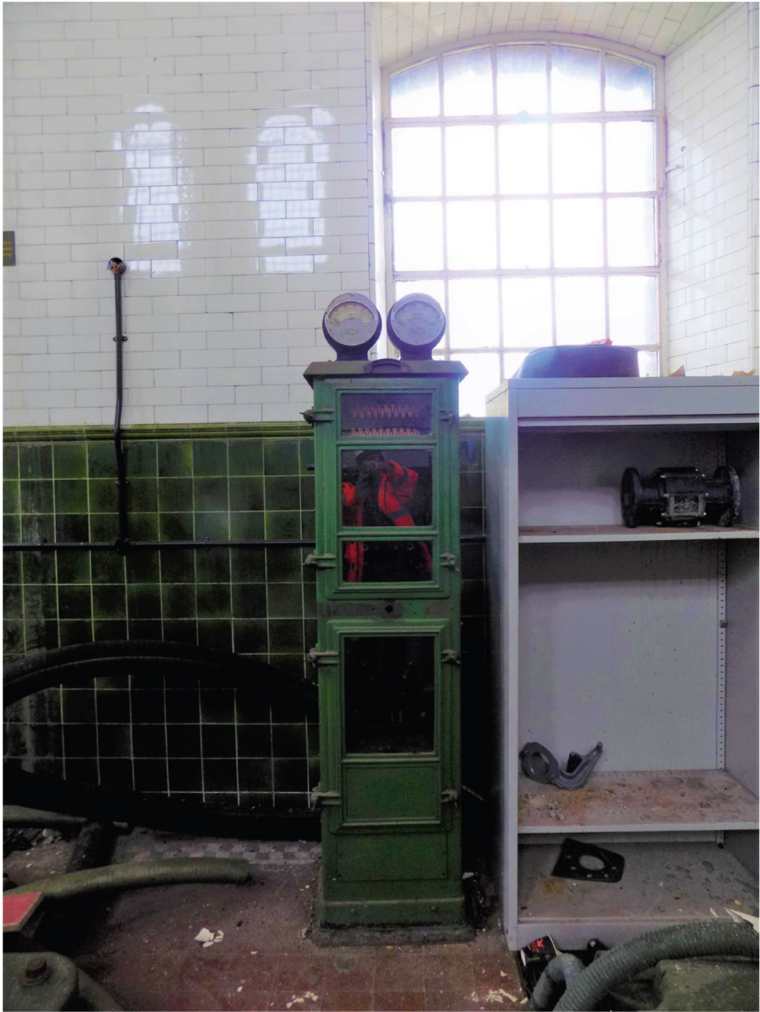
Reference:	<b>Figure 4 – Control cabinet</b>

Location:	<b>Ruston &amp; Ward - Bull Engine House</b>
Description:	Control Cabinet for 1932 Harland electric centrifugal pumps, Ruston & Ward Engine House
Condition:	<b>3</b>
Damage:	Unknown
Proposal:	Retain and relocate on site in work space. Relocate electric centrifugal pumps with associated machinery and control cabinets
Methodology:	Tbc by condition.
Heritage Comments:	<b>LS/MS</b> Low-Medium significance

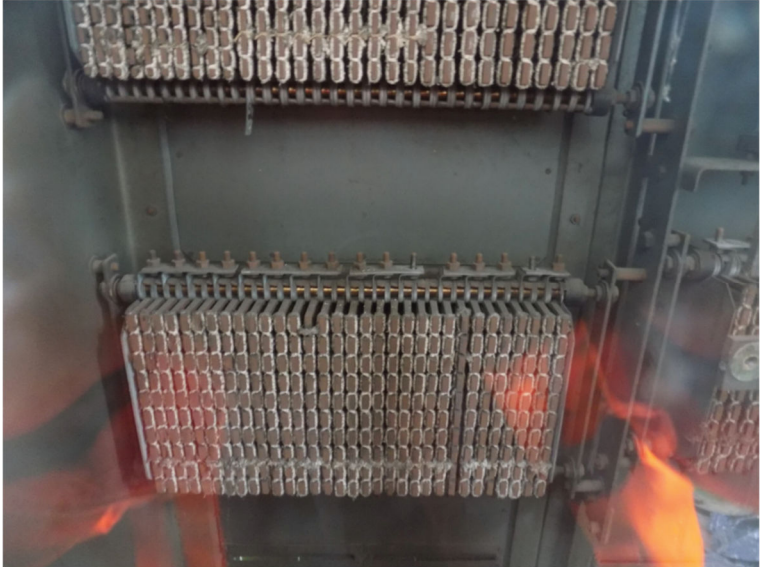
Reference:	<b>Figure 5 – Control cabinet</b>

Location:	<b>Ruston &amp; Ward - Bull Engine House</b>
Description:	Detail of Harland control cabinet for 1932 electric centrifugal pumps, Ruston & Ward Engine House
Condition:	<b>3</b>
Damage:	Unknown
Proposal:	Retain and relocate on site in work space. Relocate electric centrifugal pumps with associated machinery and control cabinets
Methodology:	Tbc by condition.
Heritage Comments:	<b>LS/MS</b> Low-Medium significance

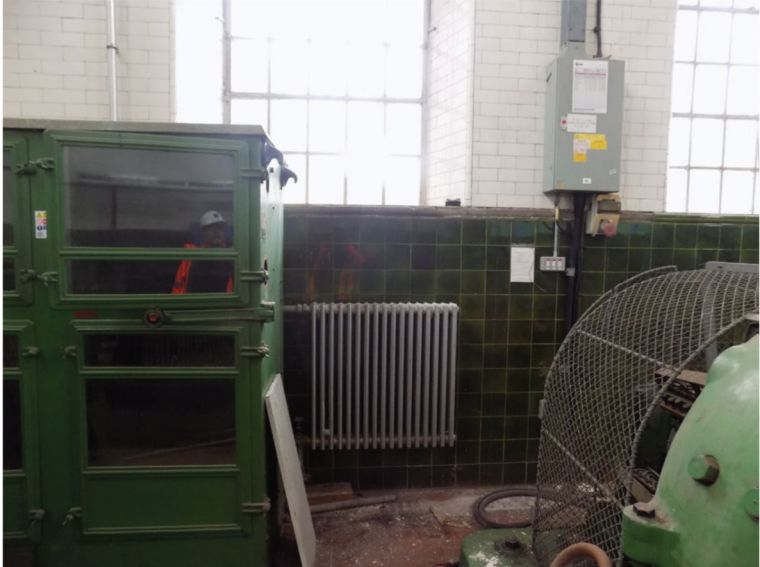
Reference:	<b>Figure 7 – Cast iron radiator</b>

Location:	<b>Ruston &amp; Ward - Bull Engine House</b>
Description:	1932 cast-iron radiator, Ruston & Ward Engine House
Condition:	<b>3</b>
Damage:	Unknown
Proposal:	Remove. Cast-iron radiator to be stripped out, not reused
Methodology:	Tbc by condition.
Heritage Comments:	<b>LS</b> Low significance

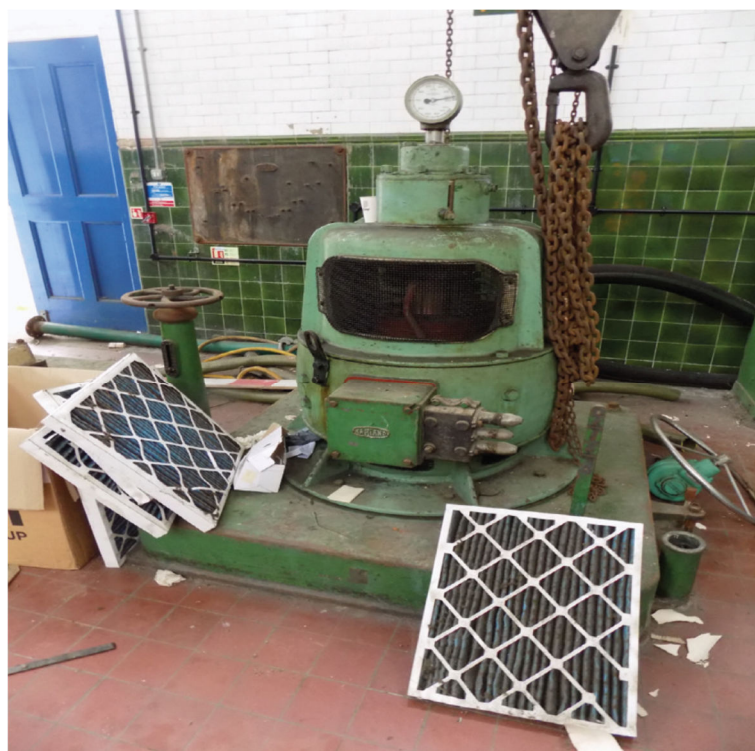
Reference:	<b>Figure 9 - Centrifugal pumps</b>
------------	-------------------------------------

Location:	<b>Ruston &amp; Ward - Bull Engine House</b>
Description:	1932 Harland DC motor, Ruston & Ward Engine House
Condition:	3
Damage:	Unknown
Proposal:	Retain and relocate on site as external feature. Relocate electric centrifugal pumps with associated machinery and control cabinets
Methodology:	Tbc by condition.
Heritage Comments:	<b>LS/MS</b> Low-Medium significance

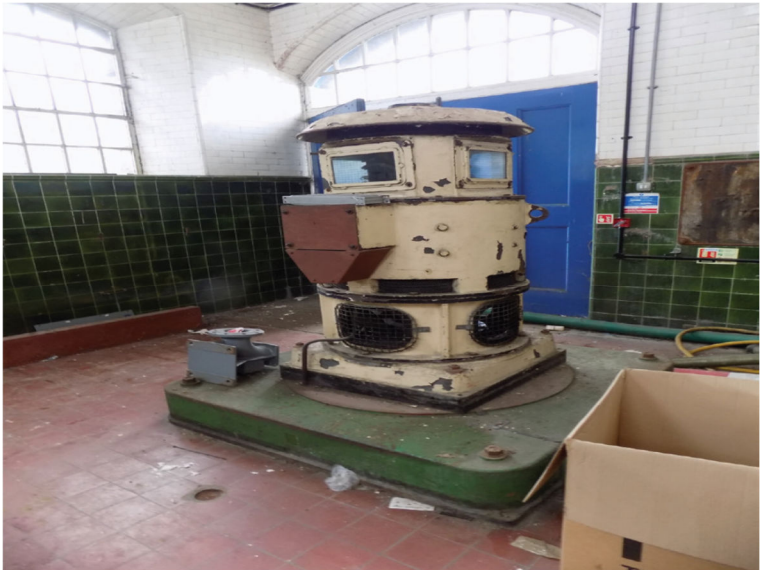
Reference:	<b>Figure 10 - Centrifugal pumps</b>

Location:	<b>Ruston &amp; Ward - Bull Engine House</b>
Description:	Replacement W H Allen DC motor, Ruston & Ward Engine House
Condition:	<b>3</b>
Damage:	Unknown
Proposal:	Retain and relocate on site as external feature. Relocate electric centrifugal pumps with associated machinery and control cabinets
Methodology:	Tbc by condition.
Heritage Comments:	<b>LS/MS</b> Low-Medium significance

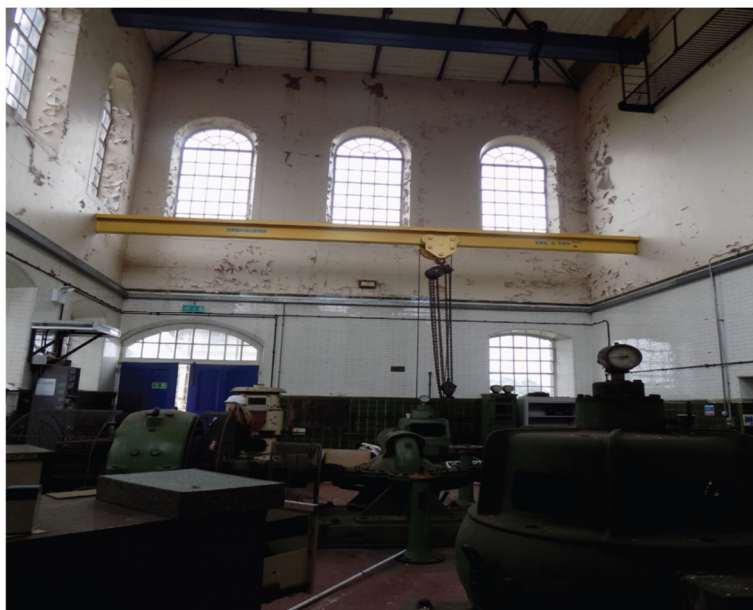
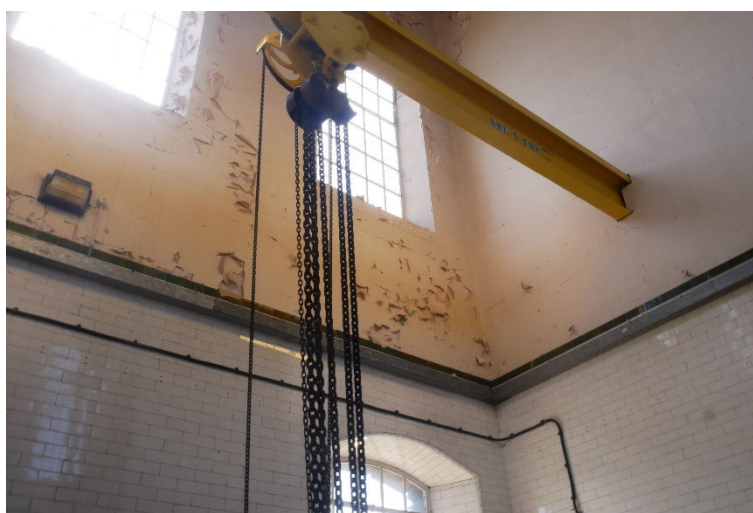
Reference:	<b>Figure 12 - Lifting beam</b>
------------	---------------------------------

Location:	<b>Ruston &amp; Ward - Bull Engine House</b>
Description:	General view of interior of former Bull Engine House, showing 1932 Harland electrical pumping equipment and 1932 lifting beam, Ruston & Ward Engine House
Condition:	<b>3</b>
Damage:	Unknown
Proposal:	Remove.
Methodology:	Tbc by condition.
Heritage Comments:	<b>LS/MS</b> Low-Medium significance

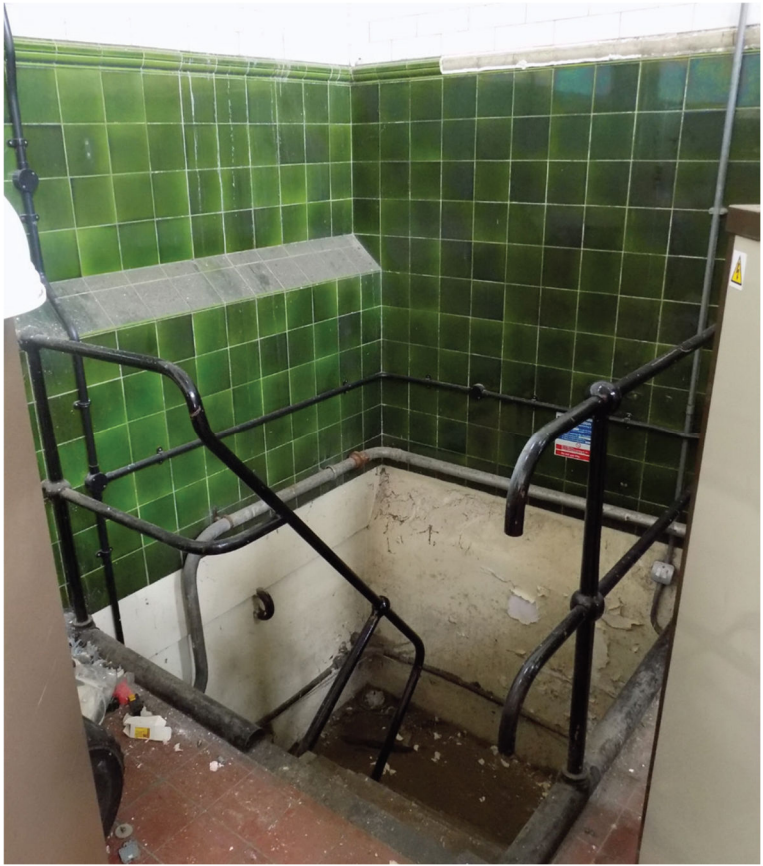
Reference:	<b>Figure 13 – Steps and handrails</b>

Location:	<b>Ruston &amp; Ward - Bull Engine House</b>
Description:	1932 steps and handrails to basement, Ruston & Ward Engine House
Condition:	<b>3</b>
Damage:	Unknown
Proposal:	Remove. Steps and handrails to be stripped out, not reused.
Methodology:	Tbc by condition.
Heritage Comments:	<b>LS</b> Low significance

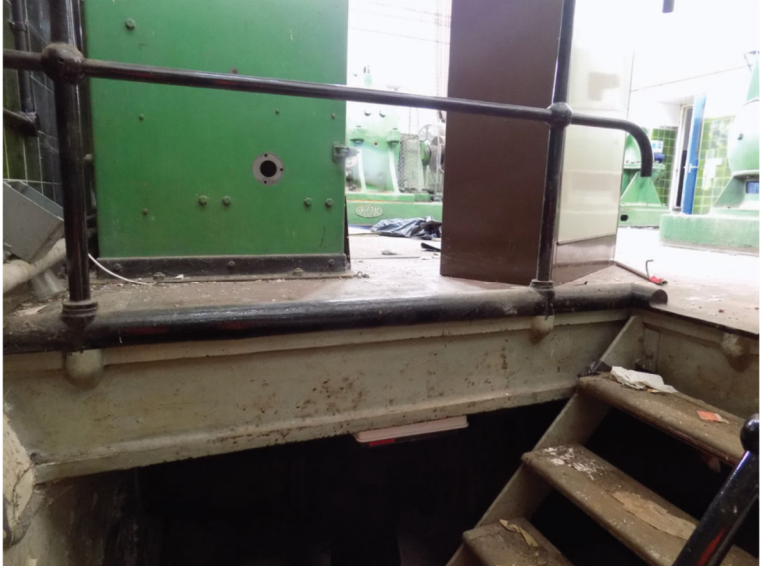
Reference:	<b>Figure 14 – Ground floor cast iron beam</b>

Location:	<b>Ruston &amp; Ward - Bull Engine House</b>
Description:	Reused cast iron beam incorporated in ground floor slab of Ruston & Ward Engine House
Condition:	<b>3</b>
Damage:	Unknown
Proposal:	Retain and relocate. Cast iron beam to remain in-situ.
Methodology:	Tbc by condition.
Heritage Comments:	<b>LS</b> Low significance

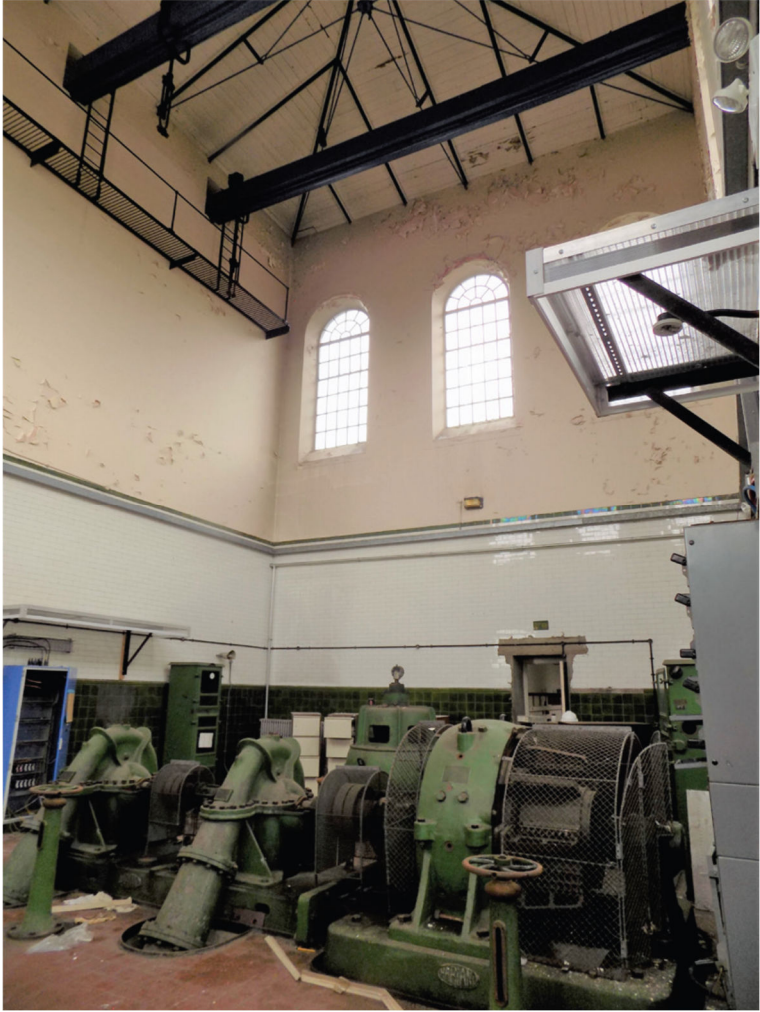
Reference:	<b>Figure 15 – Pumping equipment</b>

Location:	<b>Ruston &amp; Ward - Bull Engine House</b>
Description:	1932 Harland electrical pumping equipment & 1932 lifting beam
Condition:	<b>3</b>
Damage:	Unknown
Proposal:	Retain and relocate on site as external feature. Relocate electric centrifugal pumps with associated machinery and control cabinets
Methodology:	Tbc by condition.
Heritage Comments:	<b>LS/MS</b> Low-Medium significance

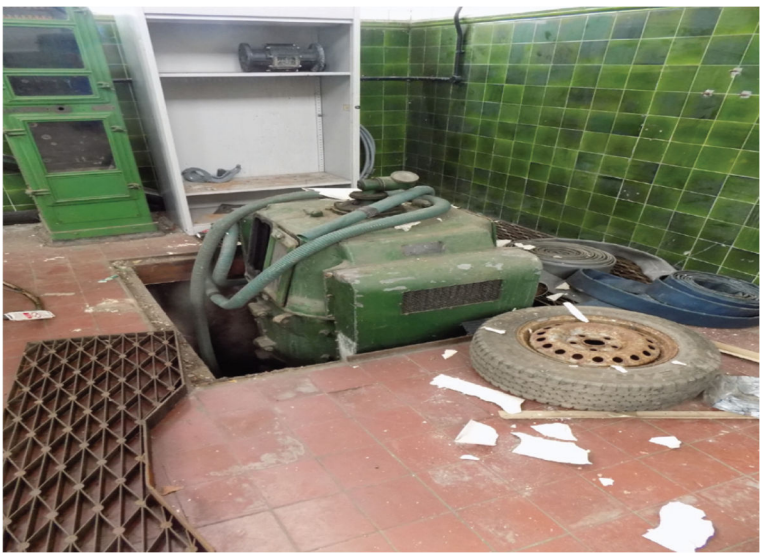
Reference:	<b>Figure 17 – DC motor</b>

Location:	<b>Ruston &amp; Ward - Bull Engine House</b>
Description:	1932 Harland DC motor, Ruston & Ward Engine House
Condition:	<b>3</b>
Damage:	Unknown
Proposal:	Retain and relocate on site. Relocate electric centrifugal pumps with associated machinery and control cabinets.

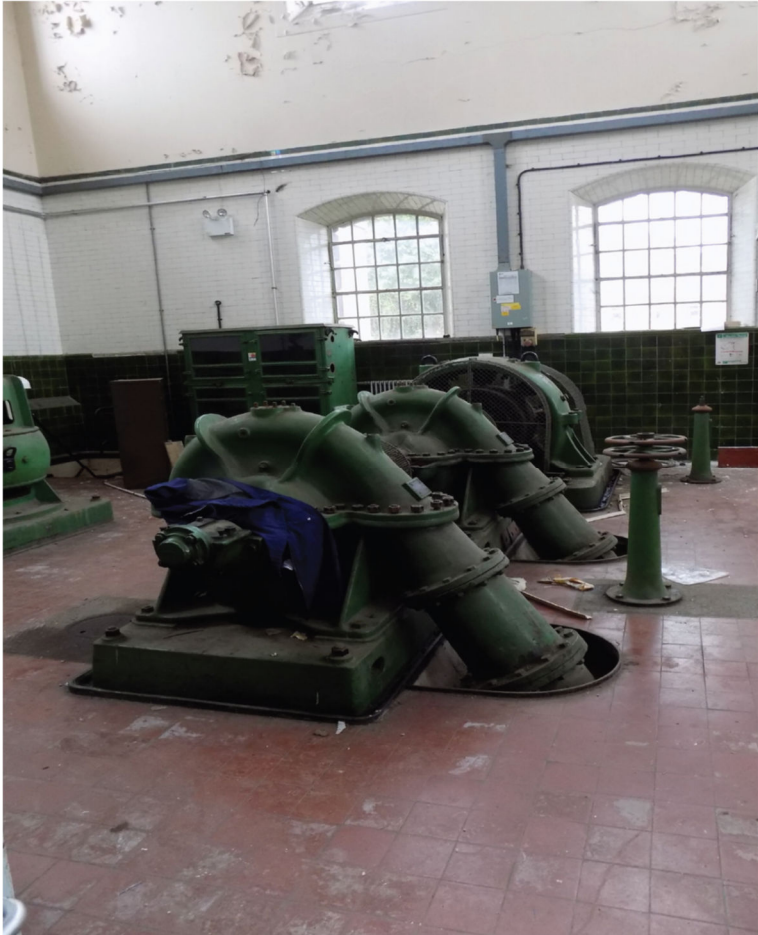
Reference:	<b>Figure 18 – Pumping equipment</b>

Location:	<b>Ruston &amp; Ward - Bull Engine House</b>
Description:	1932 Harland twin impeller electric centrifugal pump set, Ruston & Ward Engine House
Condition:	<b>3</b>
Damage:	Unknown
Proposal:	Retain and relocate on site as external feature. Relocate electric centrifugal pumps with associated machinery and control cabinets.
Methodology:	Tbc by condition.
Heritage Comments:	<b>LS/MS</b> Low-Medium significance

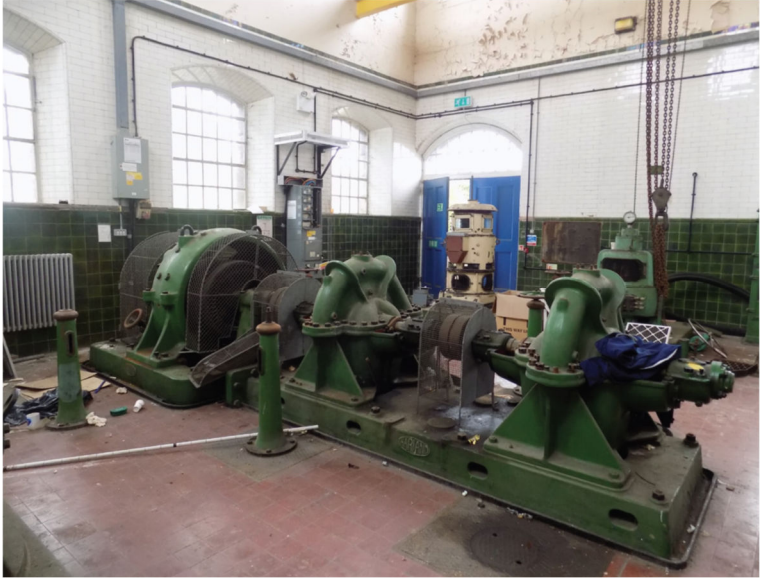
Reference:	<b>Figure 19 – Pumping equipment</b>

Location:	<b>Ruston &amp; Ward - Bull Engine House</b>
Description:	1932 Harland twin impeller electric centrifugal pump set, Ruston & Ward Engine House
Condition:	<b>3</b>
Damage:	Unknown
Proposal:	Retain and relocate on site as external feature. Relocate electric centrifugal pumps with associated machinery and control cabinets.
Methodology:	Tbc by condition.
Heritage Comments:	<b>LS/MS</b> Low-Medium significance

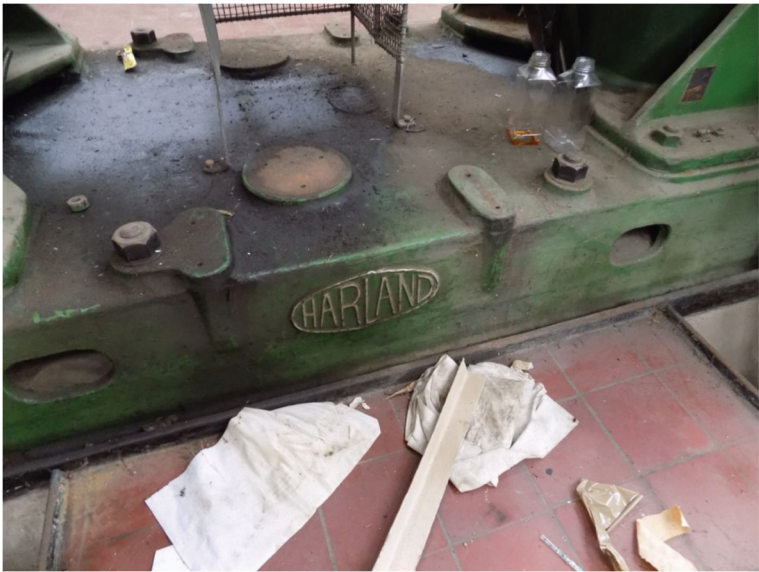
Reference:	<b>Figure 20 – Pumping equipment bedplate detail</b>

Location:	<b>Ruston &amp; Ward - Bull Engine House</b>
Description:	Bedplate detail: 1932 Harland twin impeller electric centrifugal pump set, Ruston & Ward Engine House
Condition:	<b>3</b>
Damage:	Unknown

Proposal:	Retain and relocate on site as external feature. Relocate electric centrifugal pumps with associated machinery and control cabinets.
Comments:	
Heritage Comments:	<b>LS/MS</b> Low-Medium significance

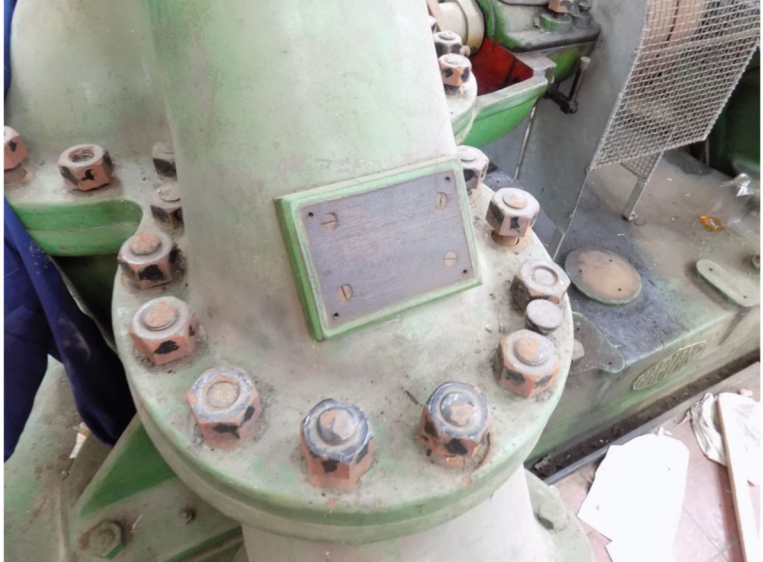
Reference:	<b>Figure 21 – Pumping equipment removed brass plate</b>

Location:	<b>Ruston &amp; Ward - Bull Engine House</b>
Description:	Detail of removed brass plate, 1932 Harland twin impeller electric centrifugal pump set, Ruston & Ward Engine House
Condition:	<b>3</b>
Damage:	Unknown
Proposal:	Retain and relocate on site as external feature. Relocate electric centrifugal pumps with associated machinery and control cabinets.
Methodology:	Tbc by condition.
Heritage Comments:	<b>LS/MS</b> Low-Medium significance

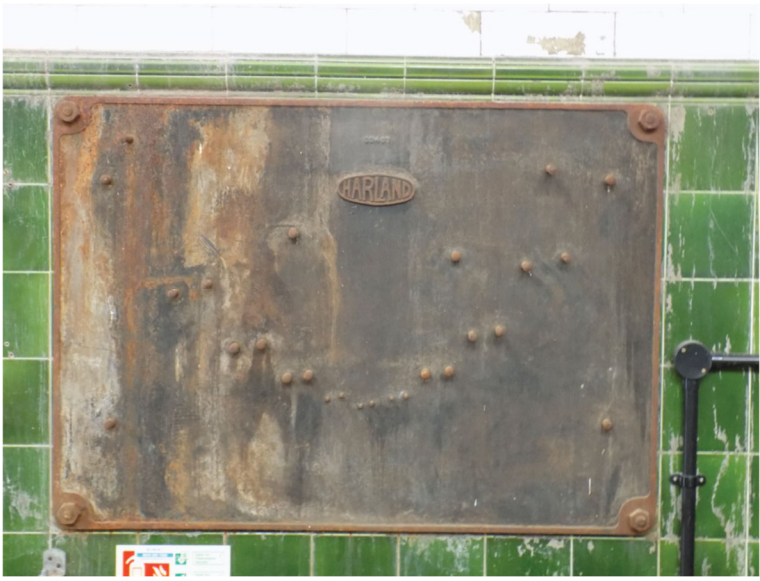
Reference:	<b>Figure 23 – Harland cover plate</b>

Location:	<b>Ruston &amp; Ward - Bull Engine House</b>
Description:	1932 Harland cover plate, Ruston & Ward Engine House
Condition:	<b>3</b>
Damage:	Unknown
Proposal:	Retain and relocate. Retain and repair cover plate.

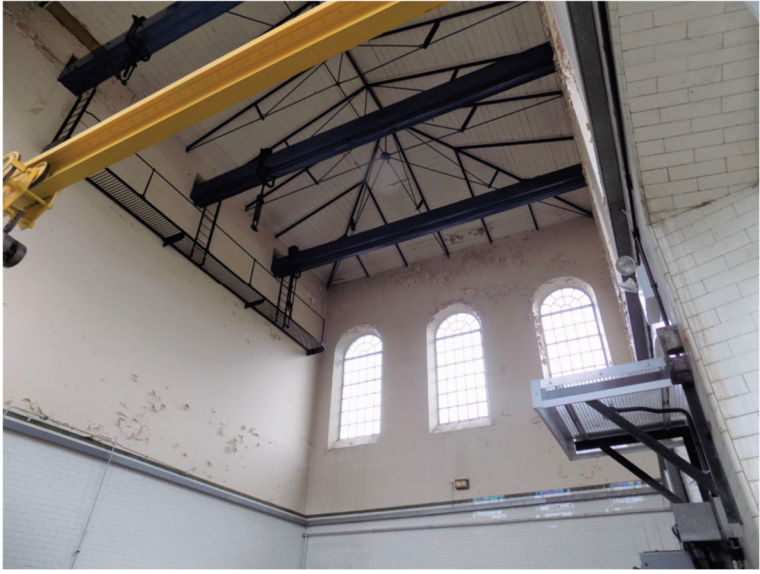
Reference:	<b>Figure 24 – Primary lifting beams</b>

Location:	<b>Ruston &amp; Ward - Bull Engine House</b>
Description:	Primary lifting beams (3 of, for three Bull engines and later DC motors), Ruston & Ward Engine House
Condition:	<b>3</b>
Damage:	Unknown
Proposal:	Retain in situ and renovate. Retain and repair lifting beams
Methodology:	Tbc by condition.
Heritage Comments:	<b>HS</b> High significance

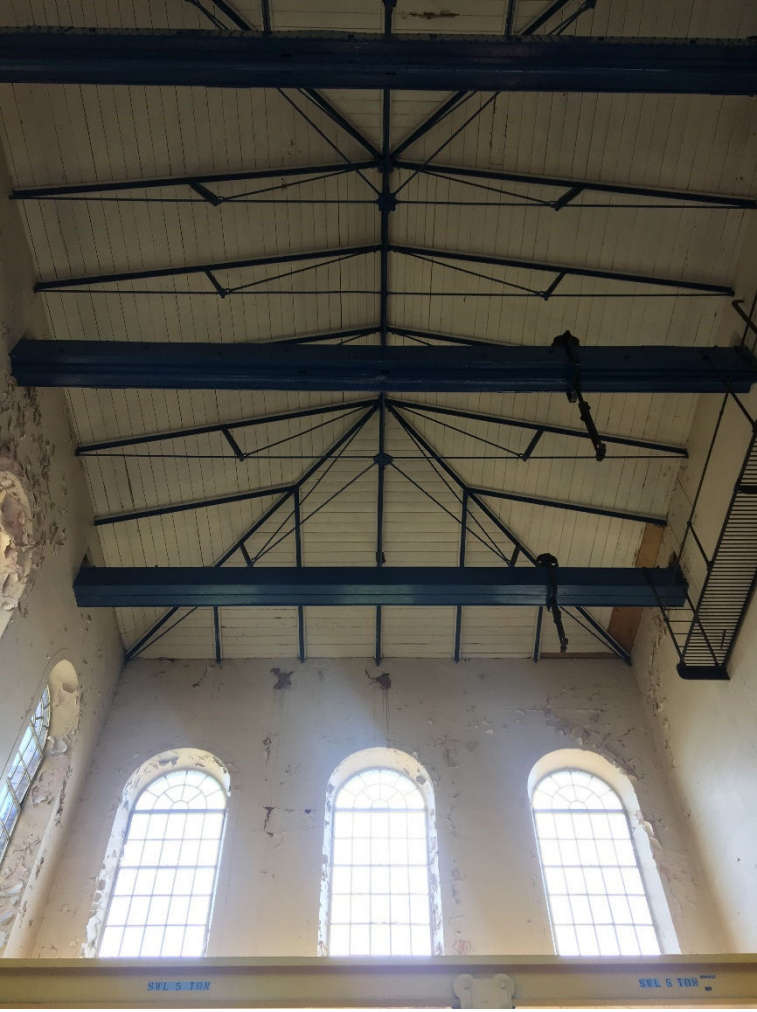
Reference:	<b>Figure 25 – Primary wrought iron roof structure</b>

Location:	<b>Ruston &amp; Ward - Bull Engine House</b>
Description:	Primary wrought-iron roof, Ruston & Ward Engine House
Condition:	<b>3</b>
Damage:	Unknown
Proposal:	Retain in situ and renovate. Retain and repair wrought iron roof structure, retain and repair underside of boarding to match existing,
Methodology:	Tbc by condition.
Heritage Comments:	<b>MS</b> Medium significance

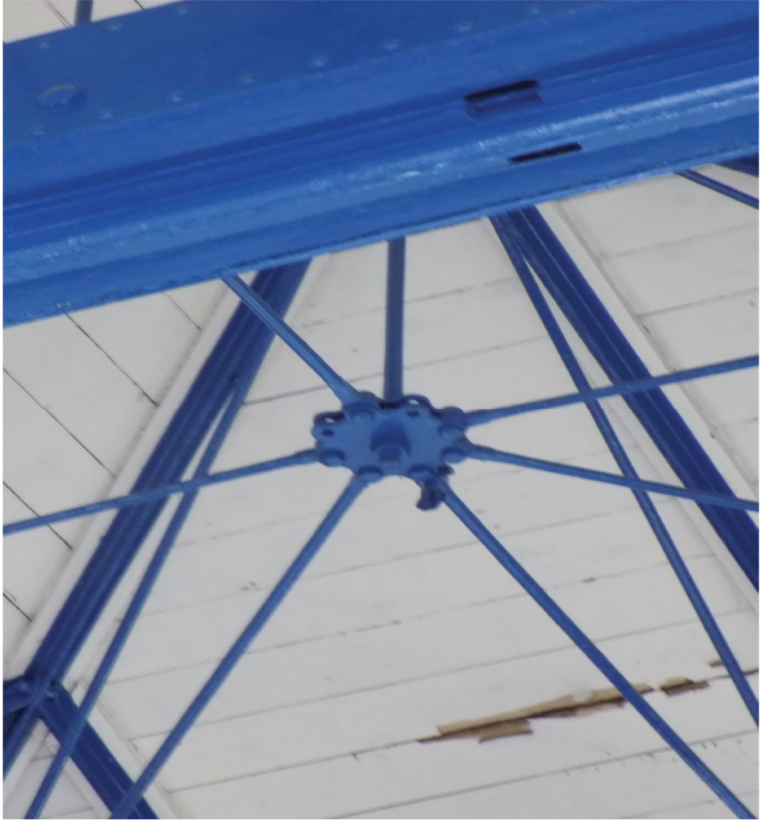
Reference:	<b>Figure 26 – Primary roof radial ties</b>

Location:	<b>Ruston &amp; Ward - Bull Engine House</b>
Description:	Detail of boss of primary wrought-iron roof (radial ties), Ruston & Ward Engine House
Condition:	<b>3</b>
Damage:	Unknown
Proposal:	Retain in situ and renovate. Retain and repair radial ties
Methodology:	Tbc by condition.
Heritage Comments:	<b>MS</b> Medium significance

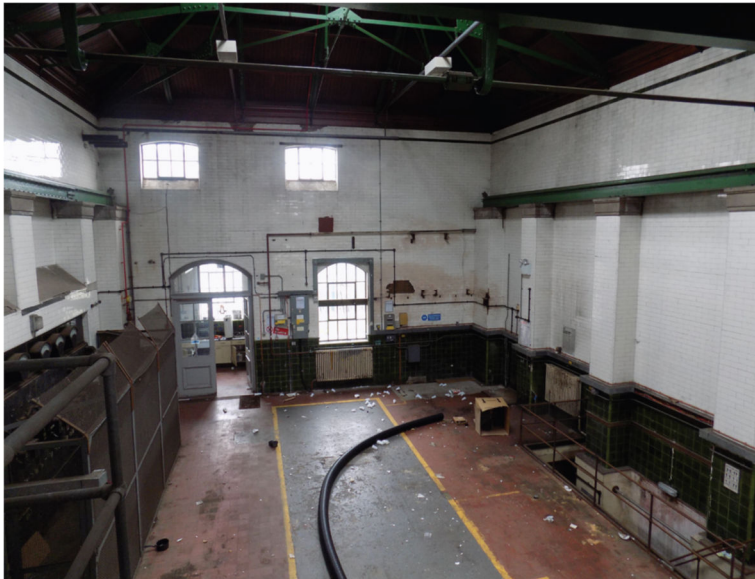
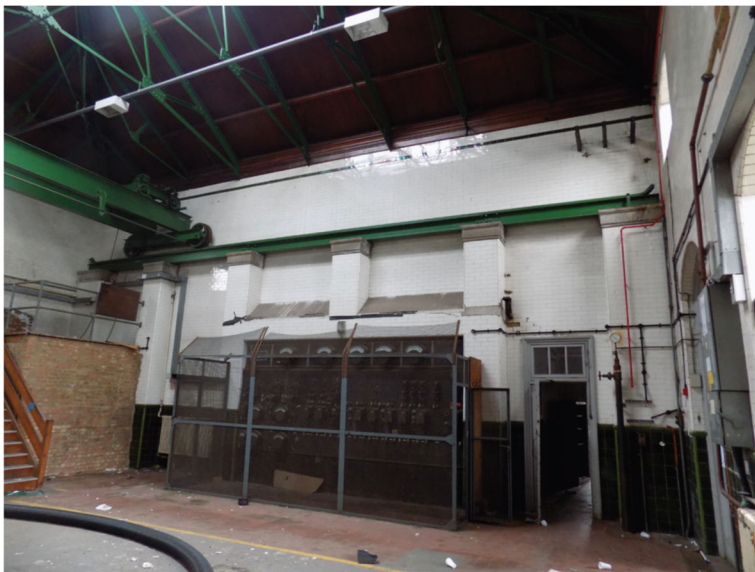
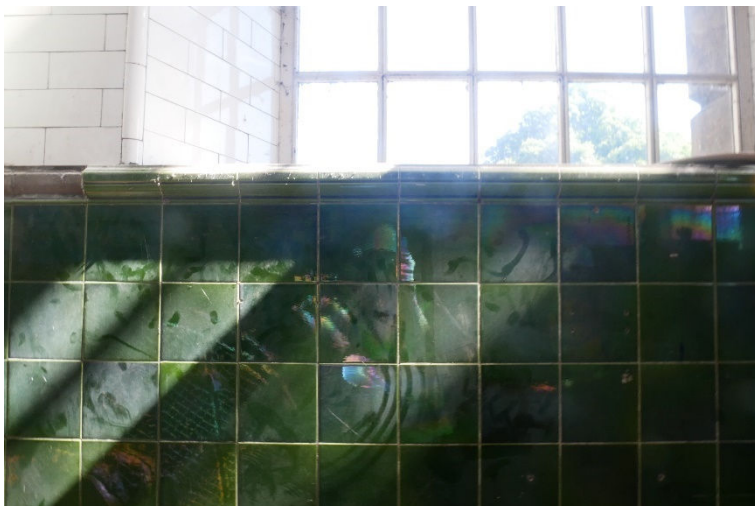
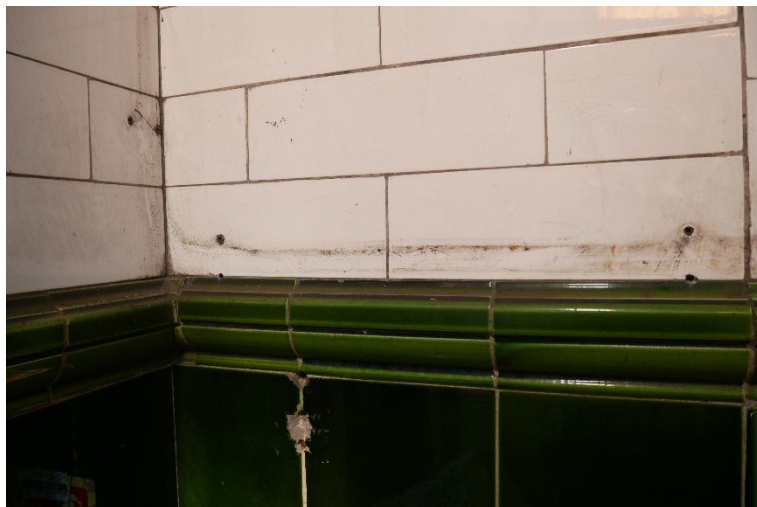
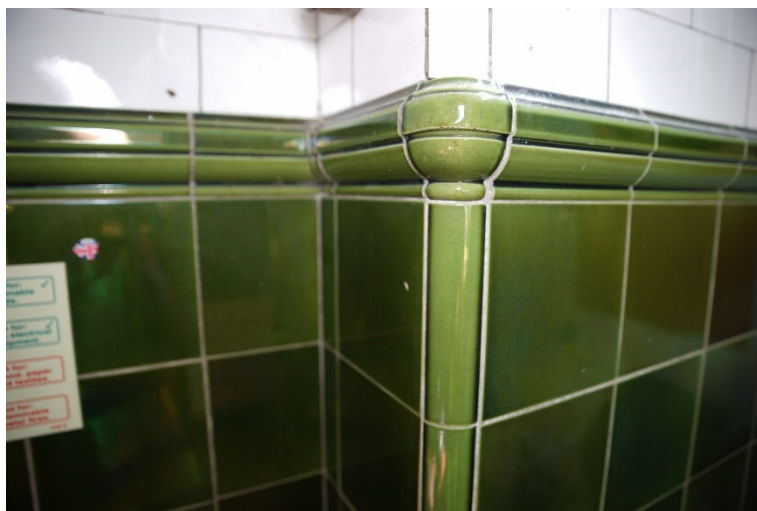
**Figure 27 – Wall tiles**

Location:	<b>Ruston &amp; Ward – Former Engine House (Workshop)</b>
Description:	Ruston & Ward Building, general view of interior of former Ruston engine house (originally Sheffield's Boiler House)
Condition:	<b>3</b>
Damage:	Ceramic glazed wall tile defects
Proposal:	Retain in situ and renovate. Retain, repair, and replace broken tiles to match existing ceramic wall tiles.
Methodology:	Tbc by condition.
Heritage Comments:	<b>MS</b> Medium significance

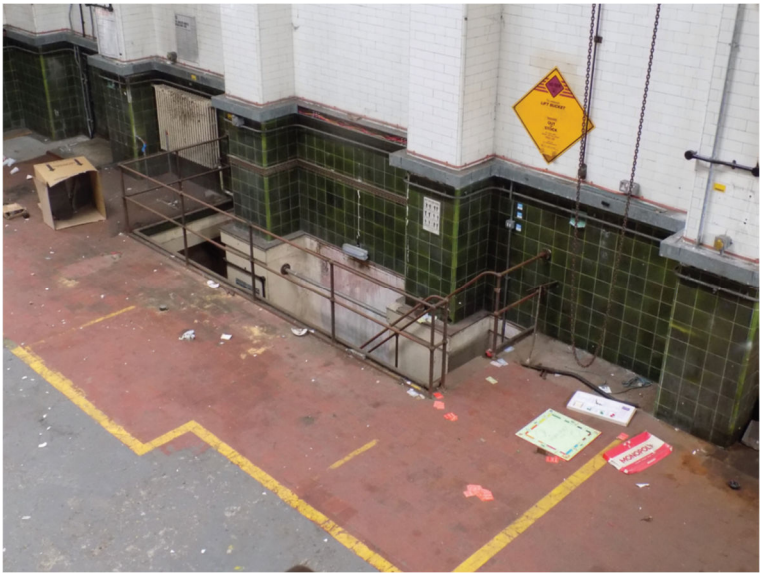
Reference:	<b>Figure 28 – Steps and handrail to basement</b>

Location:	<b>Ruston &amp; Ward – Former Engine House (Workshop)</b>
Description:	Ruston & Ward Building, 1932 steps and handrail to basement in former Ruston engine house (originally Sheffield's Boiler House)
Condition:	<b>3</b>
Damage:	Unknown
Proposal:	Remove. Steps to be retained and repaired, handrail to be stripped out. Replace or upgrade to comply with building regulations.
Methodology:	Tbc by condition.
Heritage Comments:	<b>LS</b> Low significance

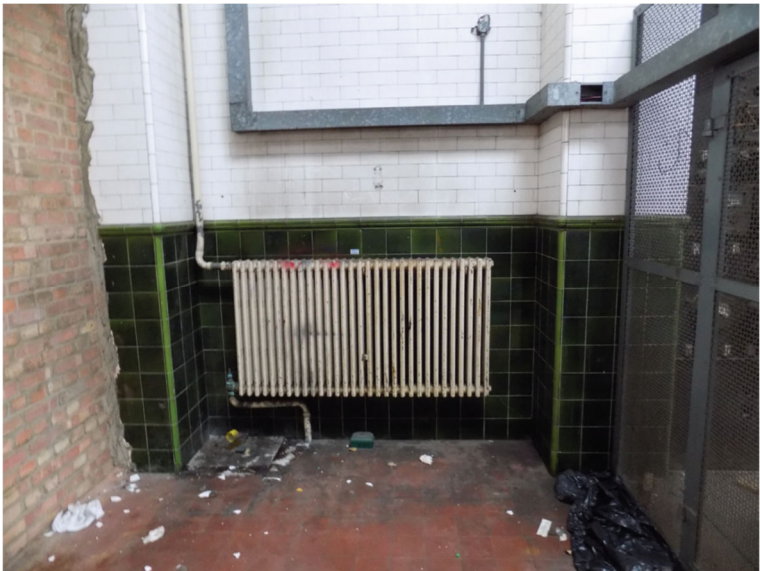
Reference:	<b>Figure 30 – Cast iron radiator</b>

Location:	<b>Ruston &amp; Ward – Former Engine House (Workshop)</b>
Description:	1932 cast-iron radiator, former Ruston engine house (originally Sheffield's Boiler House)
Condition:	<b>3</b>
Damage:	Unknown
Proposal:	Remove. Cast iron radiator to be stripped out.
Methodology:	Tbc by condition.
Heritage Comments:	<b>LS</b> Low significance

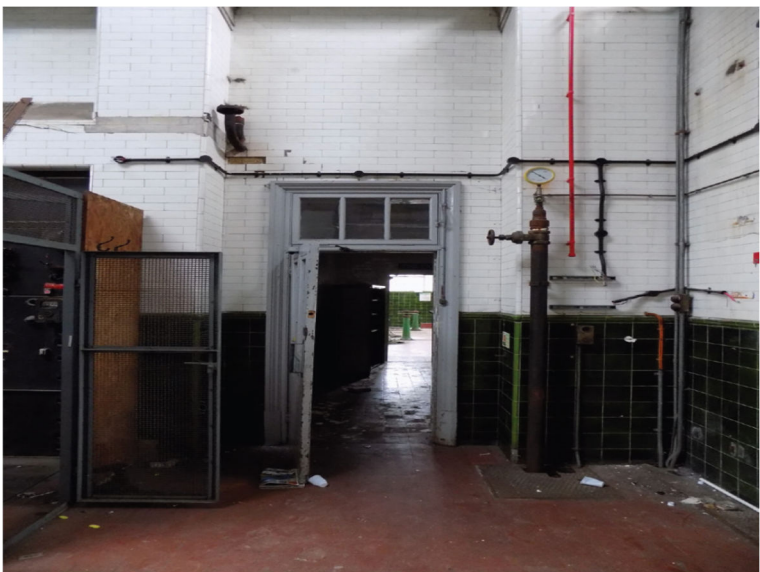
Reference:	<b>Figure 31 – Door and wall tiles</b>

Location:	<b>Ruston &amp; Ward – Former Engine House (Workshop)</b>
Description:	1932 door and wall tiles, former Ruston engine house (originally Sheffield's Boiler House)
Condition:	<b>3</b>
Damage:	Unknown

Proposal:	Retain in situ and renovate. Retain, repair, and replace broken tiles to match existing ceramic wall tiles. Door to be retained and repaired.
Methodology:	Tbc by condition.
Heritage Comments:	<b>MS</b> Medium significance

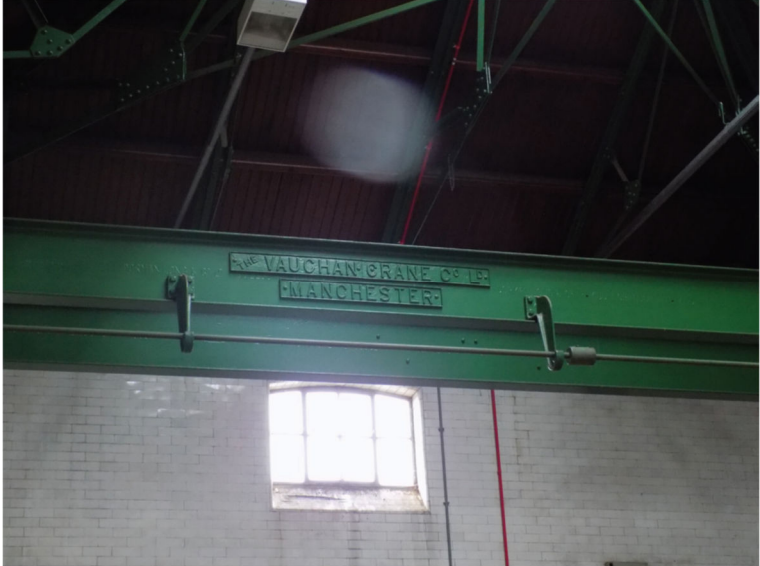
Reference:	<b>Figure 33 – Gantry</b>

Location:	<b>Ruston &amp; Ward – Former Engine House (Workshop)</b>
Description:	Maker's name on 1932 Vaughan gantry, former Ruston engine house (originally Sheffield's Boiler House)
Condition:	<b>3</b>
Damage:	Unknown
Proposal:	Retain in situ and renovate. Gantry to be retained and repaired.
Methodology:	Tbc by condition.
Heritage Comments:	<b>MS/HS</b> Medium-High significance

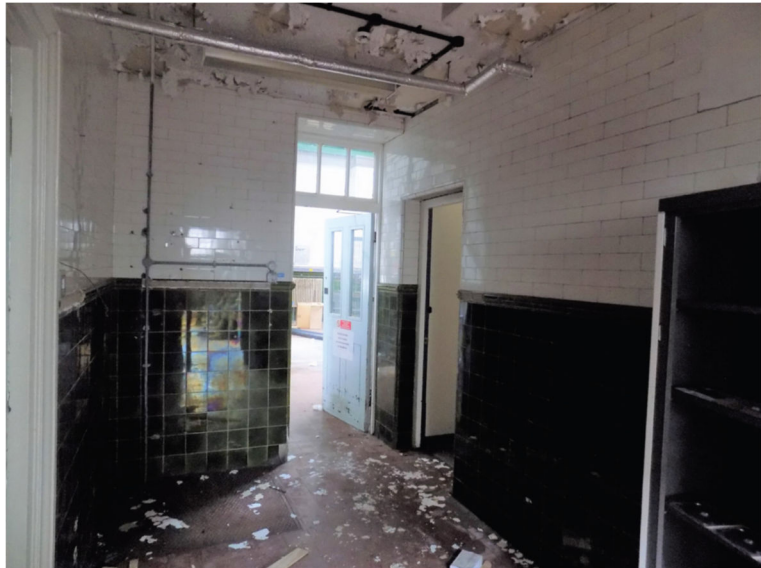
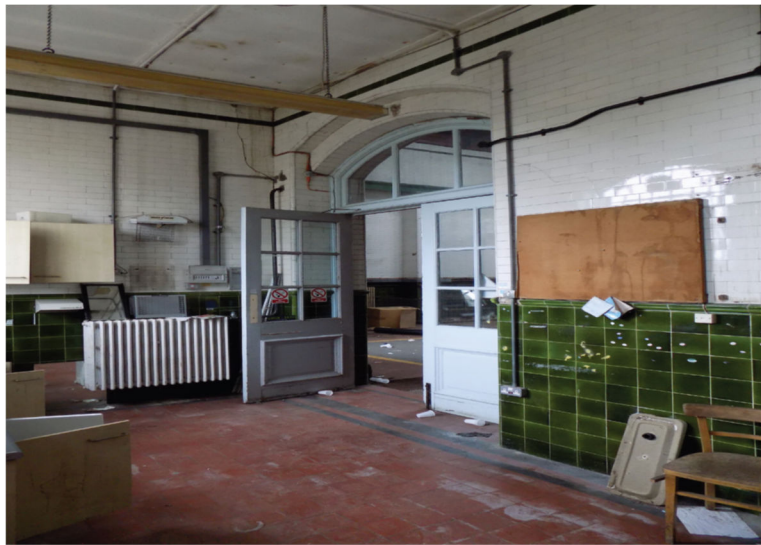
Reference:	<b>Figure 35 – Doors / Wall tiles / Floor tiles</b>
------------	---

Location:	<b>Ruston &amp; Ward – Former Engine House (Ancillary Spaces)</b>
Description:	1932 tiles and doors
Condition:	<b>3</b>
Damage:	Unknown
Proposal:	Retain in situ and renovate. Doors, ceramic wall / floor tiles to be retained, repair and or replace broken tiles to match existing.
Methodology:	Tbc by condition.
Heritage Comments:	<b>MS</b> Medium significance
