# Condition Survey Photo Record Schedule of Repairs – Ruston & Ward Interior

**Client** Waterfall Planning Ltd  
**Project** Hampton Water Works  
**Subject** Ruston & Ward Condition Survey Photo Record – Schedule of Repairs  
**Date** 26.05.2023  
**Revision** A  
**Job no.** 1685  
**Reference** 1685-A-P611 Ruston & Ward Condition Survey – Schedule of Repairs

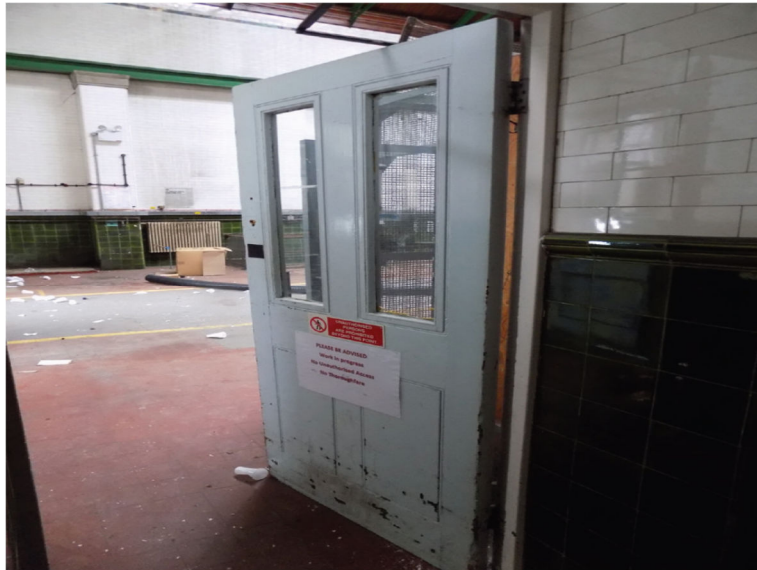
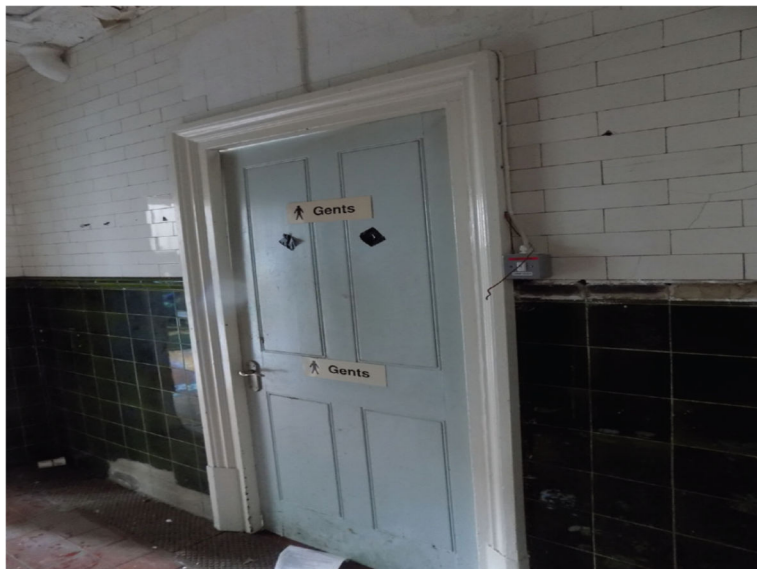
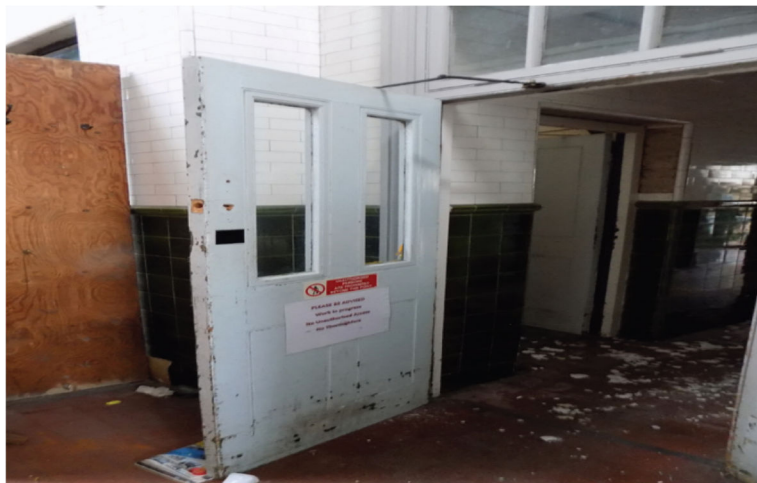
**Figure 36 – Doors**

1932 doors

Damage:	Unknown
Proposal:	Retain in situ and renovate. Doors to be repaired and or replaced to match existing. Refurbished in line with fire requirements.
Methodology:	Tbc by condition.
Heritage Comments:	<b>MS</b> Medium significance

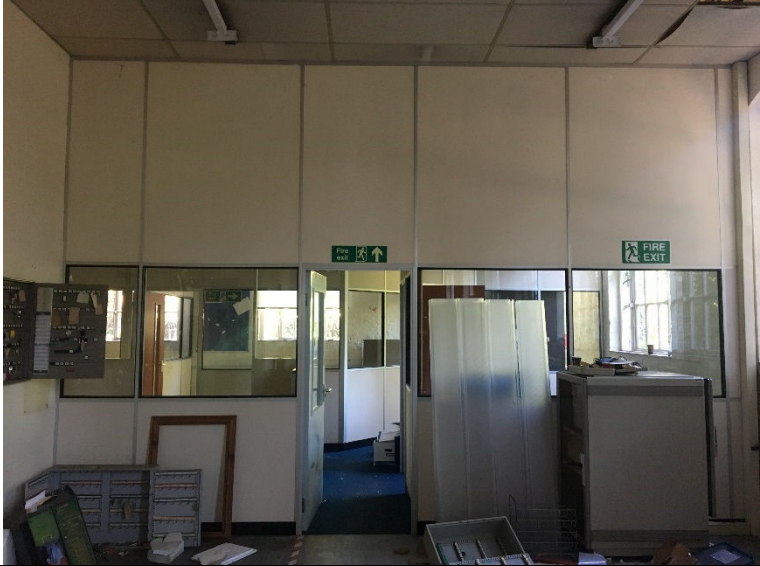
Location:	<b>Ruston &amp; Ward – Former Boiler House</b>
Description:	Much-altered interior and inserted 1932 north windows, Ruston & Ward Former Boiler House
Condition:	<b>3</b>
Damage:	Unknown
Proposal:	Retain in situ and renovate. Interior alterations, walls, floors, ceilings to be stripped out back to substrate.
Methodology:	Tbc by condition.
Heritage Comments:	<b>N/LS</b> No-Low significance

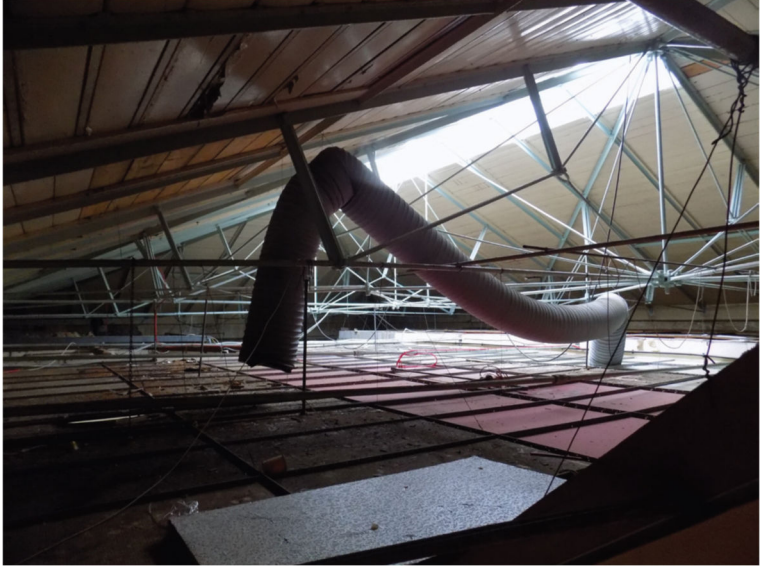
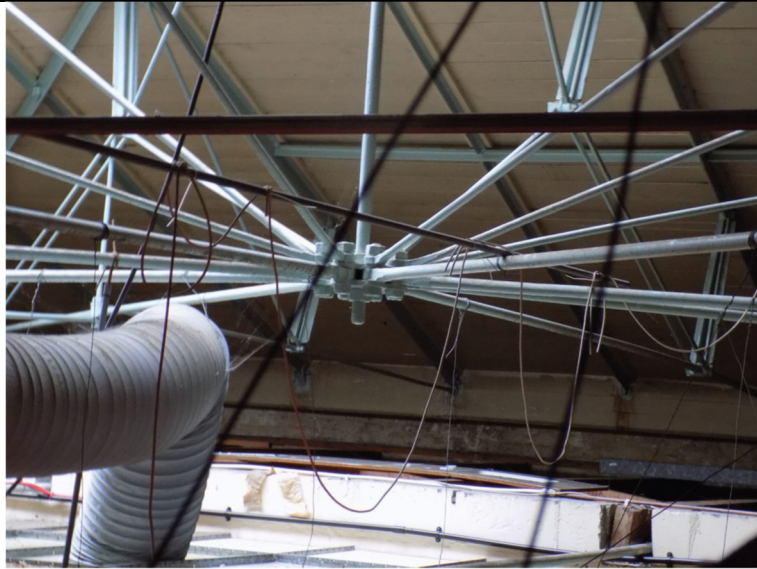
Reference:	<b>Figure 39 – Primary wrought iron roof structure</b>

Location:	<b>Ruston &amp; Ward – Former Boiler House</b>
Description:	Primary wrought-iron roof (radial ties), Ruston & Ward Former Boiler House
Condition:	<b>3</b>
Damage:	Unknown
Proposal:	Remove. Roof structure to be stripped out.
Methodology:	Tbc by condition.
Heritage Comments:	<b>MS</b> Medium significance

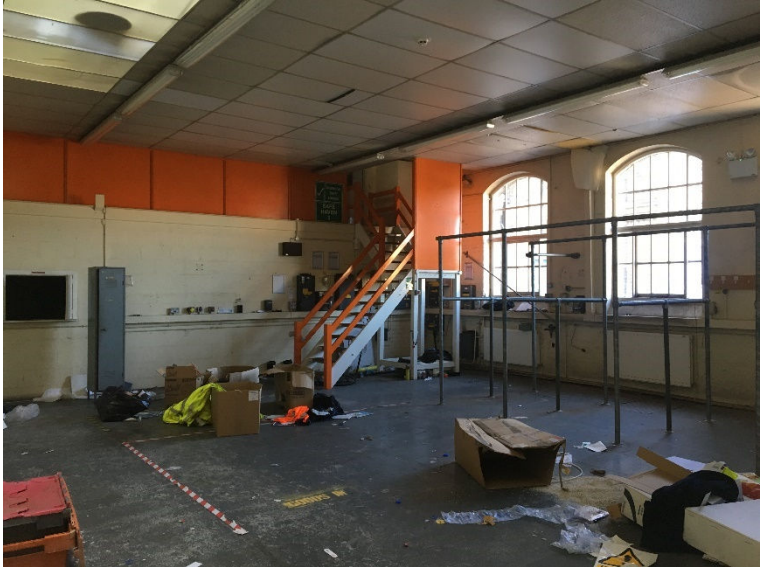
Reference:	<b>Figure 40 – Interior</b>

Location:	<b>Ruston &amp; Ward – Former Boiler House</b>
Description:	Much-altered interior and inserted stair Mezzanine floor enclosure, Ruston & Ward Former Boiler House
Condition:	<b>3</b>
Damage:	Unknown
Proposal:	Retain in situ and renovate. Interior alterations, stair, mezzanine floor to be stripped out.
Methodology:	Tbc by condition.
Heritage Comments:	<b>N/LS</b> No-Low significance
