Condition Survey Photo Record Schedule of Repairs – Karslake Interior

Client Waterfall Planning Ltd
Project Hampton Water Works
Subject Karslake Condition Survey Photo Record – Schedule of Repairs
Date 26.05.2023
Revision A
Job no. 1685
Reference 1685-A-P612 Karslake Condition Survey – Schedule of Repairs

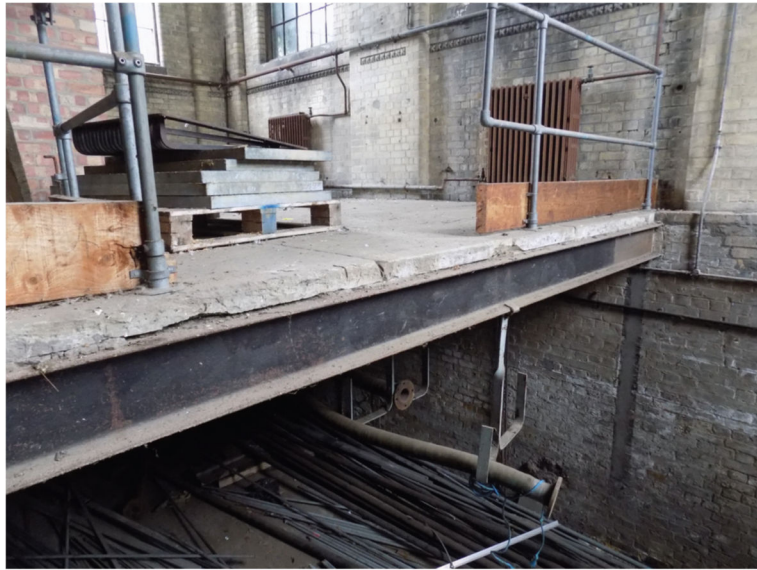
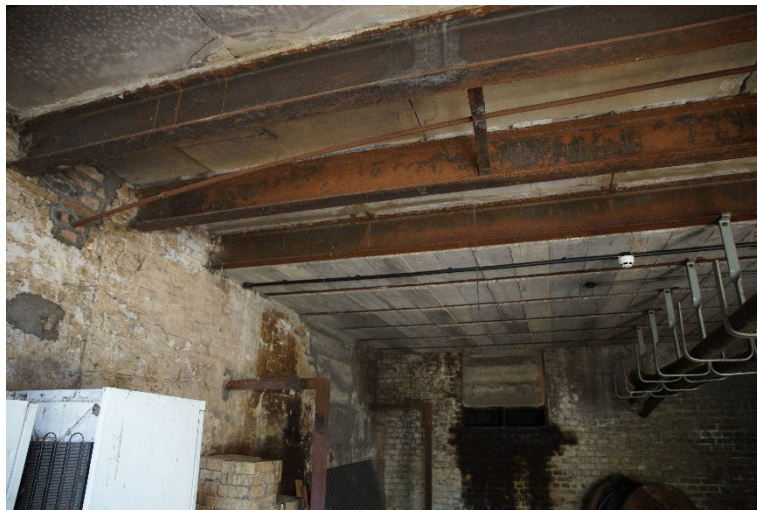
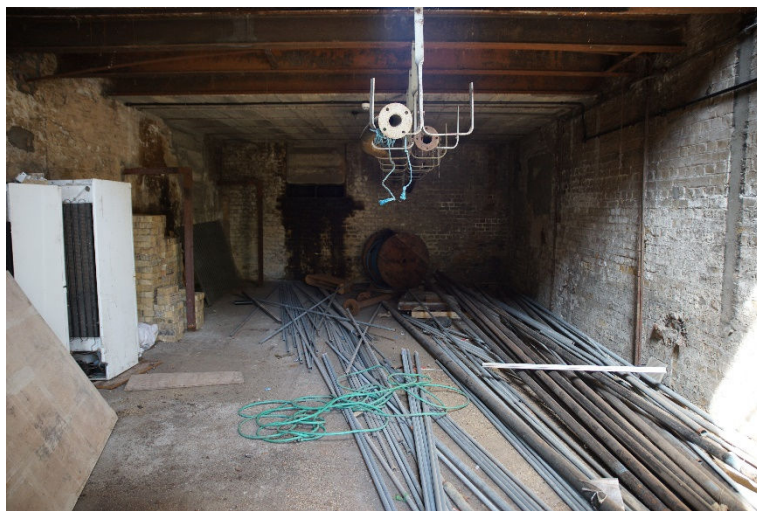
Figure 1 – Intermediate floor

Description: Intermediate floor of York slabs on rolled iron or steel joists (high significance)

Condition: **3**

Proposal:	Retain in situ and renovate.
Methodology:	Tbc by condition.
Heritage Comments:	HS High significance

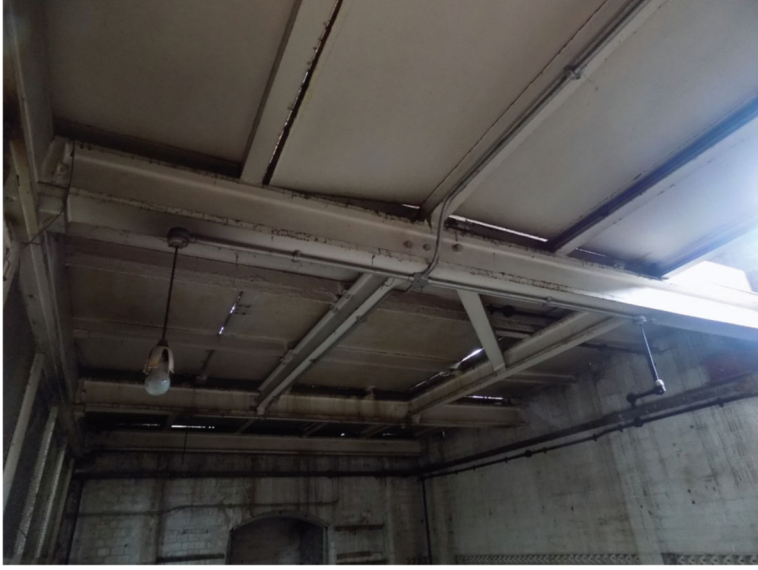
Reference:	Figure 2 – Intermediate floor

Location:	Ruston & Ward - Bull Engine House
Description:	Middle mezzanine (cylinder) floor, with cast-iron columns and staircase (high significance – steel wall panels of no significance)
Condition:	3
Damage:	Unknown
Proposal:	Retain in situ and renovate. Strengthen, acoustic and fire treatment.
Methodology:	Tbc by condition.
Heritage Comments:	HS High significance

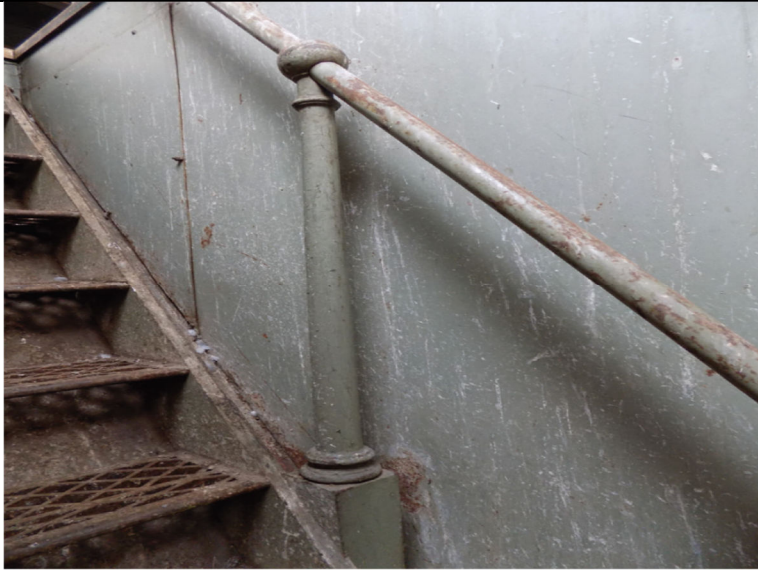
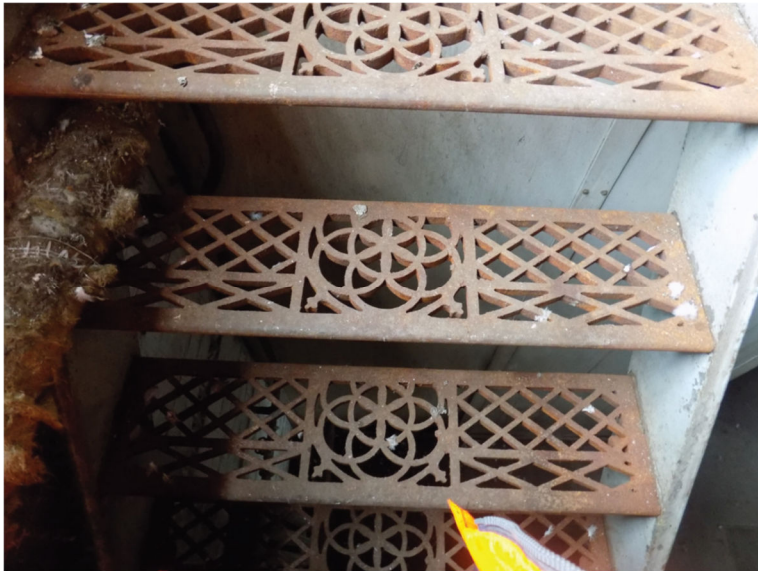
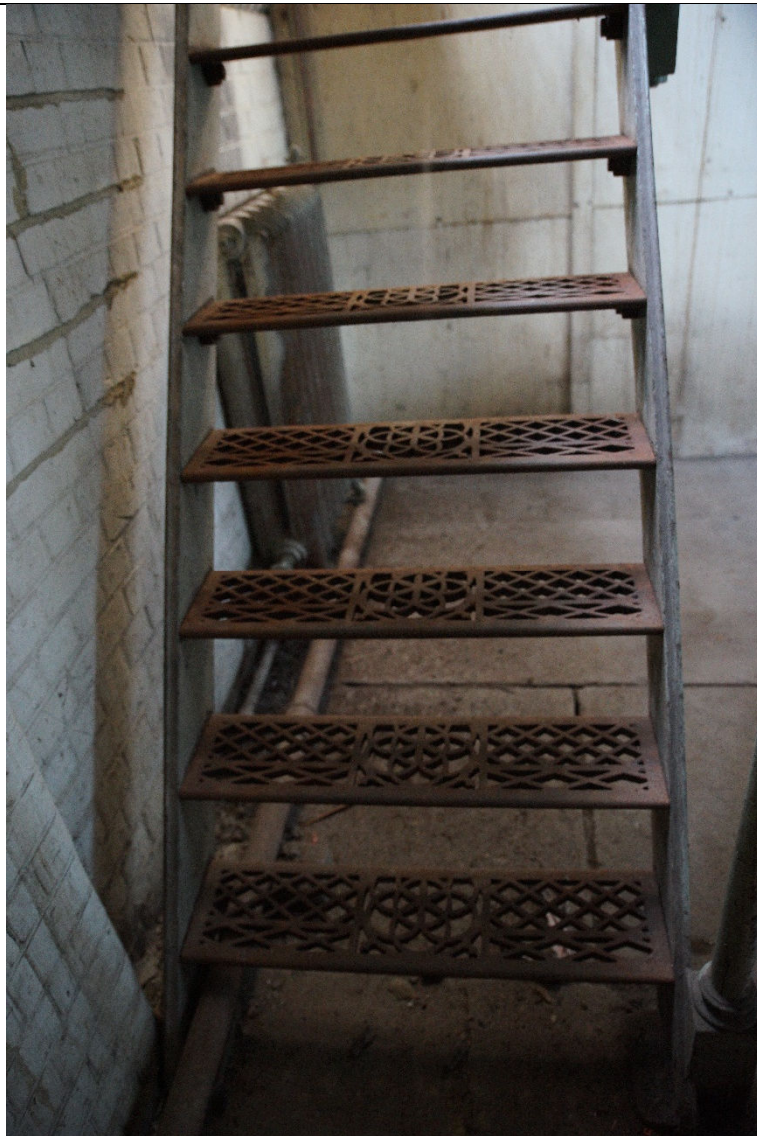
Reference:	Figure 3 – Intermediate floor – metal staircases

Location:	Karslake – Former Bean Engine House
Description:	Cast-iron columns, (medium significance)
Condition:	3
Damage:	Unknown
Proposal:	Retain and relocate. Relocate within apartment.
Methodology:	Tbc by condition.
Heritage Comments:	MS Medium significance

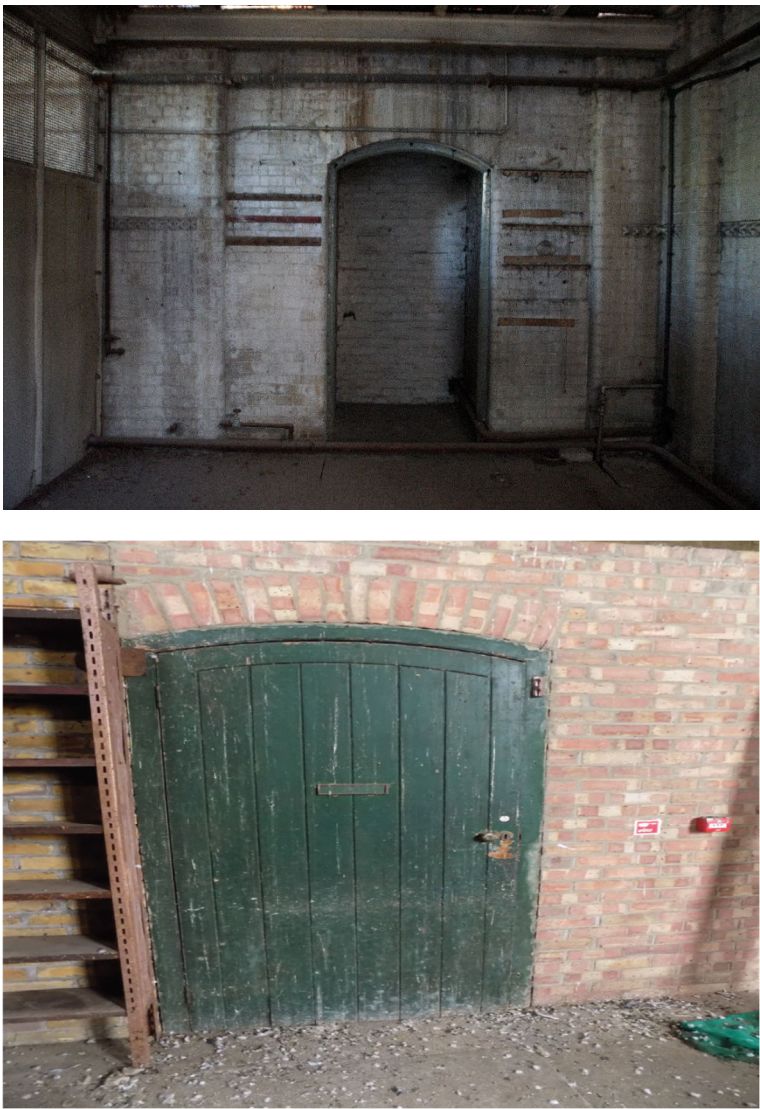
Reference:	Figure 4 – Door recesses

Location:	Karslake – Former Bean Engine House
Description:	One of two recesses on the middle mezzanine (cylinder) floor, with door frame (high significance) Re-located primary door on middle mezzanine (cylinder) floor
Condition:	3
Damage:	Unknown
Proposal:	Retain in situ and renovate.
Methodology:	Tbc by condition.
Heritage Comments:	HS High significance

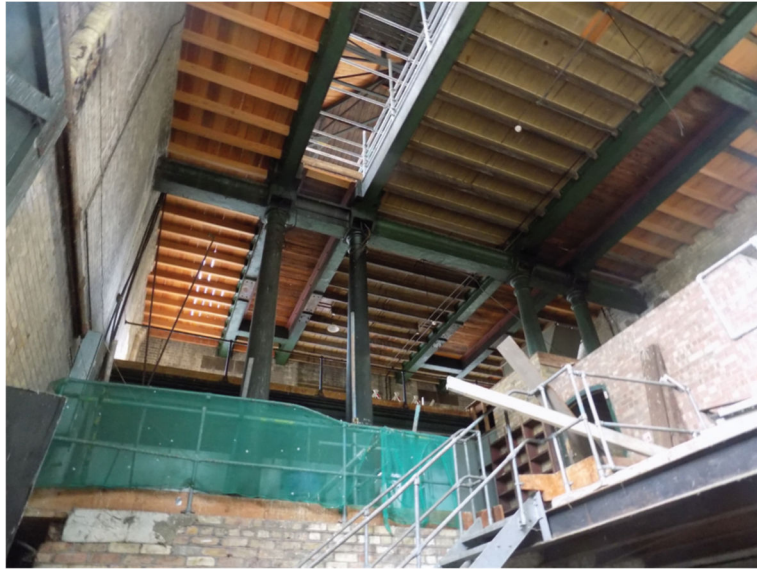
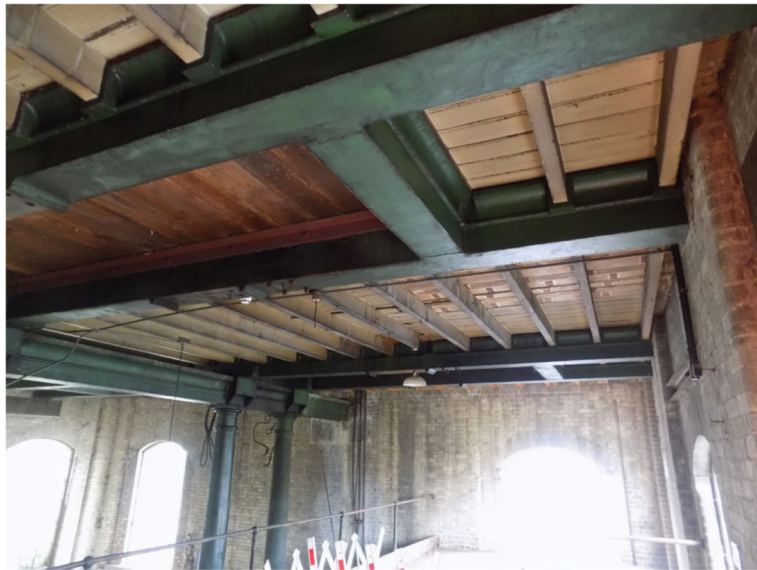
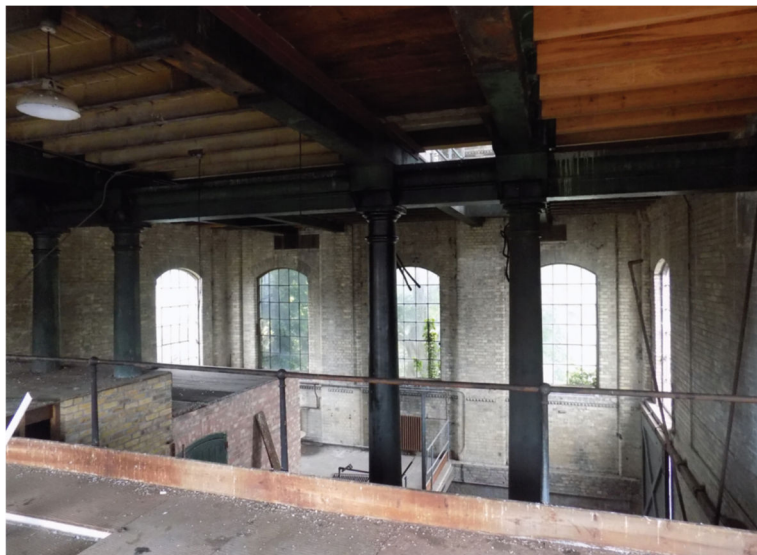
Figure 5 – Intermediate floor

Location:	Karslake – Former Bean Engine House
Description:	Surviving beam support structures (cast-iron columns and entablature), staircases and handrails, mezzanine and beam floor (spring beams and flooring) (all of high significance).
Condition:	3
Damage:	Unknown
Proposal:	Retain in situ and renovate. Acoustic and fire treatment.
Methodology:	Tbc by condition.
Heritage Comments:	HS High significance

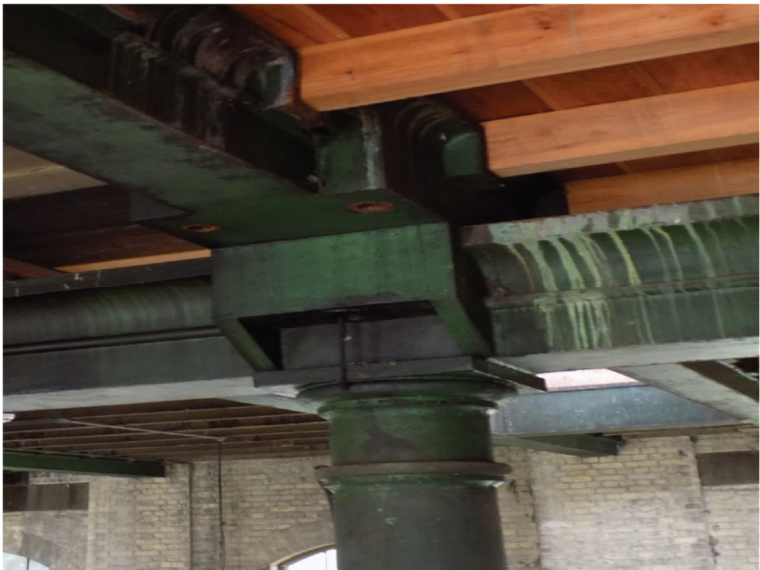
Reference:	Figure 6 – Intermediate floor - columns

Location:	Karslake – Former Bean Engine House
Description:	Cast-iron columns, (medium significance)
Condition:	3
Damage:	Unknown
Proposal:	Retain in situ and renovate. Fire treatment.
Methodology:	Tbc by condition.
Heritage Comments:	MS Medium significance

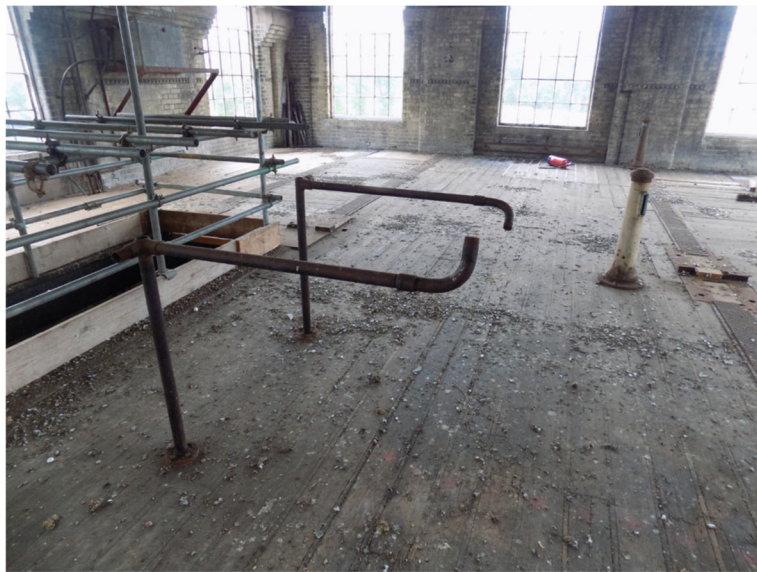
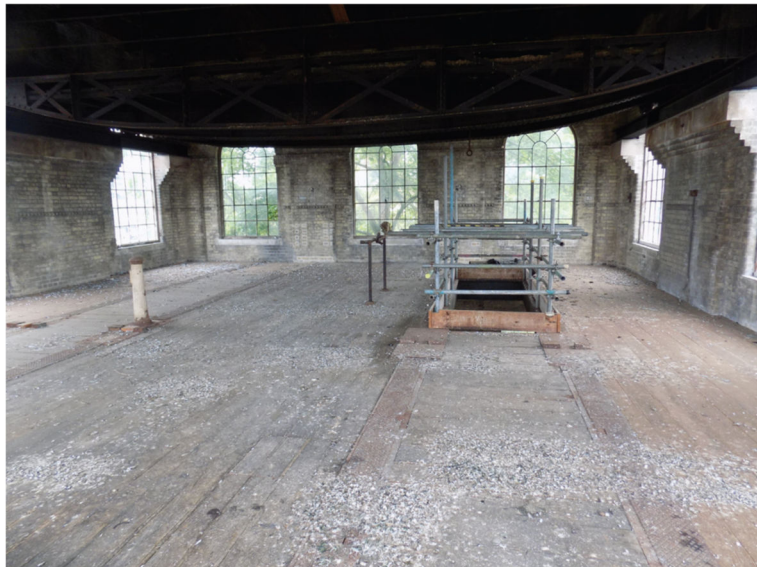
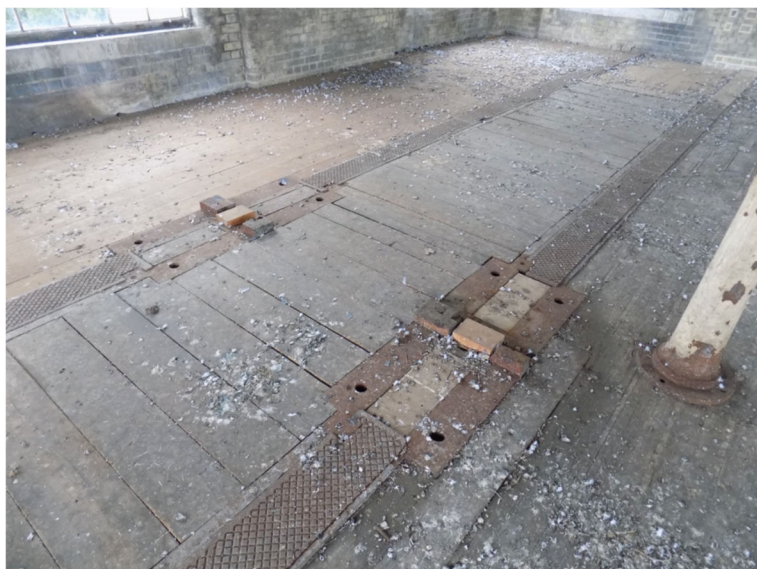
Reference:	Figure 7 – Beam loft floor
------------	-----------------------------------

Description:	Beam loft floor (all high significance) Beam loft floor showing spring beams and trunnion bearing support (high significance) and later infill to beam openings (no significance)
Condition:	3
Damage:	Unknown
Proposal:	Retain in situ and renovate. Acoustic and fire treatment.
Methodology:	Tbc by condition.
Heritage Comments:	HS High significance

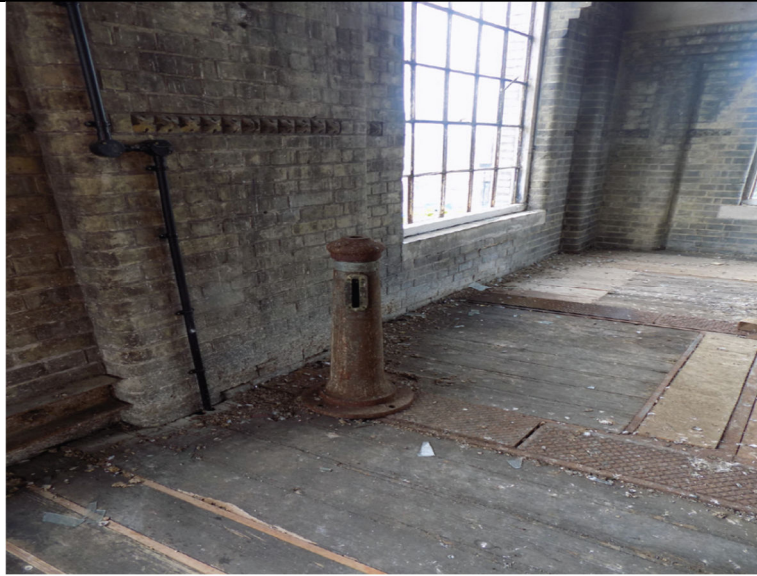
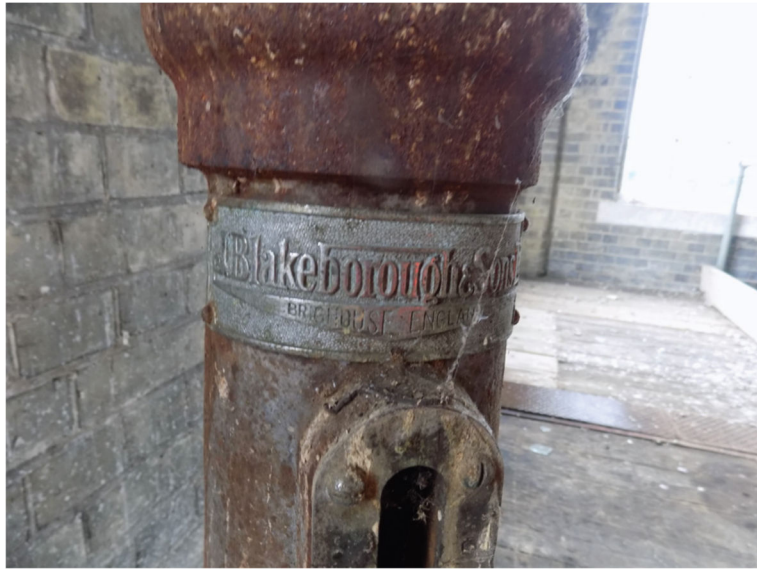
Location:	Karslake – Former Bean Engine House
Description:	Cast-iron Blakesborough level indicators (two of, ex-situ) (high significance)
Condition:	3
Damage:	Unknown
Proposal:	Retain and relocate.
Methodology:	Tbc by condition.
Heritage Comments:	HS High significance

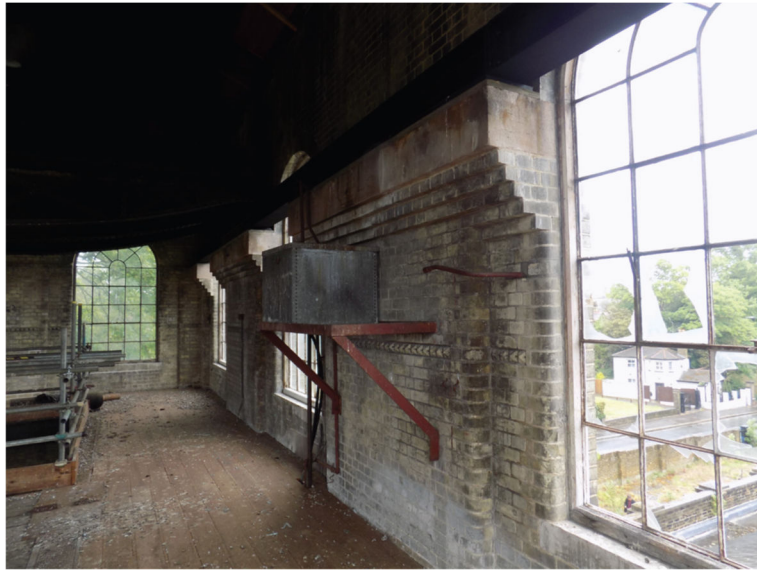
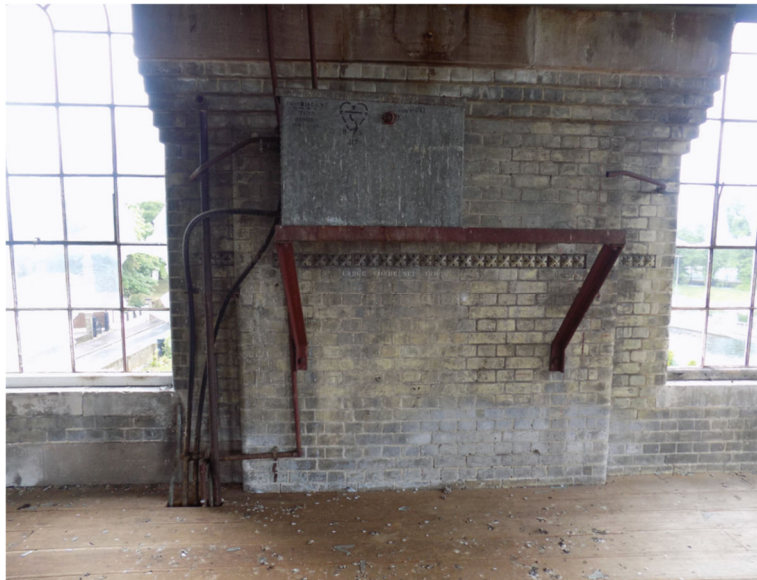
Reference:	Figure 9 – Header tank
------------	-------------------------------

Location:	Karslake – Former Bean Engine House
Description:	Header tank on welded steel supports (no significance)
Condition:	3
Damage:	Unknown
Proposal:	Remove.
Methodology:	Tbc by condition.
Heritage Comments:	N No significance

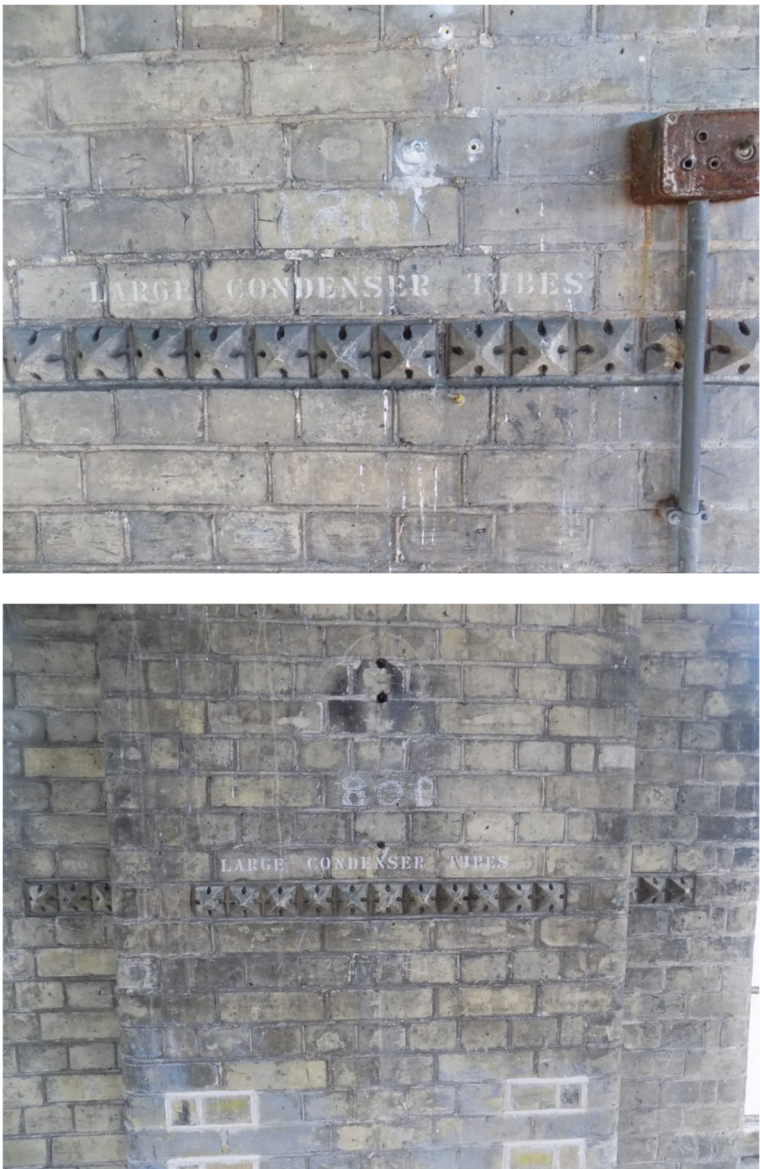
Reference:	Figure 10 - Stencilled "Large Condenser Tubes"

Location:	Karslake – Former Bean Engine House
Description:	Stencilled "Large Condenser Tubes" (one of two) (high significance)
Condition:	3
Damage:	Unknown
Proposal:	Retain in situ and renovate. Apartment feature.
Methodology:	Tbc by condition.
Heritage	HS High significance
Comments:

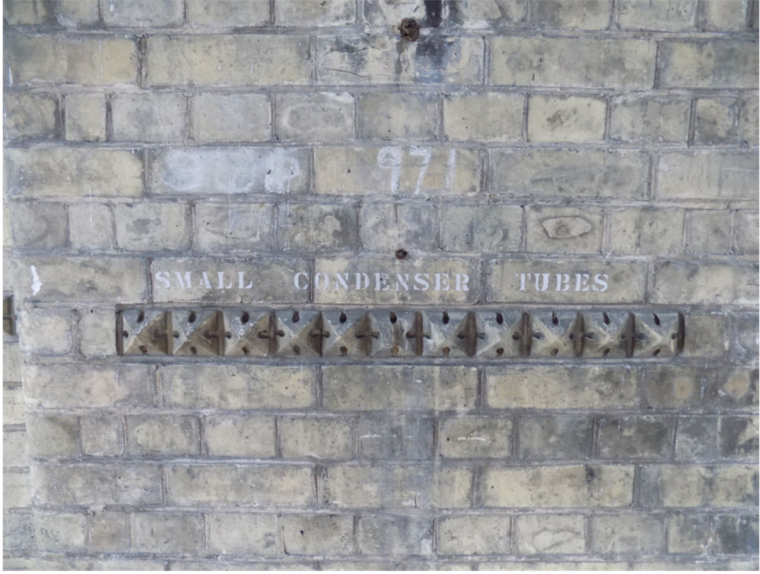
Reference:	Figure 11 – Stencilled “Small Condenser Tubes”

Location:	Karslake – Former Bean Engine House
Description:	Stencilled “Small Condenser Tubes” (one of two) (high significance)
Condition:	3
Damage:	Unknown
Proposal:	Retain in situ and renovate. Apartment feature.
Methodology:	Tbc by condition.
Heritage Comments:	HS High significance

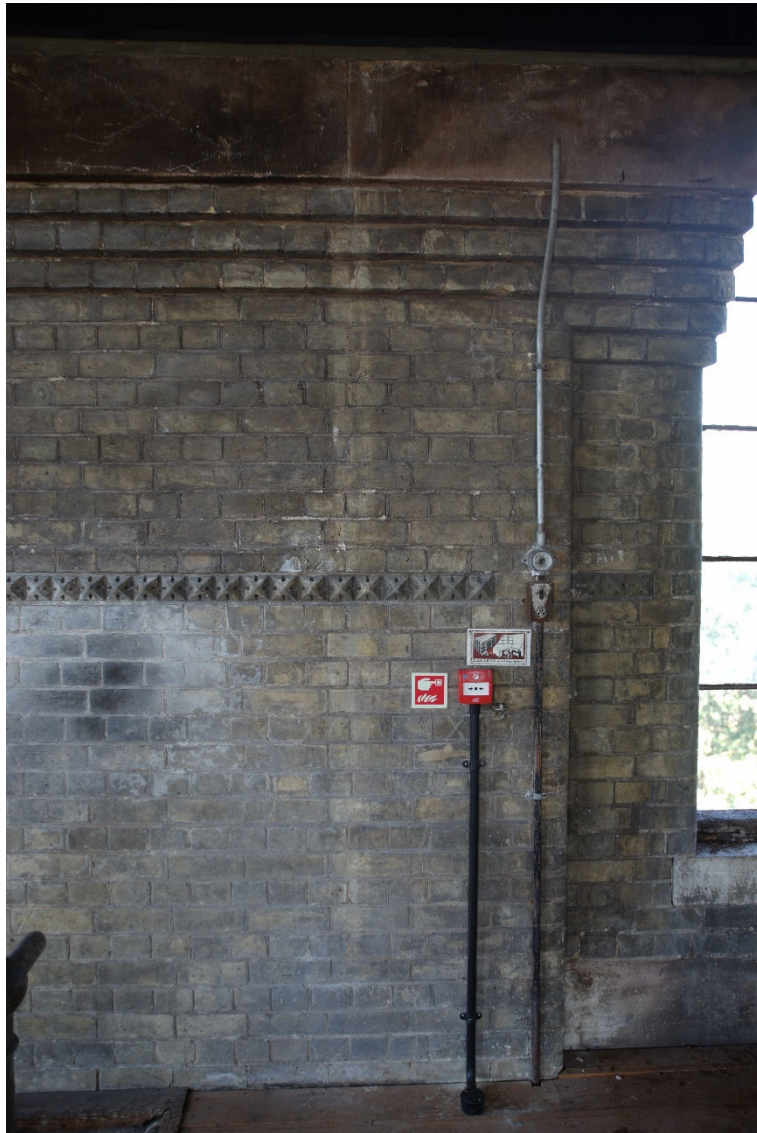
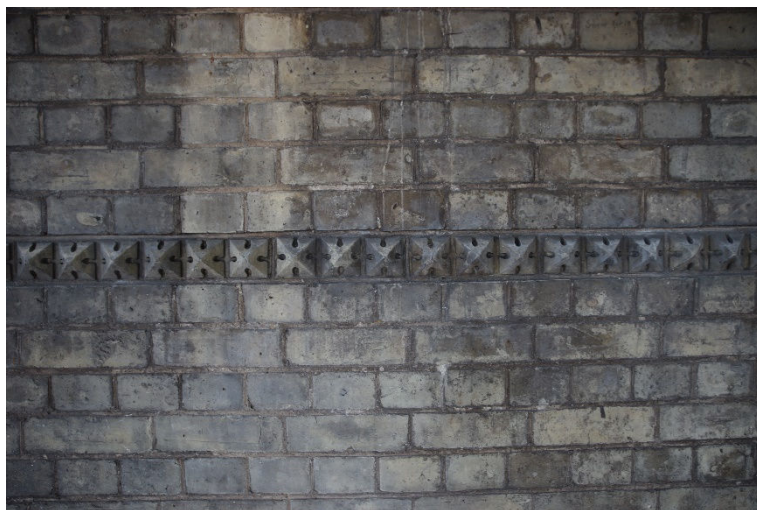
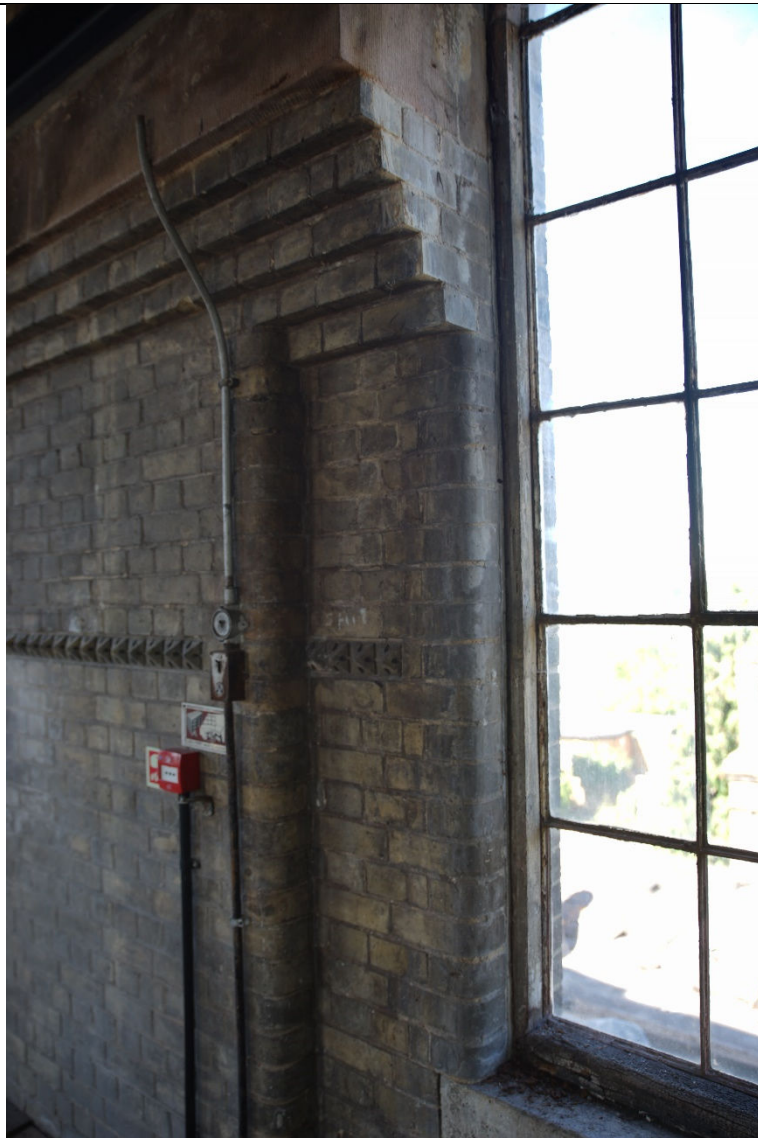
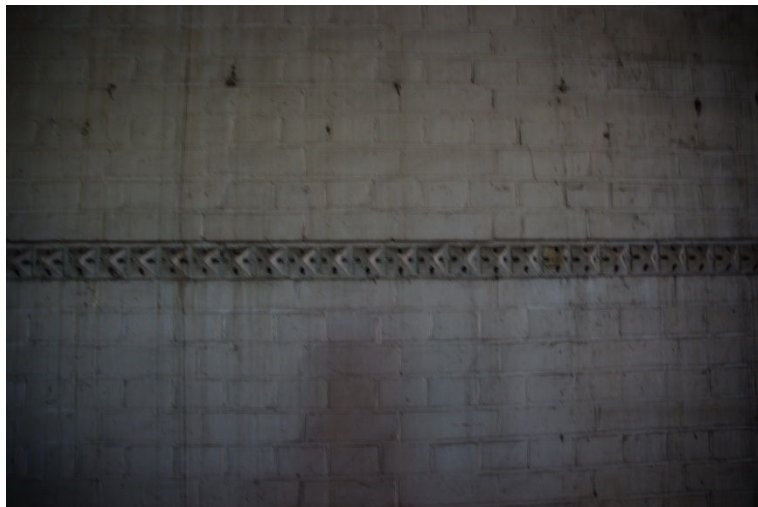
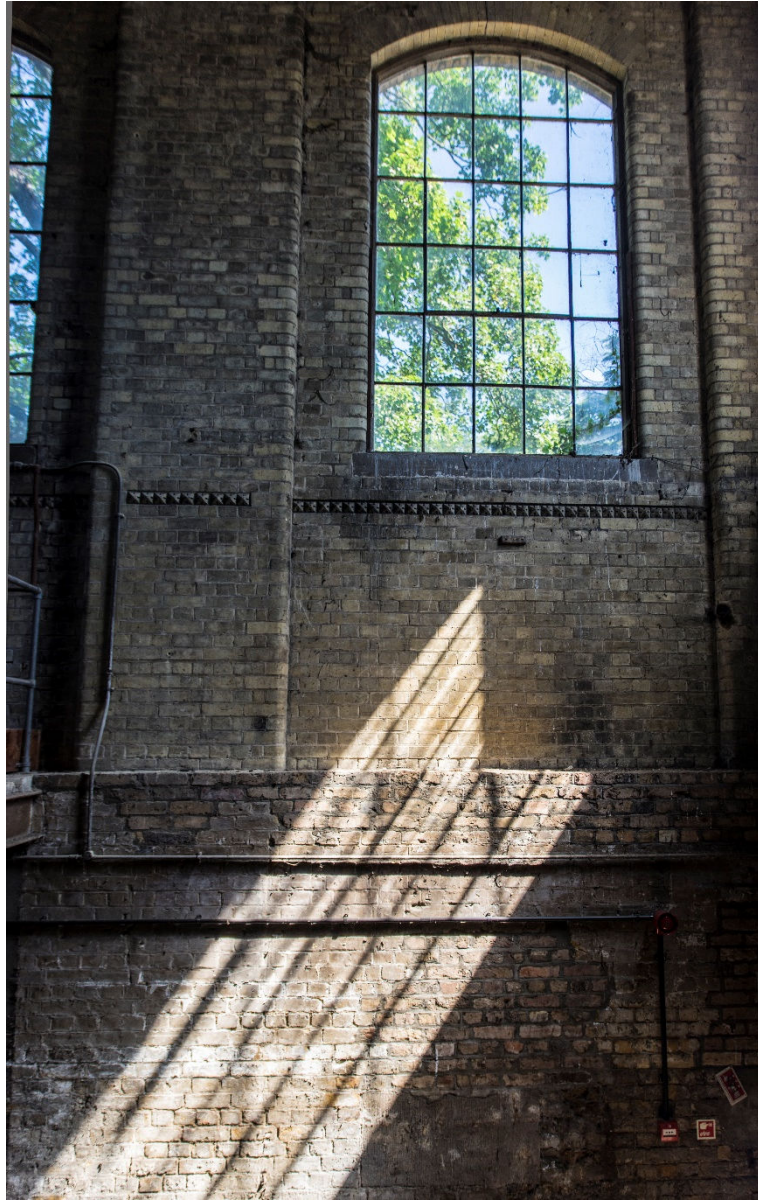
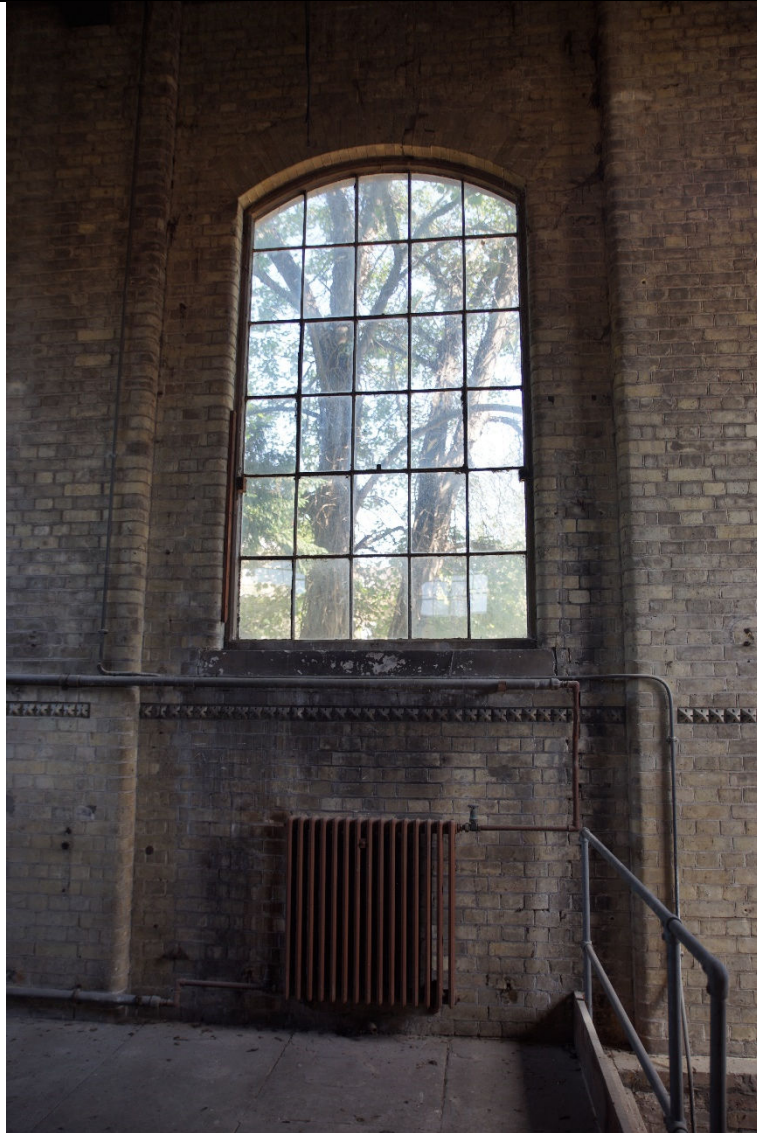
Figure 12 – Brickwork motif linear detail

Location: **Karslake – Former Bean Engine House**
Description: General view of interior brick work detailing

Condition:	3
Damage:	Unknown
Proposal:	Retain in situ and renovate. Apartment feature.
Methodology:	Tbc by condition.
Heritage Comments:	HS High significance

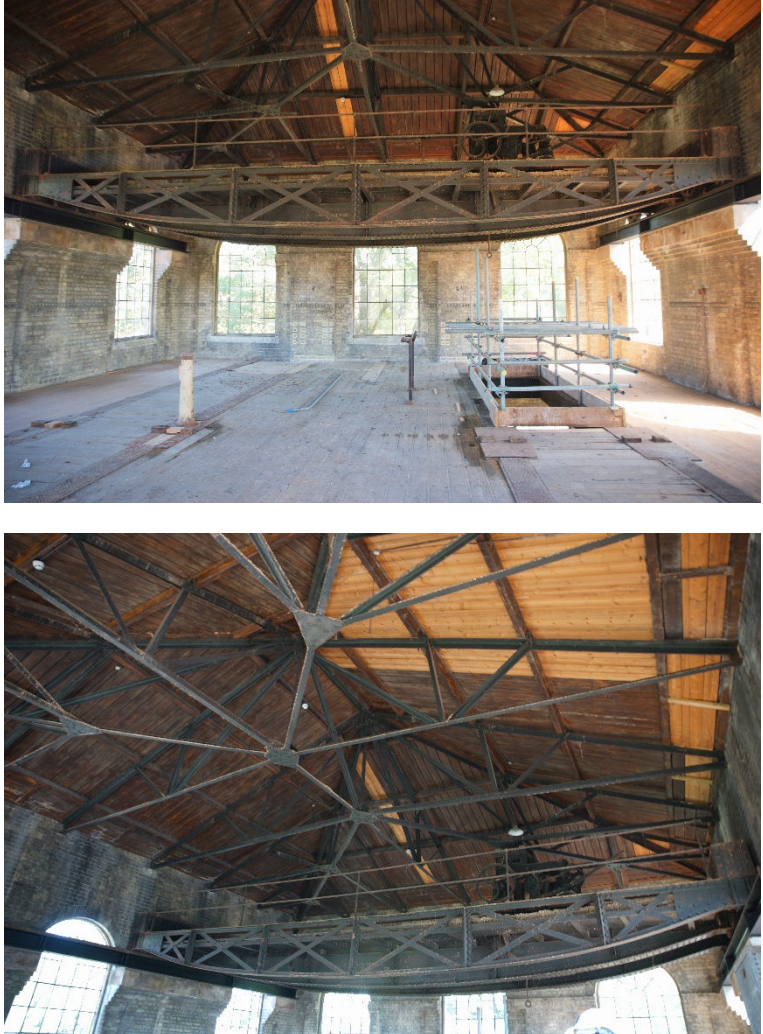
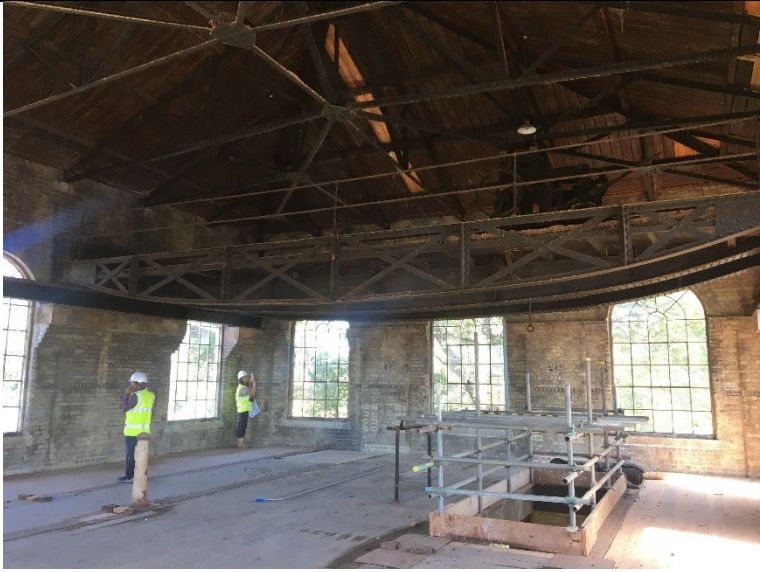
Reference:	Figure 13 – Spring Beams

Location:	Karslake – Former Bean Engine House
Description:	Gantry and roof
Condition:	3
Damage:	Unknown
Proposal:	Retain in situ and renovate. Apartment feature. Roof structure to be retained and repaired, retain and repair underside of boarding to match existing
Methodology:	Tbc by condition.
Heritage Comments:	HS High significance

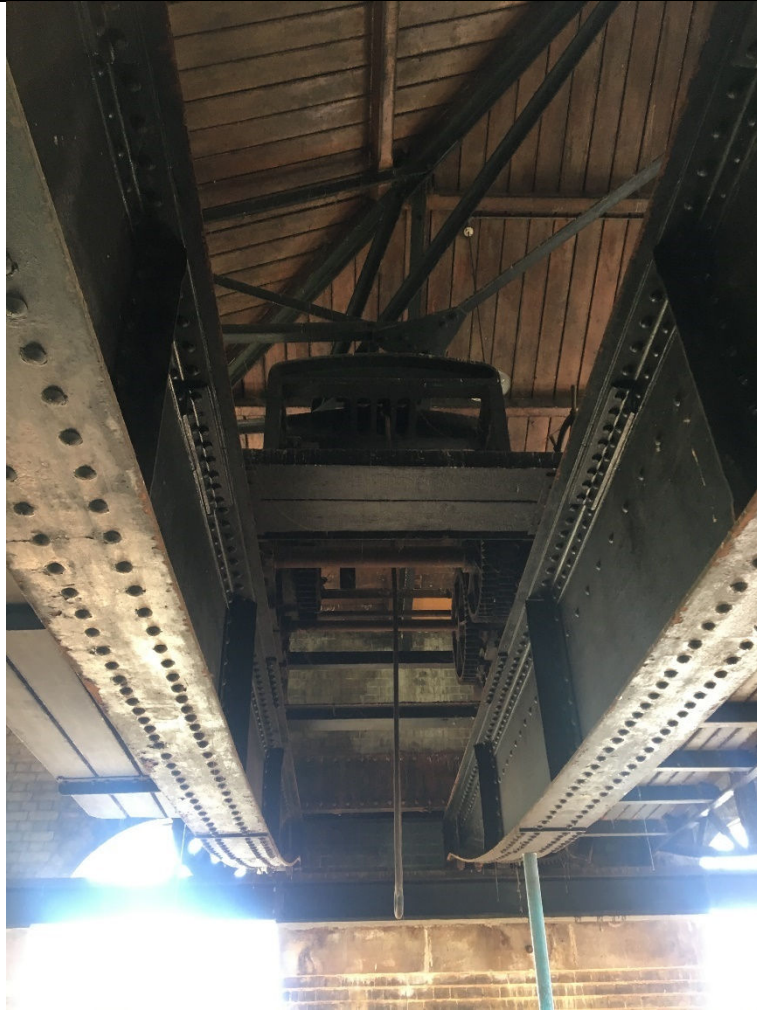
Reference:	Figure 14 – Gantry traveller

Location:	Karslake – Former Bean Engine House
Description:	Hand-cranked gantry traveller (high significance)
Condition:	3
Damage:	Unknown
Proposal:	Retain in situ and renovate. Apartment feature. Gantry to be retained and repaired.
Methodology:	Tbc by condition.
Heritage Comments:	HS High significance

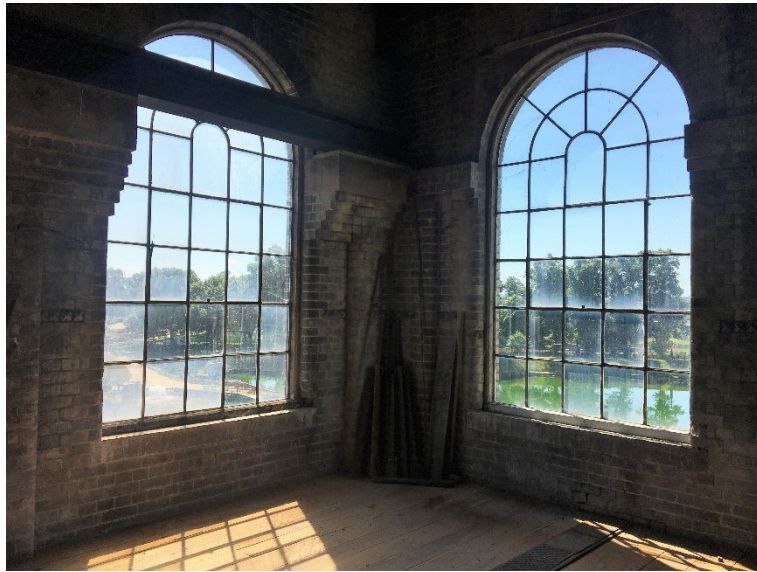
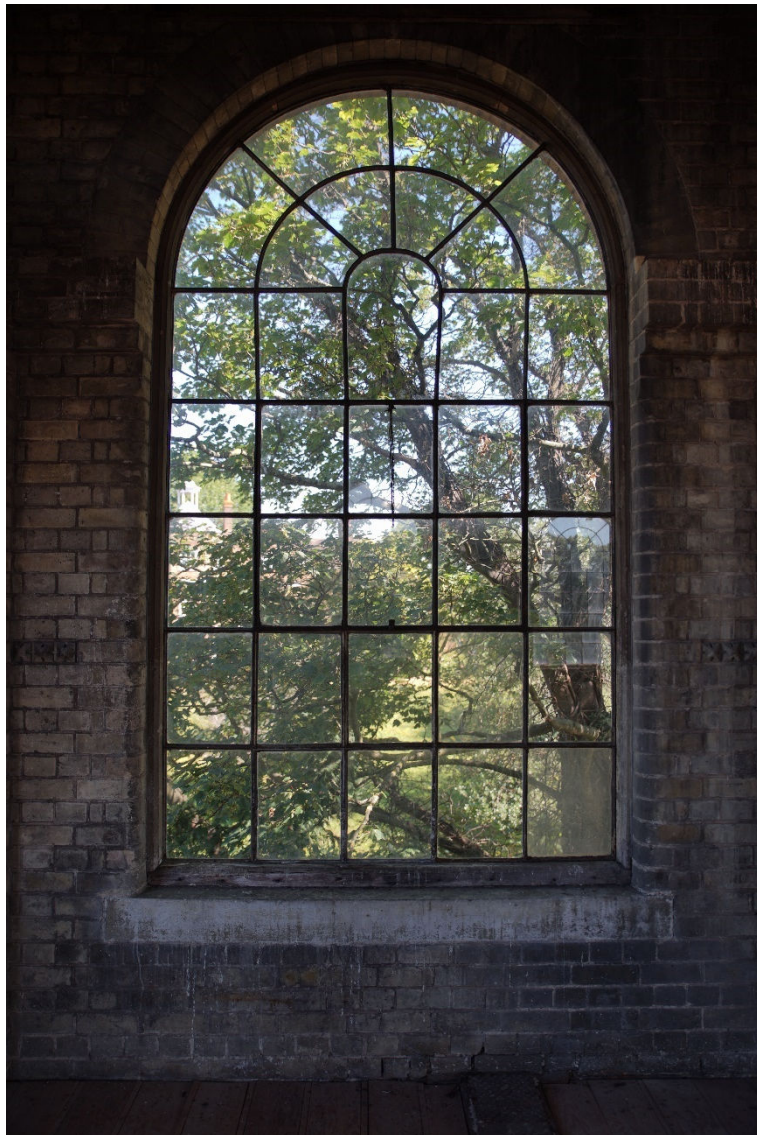
Figure 15 – Cast Iron windows

Description:	Cast-iron windows,
Condition:	3
Damage:	Unknown
Proposal:	Retain in situ and renovate.
Methodology:	Tbc by condition.
Heritage Comments:	HS High significance

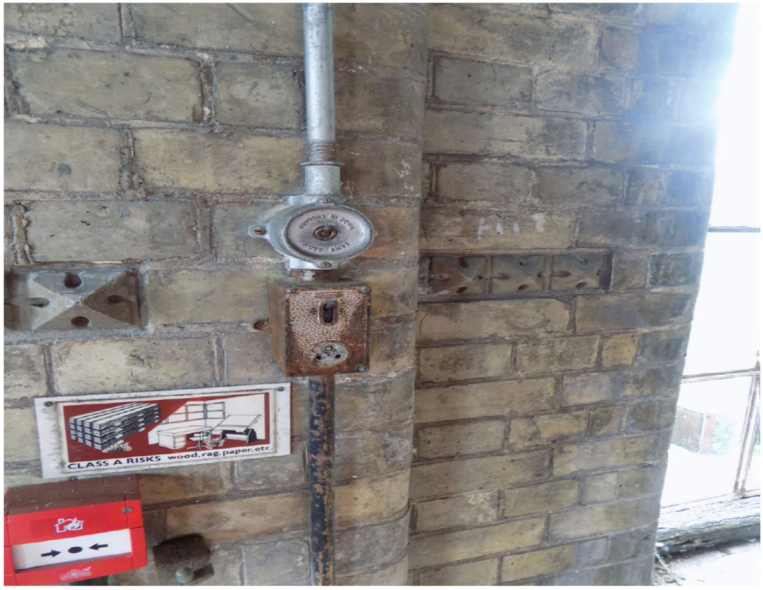
Reference:	Figure 16 – Electrical conduits

Location:	Karslake – Former Bean Engine House
Description:	1930s electrical conduits, switches and sockets (low significance)
Condition:	3
Damage:	Unknown
Proposal:	Remove.
Methodology:	Tbc by condition.
Heritage Comments:	LS Low significance

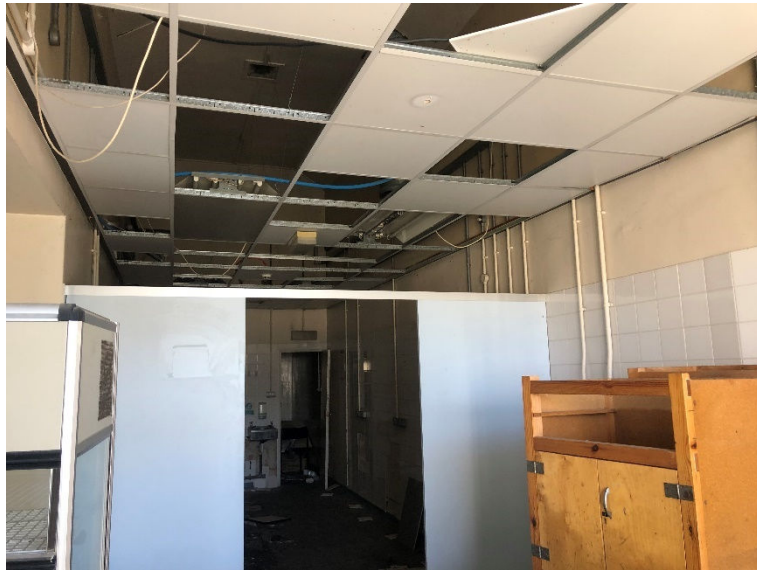
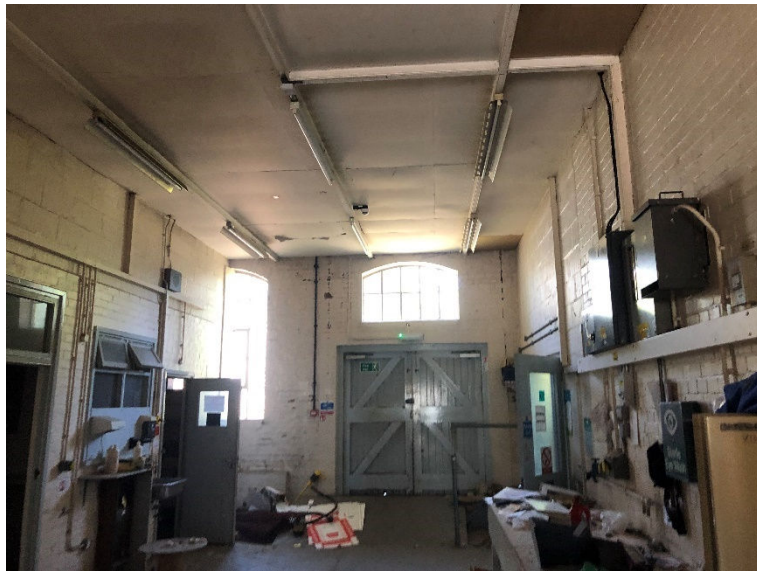
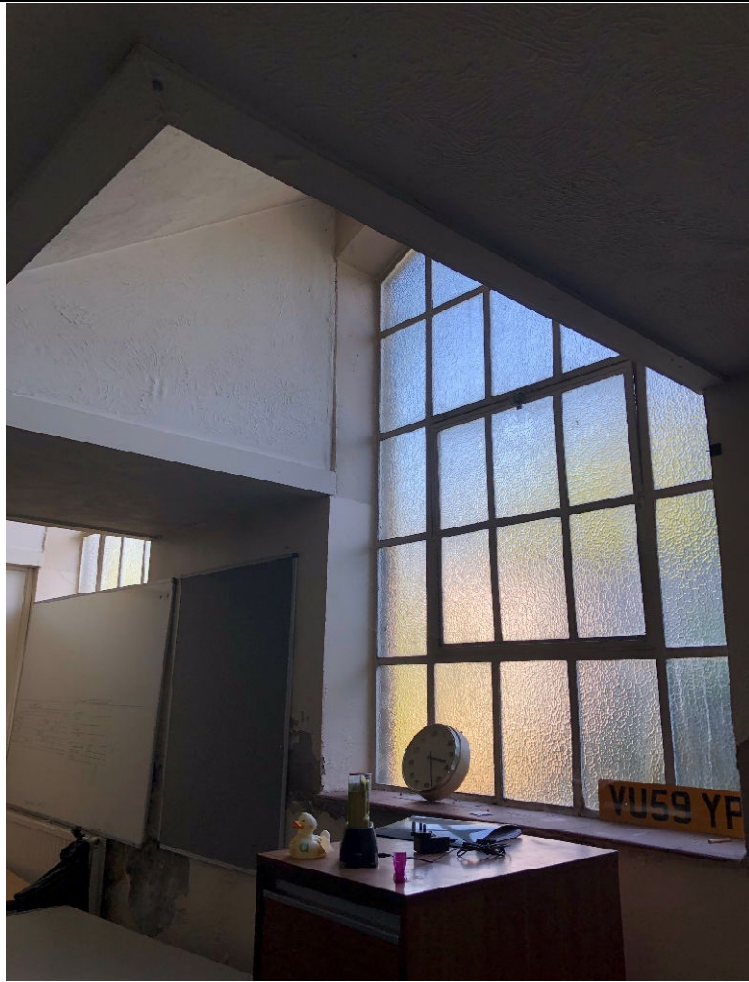
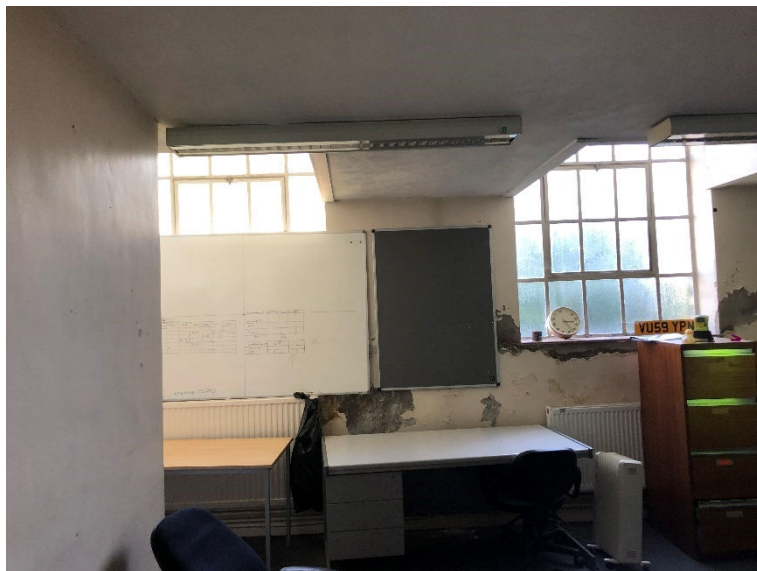
Figure 17 – Interior

Location:	Karslake – Former Boiler House
Description:	Much altered interior (low significance)
Condition:	3
Damage:	Unknown
Proposal:	Remove. Interior alterations, walls, floors, ceilings to be stripped out back to substrate
Methodology:	Tbc by condition.

Heritage Comments:	LS Low significance
-----------------------	---------------------
