Condition Survey Photo Record Schedule of Repairs – Karslake Interior

Client Waterfall Planning Ltd
Project Hampton Water Works
Subject Karslake Condition Survey Photo Record – Schedule of Repairs
Date 26.05.2023
Revision A
Job no. 1685
Reference 1685-A-P612 Karslake Condition Survey – Schedule of Repairs

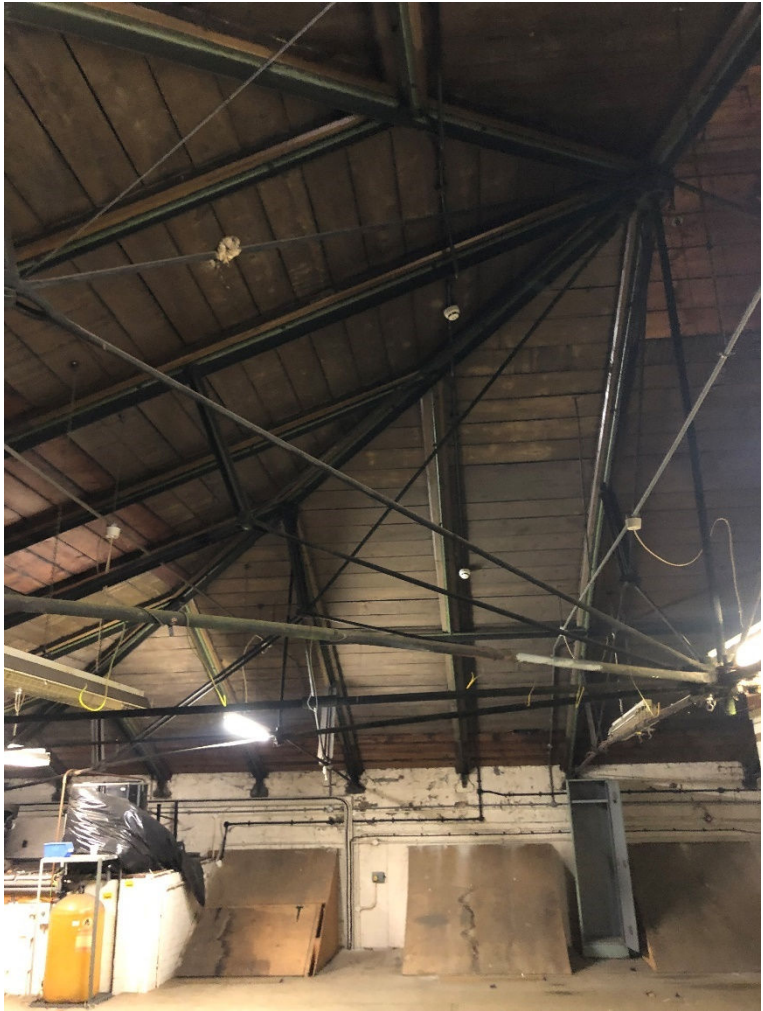
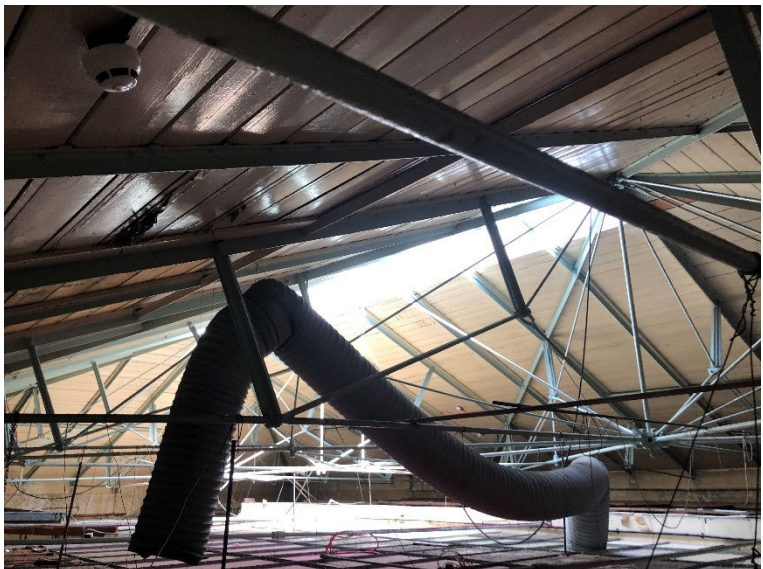
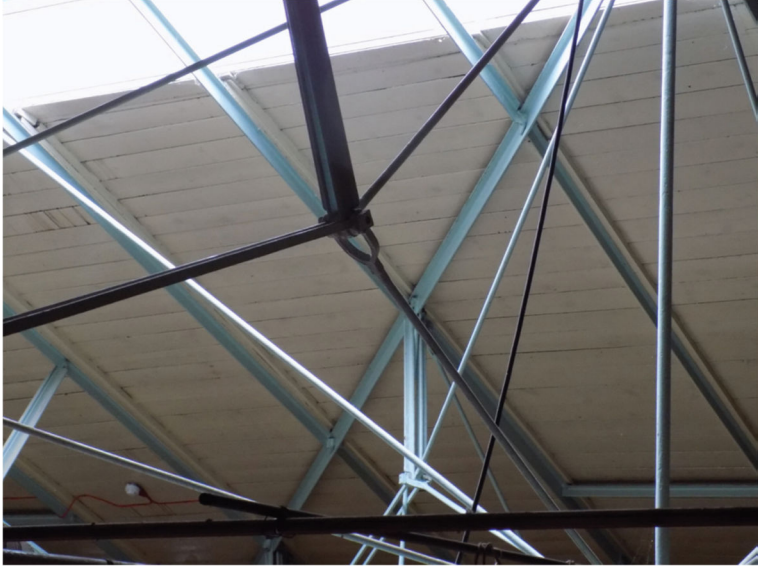
Reference: **Figure 18 – Primary wrought iron roof structure**

Location:	Karslake – Former Boiler House
Description:	General view of primary wrought-iron boiler house roof with radial ties and modern suspended ceiling (medium significance) Boss of primary wrought-iron roof (radial ties) (medium significance) Detail of primary wrought-iron roof elements.
Condition:	3
Damage:	Unknown
Proposal:	Remove.
Methodology:	Tbc by condition.
Heritage Comments:	MS Medium significance

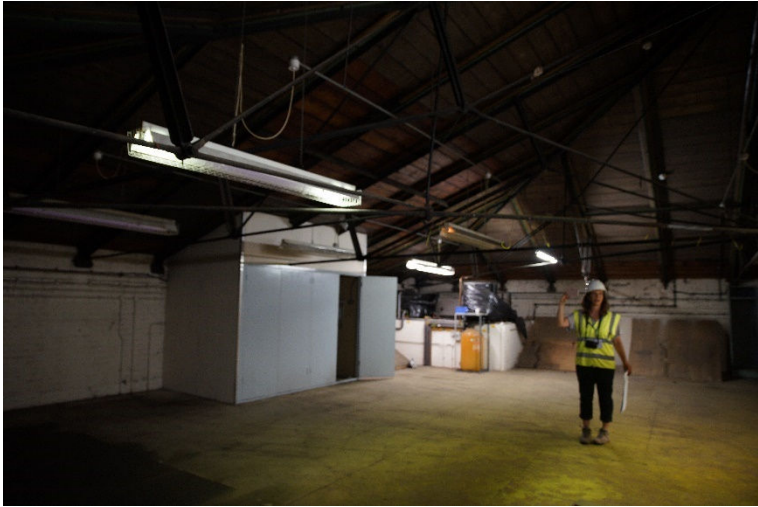
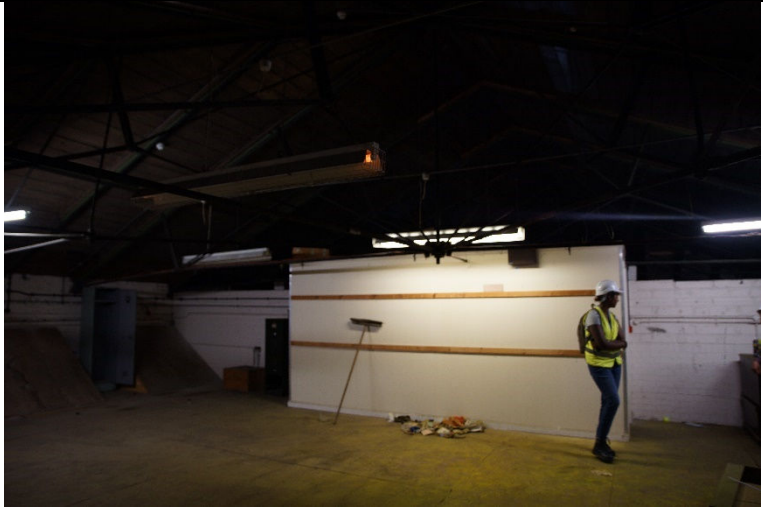
Reference:	Figure 19 – Intermediate floor

Location:	Karslake – Former Boiler House	
Description:	Much-altered interior and inserted stair Mezzanine floor enclosure, Karslake Former Boiler House	
Condition:	3	
Damage:	Unknown	
Proposal:	Remove. Interior alterations, stair, mezzanine floor to be stripped out.	
Methodology:	Tbc by condition.	
Heritage Comments:	LS Low significance

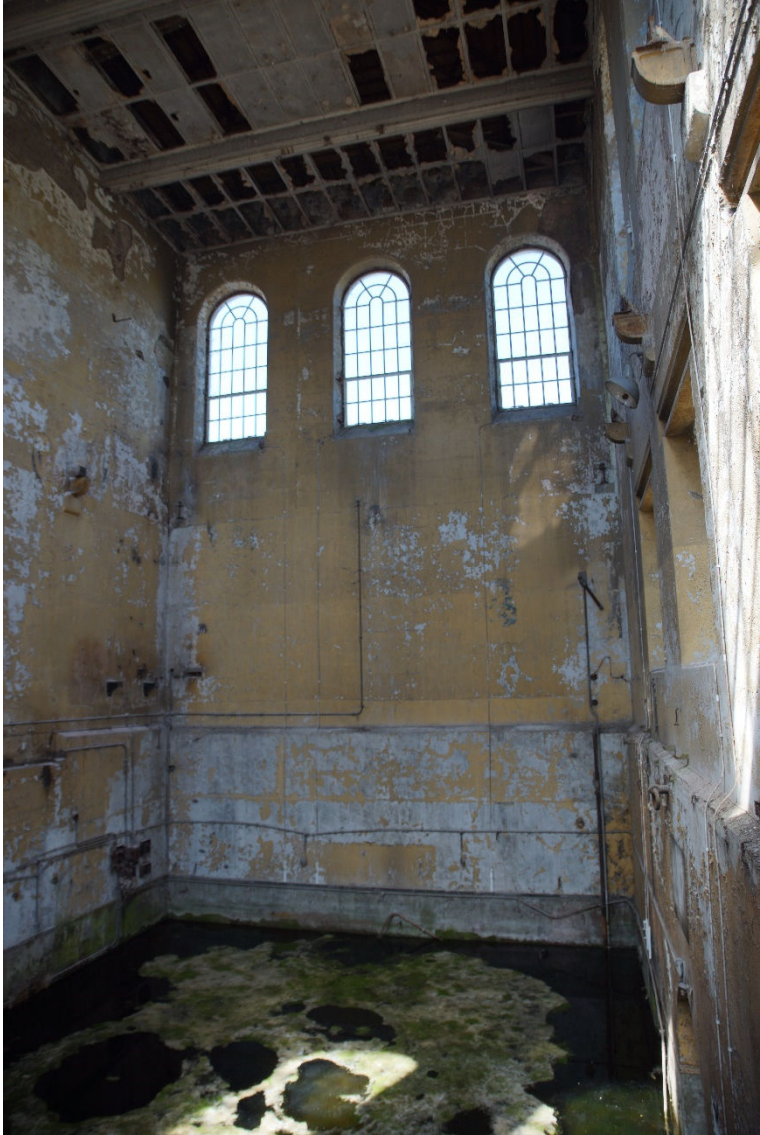
Reference:	Figure 20 – Interior

<p>The photograph shows the interior of a room in poor condition. The walls are heavily peeling, revealing a yellowish-brown substrate. Three arched windows with metal grates are set into the wall. The ceiling is damaged, with missing panels and exposed wooden beams. The floor is dark and appears to be covered in a layer of mold or debris. The overall appearance is one of significant neglect and decay.</p>
Location:	Karslake – Former Bull Engine House
Description:	Interior detail showing full height of wall adjacent to boiler house.
Condition:	3
Damage:	Unknown
Proposal:	Remove. Refinish overclad.
Methodology:	Tbc by condition.
Heritage Comments:	LS Low significance

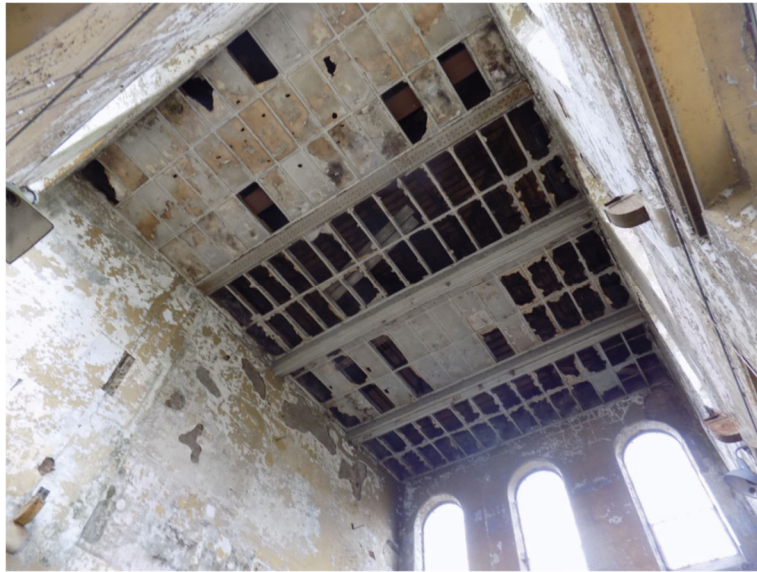
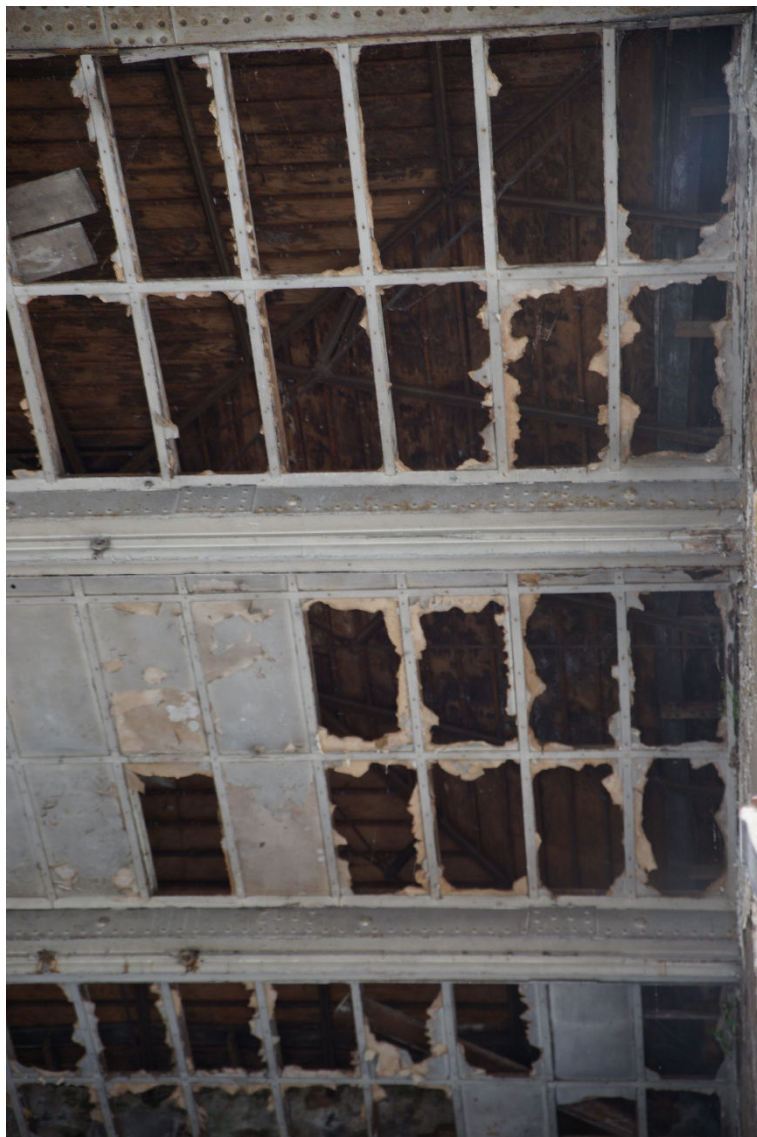
Figure 21 – Interior

Description:	Interior detail showing later, inserted ceiling under sarked roof.,
Condition:	3
Damage:	Unknown
Proposal:	Remove.
Methodology:	Tbc by condition.
Heritage Comments:	LS Low significance

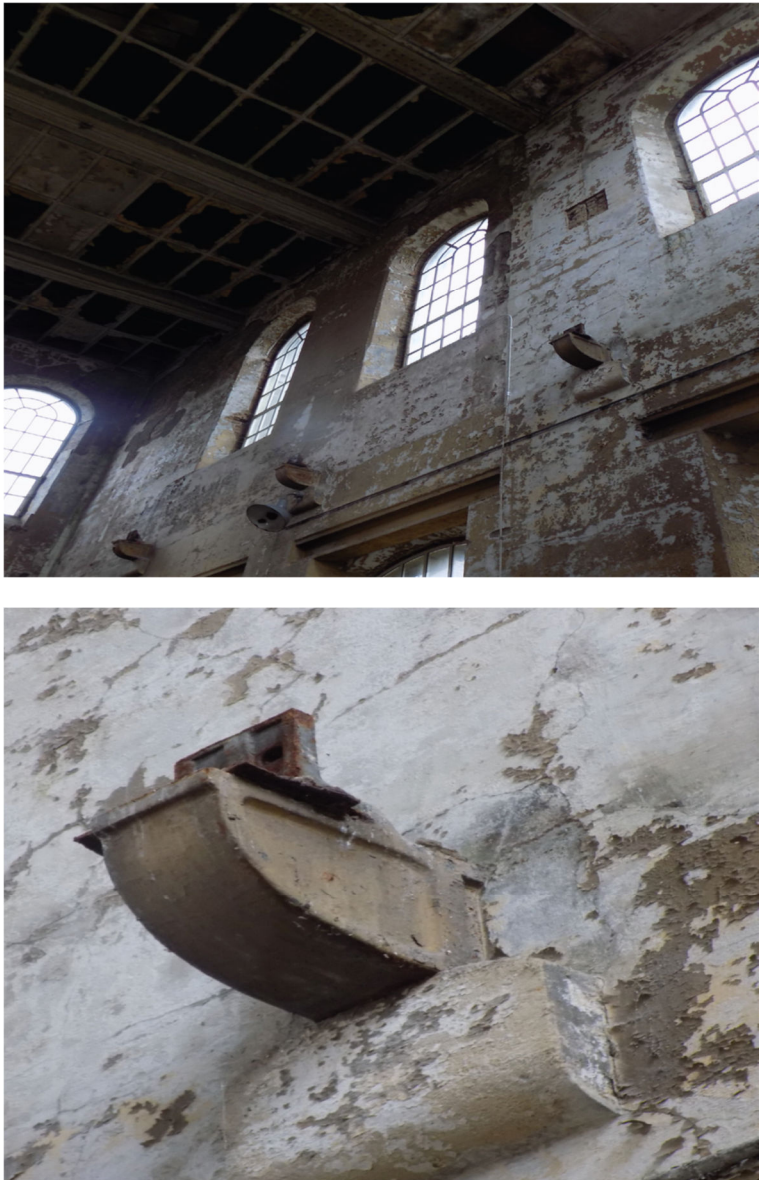
Reference:	Figure 22 – Interior

Location:	Karslake – Former Bull Engine House
Description:	Interior detail showing corbels for engine lifting beams. These are the last remnants of the Buill Engine and therefore have relatively high level of interest.
Condition:	3
Damage:	Unknown
Proposal:	Retain in situ and renovate. Apartment feature.
Methodology:	Tbc by condition.
Heritage Comments:	HS High significance

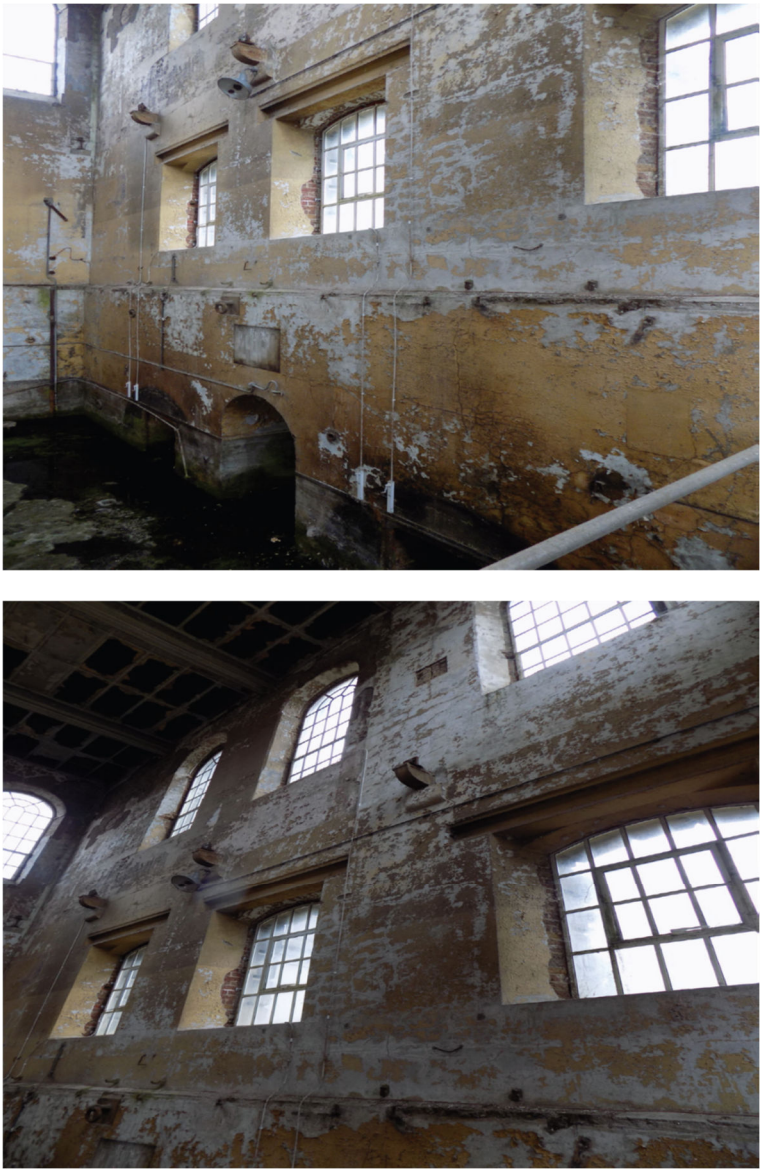
Reference:	Figure 23 – Interior

Location:	Karslake – Former Bull Engine House
Description:	Interior showing original windows at upper level and 1930s windows at ground floor level.
Condition:	3
Damage:	Unknown
Proposal:	Retain in situ and renovate. Ground level to be replaced, upper level retained and restored.
Methodology:	Tbc by condition.
Heritage Comments:	MS Medium significance
