# Condition Survey Photo Record Schedule of Repairs – Ruston & Ward External

**Client** Waterfall Planning Ltd  
**Project** Hampton Water Works  
**Subject** Ruston & Ward Condition Survey Photo Record – Schedule of Repairs  
**Date** 26.05.2023  
**Revision** A  
**Job no.** 1685  
**Reference** 1685-A-P613 Ruston & Ward Condition Survey – Schedule of Repairs

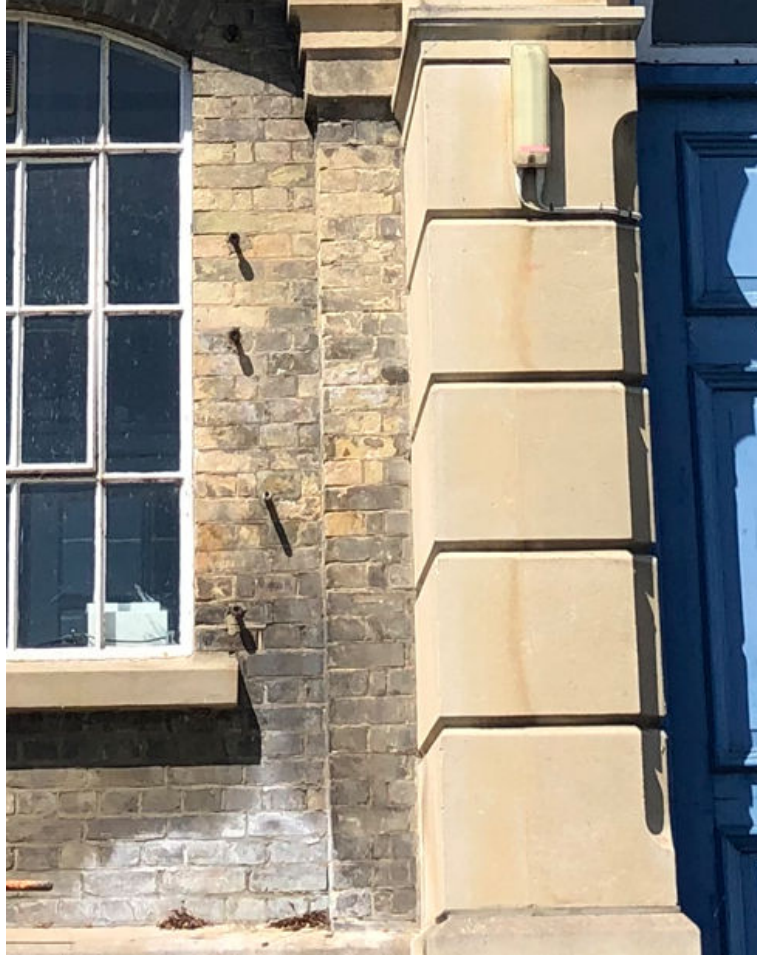
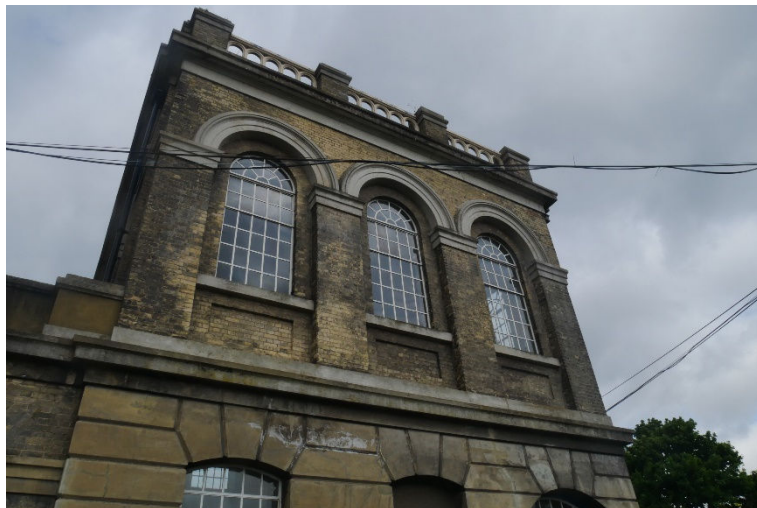
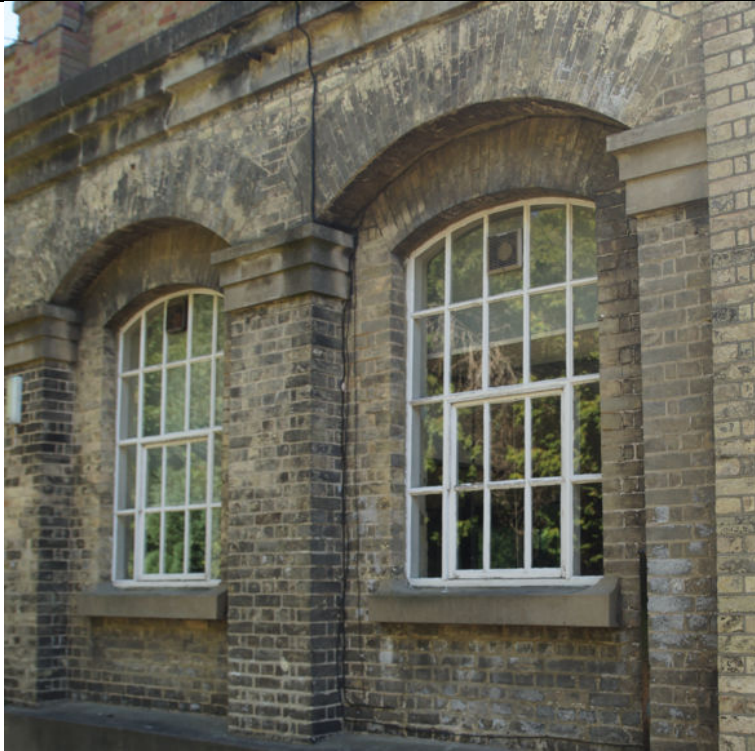
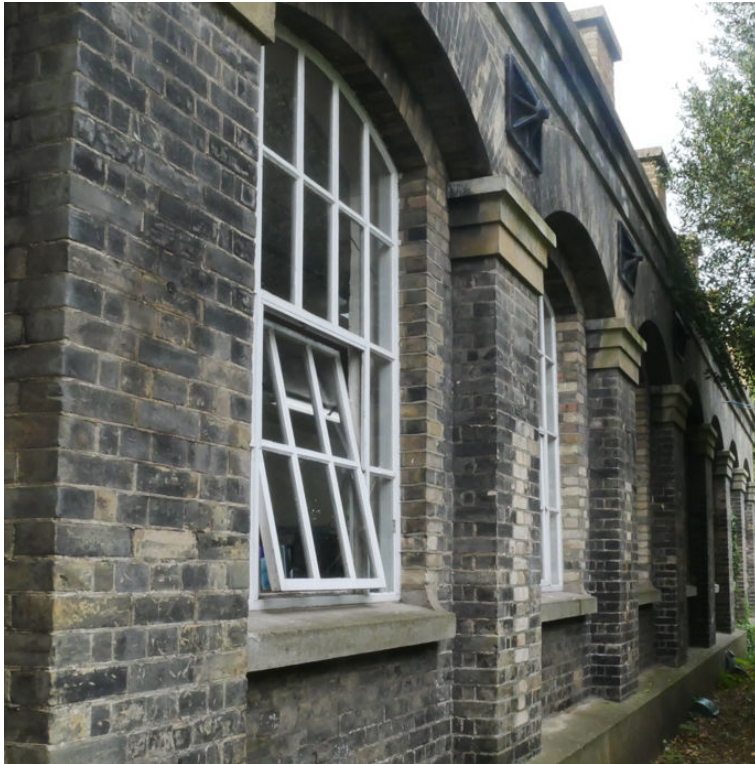
**Figure 1 – Brickwork – discolouring and staining**

Location:	<b>Ruston &amp; Ward - Bull Engine House / Boiler House / Former Engine House</b>
Description:	Brickwork discoloring and staining over time
Condition:	<b>3</b>
Damage:	Unknown
Proposal:	Retain in situ and renovate. Undertaking cleaning of any brickwork with associated defects restored as required.
Methodology:	Tbc by condition.

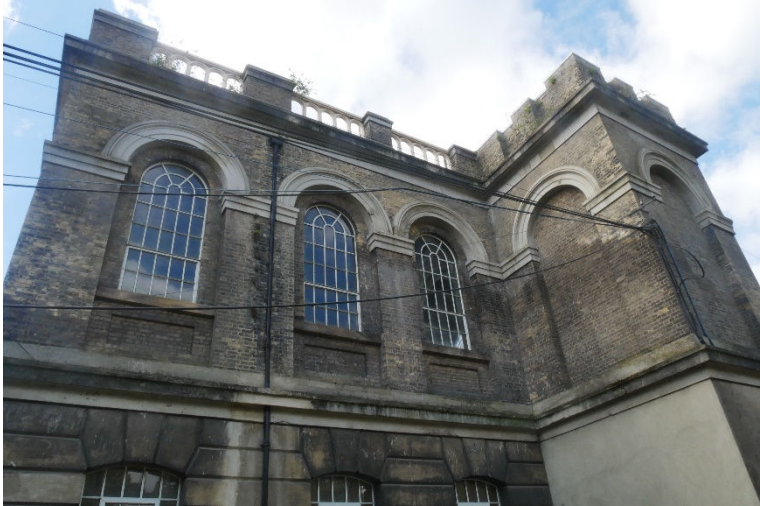
Heritage Comments:	<b>MS</b> Medium significance
Reference:	<b>Figure 2 – Brickwork - organic growth</b>

Location:	<b>Ruston &amp; Ward - Bull Engine House / Boiler House / Former Engine House</b>
Description:	Brickwork with organic growth over time
Condition:	<b>3</b>
Damage:	Unknown
Proposal:	Retain in situ and renovate. Remove any plant growth within finish material and restore any associated damage/defects
Methodology:	Tbc by condition.
Heritage Comments:	<b>MS</b> Medium significance

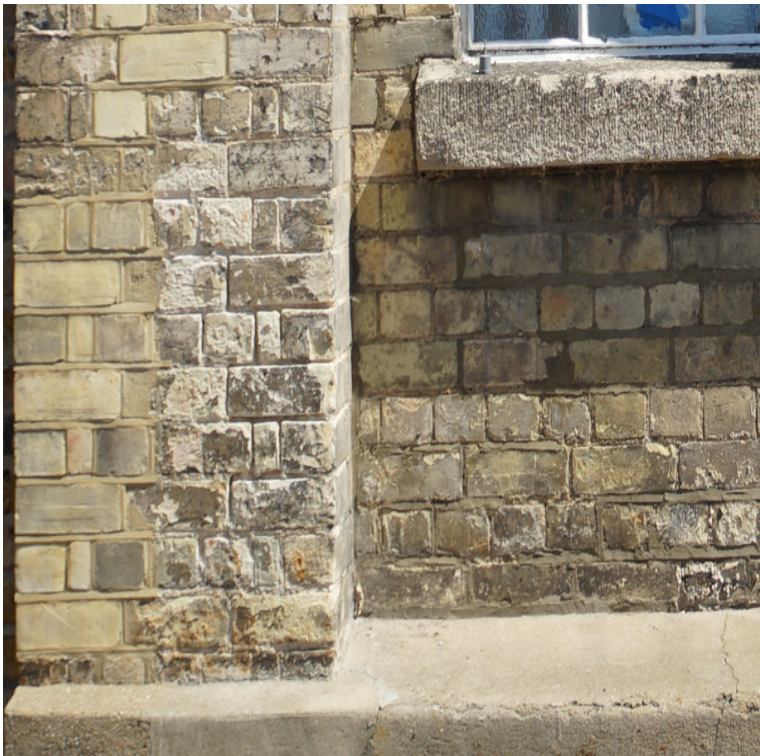
Reference:	<b>Figure 3 – Brickwork – minor material failure</b>

Location:	<b>Ruston &amp; Ward - Bull Engine House / Boiler House / Former Engine House</b>
Description:	Brickwork minor material failure over time
Condition:	<b>3</b>
Damage:	Unknown
Proposal:	Retain in situ and renovate. Undertaking re-pointing areas of mortar failure with associated defects restored as required.
Methodology:	Tbc by condition.
Heritage Comments:	<b>MS</b> Medium significance

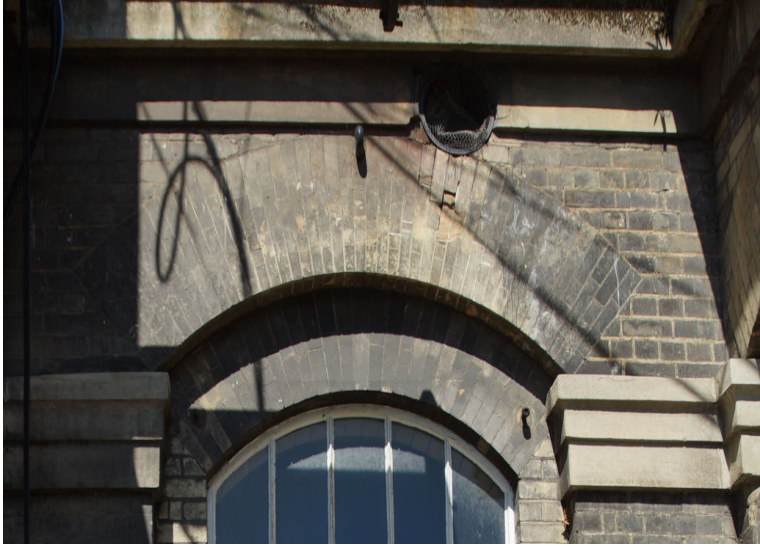
Reference:	<b>Figure 4 – Brickwork – extensive material failure</b>

Location:	<b>Ruston &amp; Ward - Bull Engine House / Boiler House / Former Engine House</b>
Description:	Brickwork extensive material failure over time
Condition:	<b>4</b>
Damage:	Unknown
Proposal:	Retain in situ and renovate. Undertaking substantial restoration works required such as replacing or repairing any decayed bricks and re-pointing.

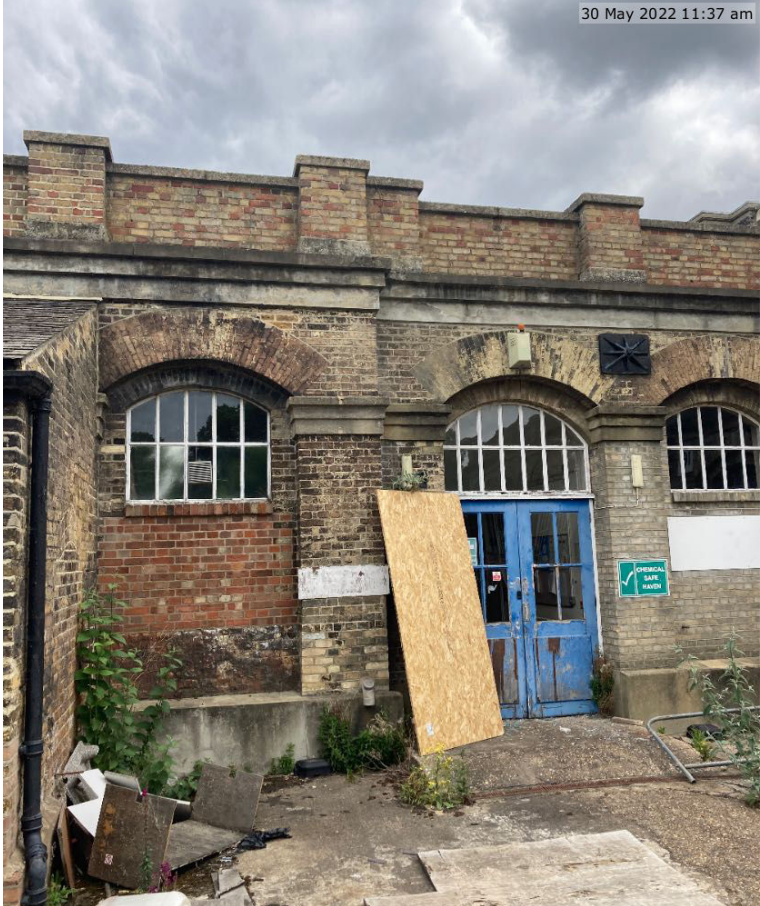
Location:	<b>Ruston &amp; Ward - Bull Engine House / Boiler House / Former Engine House</b>
Description:	Incorrect material form historic works
Condition:	<b>3</b>
Damage:	Unknown
Proposal:	Retain in situ and renovate. Any areas of brickwork that varies from the predominant finish type should be re-finished or replaced as required
Methodology:	Tbc by condition.
Heritage Comments:	<b>LS/MS</b> Low-Medium significance

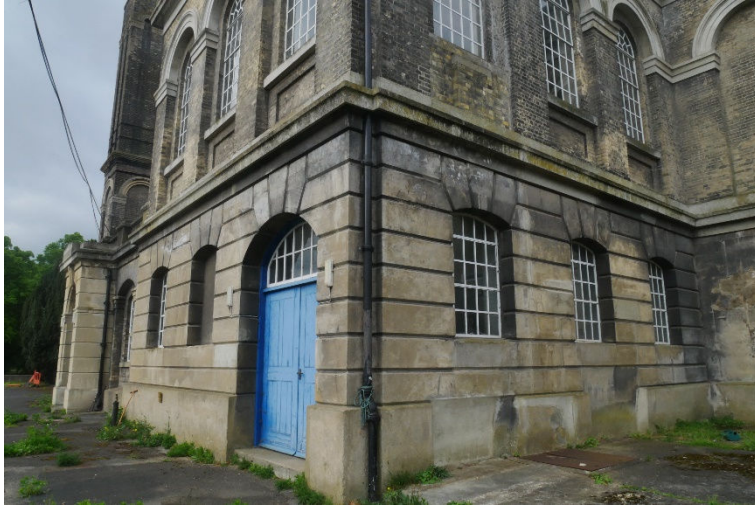
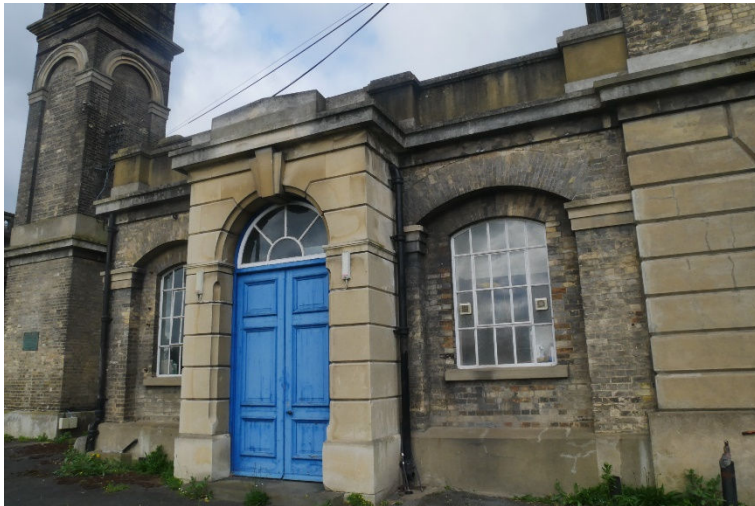
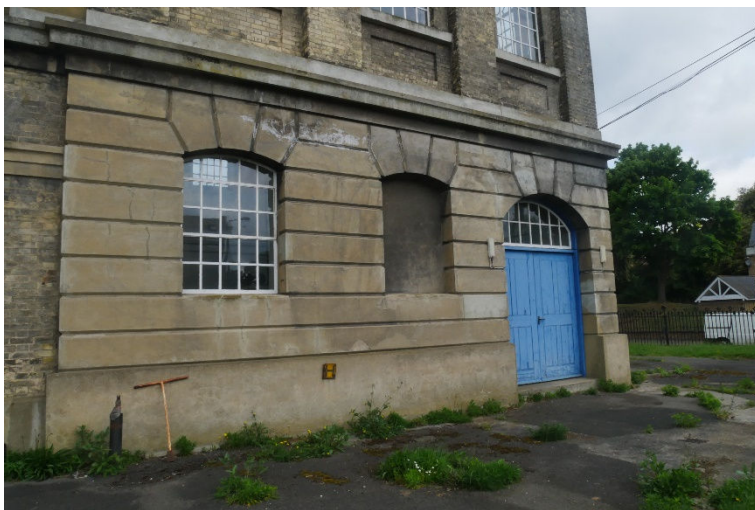
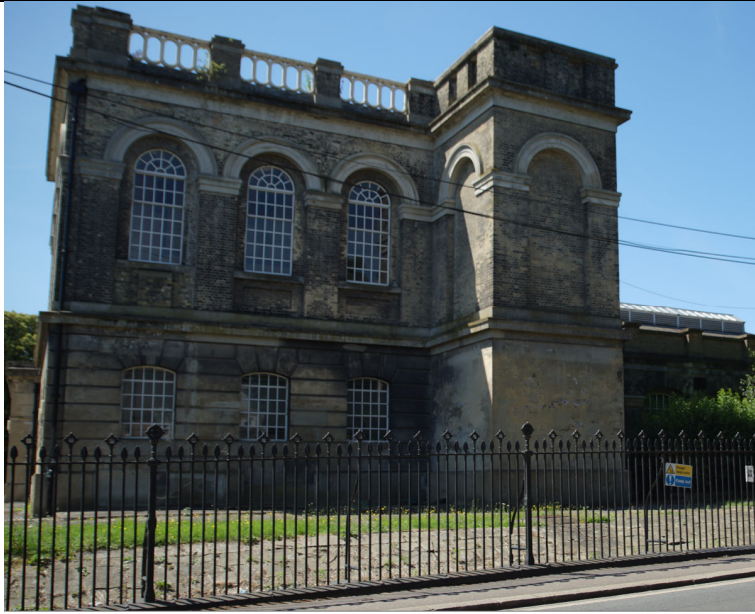
**Figure 6 – Stonework, render, plaster – discolouring and staining**

Location:	<b>Ruston &amp; Ward - Bull Engine House / Boiler House / Former Engine House</b>
Description:	Stonework, render, plaster discoloring and staining over time
Condition:	<b>3</b>
Damage:	Unknown
Proposal:	Retain in situ and renovate. Undertaking cleaning of any stonework, render, plaster with associated defects restored as required.
Methodology:	Tbc by condition.
Heritage Comments:	<b>MS</b> Medium significance

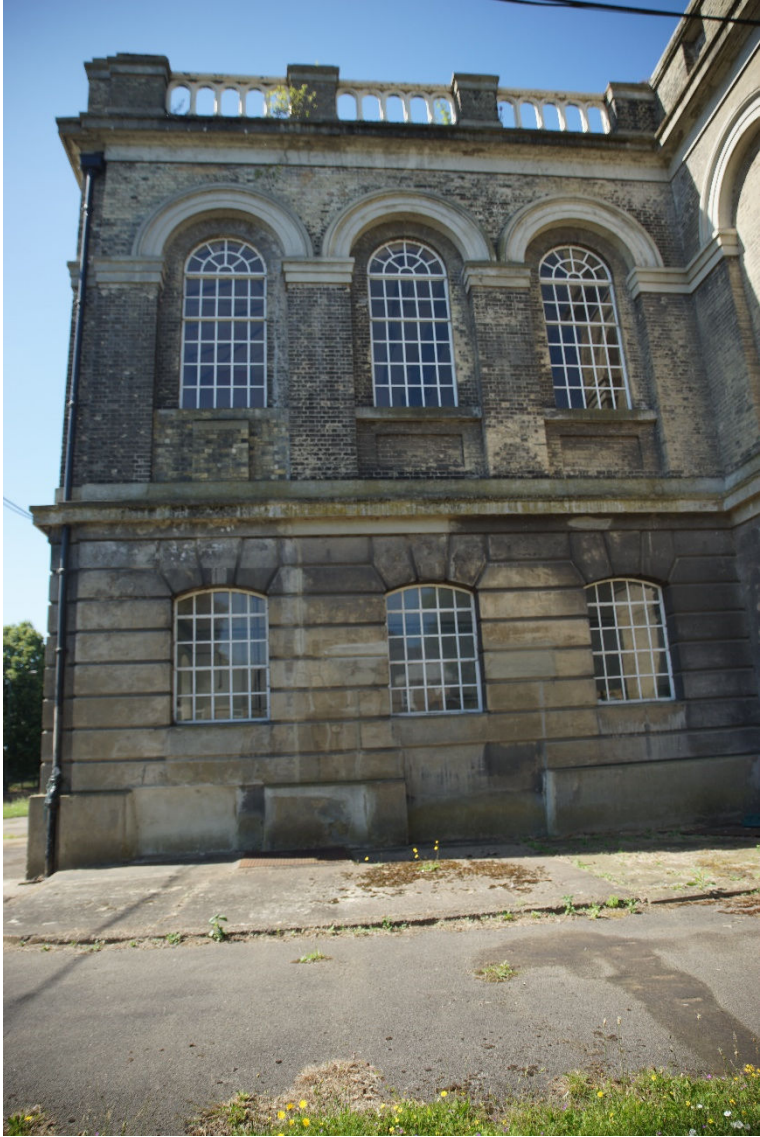
Reference:	<b>Figure 7 – Stonework, render, plaster - organic growth</b>

Location:	<b>Ruston &amp; Ward - Bull Engine House / Boiler House / Former Engine House</b>
Description:	Stonework ,render, plaster with organic growth over time
Condition:	<b>3</b>
Damage:	Unknown
Proposal:	Retain in situ and renovate. Remove any plant growth within finish material and restore any associated damage/defects
Methodology:	Tbc by condition.
Heritage Comments:	<b>MS</b> Medium significance

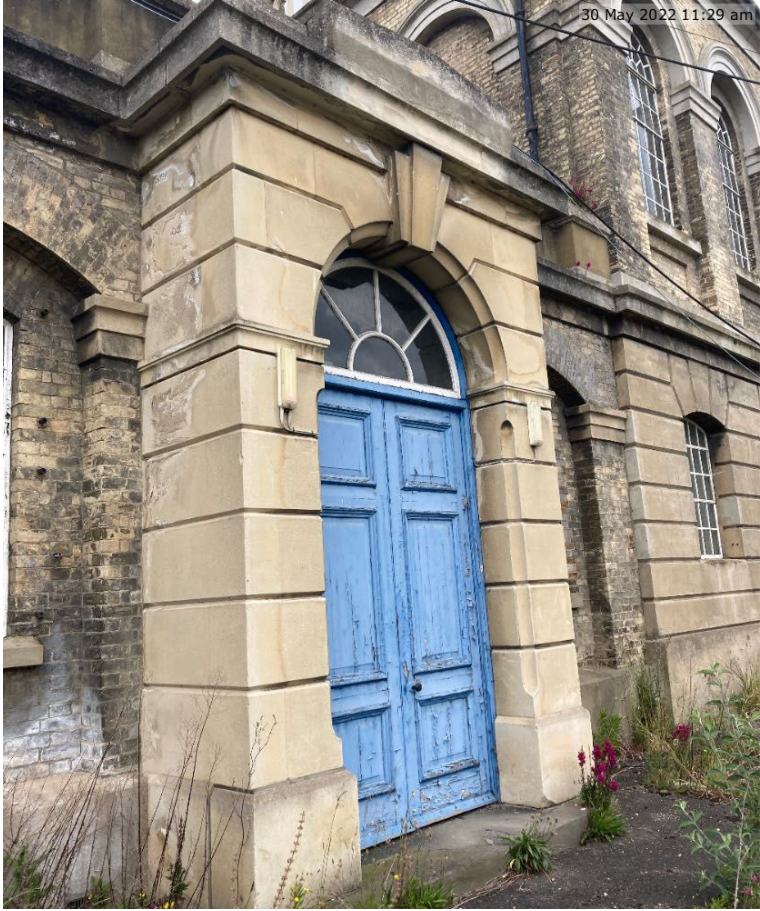
Reference:	<b>Figure 8 – Stonework – minor material failure</b>

Location:	<b>Ruston &amp; Ward - Bull Engine House / Boiler House / Former Engine House</b>
Description:	Brickwork extensive material failure over time
Condition:	<b>3</b>
Damage:	Unknown
Proposal:	Retain in situ and renovate. Re-finish any dilapidated areas of stonework, render and plaster
Methodology:	Tbc by condition.
Heritage Comments:	<b>MS</b> Medium significance

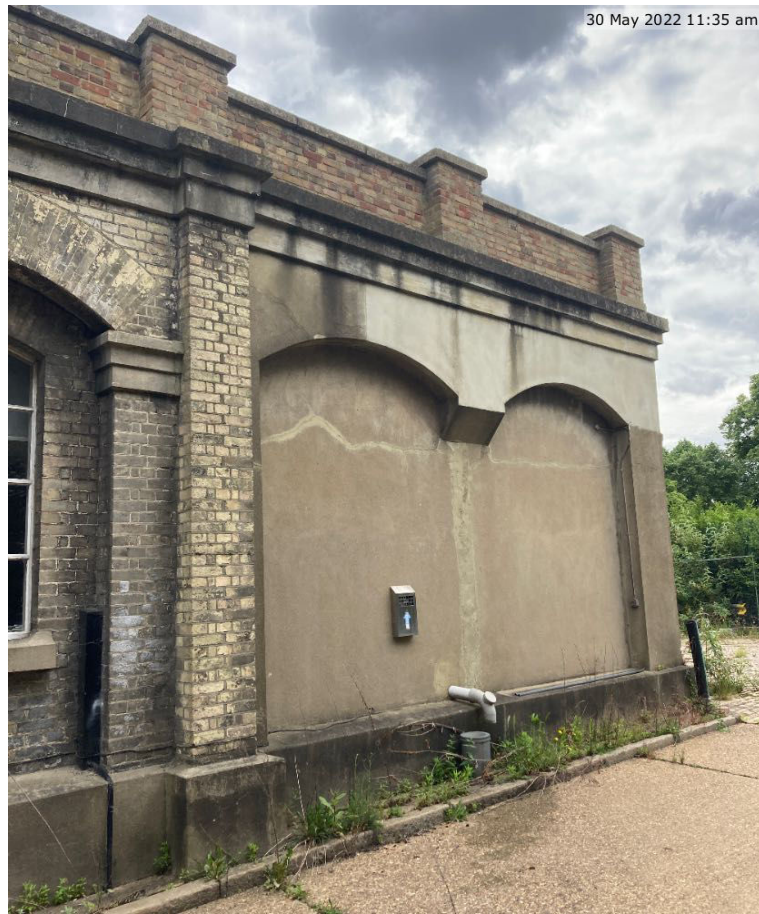
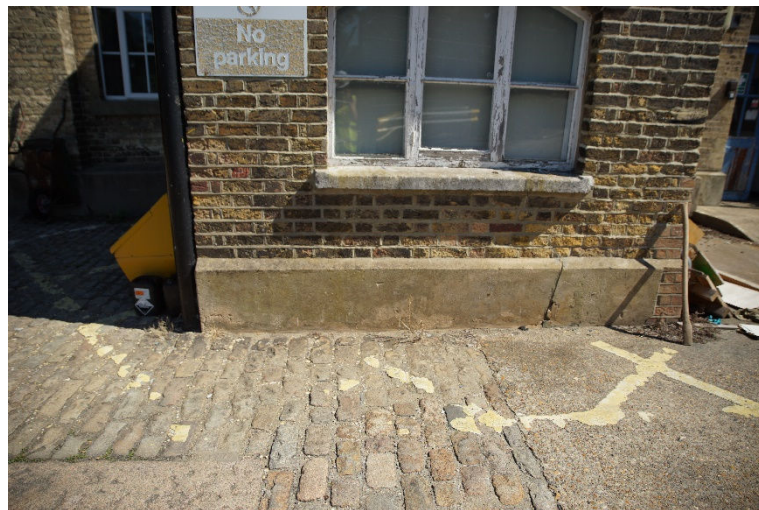
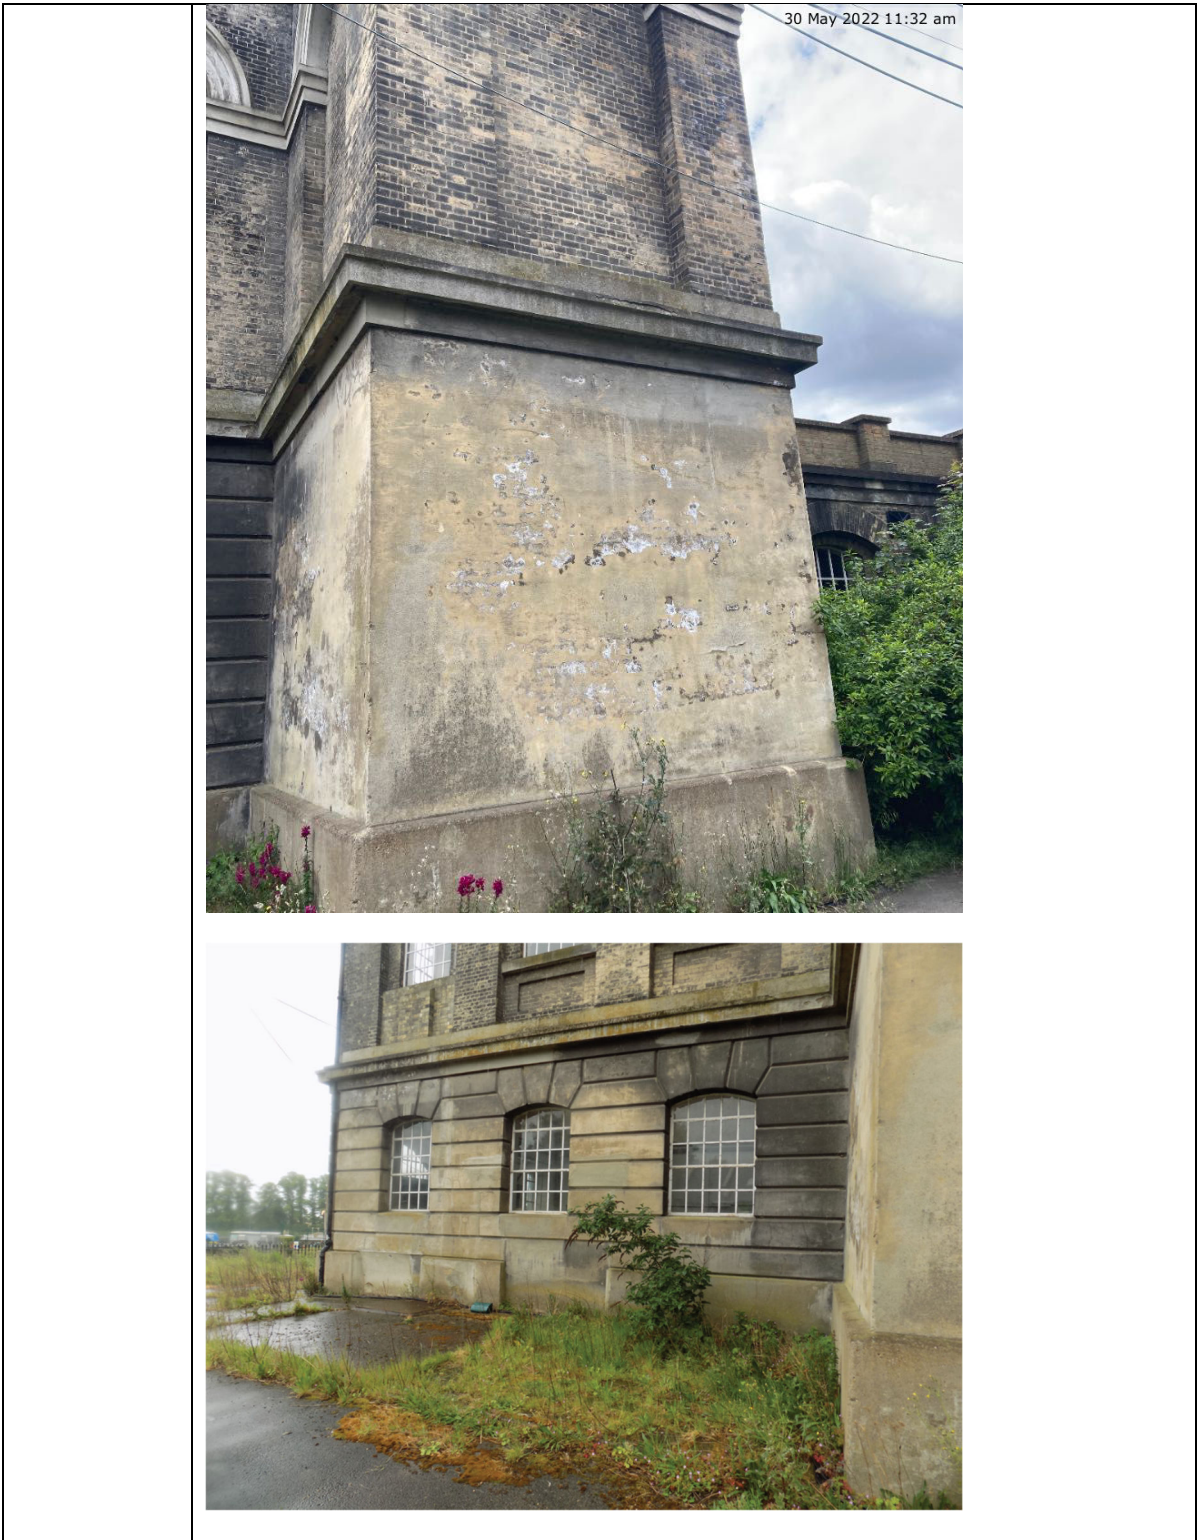
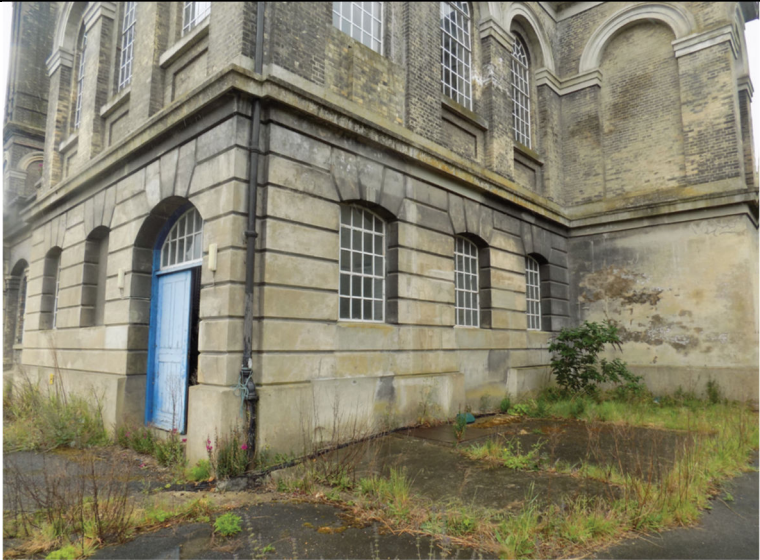
**Figure 9 – Render, plaster defected finish**

Location:	<b>Ruston &amp; Ward - Bull Engine House / Boiler House / Former Engine House</b>
Description:	Render, plaster defected finish over time, showing cement repairs to base of pump head building, showing cement patched area marking the location of lost bay
Condition:	<b>3</b>
Damage:	Unknown
Proposal:	Retain in situ and renovate. Re-finish any cracked or failed render or plaster
Methodology:	Tbc by condition.
Heritage Comments:	<b>MS</b> Medium significance

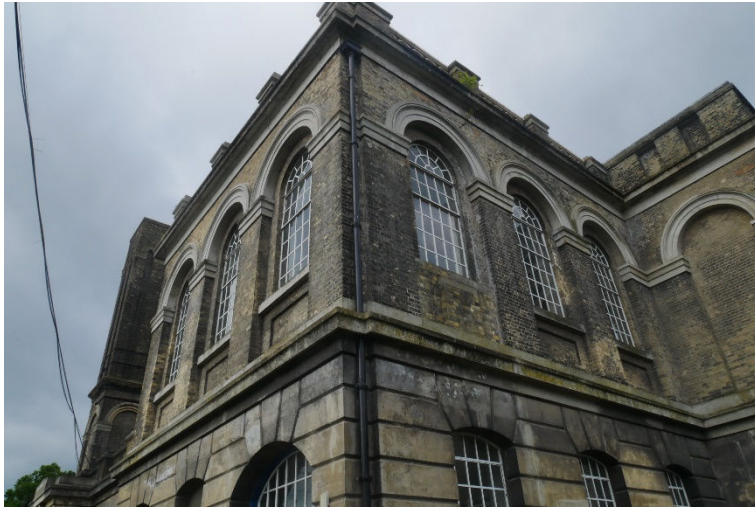
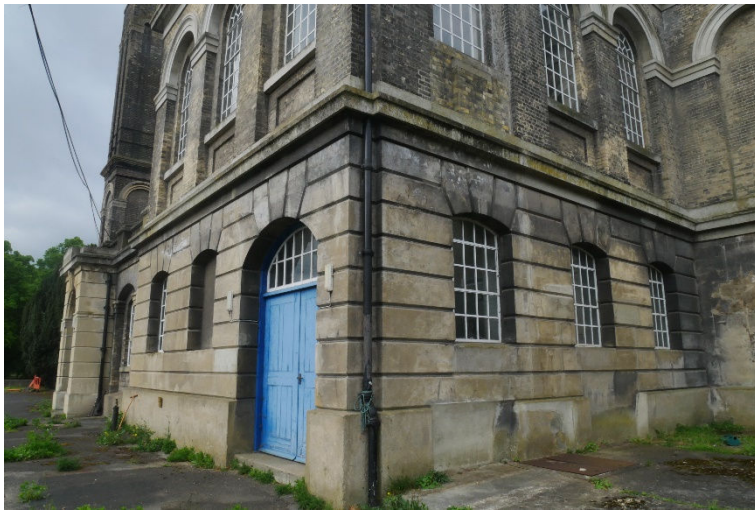
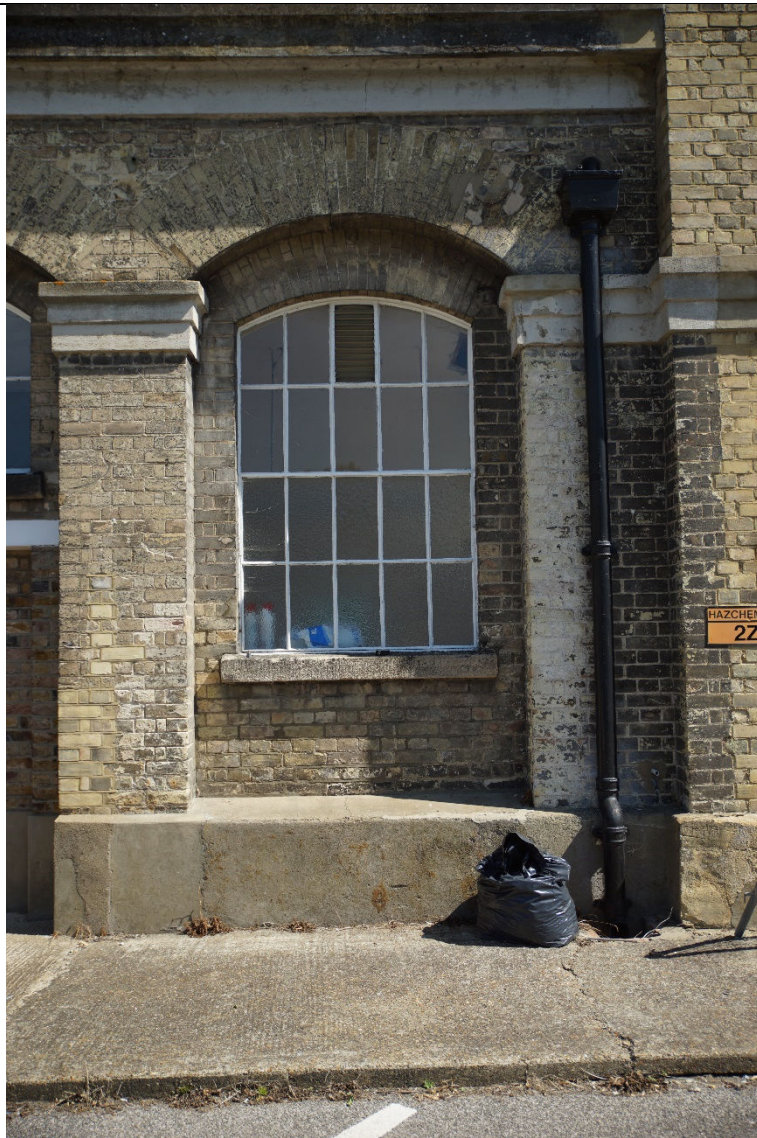
**Figure 11 – Metalwork – defective rainwater goods**

Location:	<b>Ruston &amp; Ward - Bull Engine House / Boiler House / Former Engine House</b>
Description:	Defective rainwater goods over time
Condition:	<b>3</b>
Damage:	Unknown
Proposal:	Retain in situ and renovate. Replace rainwater goods with new conservation grade or restore if defect is only minimal such as organic growth blockages
Methodology:	Tbc by condition.
Heritage Comments:	<b>MS</b> Medium significance

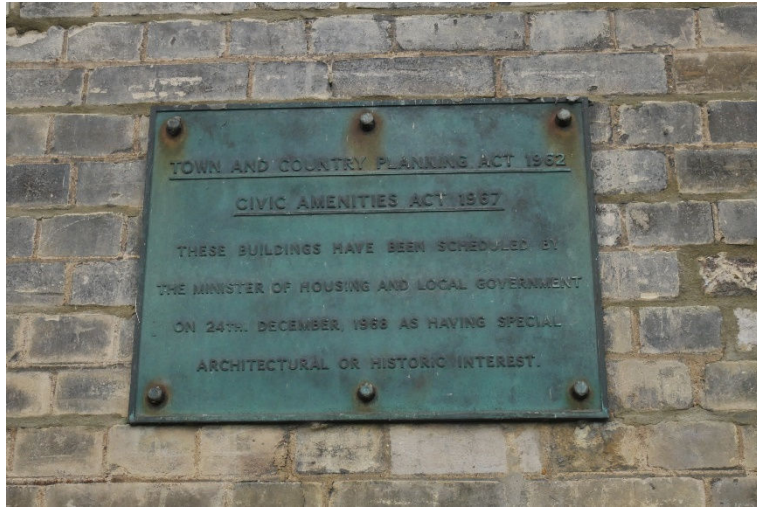
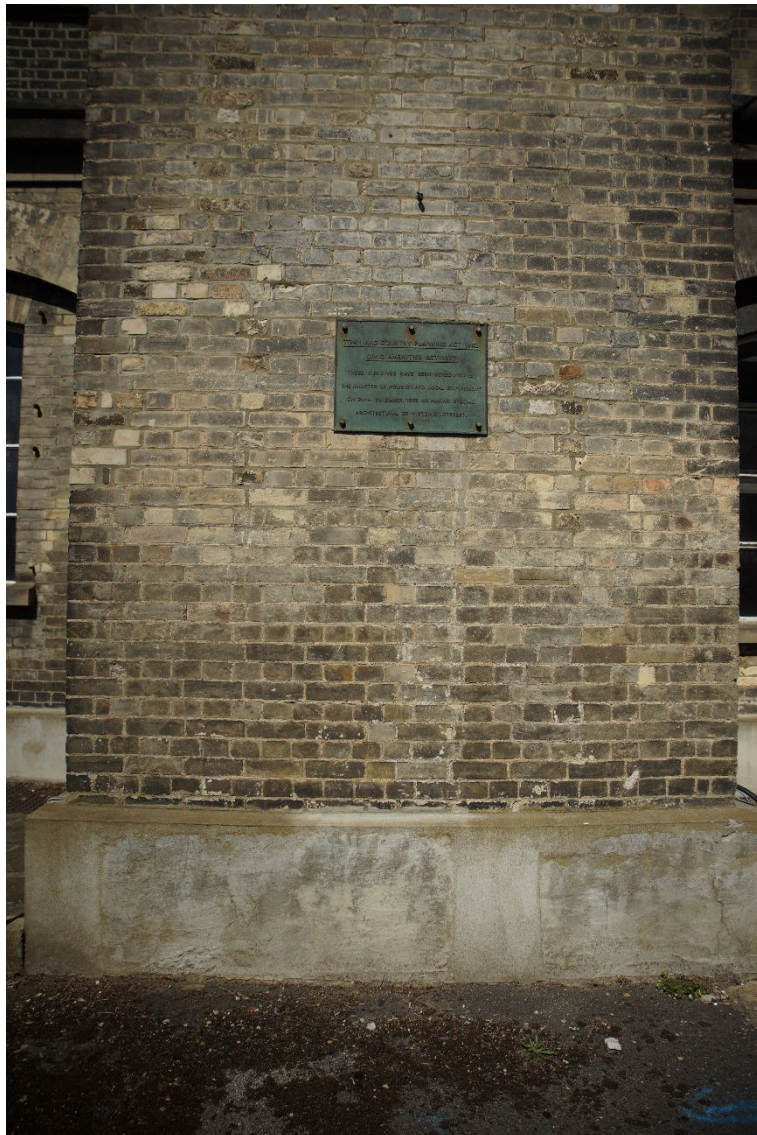
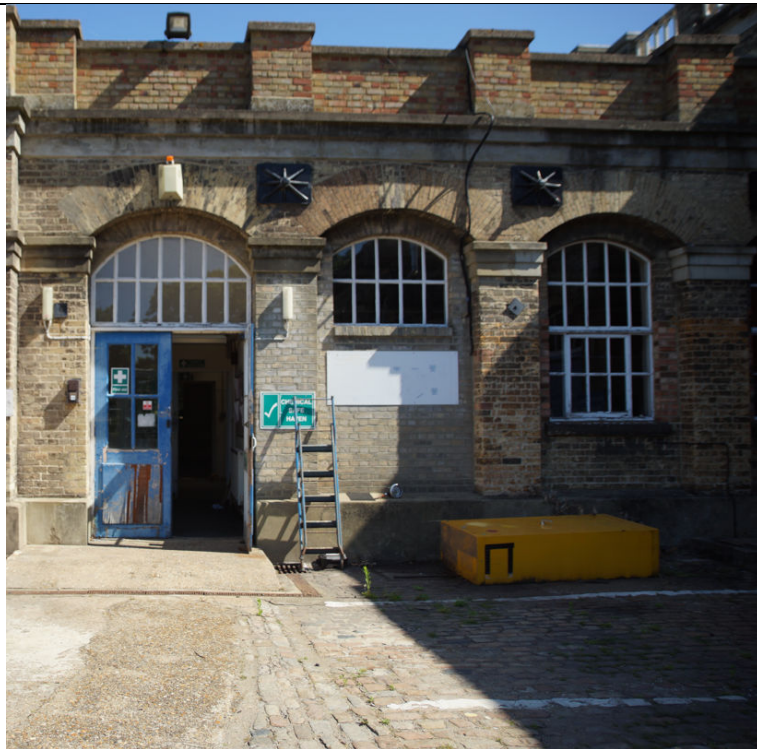
**Figure 13 – Metalwork – Discolored signs or features**

Location:	<b>Ruston &amp; Ward - Bull Engine House / Boiler House / Former Engine House</b>
Description:	Discolored signs or features over time, 1968 Plaque identifying Ruston & Ward as a Listed building
Condition:	3
Damage:	Unknown
Proposal:	Retain in situ and renovate. Undertake restoration works of any existing features or signage to be retained
Methodology:	Tbc by condition.
Heritage Comments:	<b>MS</b> Medium significance

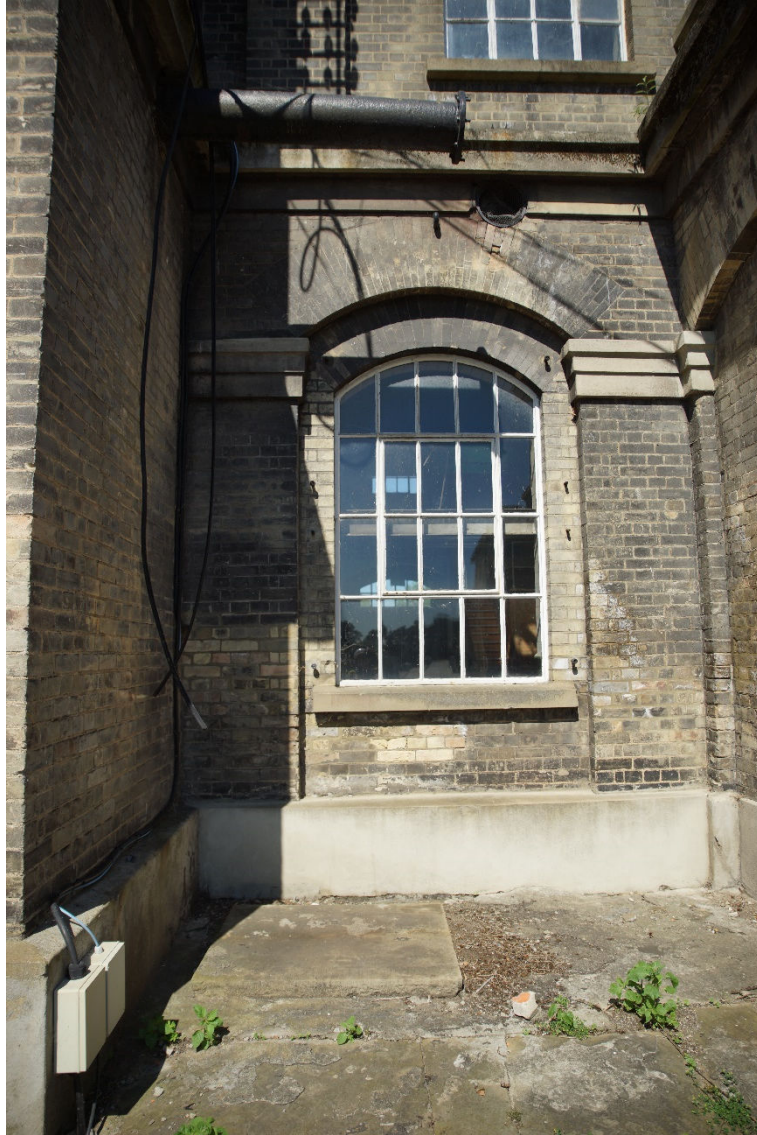
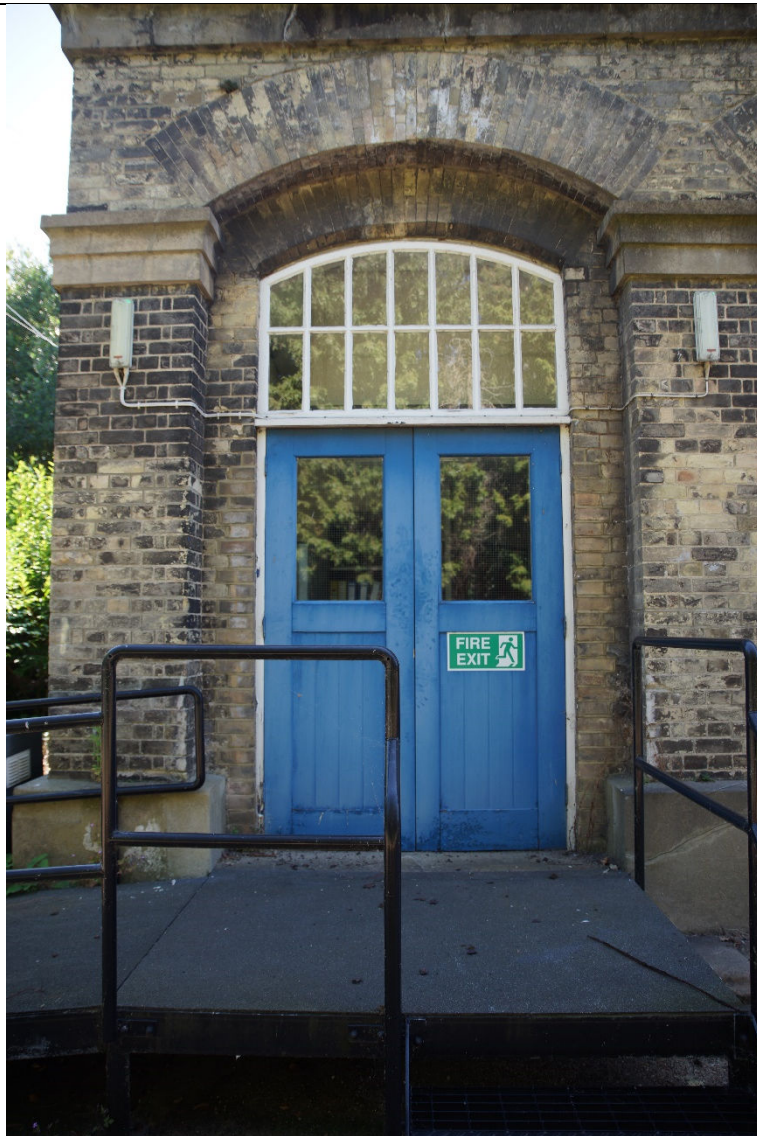
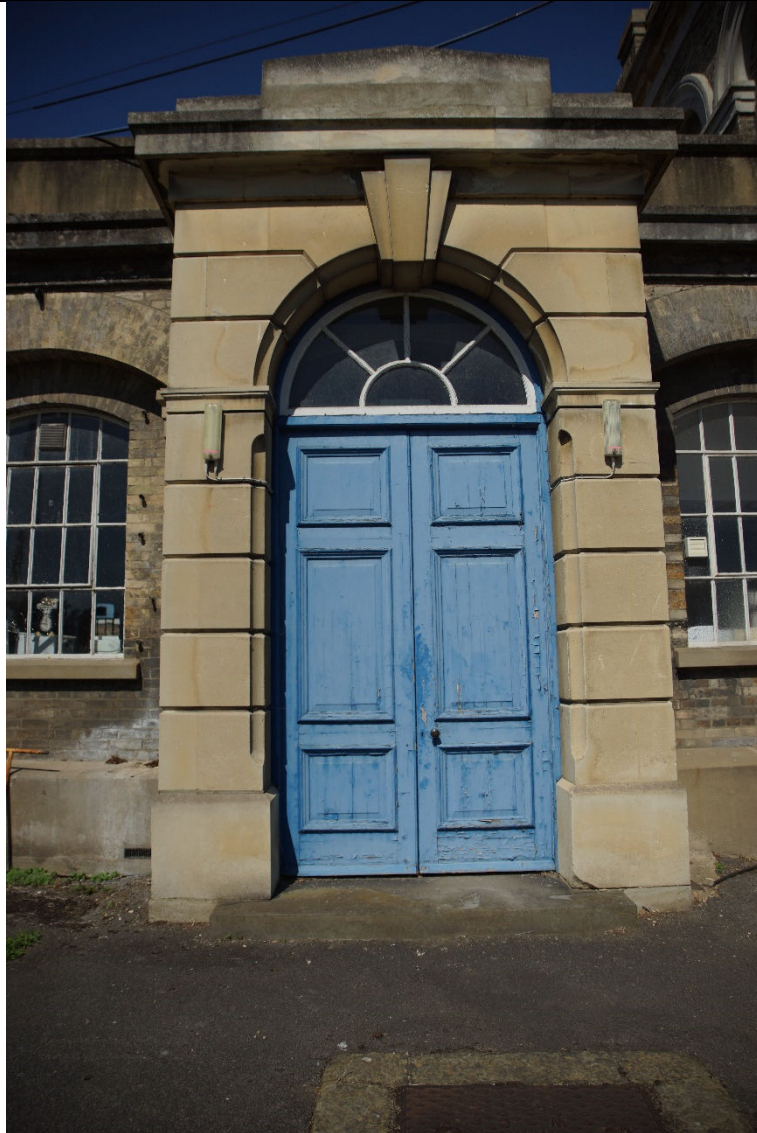
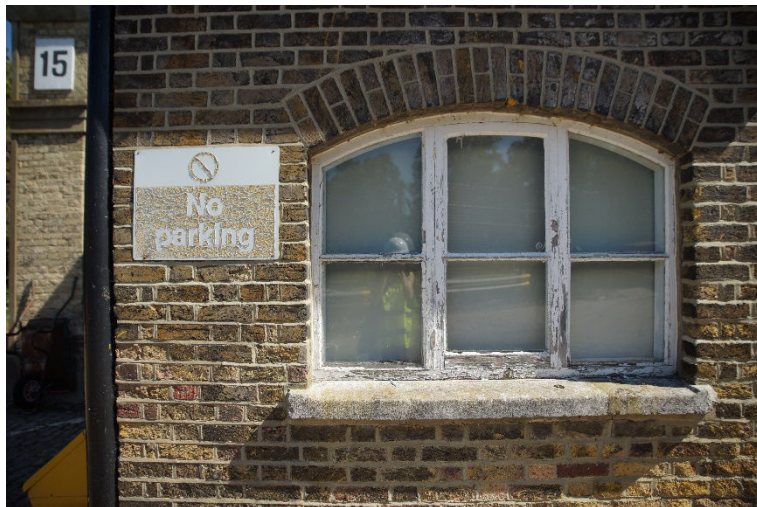
Reference:	<b>Figure 15 – Fixtures – external fixtures</b>
------------	---

Location:	<b>Ruston &amp; Ward - Bull Engine House / Boiler House / Former Engine House</b>
Description:	Remove external fixtures, light fittings, alarm fittings, signage
Condition:	<b>3</b>
Damage:	Unknown
Proposal:	Retain in situ and renovate. Retain elements with heritage significance.
