Condition Survey Photo Record

Schedule of Repairs – Karslake Exterior

Client Waterfall Planning Ltd
Project Hampton Water Works
Subject Karslake Condition Survey Photo Record – Schedule of Repairs
Date 26.05.2023
Revision A
Job no. 1685
Reference 1685-A-P614 Karslake Condition Survey – Schedule of Repairs

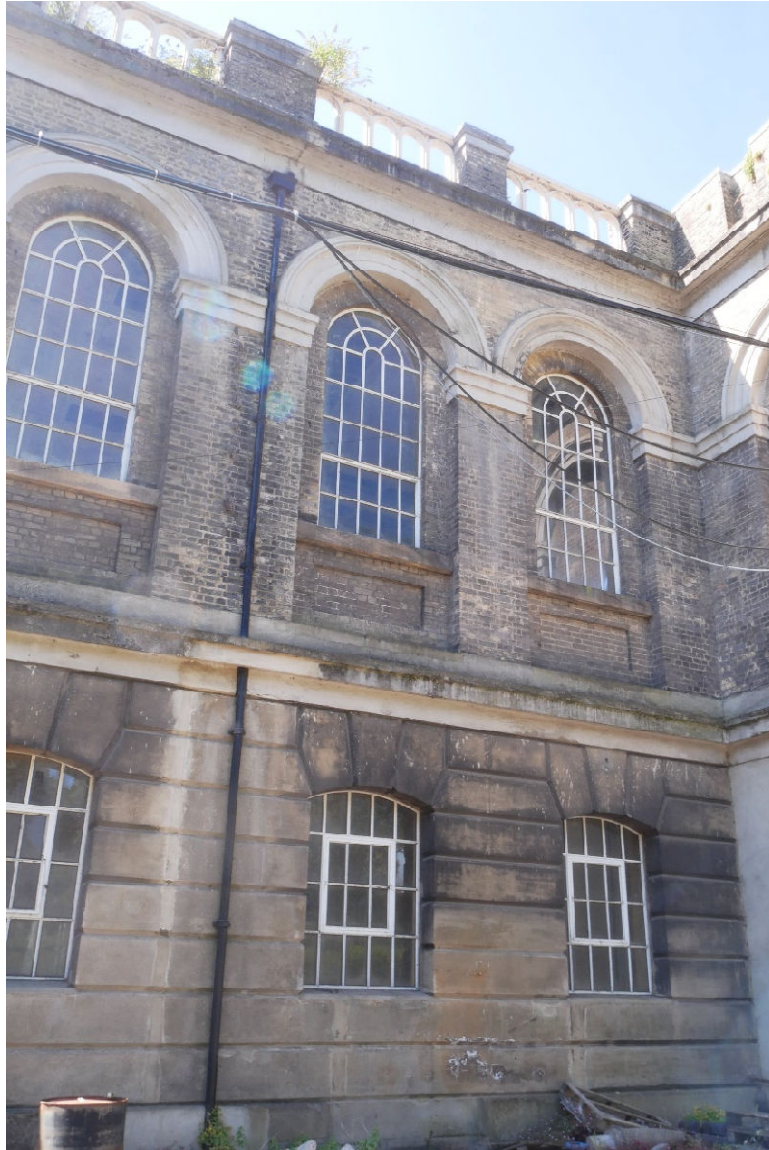
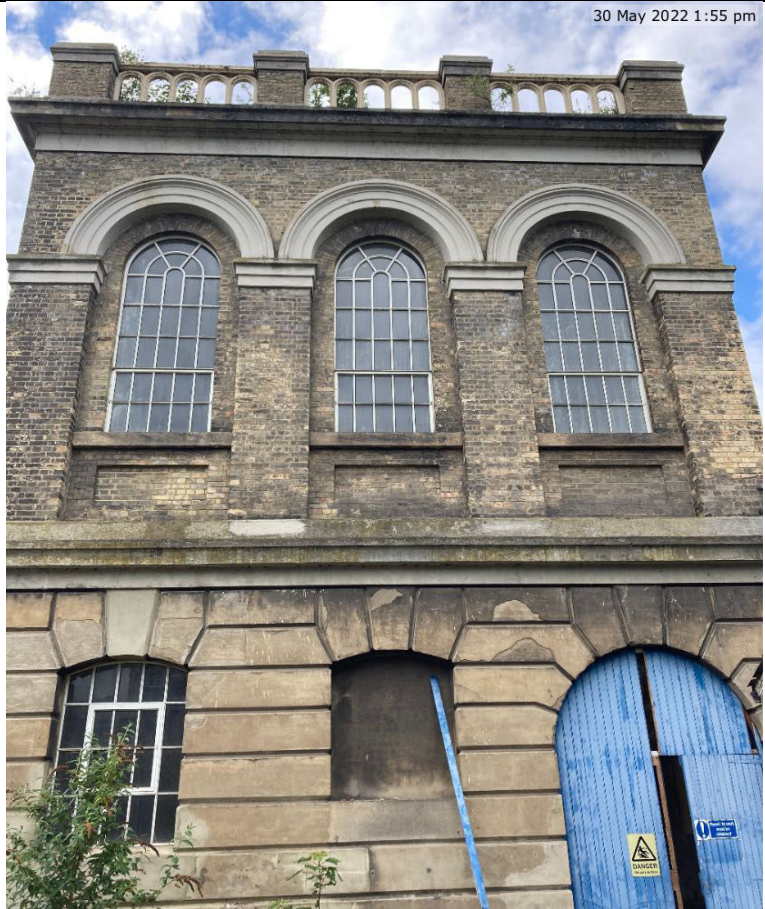
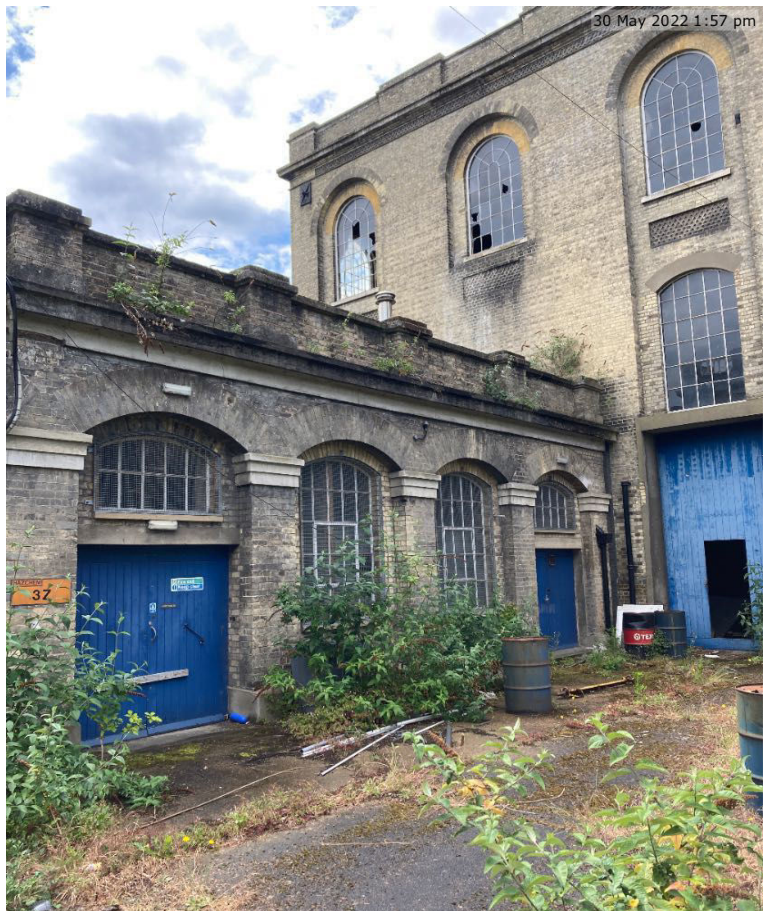
Figure 1 – Brickwork – discolouring and staining

Location:	Karslake - Bull Engine House / Boiler House / Beam Engine House
Description:	Brickwork discoloring and staining over time
Condition:	3
Damage:	Unknown
Proposal:	Retain in situ and renovate. Undertaking cleaning of any brickwork with associated defects restored as required.
Methodology:	Tbc by condition.
Heritage Comments:	MS Medium significance

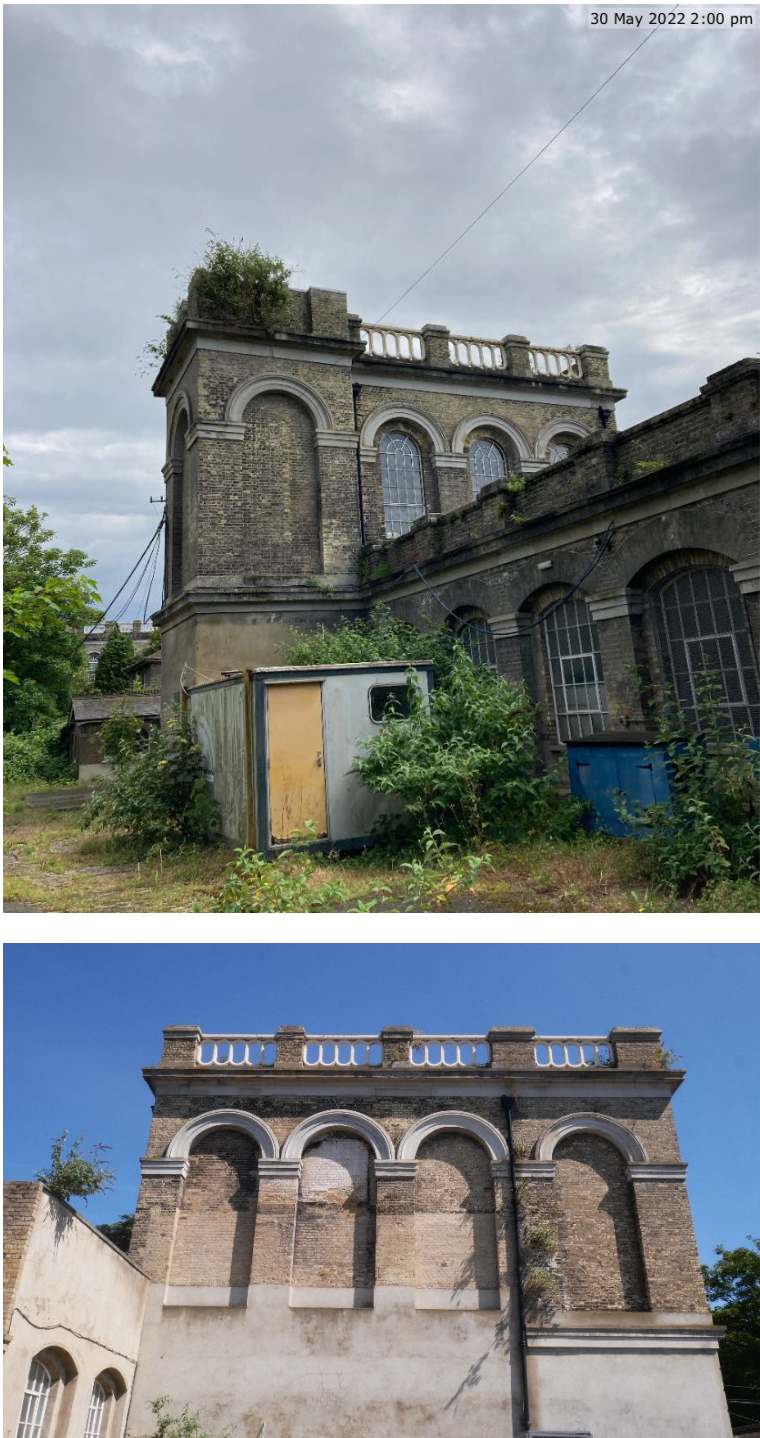
Reference:	Figure 2 – Brickwork - organic growth

Location:	Karslake - Bull Engine House / Boiler House / Beam Engine House
Description:	Brickwork with organic growth over time
Condition:	3
Damage:	Unknown
Proposal:	Retain in situ and renovate. Remove any plant growth within finish material and restore any associated damage/defects
Methodology:	Tbc by condition.
Heritage Comments:	MS Medium significance

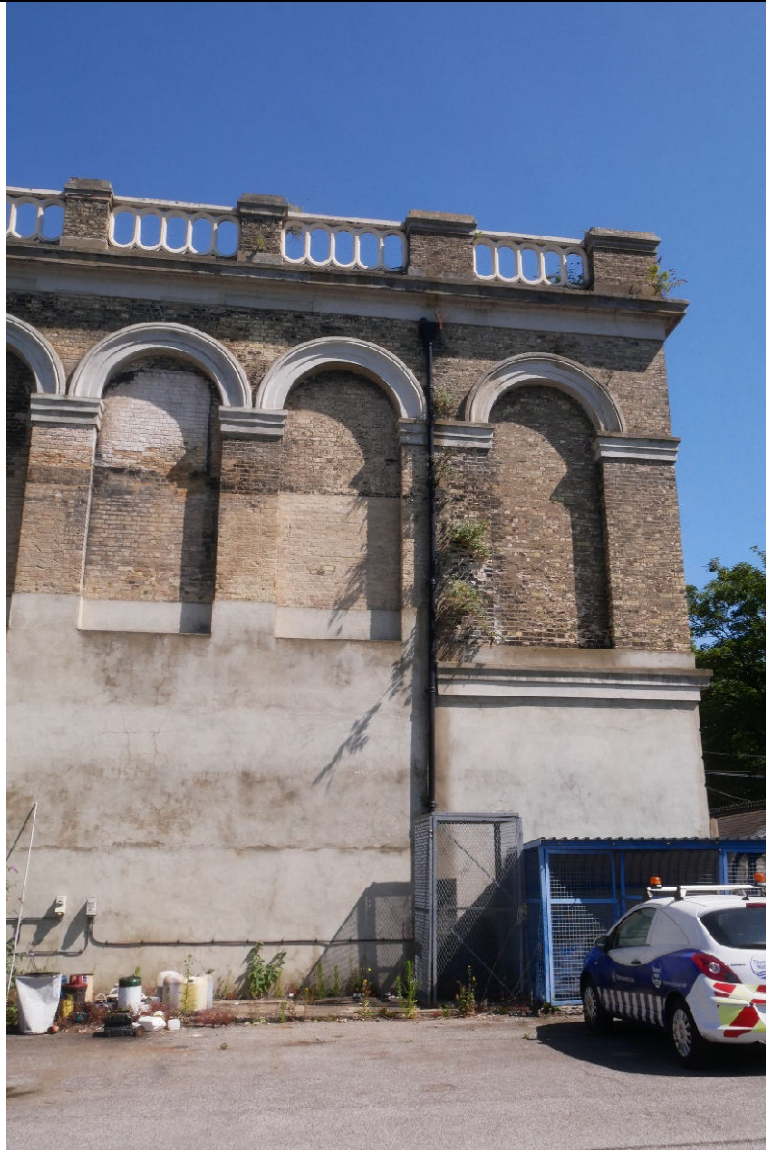
Reference:	Figure 3 – Brickwork – minor material failure

Location:	Karslake - Bull Engine House / Boiler House / Beam Engine House
Description:	Brickwork minor material failure over time
Condition:	3
Damage:	Unknown
Proposal:	Retain in situ and renovate. Undertaking re-pointing areas of mortar failure with associated defects restored as required.
Methodology:	Tbc by condition.
Heritage Comments:	MS Medium significance

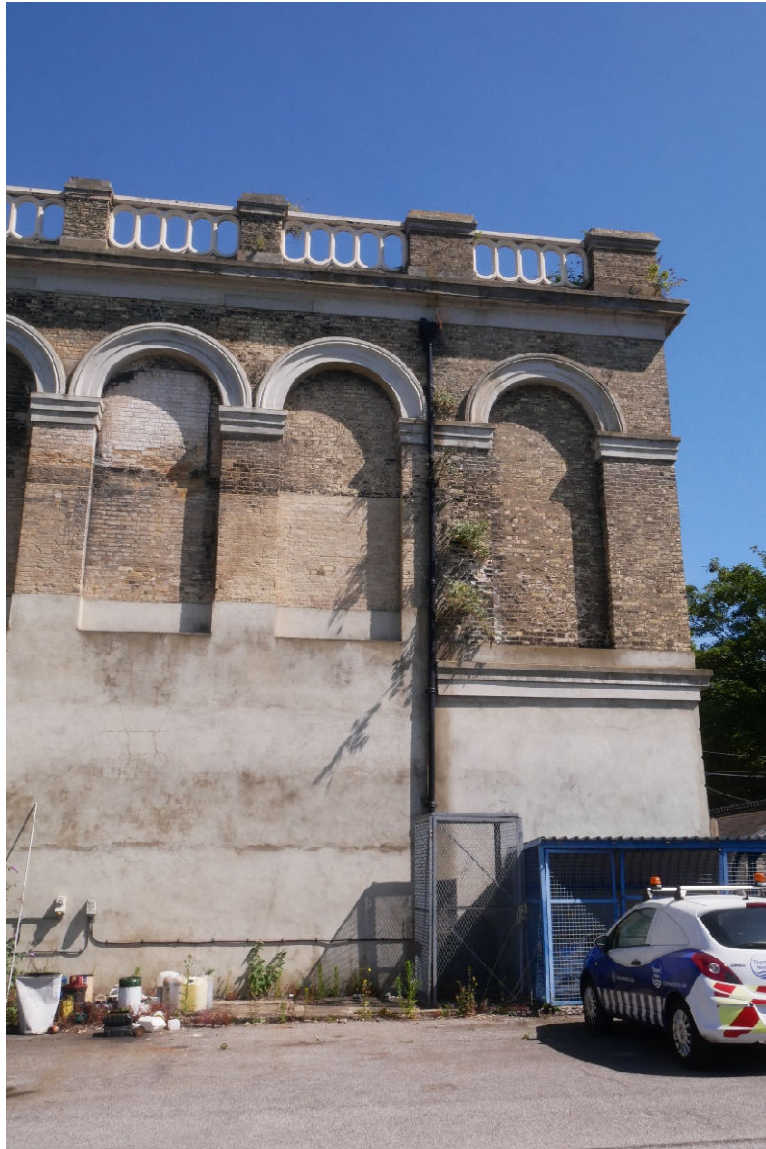
Reference:	Figure 4 – Brickwork – extensive material failure
------------	--

Location:	Karslake - Bull Engine House / Boiler House / Beam Engine House
Description:	Brickwork extensive material failure over time
Condition:	4
Damage:	Unknown
Proposal:	Retain in situ and renovate. Undertaking substantial restoration works required such as replacing or repairing any decayed bricks and re-pointing.
Methodology:	Tbc by condition.
Heritage Comments:	MS Medium significance

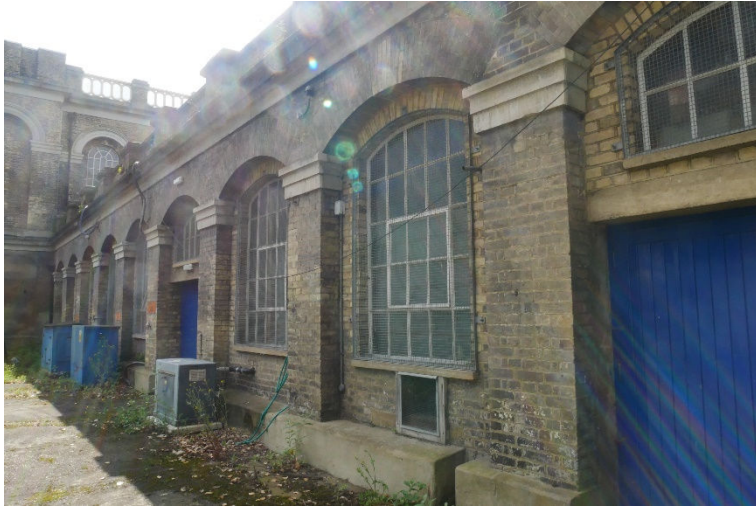
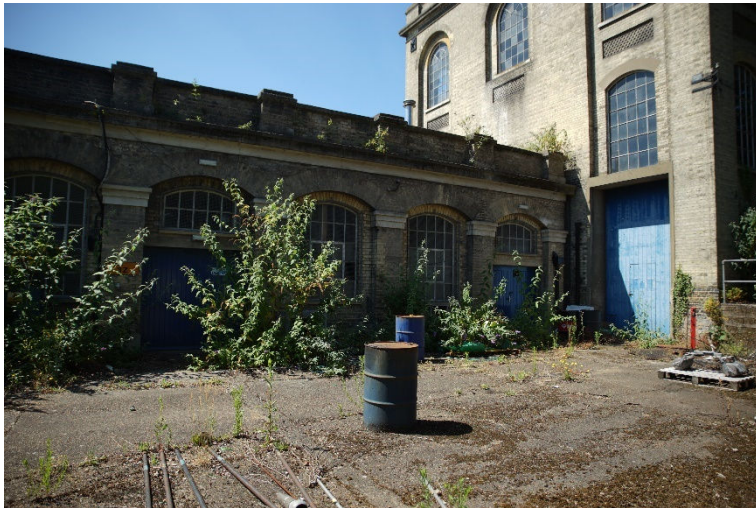
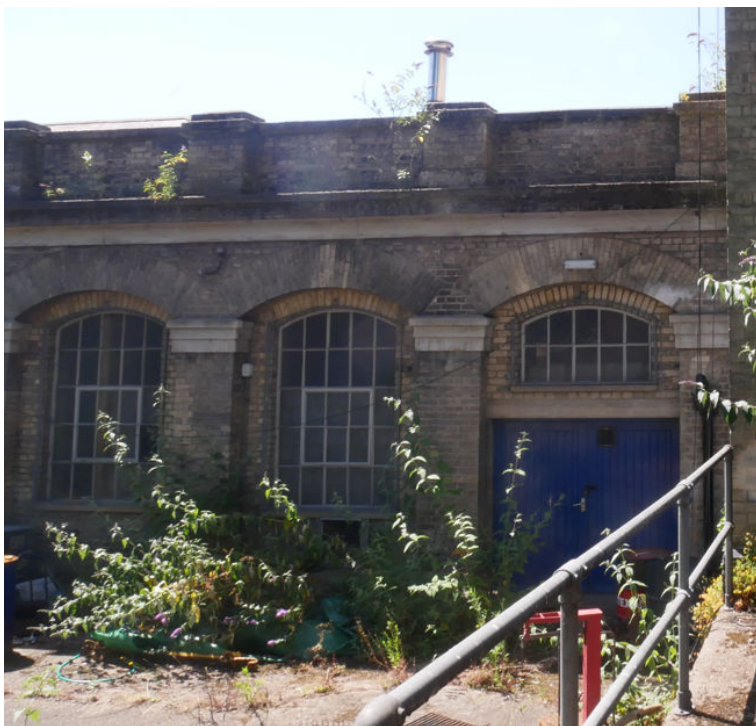
Reference:	Figure 5 – Brickwork – incorrect material from historic works
------------	--

Description:	Incorrect material form historic works
Condition:	3
Damage:	Unknown
Proposal:	Retain in situ and renovate. Any areas of brickwork that varies from the predominant finish type should be re-finished or replaced as required
Methodology:	Tbc by condition.
Heritage Comments:	LS/MS Low-Medium significance

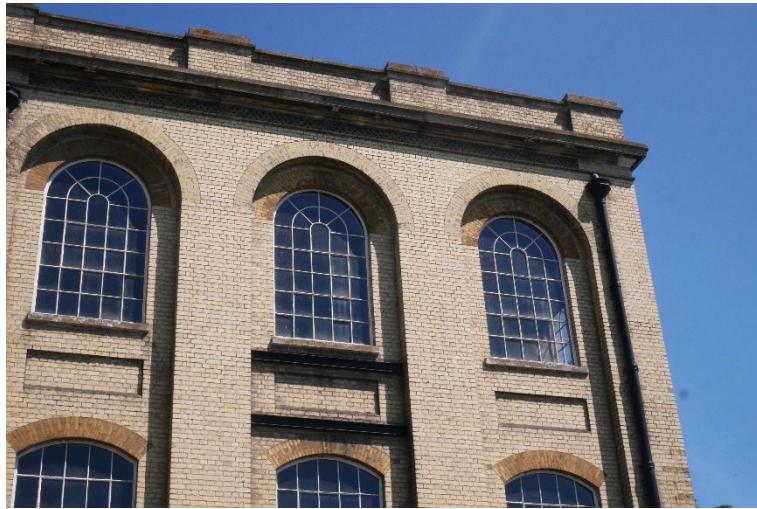
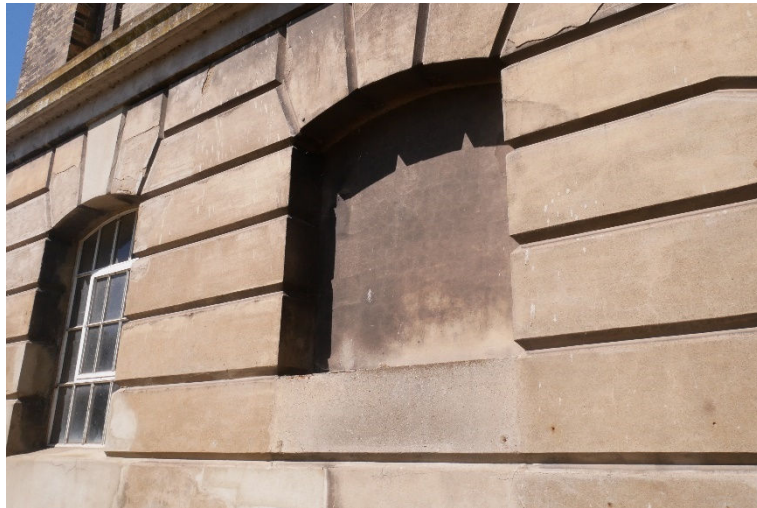
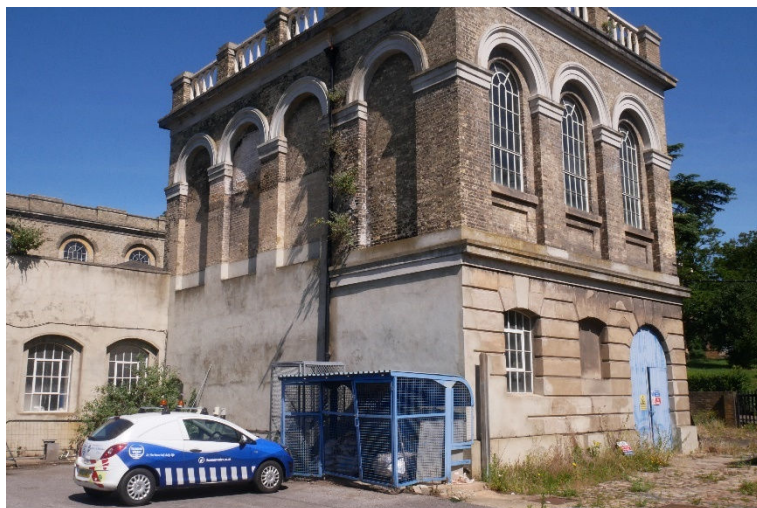
Reference:	Figure 6 – Stonework, render, plaster – discolouring and staining
------------	--

Location:	Karslake - Bull Engine House / Boiler House / Beam Engine House
Description:	Stonework, render, plaster discoloring and staining over time
Condition:	3
Damage:	Unknown
Proposal:	Retain in situ and renovate. Undertaking cleaning of any stonework, render, plaster with associated defects restored as required.
Methodology:	Tbc by condition.

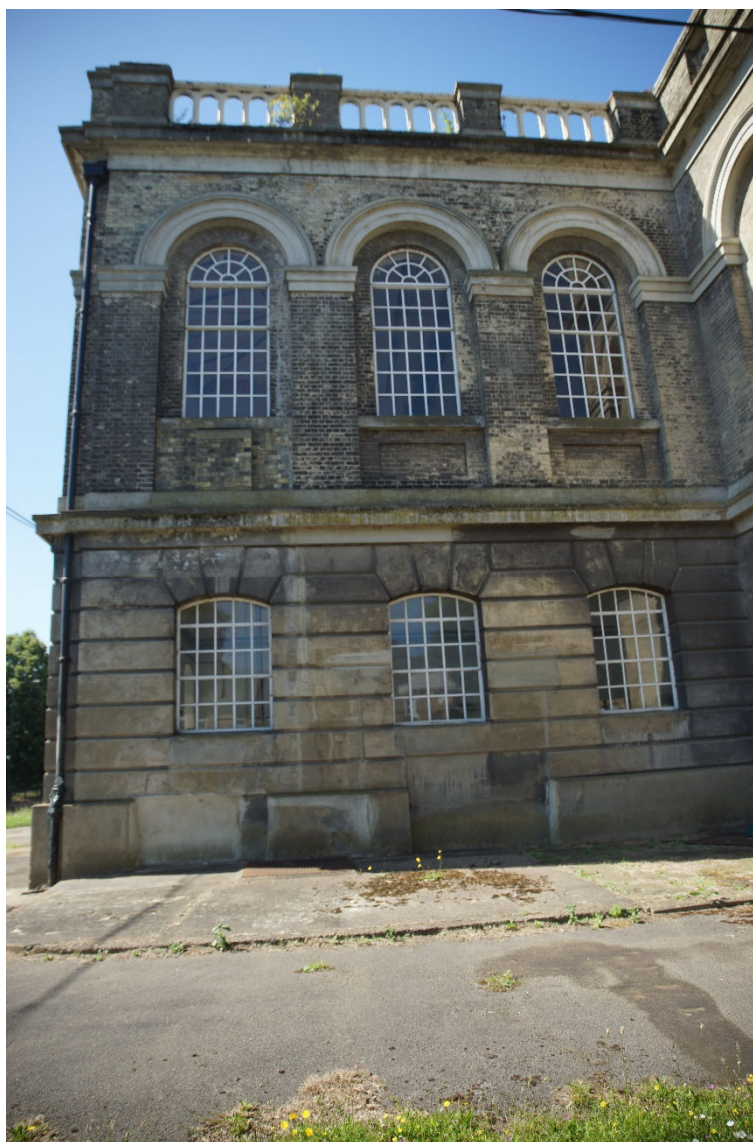
Reference:	Figure 7 – Stonework, render, plaster - organic growth
------------	---

Location:	Karslake - Bull Engine House / Boiler House / Beam Engine House
Description:	Stonework ,render, plaster with organic growth over time
Condition:	3
Damage:	Unknown
Proposal:	Retain in situ and renovate. Remove any plant growth within finish material and restore any associated damage/defects
Methodology:	Tbc by condition.
Heritage Comments:	MS Medium significance

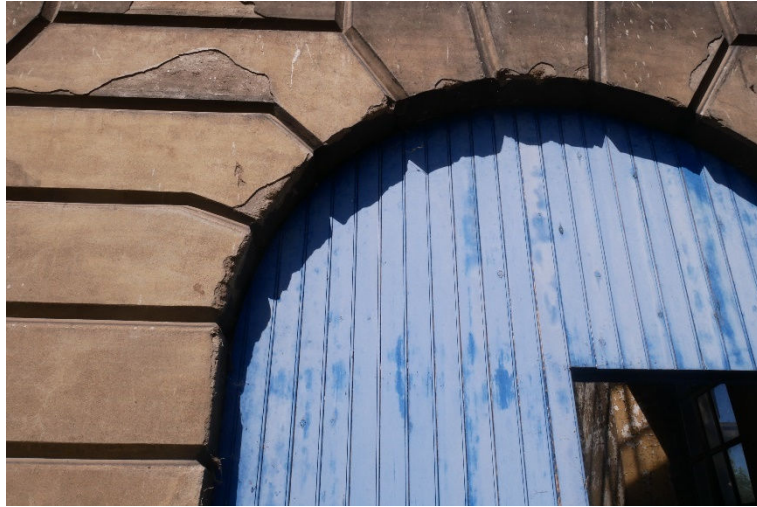
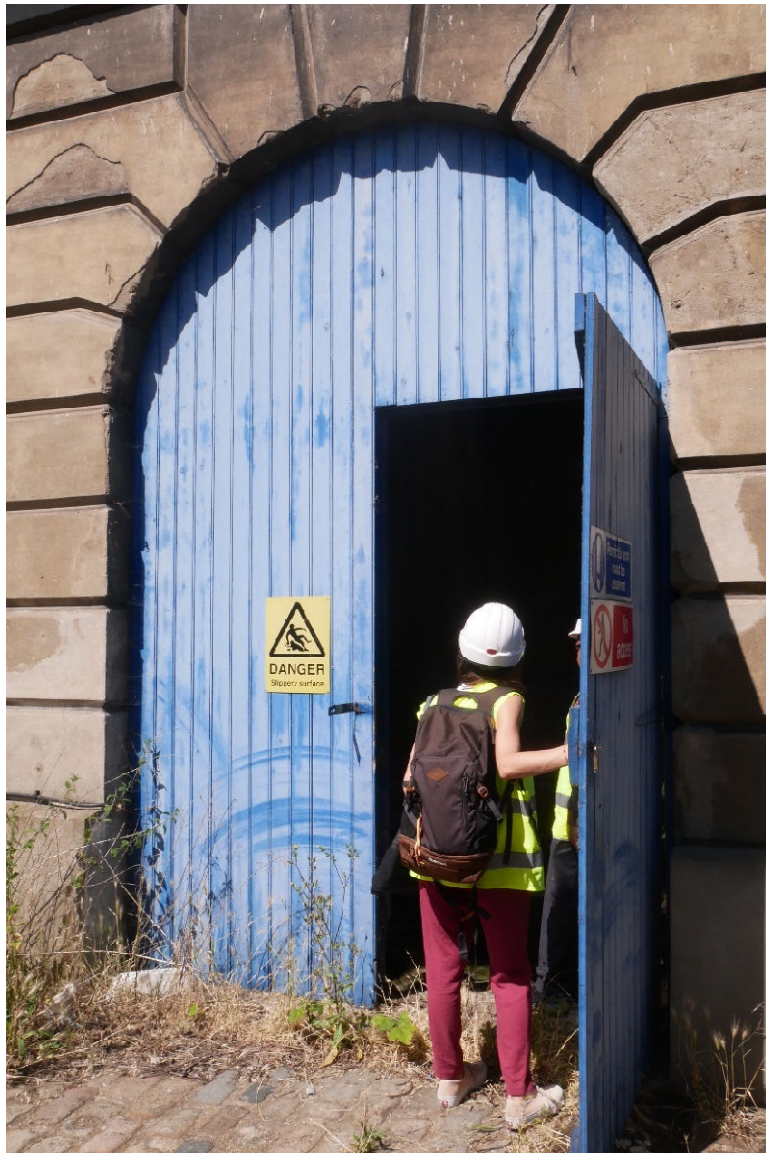
Reference:	Figure 8 – Stonework – minor material failure
------------	--

Location:	Karslake - Bull Engine House / Boiler House / Beam Engine House
Description:	Stonework extensive material failure over time
Condition:	3
Damage:	Unknown

Proposal:	Retain in situ and renovate. Re-finish any dilapidated areas of stonework, render and plaster
Methodology:	Tbc by condition.
Heritage Comments:	MS Medium significance

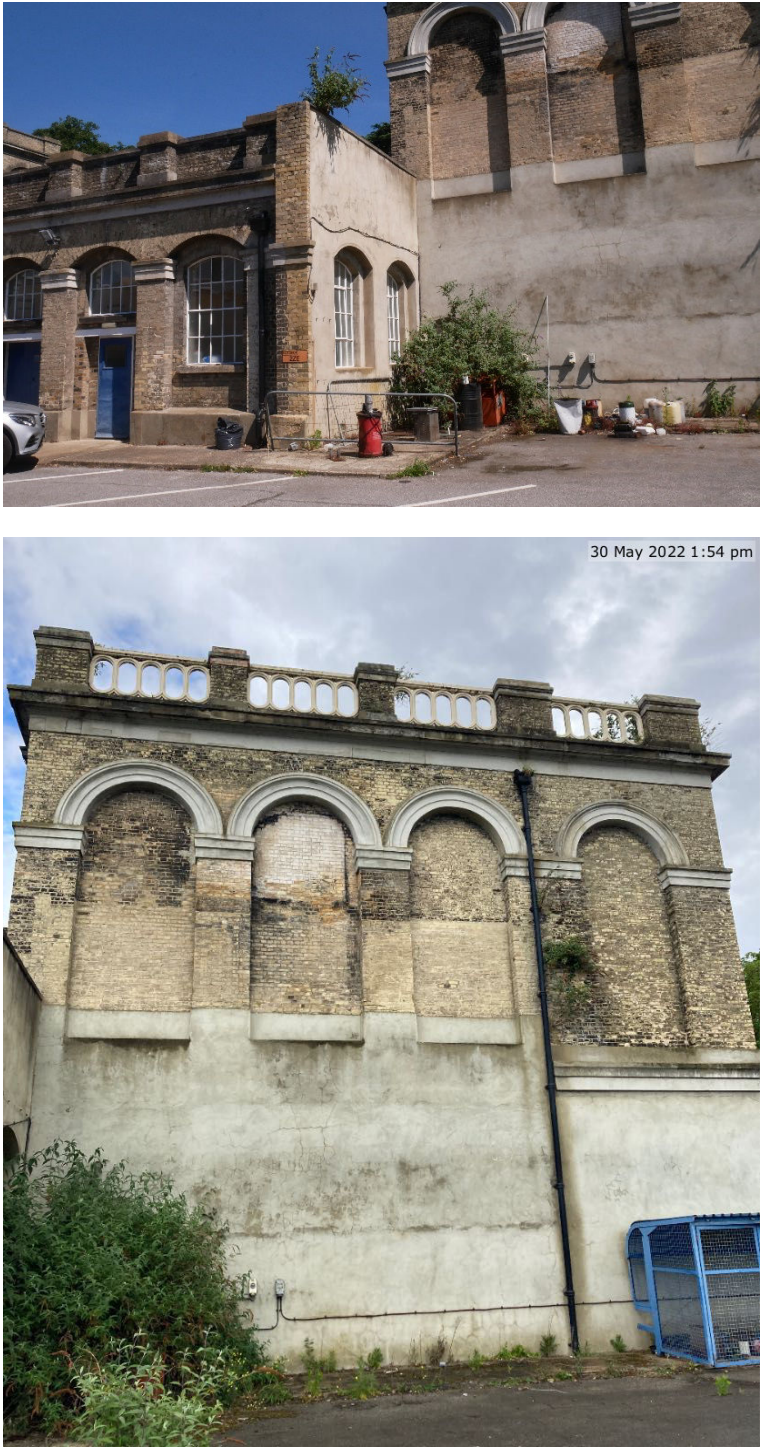
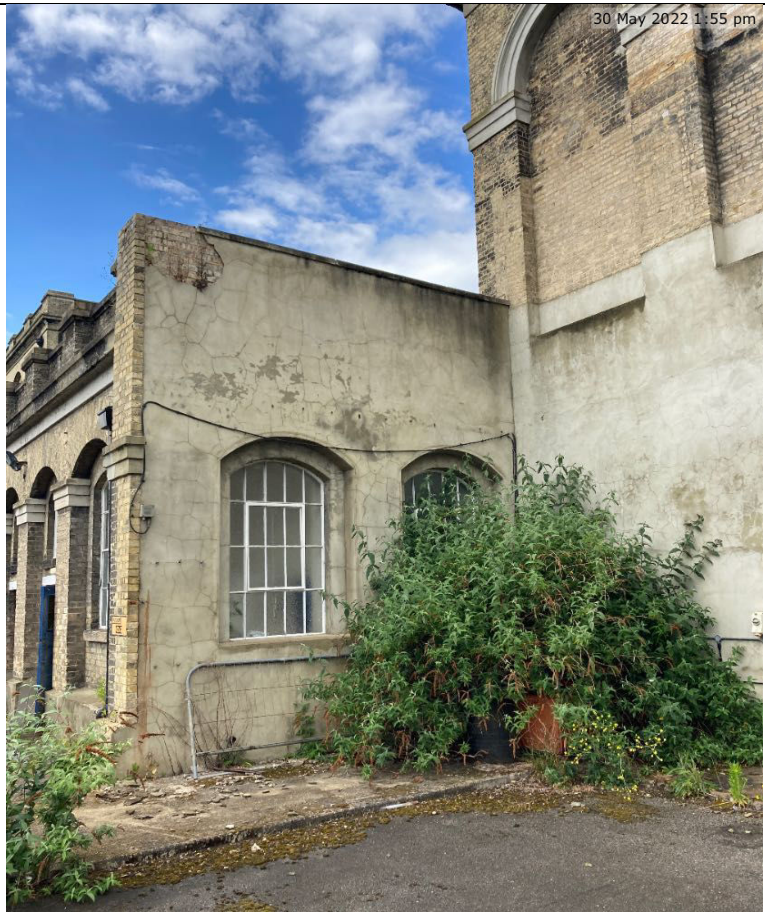
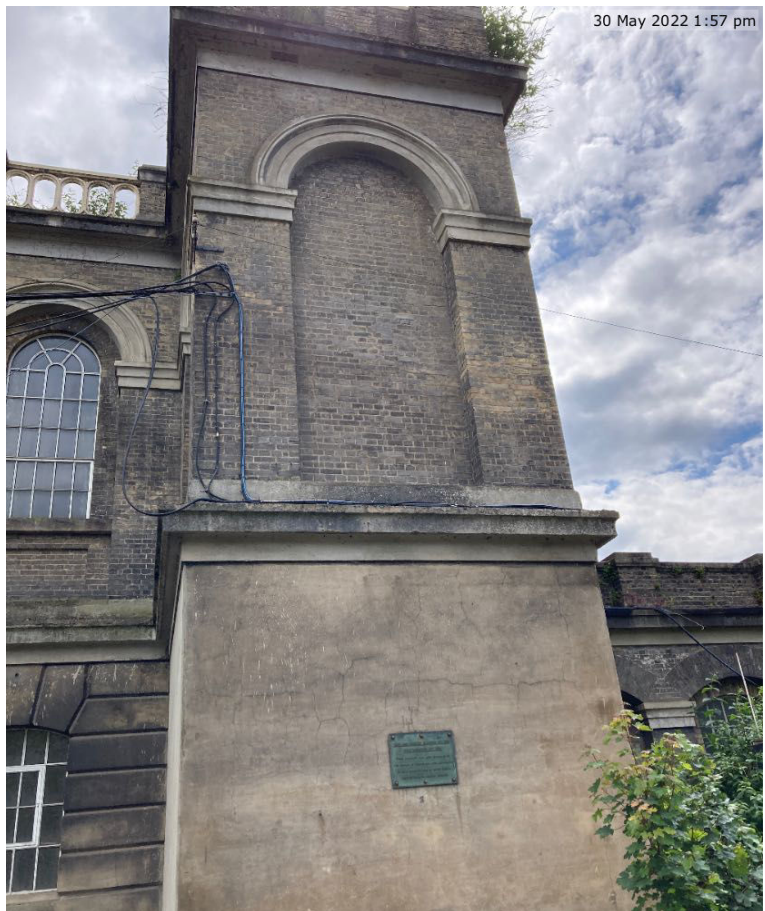
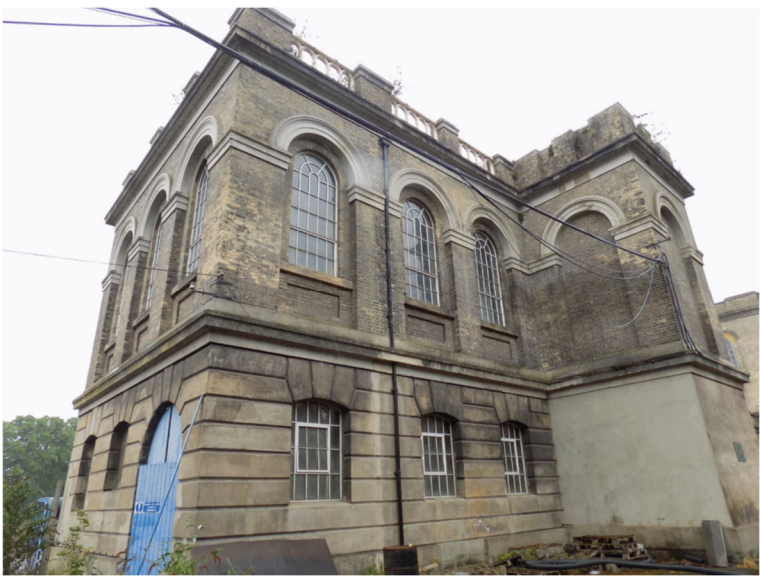
Reference:	Figure 9 – Render, plaster defected finish

Location:	Karslake - Bull Engine House
Description:	Render, plaster defected finish over time, showing cement repairs to base of pump head building,
Condition:	3
Damage:	Unknown
Proposal:	Retain in situ and renovate. Re-finish any cracked or failed render or plaster
Methodology:	Tbc by condition.
Heritage Comments:	MS Medium significance

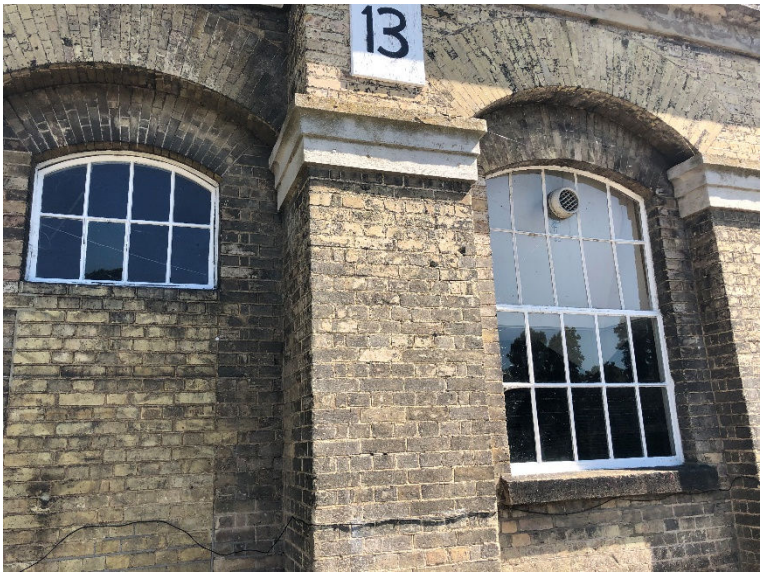
Reference:	Figure 10 – Stonework – window cills

Location:	Karslake - Bull Engine House / Boiler House / Beam Engine House
Description:	Stone window cill material failure or damage
Condition:	3
Damage:	Unknown
Proposal:	Retain in situ and renovate. Repair or replace window cill
Methodology:	Tbc by condition.

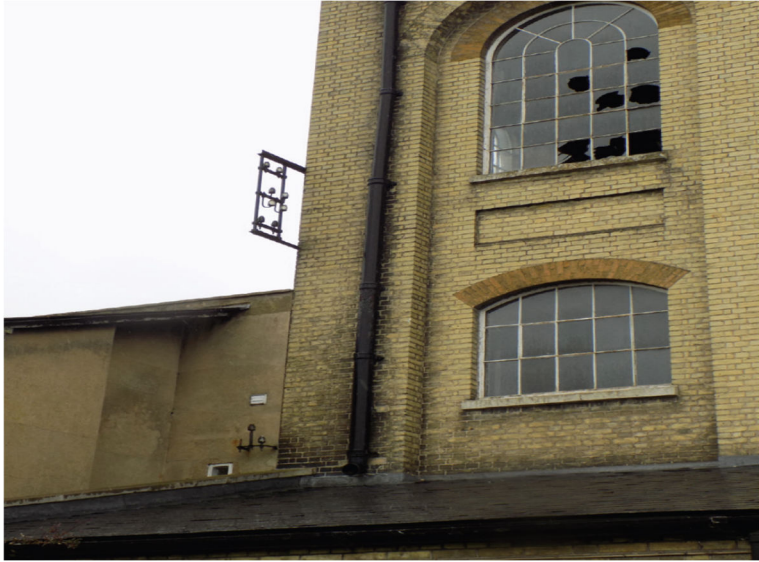
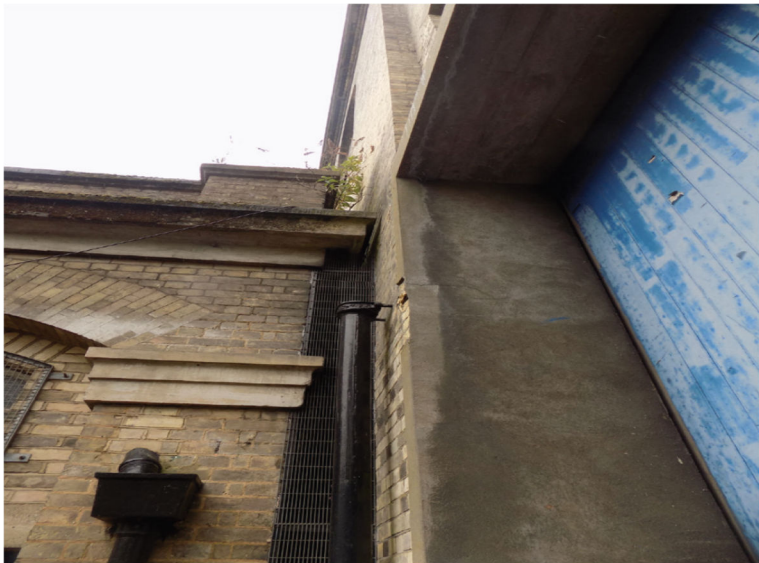
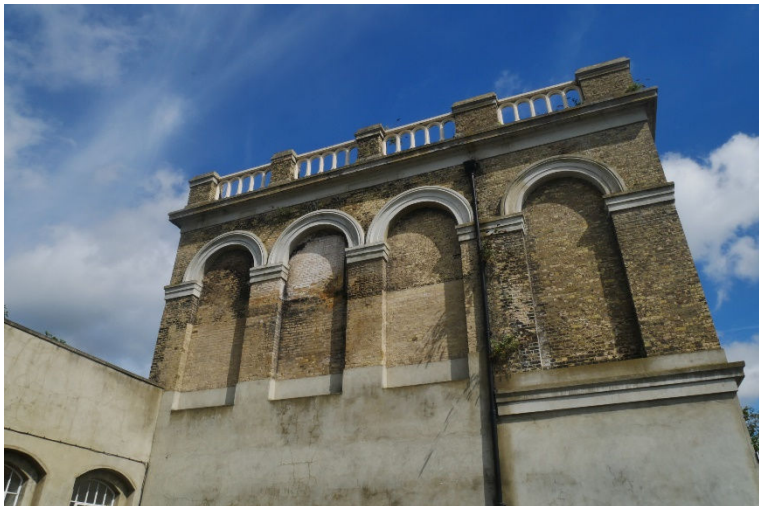
Reference:	Figure 11 – Metalwork – defective rainwater goods
------------	--

Location:	Karslake - Bull Engine House / Boiler House / Beam Engine House
Description:	Defective rainwater goods over time
Condition:	3
Damage:	Unknown
Proposal:	Retain in situ and renovate. Replace rainwater goods with new conservation grade or restore if defect is only minimal such as organic growth blockages
Methodology:	Tbc by condition.
Heritage Comments:	MS Medium significance

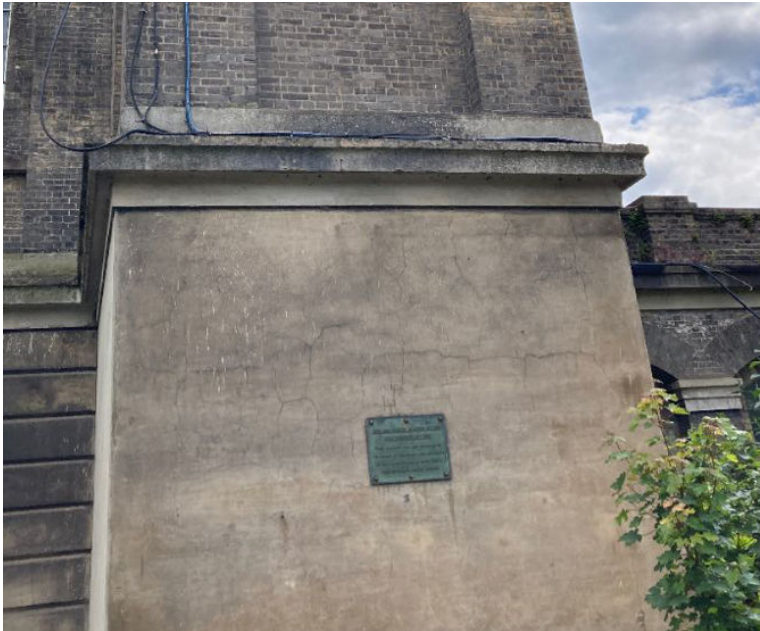
Reference:	Figure 13 – Metalwork – Discolored signs or features

Location:	Karslake - Bull Engine House / Boiler House / Beam Engine House
Description:	Discolored signs or features over time, 1968 Plaque identifying Karslake as a Listed building
Condition:	3
Damage:	Unknown
Proposal:	Retain in situ and renovate. Undertake restoration works of any existing features or signage to be retained
Methodology:	Tbc by condition.
Heritage Comments:	HS High significance

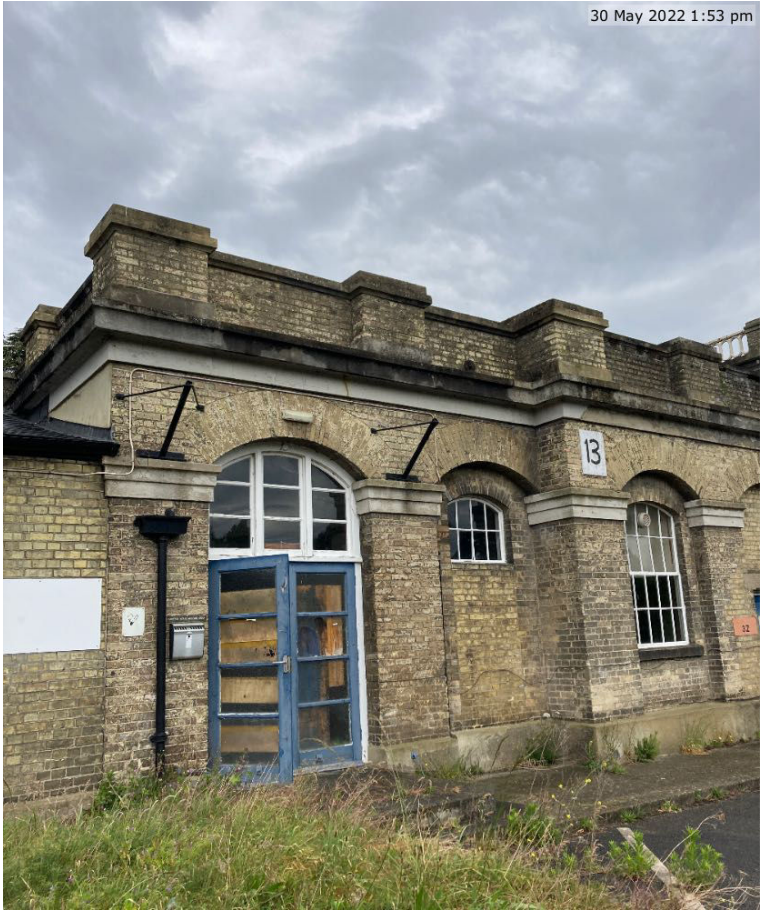
Reference:	Figure 14 – Metalwork – defunct features

Location:	Karslake - Bull Engine House / Boiler House / Beam Engine House
Description:	Removal of defunct metalwork features. Karslake Bolier House, antenna of unknown purpose over pilasters.
Condition:	3
Damage:	Unknown
Proposal:	Retain in situ and renovate. Retain elements with heritage significance.
Methodology:	Tbc by condition.
Heritage Comments:	LS Low significance
