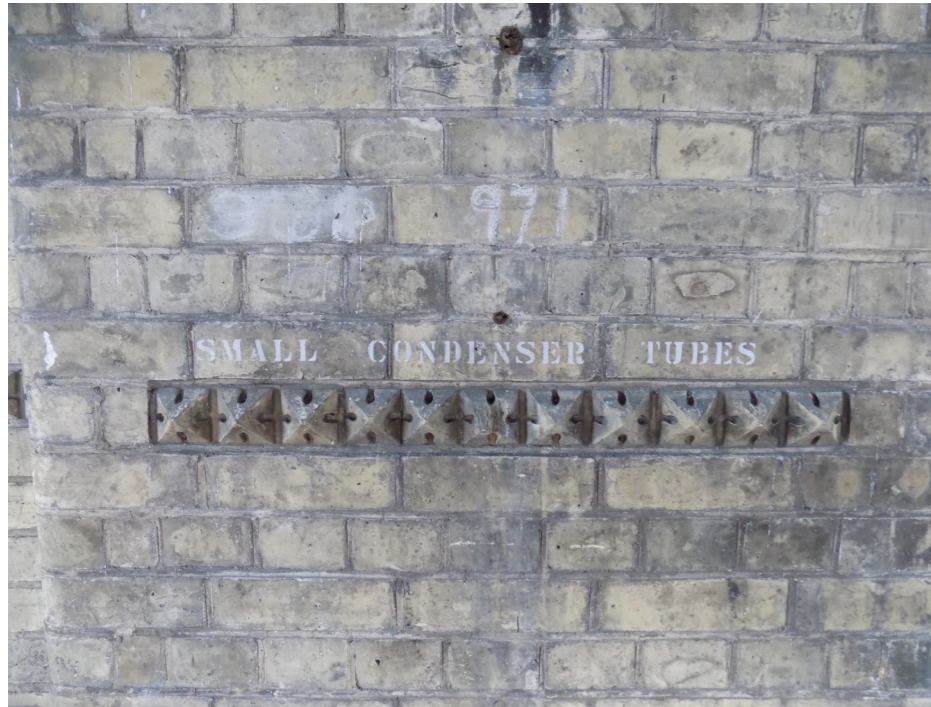
Figure 102: Stencilled "Small Condenser Tubes" (one of two) (high significance)

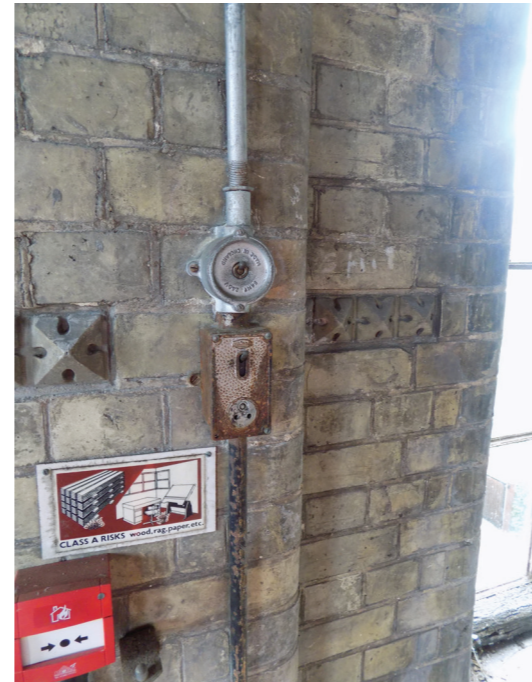
Figures 103: 1930s electrical conduits, switches and sockets (low significance)

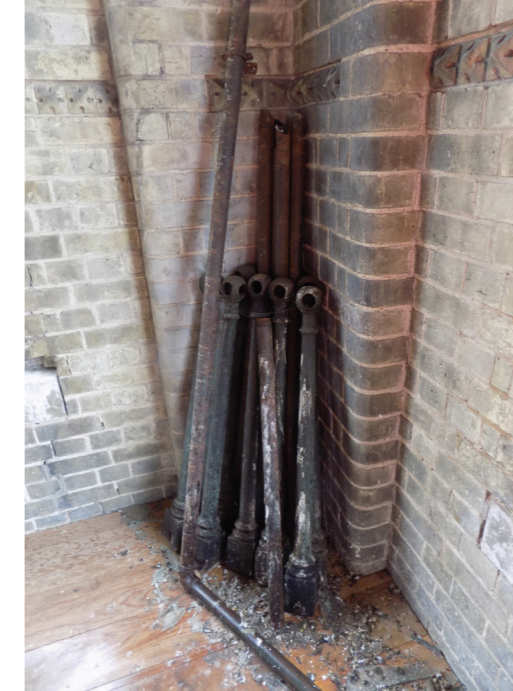
Figures 104: Displaced cast-iron handrail balusters (high significance)

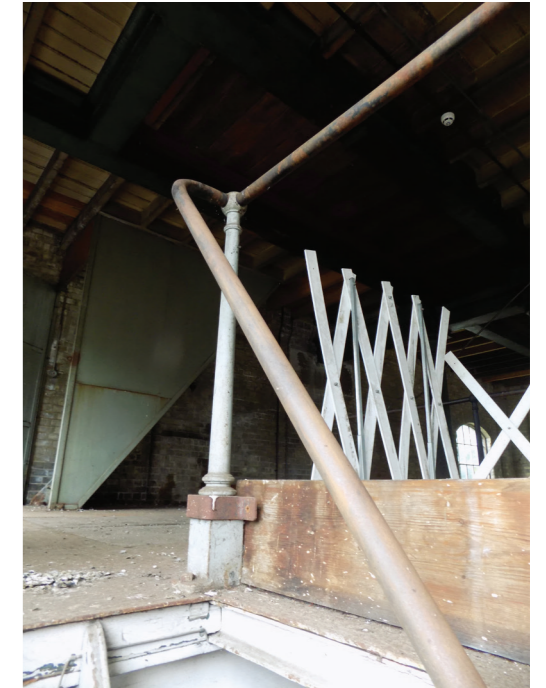
Figures 105: Cast-iron handrail baluster (later steel handrail?) (high significance)

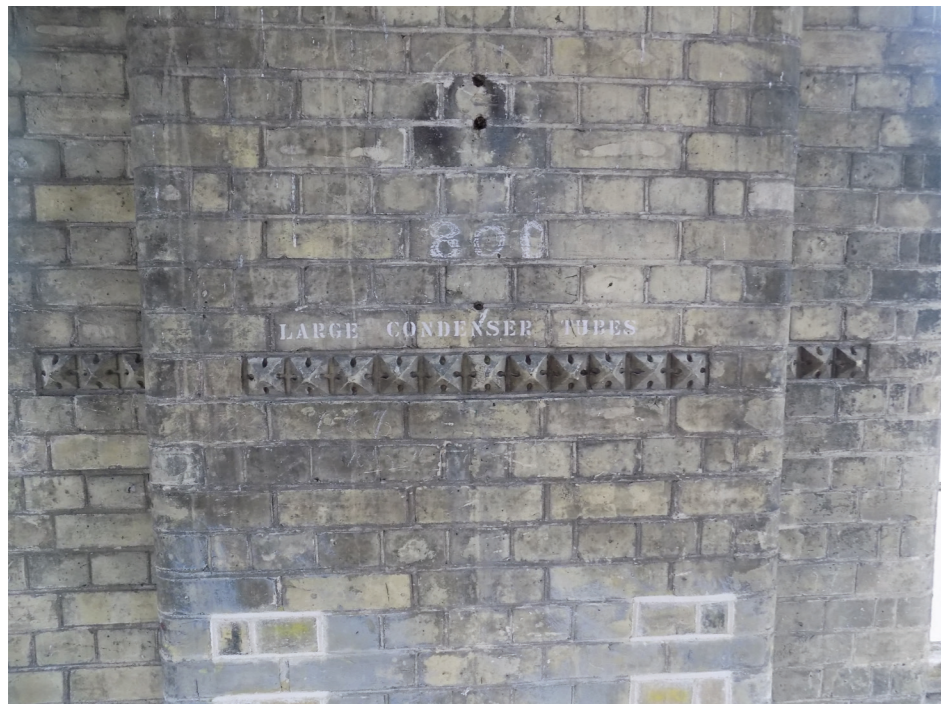
Figure 108: Stencilled "Large Condenser Tubes" (one of two) (high significance)

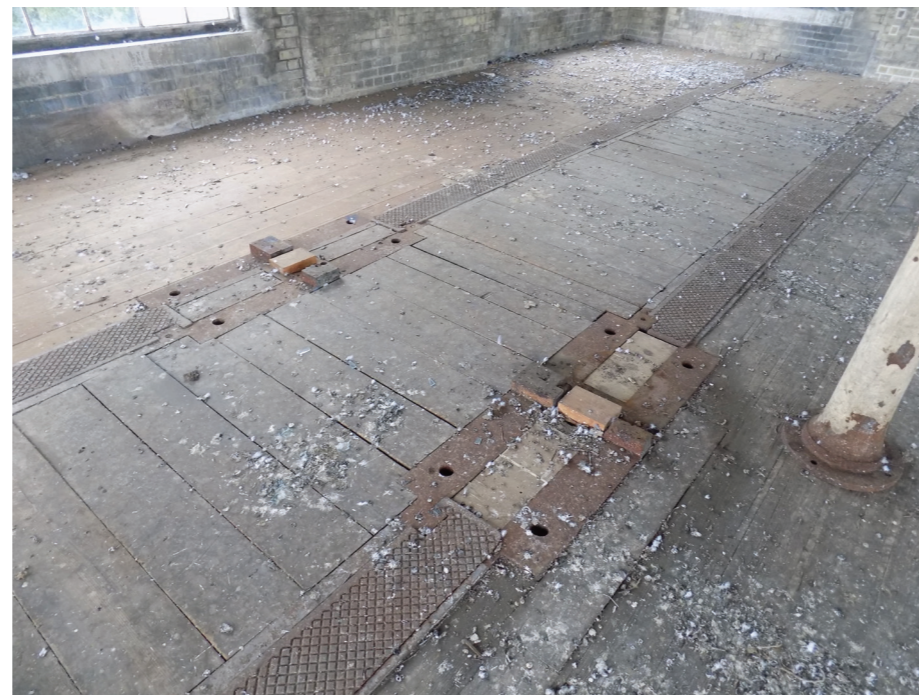
Figure 107: Beam loft floor showing spring beams and trunnion bearing support (high significance) and later infill to beam openings (no significance)

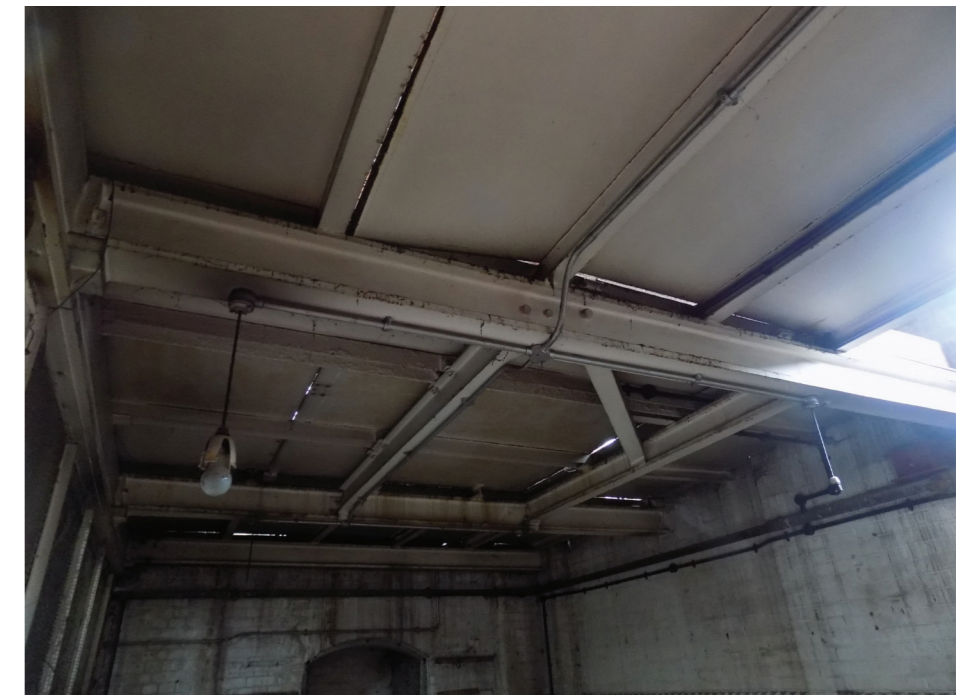
Figure 106: Beam loft floor and supporting joists from beneath (high significance) (steel sheet cladding of no significance)

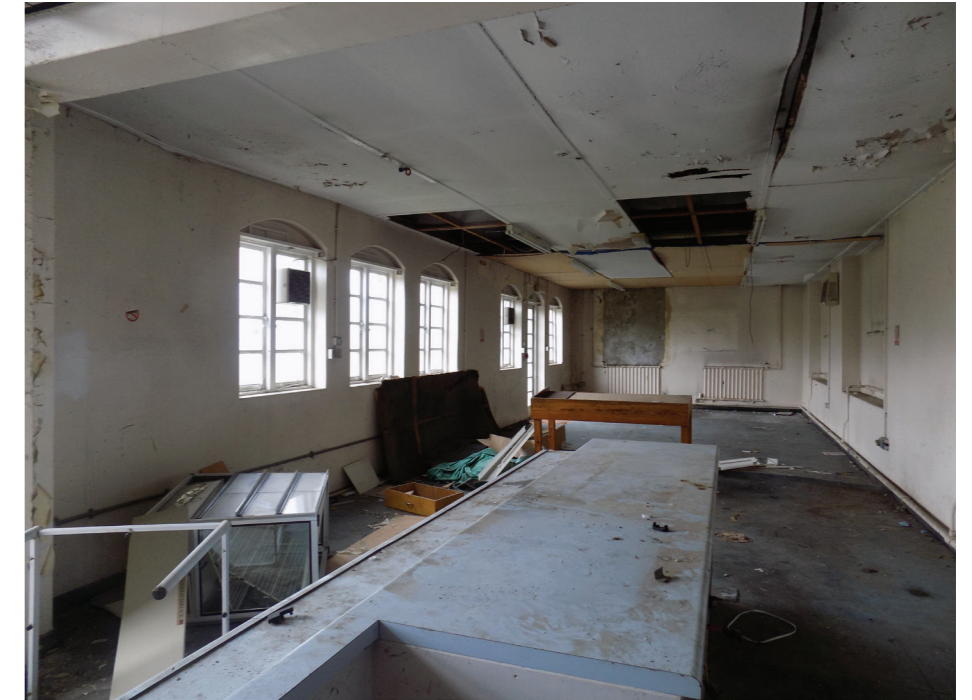
Figures 110: Primary timber casement windows in 19th-century extension south of Beam Engine House (medium significance)

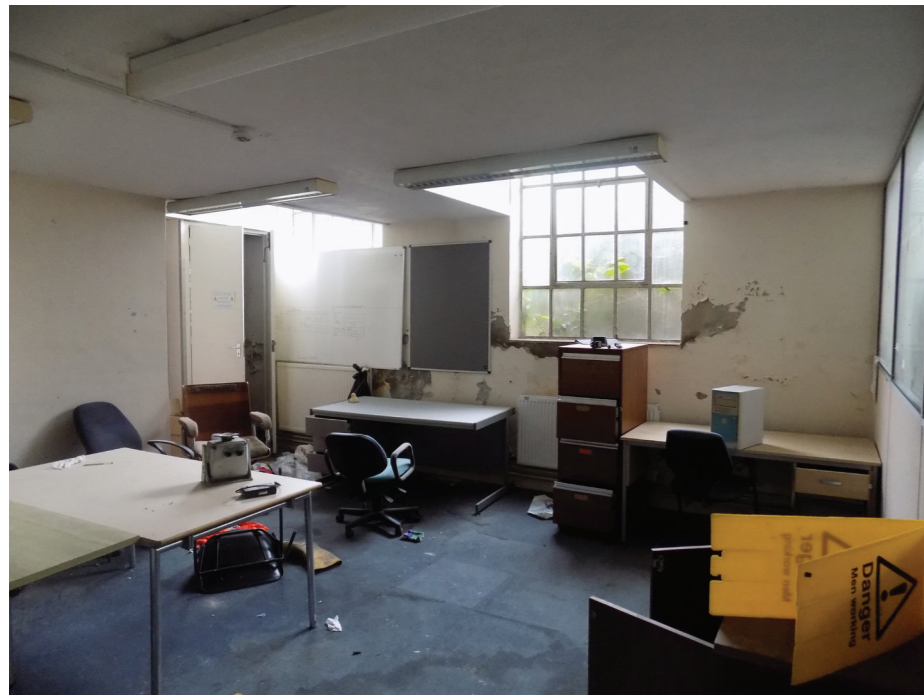
Figure 113: 1930s Crittall-type steel casement windows in north wall of Former Boiler House (wall originally blind) (low significance)

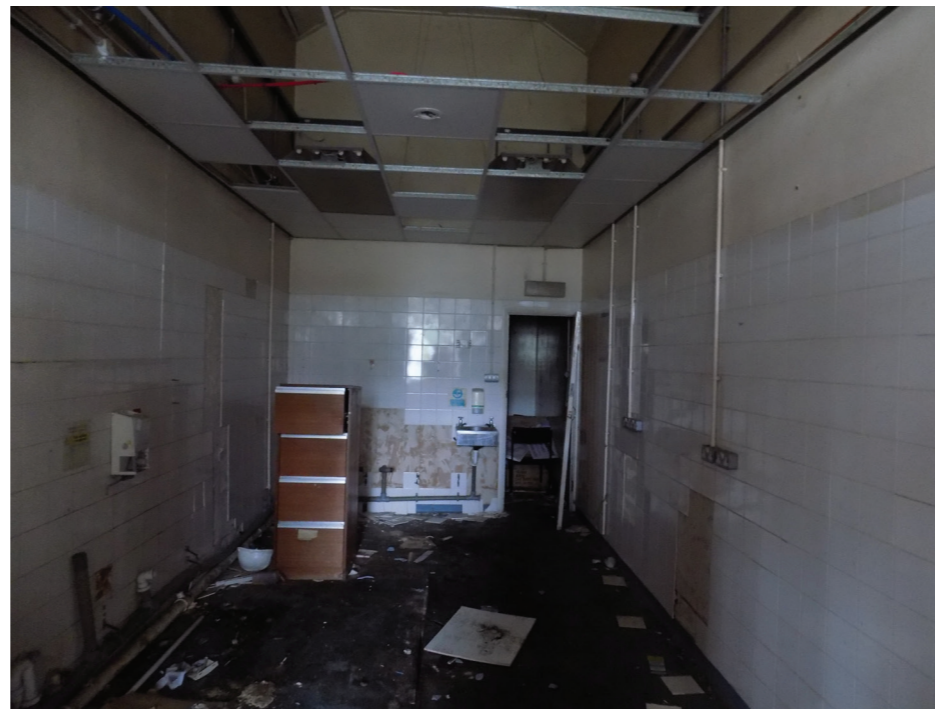
Figures 111: 1930s flat panel cast-iron radiators in 19th-century extension south of Beam Engine House (low significance)

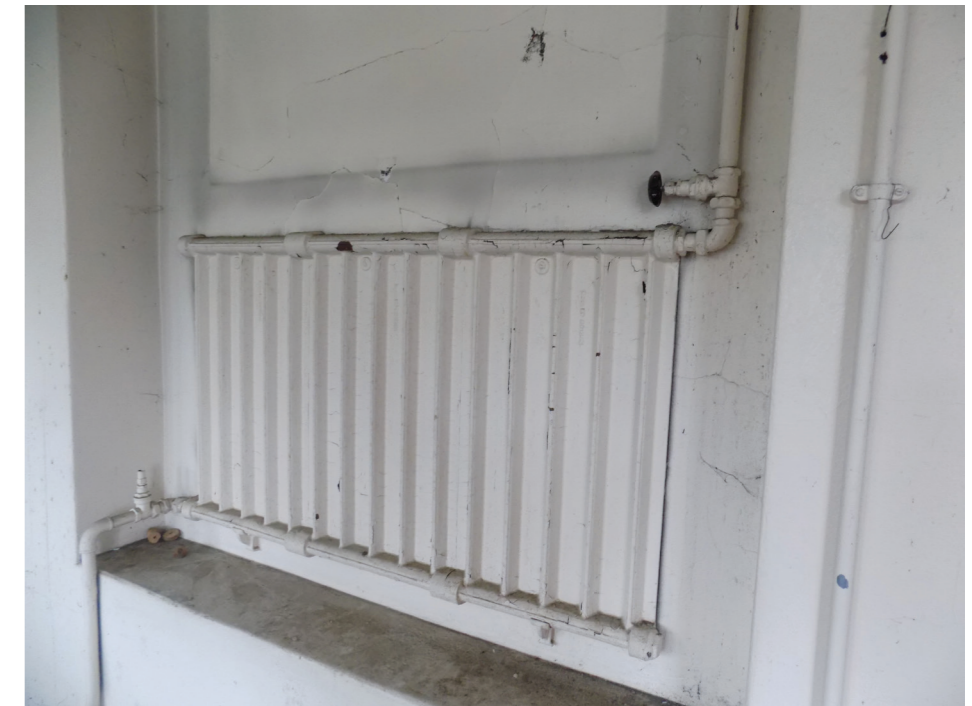
Figures 111: 1930s flat panel cast-iron radiators in 19th-century extension south of Beam Engine House (low significance)

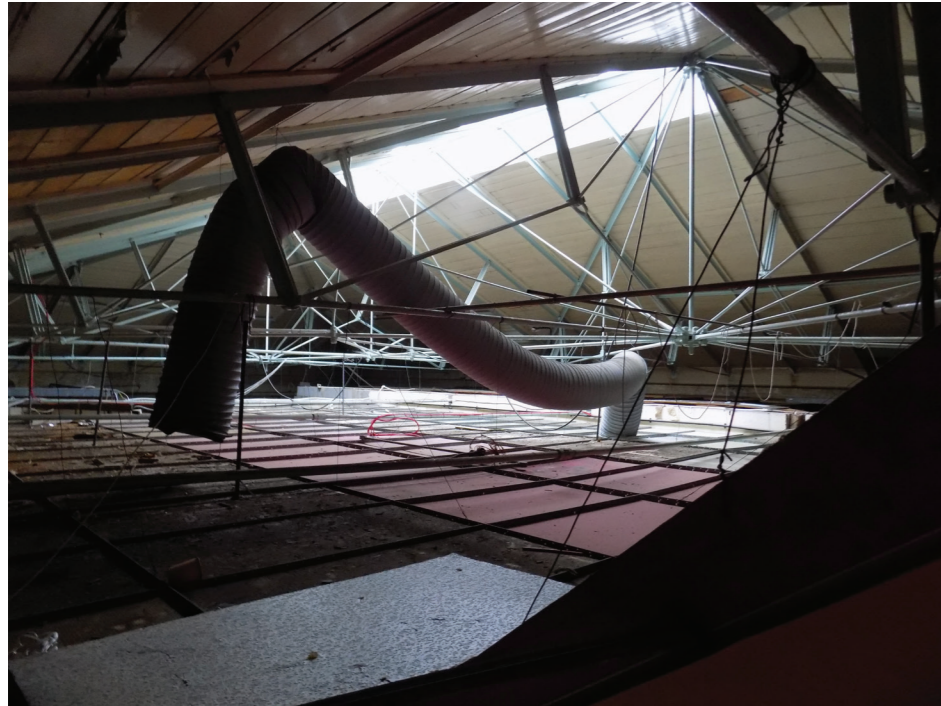
Figure 114: General view of primary wrought-iron boiler house roof with radial ties and modern suspended ceiling (medium significance)

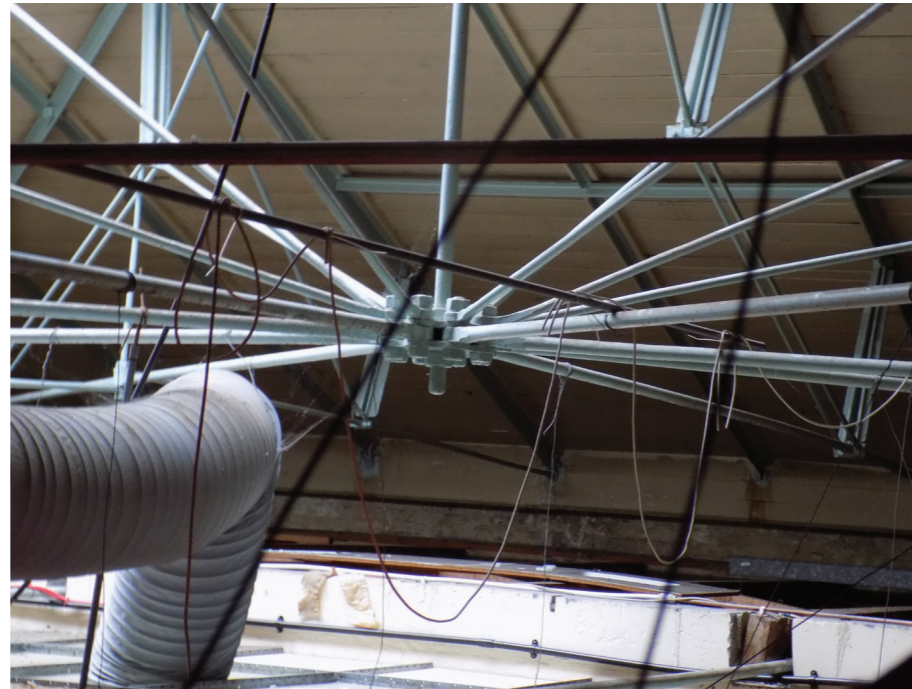
Figure 115: Boss of primary wrought-iron roof (radial ties) (medium significance)

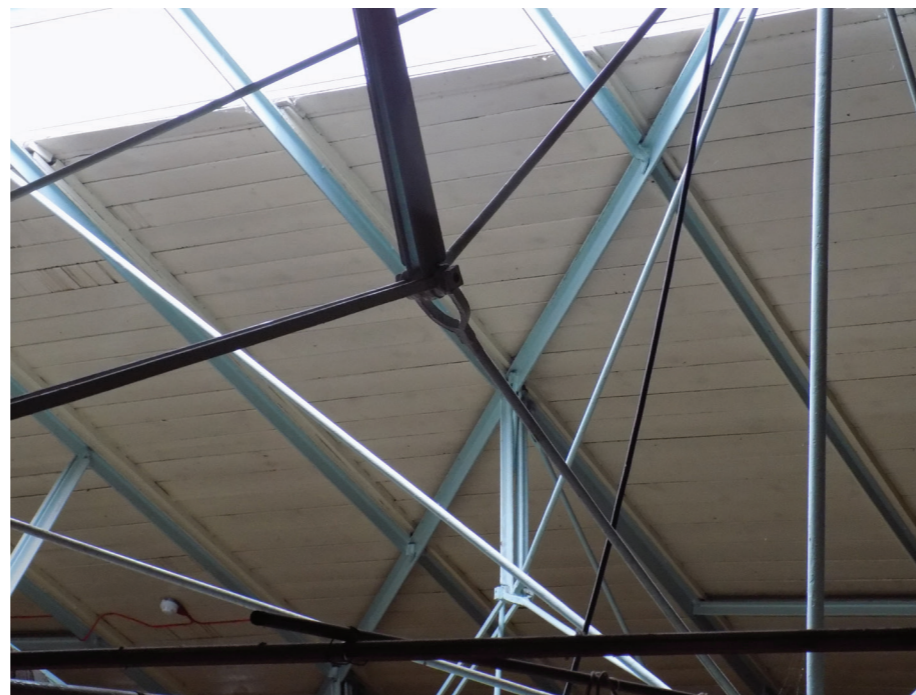
Figure 116: Detail of primary wrought-iron roof elements (medium significance)
