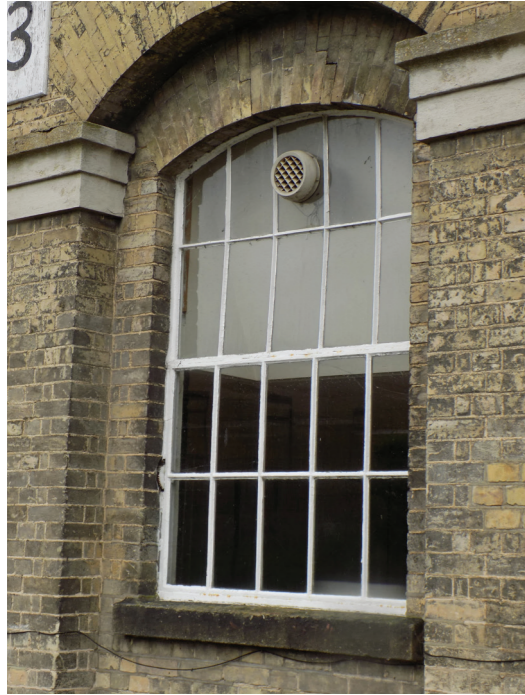
Figure 132: Karslake Boiler House, South Elevation. Cast Iron window, showing slight bow indicating a high degree of repair might be required.

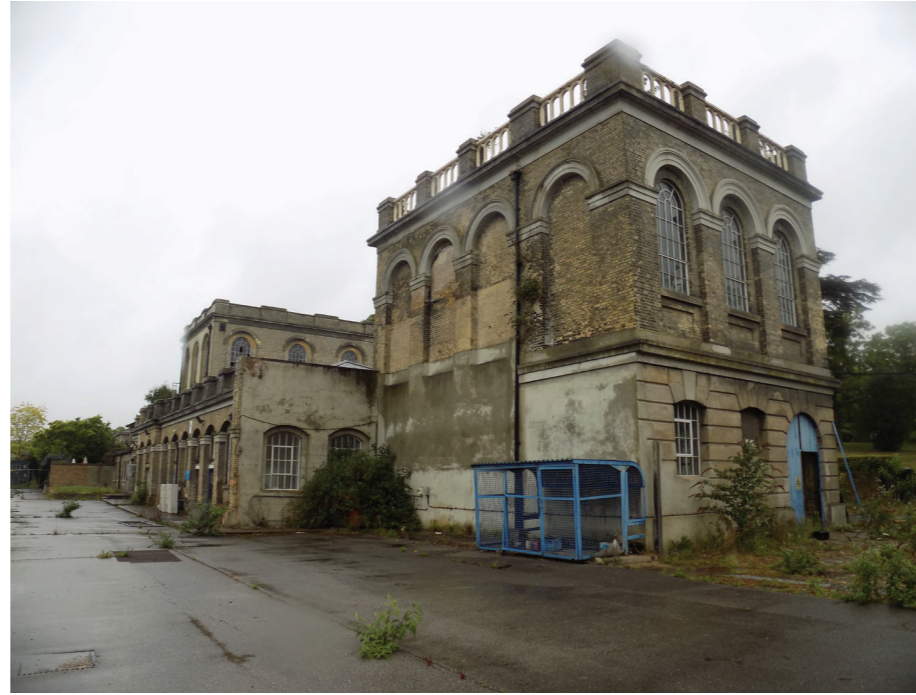
Figure 133: Karslake East Bull Engine House showing cement repairs where former warehouse building has been removed.

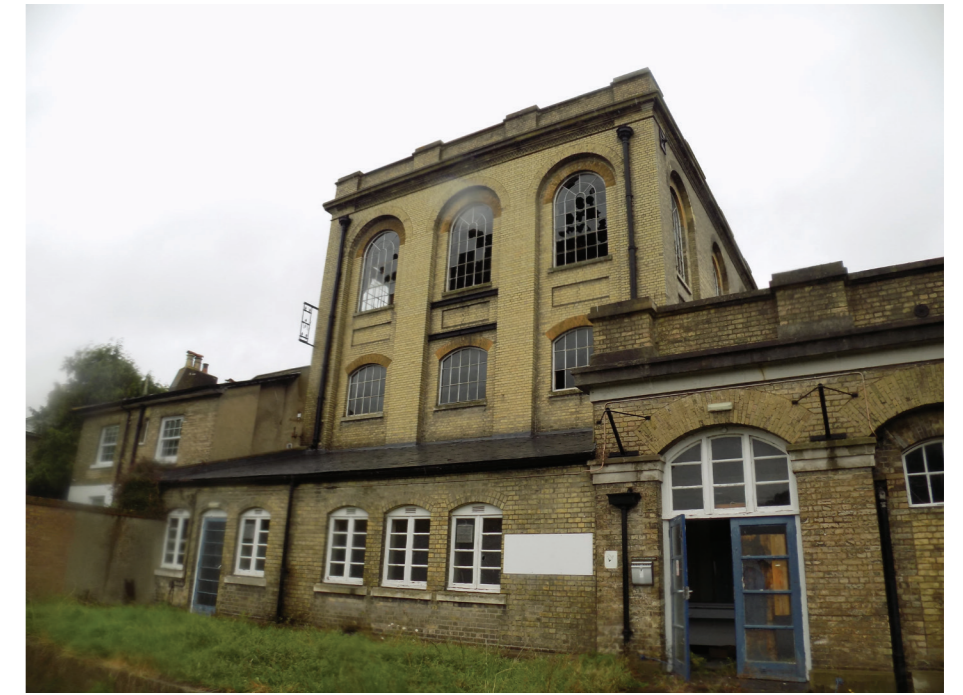
Figure 134: Karslake West Beam Engine Building showing Boiler House entry and lower storey welfare area with timber framed windows.

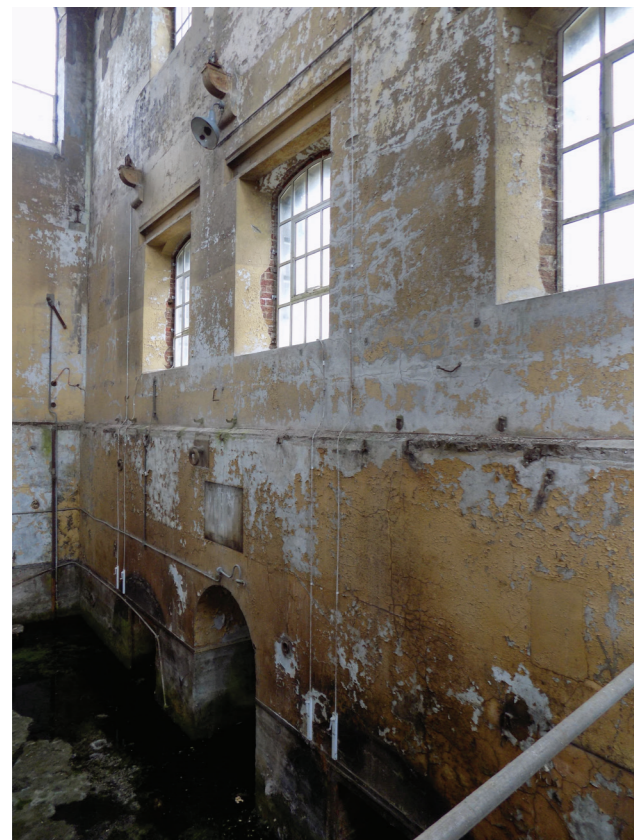
Figure 136: Interior detail showing below ground level and later inserted windows at ground floor level.

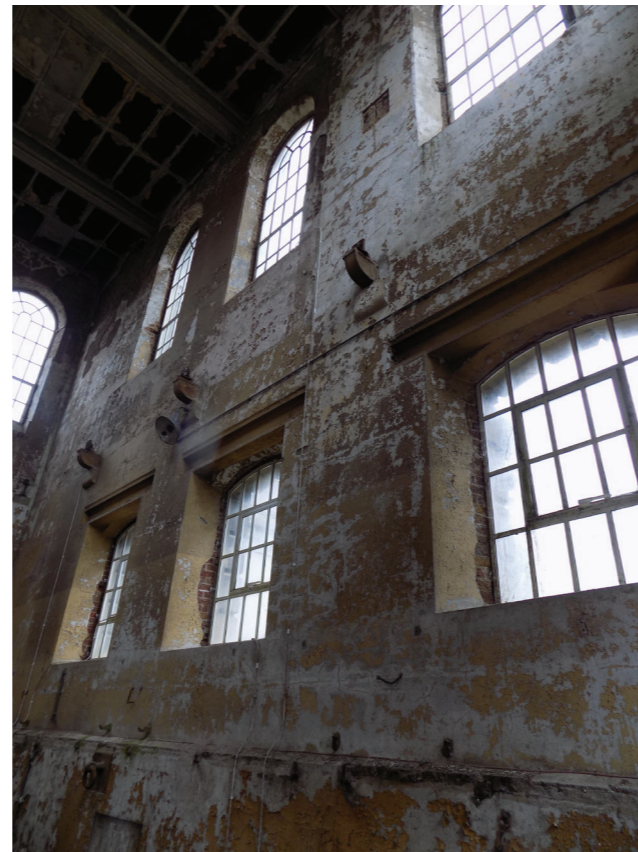
Figure 137: Interior showing original windows at upper level and 1930s windows at ground floor level.

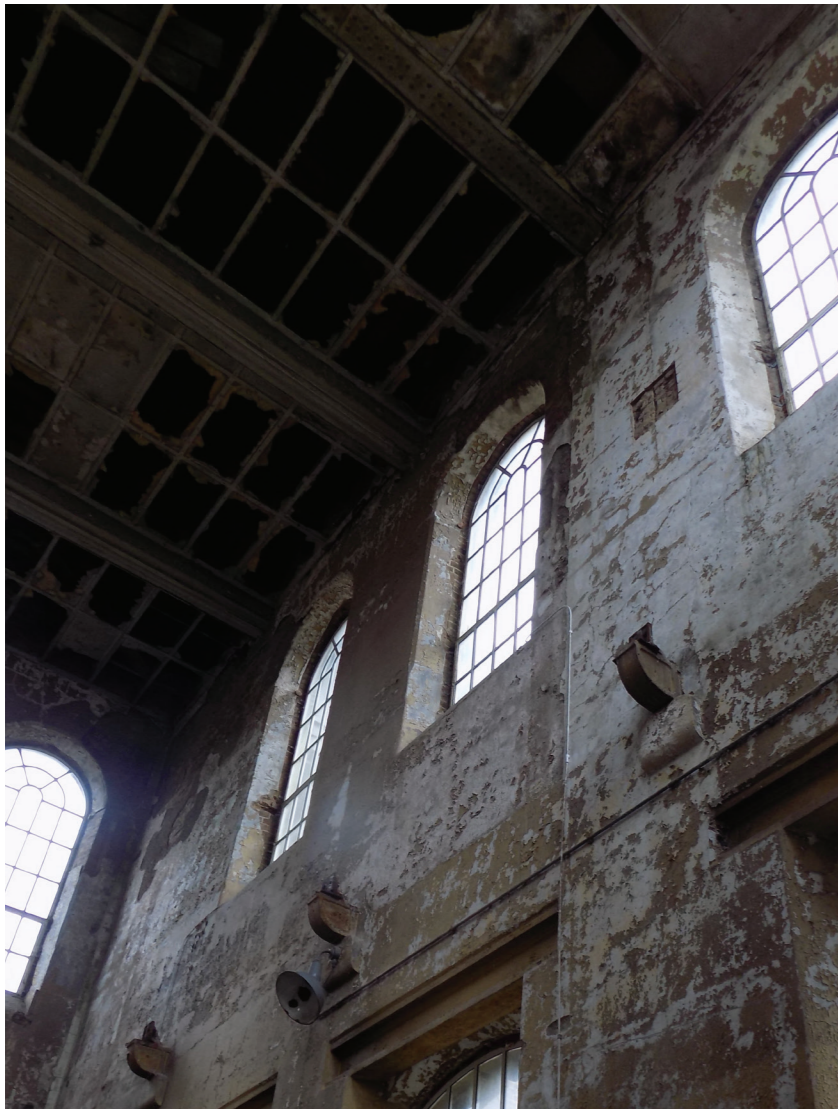
Figure 139: Interior detail showing corbels for engine lifting beams. These are the last remnants of the Bull Engine and therefore have relatively high level of interest.

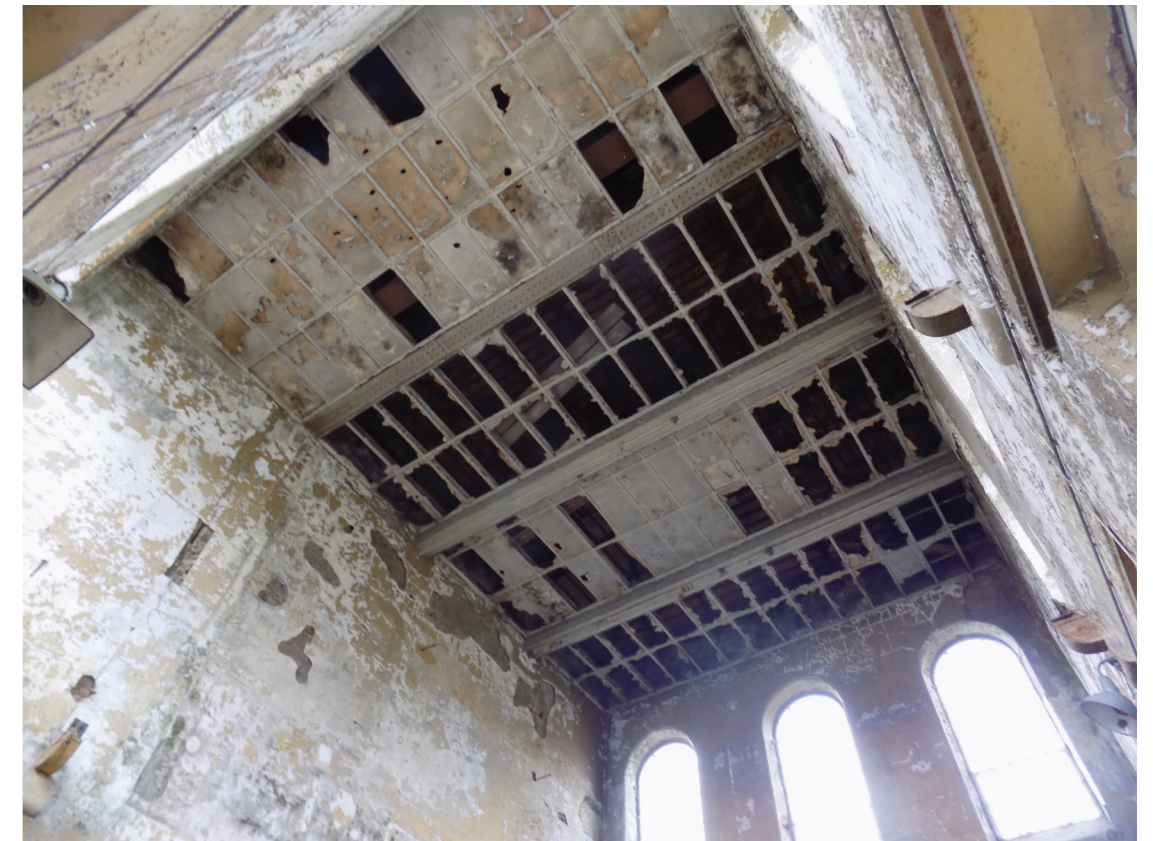
Figure 140: Later, inserted ceiling under sarked roof of low significance,

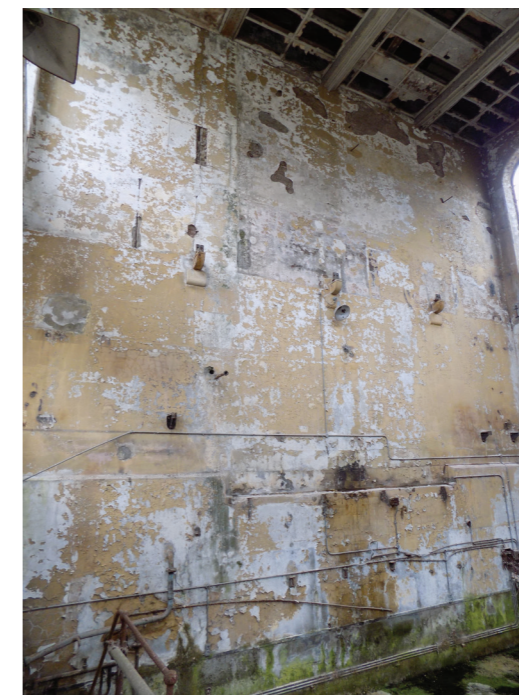
Figure 141: Interior detail showing fittings for Bull Engine installation.

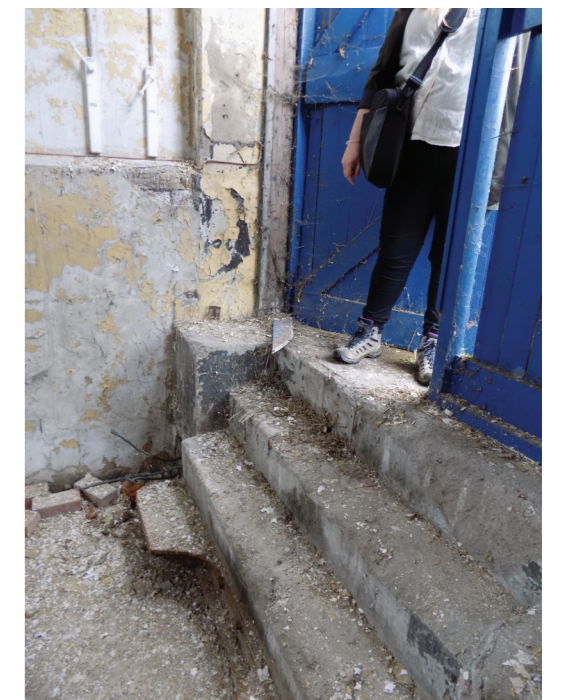
Figure 142 Interior steps showing relationship to exterior ground level.
