KEW GARDENS

2279-7_W1

THE JAPANESE GATEWAY CONDITION SURVEY REPORT

March 2021

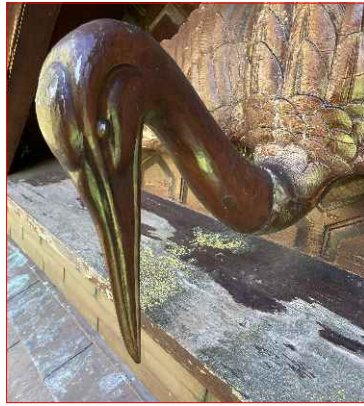
Paint flaking to sculpture

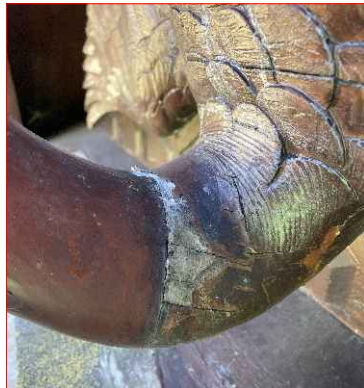
Weak details such as wings and Crane necks have been subject to previous repair and should be checked at intervals.

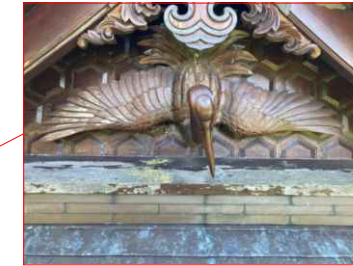
Gable sills subject to weather and could be considered for copper cladding subject to suitable detailing

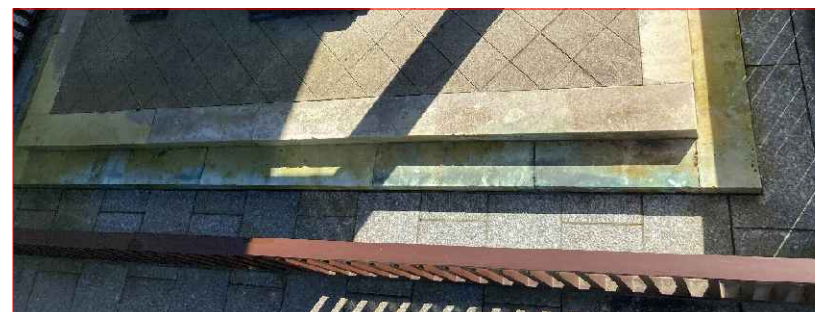
The steps are suffering from copper staining all around the roof perimeter

Water run off from above is causing copper staining to stone paving below, mostly along the East and West sides.

There is little that can be done to avoid this, cleaning and stain blocking could be considered to slow its effect.

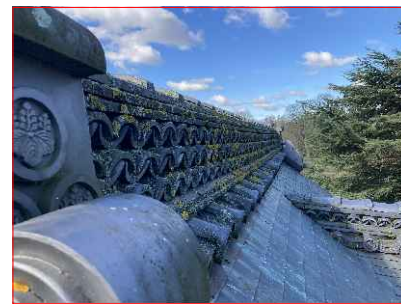
Moss growth to north face of ridge

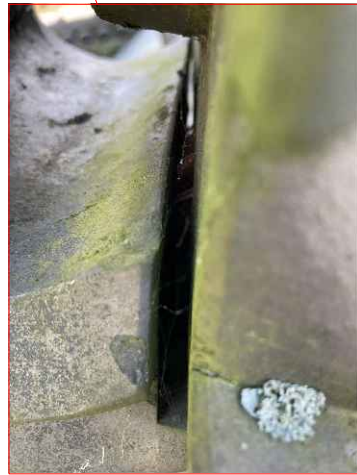
Ridge element slipping slightly

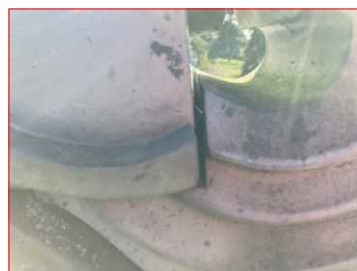
Ridge element slipping slightly

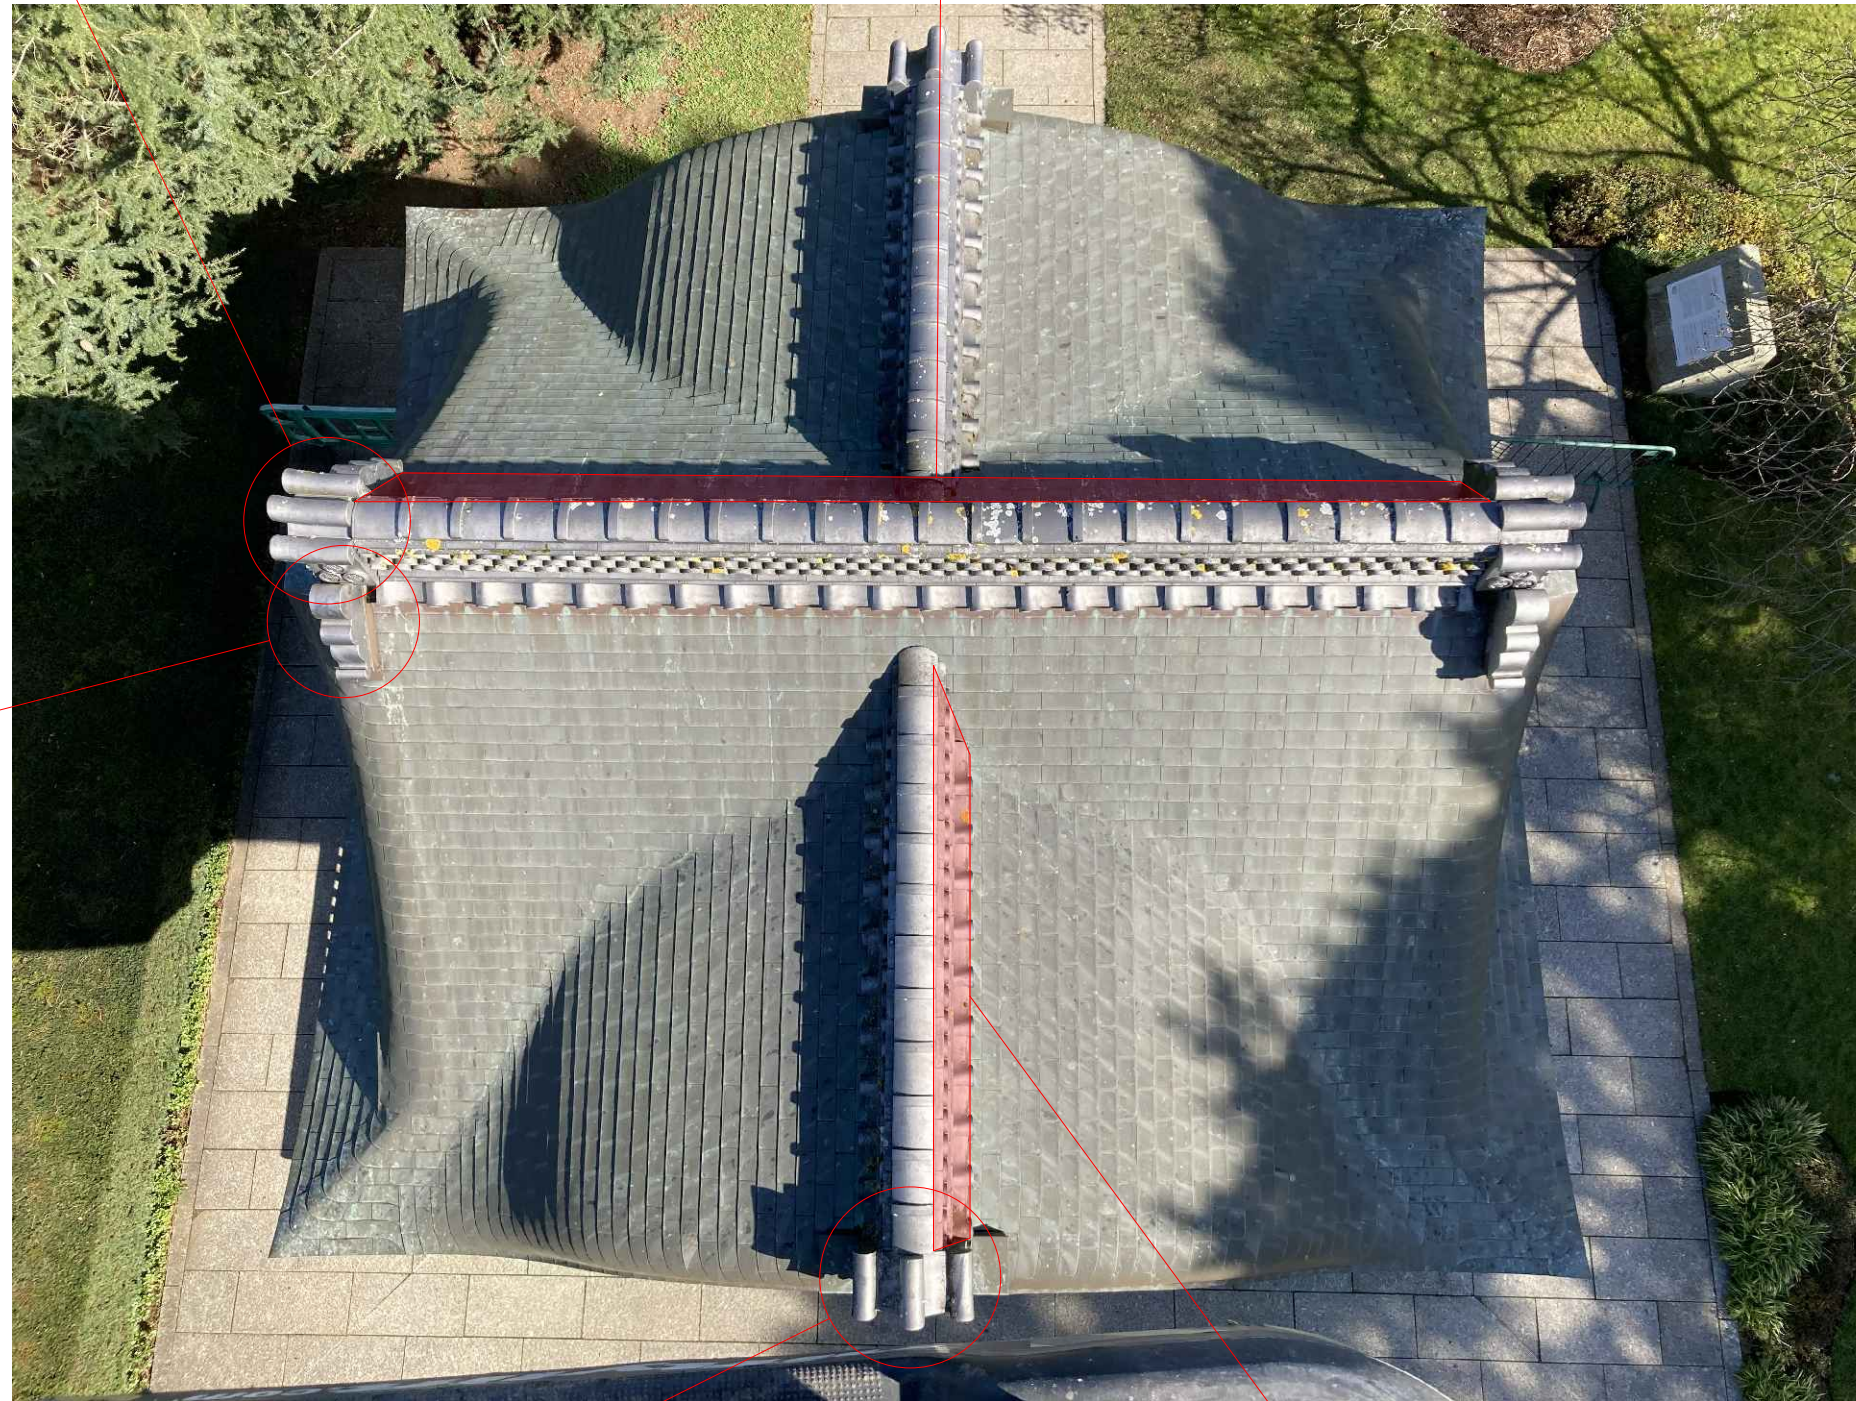
Title
ROOF
PLAN
As Existing

Ridge finial brackets are secured with threaded stainless steel studding hung/balanced from the central finial. The brackets can be moved by hand, but their fixing appears as intended.

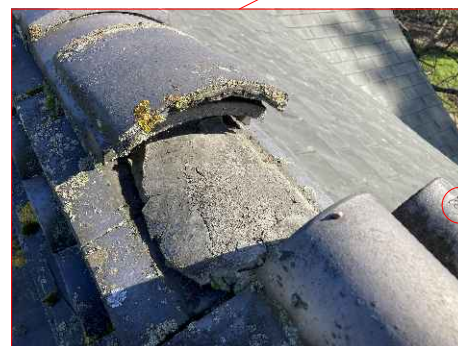
The ridge tiles may not have achieved a good bond with their bedding mortar due to the impervious and smooth glazed surface. One tile could be lifted away behind the finial. No tiles are missing or slipped.

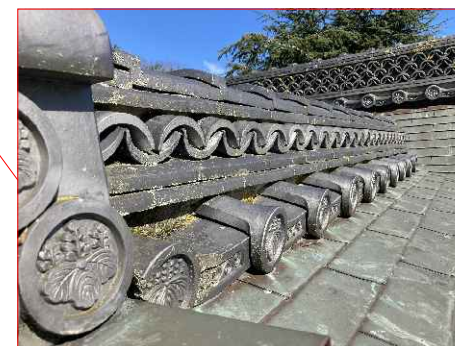
Moss growth to south east of lower ridge
