**Japanese Gateway**  
Kew Gardens  
Copper Repoussé Trails  
October 2023

Dorothea Restoration was commissioned by Acanthis Clews Architects, on behalf of Royal Botanic Gardens Kew, to inspect the replica gate of Nishi Hongan-ji (Western Temple of Original Vow) the original located in Kyoto, Japan. The structure was created for the Japan-British Exhibition held at White City in London in 1910. The structure is grade II listed and was first listed in 1950 by Historic England.

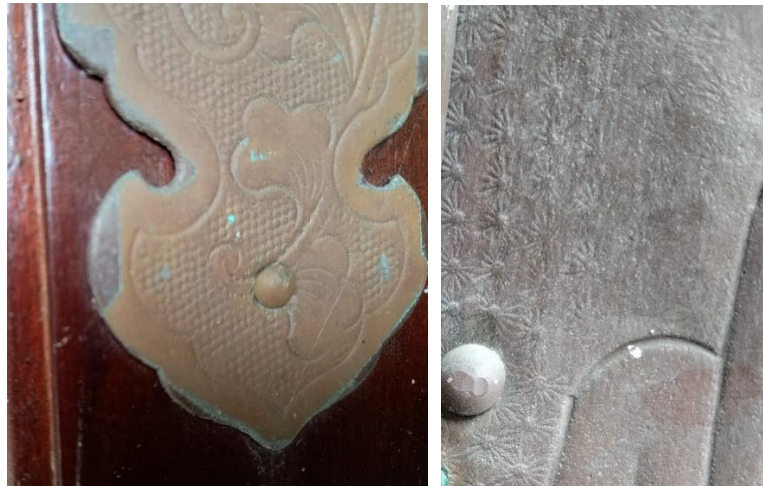
Photo above identifies one of the areas where the patination has chipped off the surface of the copper leaving the edge exposed. The photos also highlight the variation in colour across the copper, based on exposure to the elements.

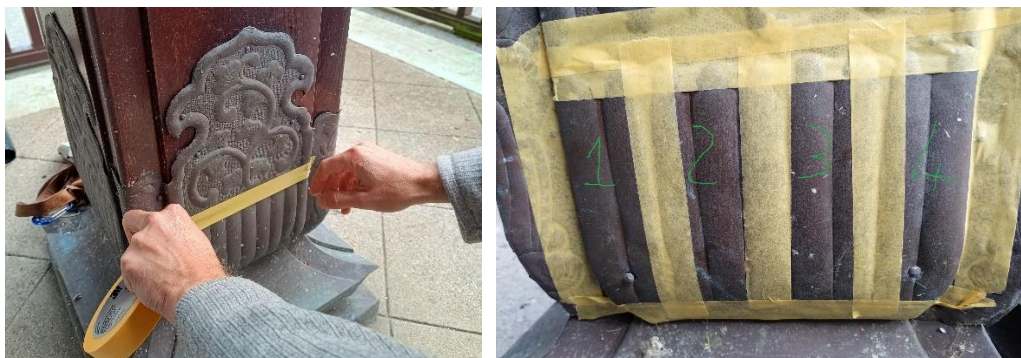
Dorothea identified an area at the base of the right-hand post facing the river to carry out samples and the area what taped off to create four equally sized areas as shown below. The area was taped off using a low tack masking tape.

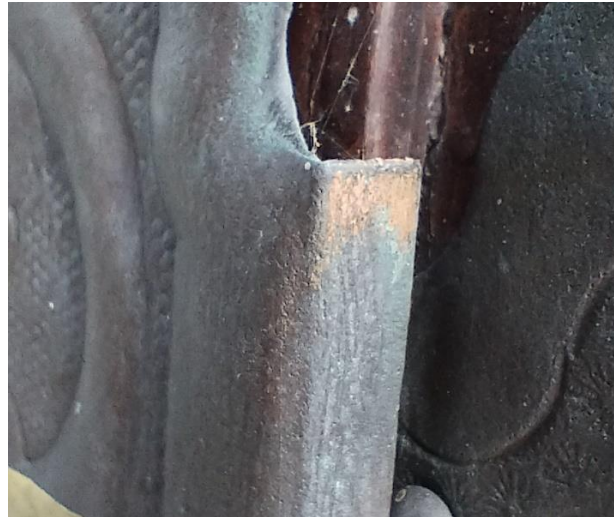
A sample area was chosen, and a small sharp blade was used to scrape the surface to identify any buildup on the surface and reveal the nutty brown patina underneath. The dirt and debris on the surface of the components have formed a hard coating over the top of the patina.

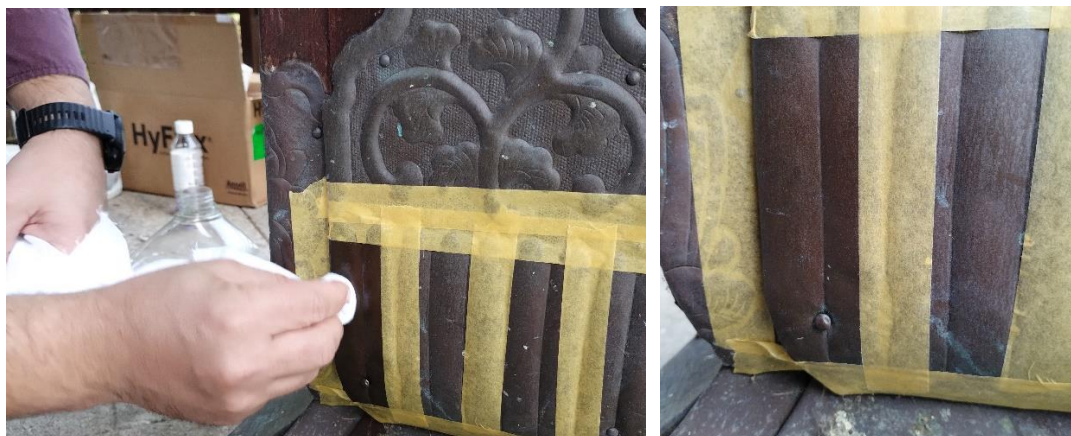
#### Area 1

Area 1 was cleaned by hand using a cotton lint free cloth and white spirits to remove loose debris and dirt from the surface. Medium level of force was applied to release any guano from the surface and the cloth rotated to ensure residue was not spread across the surface. After drying the surface with an absorbent white paper roll the surface was left to dry naturally.

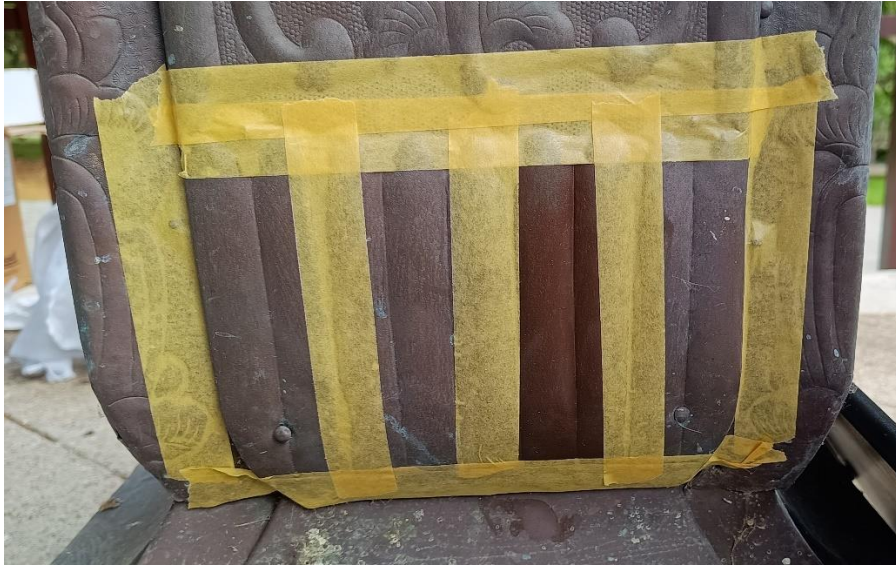
### Area 2 & 3

Were cleaned using methylated spirits and the same principle was used as in area 1. The lint free cloth was changed between area 2 & 3 to avoid contamination and the surface dried very quickly as the alcohol evaporated from the surface.

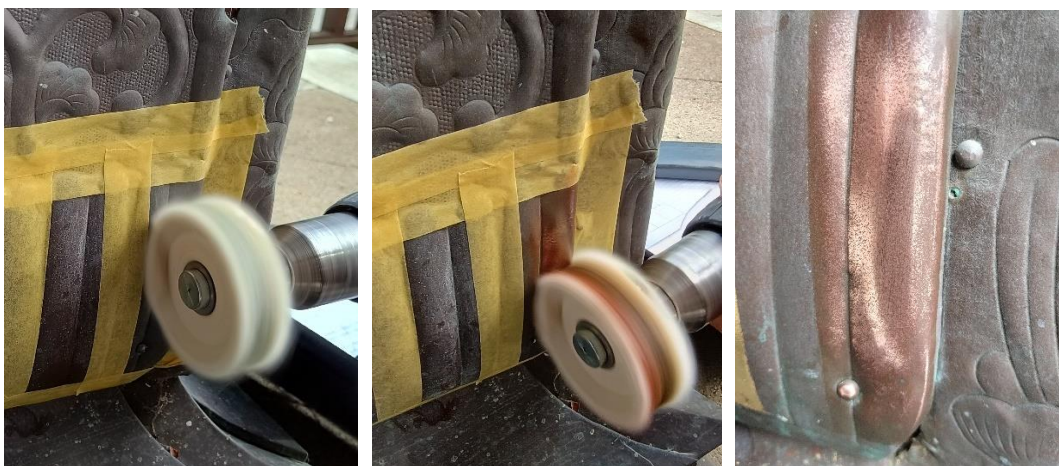
### Area 4

The final area was cleaned using a polish mop and 1000gm mirror finish polishing bar designed for use on non-ferrous metals. The dirt, debris and existing patina was removed to reach the copper surface. The copper was polished to remove the dirt from the surface however the pressure was light and not aggressive enough to remove any dirt from indentations within the surface. The area selected was chosen to avoid any damage to highly decorative areas where polishing would be difficult without losing some of the detailing.

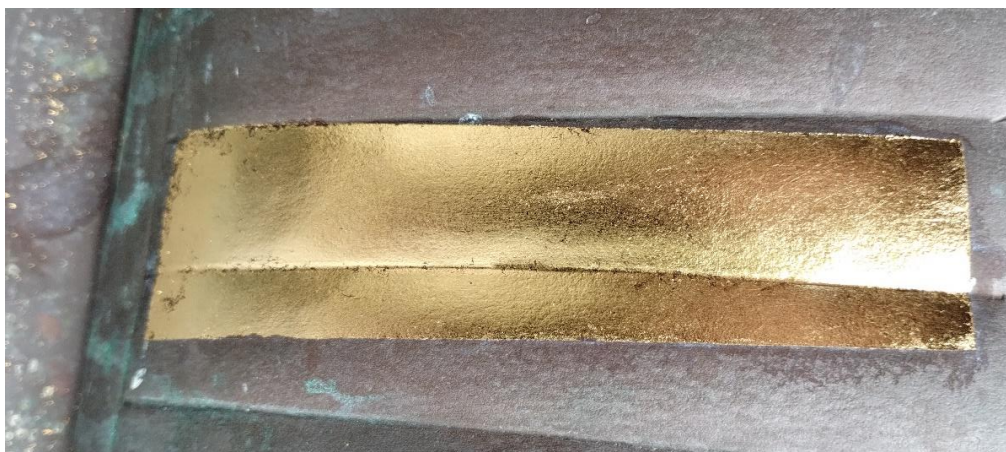
### Area 3

Once dry the surface was treated with mordent solution to provide a key on the surface. The area was coat with a thin layer of 3 hour Le Franc oil-based size and left to dry ready for 23.5ct gold to be applied. Once the surface had adequately dried the loose-leaf gold was applied and brushed into indents and pin holes within the surface of the copper.
