Timber assessment of the Japanese Gateway

ROYAL BOTANICAL GARDENS, KEW.

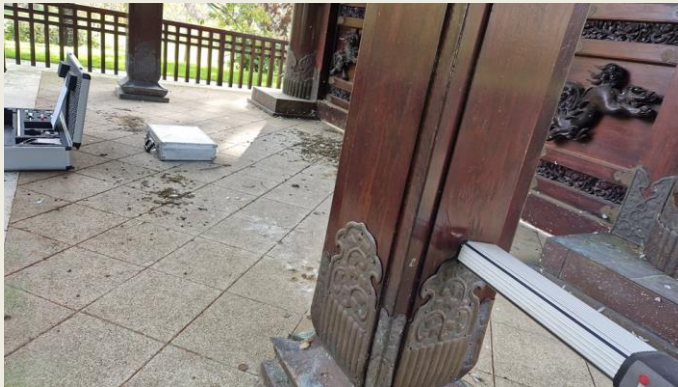
Post 6 – MD 8.

The trace shows *'this'* post consists of separate outer cover plates of 60mm section, with what is assumed to be a single central post of 170mm section.

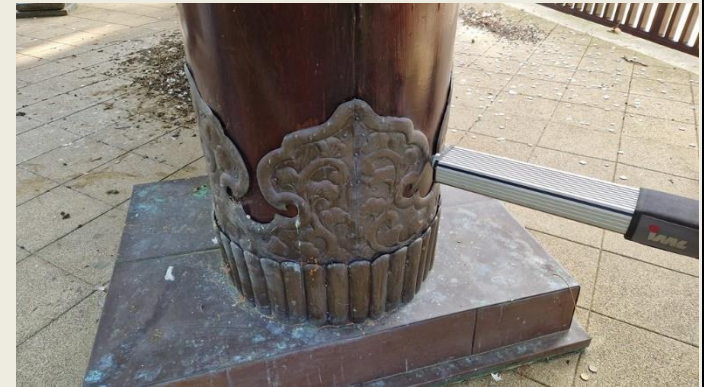
Posts 5 and 2 – MDs 9 and 10.

Both round posts were drilled at different orientations (N-S and E – W). Both showed 80 – 85mm outer section – then space. The probe normally auto retracts after 100mm of space, as the probe oscillates and then deflects producing anomalous readings. However, in the case of graph 9, the probe continued through nearly 200mm of space, indicating the round posts are almost certainly hollow.

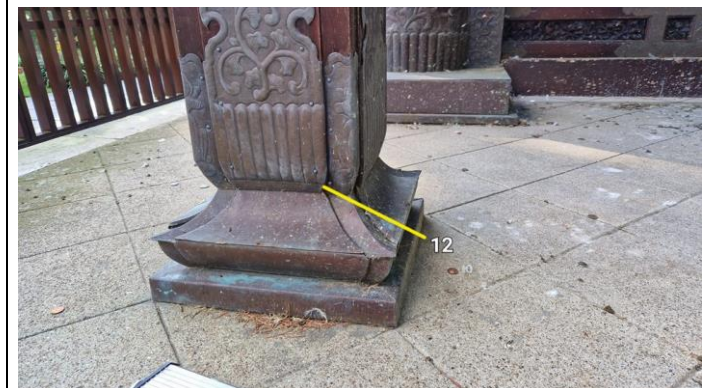
Post 1

Some deterioration of the outer surface of the cover plate. This post is drilled at its corner (as opposed to though one of its faces). It is not clear whether the outer cover plate is thicker than that of post 6, or whether a section of some other element has been picked up. There is a cavity 130 – 180mm which doesn't appear to be a decay trace.

More sound material was then encountered until 340mm – when a hard material (probably a metal fixing) was encountered.

Even though the post was drilled at an angle, the trace indicates a possibility that the corner posts ((1, 3, 4 and 6) might not be of a similar construction.

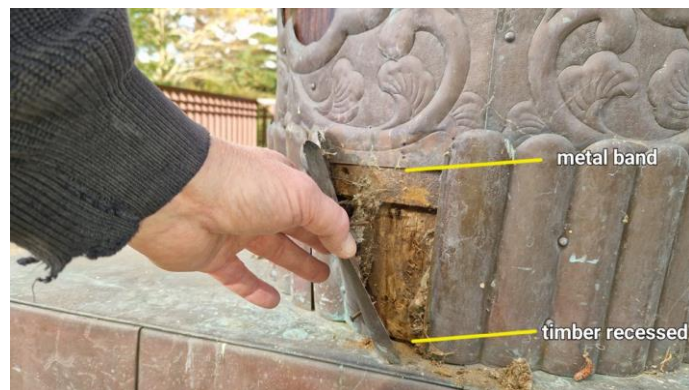
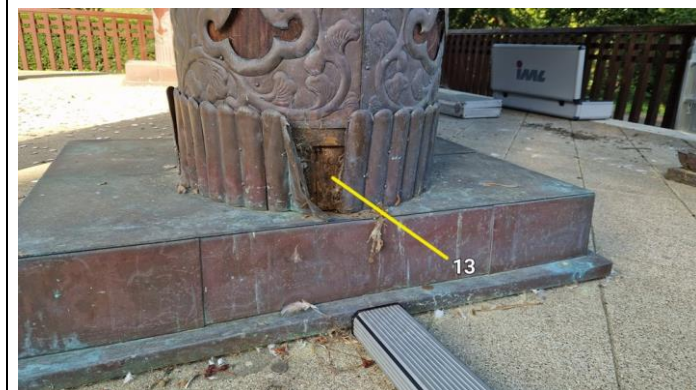
Post 2

The plate had become detached as shown.

There is some very superficial deterioration of the timber surfaces.

MD below the metal band showed the post remains hollow at its base where it bears onto the plinth.

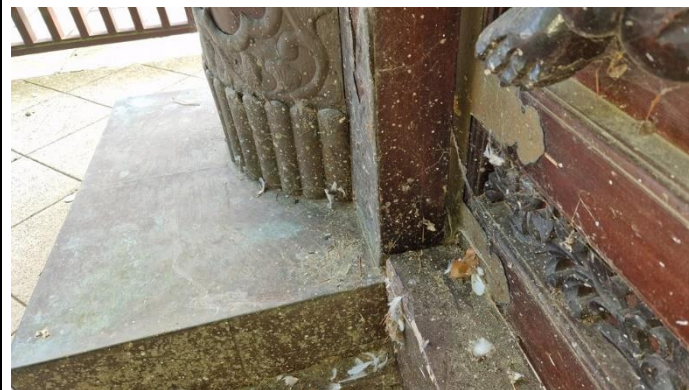
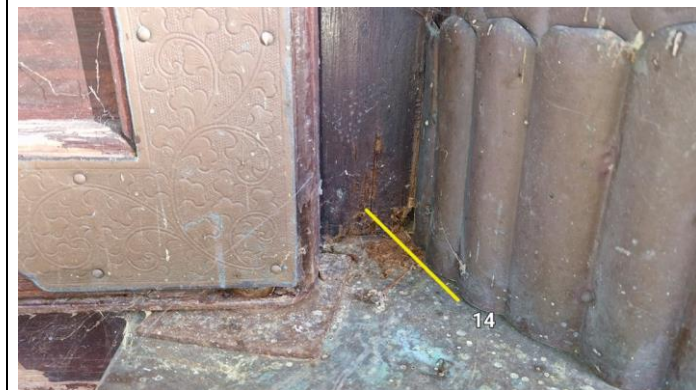
Post 2 – vertical stop.

First photo showing N side which appears sound.

The timber was drilled from the S side where there is some deterioration of the bar at its base. MD showed sound material for 75mm, a small gap, then hard material – almost certainly a metal fixing.

The base of the door interfacing with the pivot hinge is sound – although the metal is corroding – see post 5.

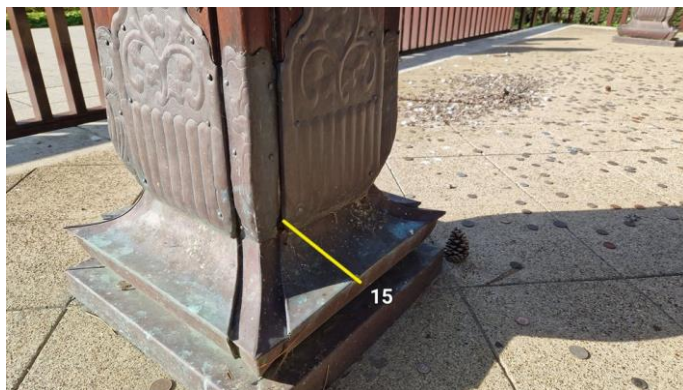
Post 3

Possibly some deterioration of the outer plate – although the probe might have deflected below it, but sound material centrally.

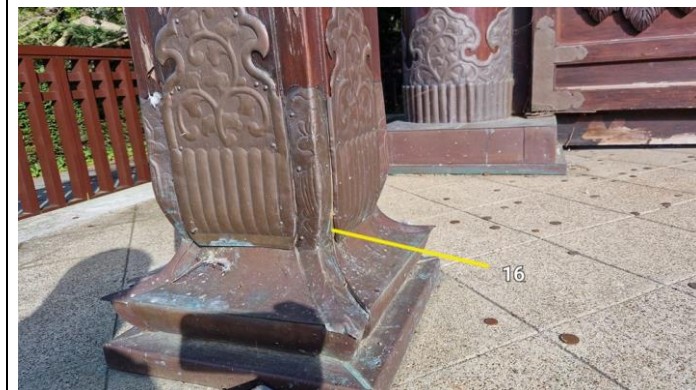
Post 4

Showing sound trace through cover plates and central section.

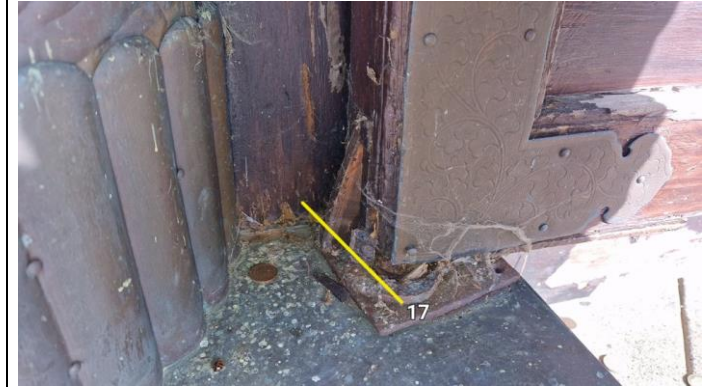
Post 5

There is some deterioration of the base of the vertical stop bar which was drilled. MD showed a similar trace to 14, with the probe hitting hard material at 120mm. The plate was in tact around the post base, so MD 9 (used for calibration) is as low as the drill can go.

The pivot hinge has rusted and there is probably very localised decay to the timber around socket in the hinge stile for the pivot hinge, which has resulted on the door collapsing on the pivot hinge – pushing out what is probably the socket cover fillet in the process.

As mentioned above, the most significant defect is the deterioration of the lower pivot hinges of both doors – although the W door is the worst effected, where the lower pivot hinge arrangement has collapsed.

Whatever the sequence of events, the door requires a localised repair in this corner – and remounting.

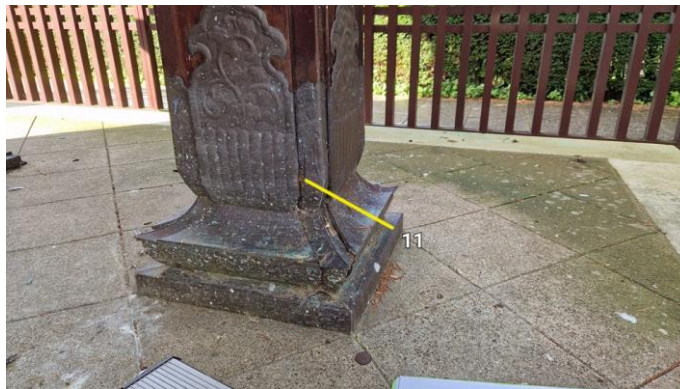
Post 6

MD showing sound cover plate and central post (which has a central seasoning fissure at 170mm). The probe then couldn't progress after 265mm, due to the density and strength of the timber – possibly encountering a knot.
