# Schedule of repairs

**Project name:** 3 Maids of Honour  
**Job No:** 6388  
**Location:** 3 Maids of Honour, London  
**Date:** 14/03/2024

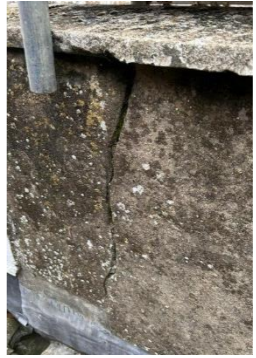
<p>1.5.0 Front parapet</p>	<p>The front parapet wall has been finished on the inside brickwork with a render system of which this render has several cracks which are quite significant and sections of render which have broken away.</p>	<p>All blown render on the inside brickwork of front parapet wall to be removed, wall to be cleaned, primed, and made ready for our two-coat scratch render system in lime mortar. New renders stop feeds to be installed where required. The repair areas will consist of two coats of scratched render system using a lime mortar mix.</p>

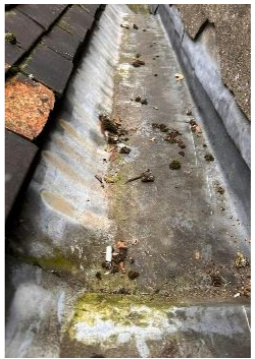
<p>1.6.0 Lead work</p>	<p>Lead work throughout presents poor workmanship.</p>	<p>Existing lead abutments to be tidied up and carefully repaired as required.</p>

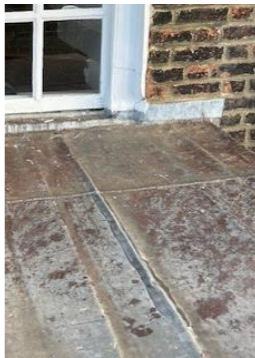
<p>1.7.0 Lead roof above WC F05</p>	<p>Lead is in very poor condition presenting one major split that allows water ingress. Lead work around RWP allows water ingress.</p>	<p>As required new lead sheeting to be carefully welded over splits to form permanent repair. A lead collar to be installed to RWP to prevent any water ingress. All lead works to be installed in accordance with lead sheet association practice.</p>

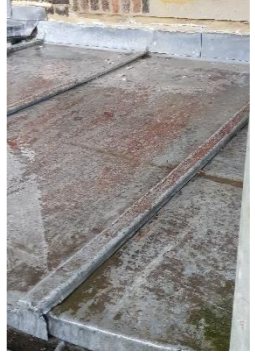
<p>1.8.0 Lead roof above Kitchen</p>	<p>Lead roof above Ground Floor Kitchen presents exposed nails and signs of stress, indicative of potential split.</p>	<p>Small patches of lead sheet to be carefully welded over area of stressed lead to form permanent repair.</p>

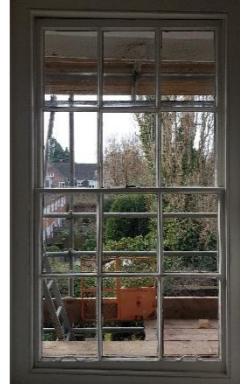
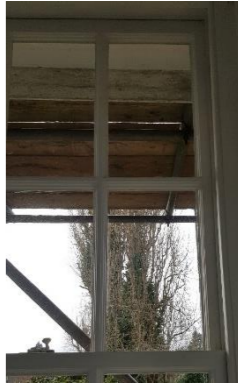
<p>Image 3.1.1      Image 3.1.2</p>

FEATURE	DESCRIPTION/CONDITION	PROPOSED REMEDIAL WORKS	PHOTO
3.1.0 Windows	Existing timber sash windows are showing signs of wear and tear. 1No glass pane WS08 is cracked and in need of replacement. Operation of the windows is difficult with most of the windows not opening fully. Paint finish failing on all windows.	All windows to be overhauled. New cords to be fitted, new staff beads added where the existing are failing. All windows to be rebalanced. Failing paint finish internal and external to be made good. Window specialist to remove failing paint and prime. External paint to match existing.

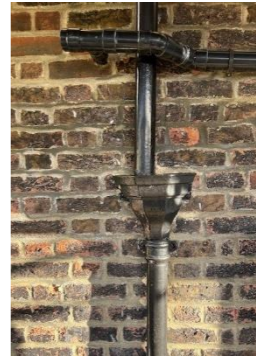
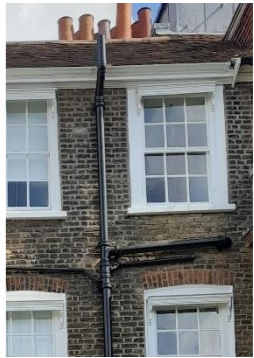
<p>Image 3.2.1      Image 3.2.2</p>

3.2.0 RWP and hoppers	Existing RWPs and hopper are plastic-painted black.	Replace all rainwater items with heritage cast iron style products and fixings and colour-matched fixings.

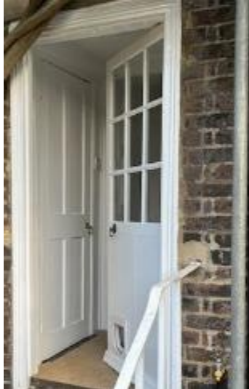
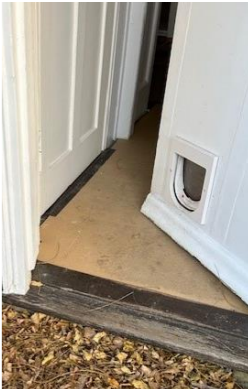
<p>Image 2.1.1      Image 2.1.2</p>

<p>Image 2.1.1</p>
3.5.0 Rear door	The existing rear door top hinge has dropped, resulting the door leaf not seating correctly in the opening, causing interference with the floor and hindering its ability to fully open.	Existing door hinges to be carefully adjusted to achieve optimal alignment with the floor, thereby facilitating full door opening.

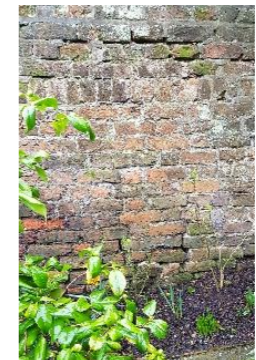
Image 4.2.1

The garden wall shared with neighbours at No 2 presents loose bricks.

Carefully rake out any failing mortar, stabilise all loose bricks, and replace any damaged or missing bricks with bricks to match existing and relime with lime mortar.

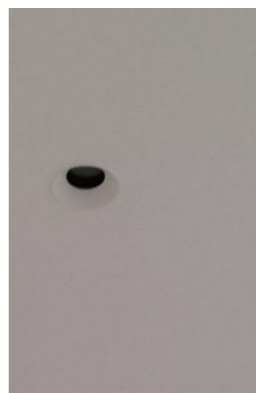
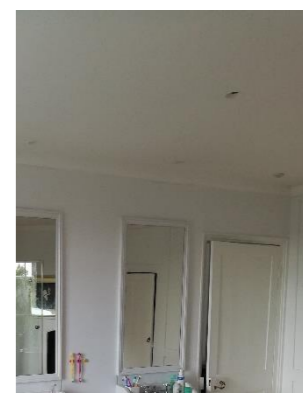
FEATURE	DESCRIPTION/CONDITION	PROPOSED REMEDIAL WORKS	PHOTO
5.1.0 Ceiling	Modern ceiling downlights.	Carefully remove modern light fixtures and infill the openings to match existing ceiling construction. Replace retained modern light fittings with low-energy downlights.

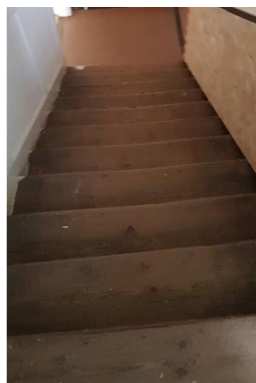
<p>Image 5.2.1</p>

<p>Image 5.1.1      Image 5.1.2</p>
5.2.0 Stair Treads	Several of the treads in the lower flights of stairs are deflecting excessively under load from Ground to First Floor.	Carefully work from below the treads to pack with timber wedges to ensure good contact with the supporting strings.
