CONDITION INSPECTION
IN RESPECT OF SITE KNOWN AS
GROSVENOR GARAGE, FITZGERALD AVENUE
BARNES, LB OF RICHMOND, SW14 8SZ

January 2024

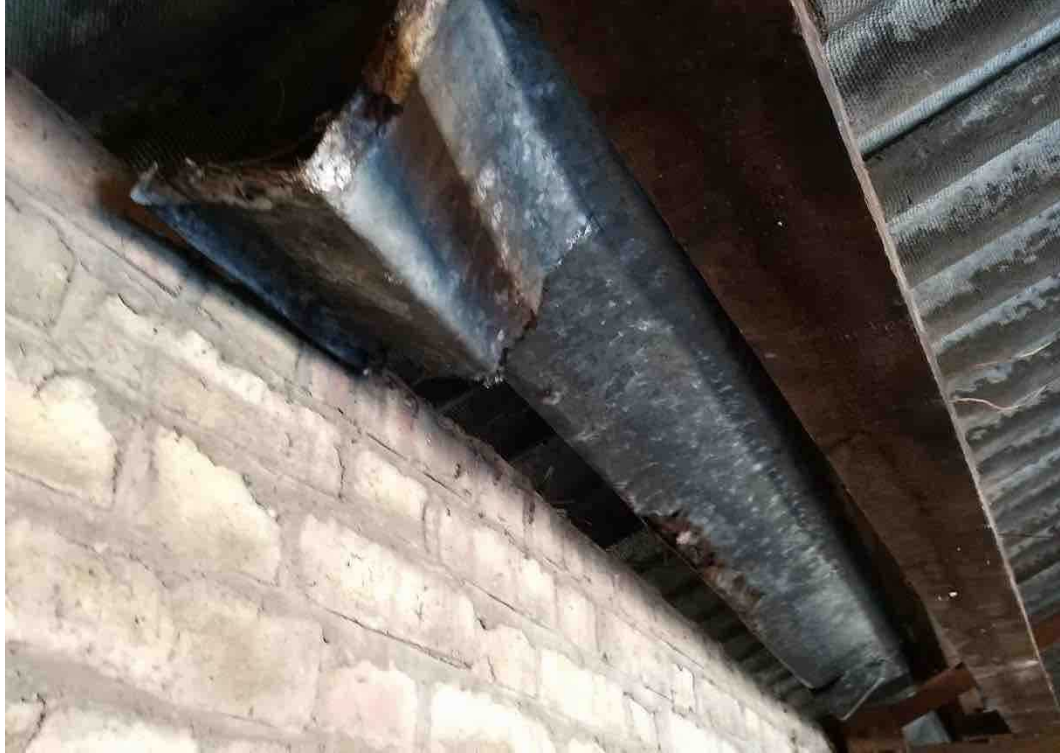
30. Water ingress staining to west wall of unit 6 due to the outward movement of the wall.

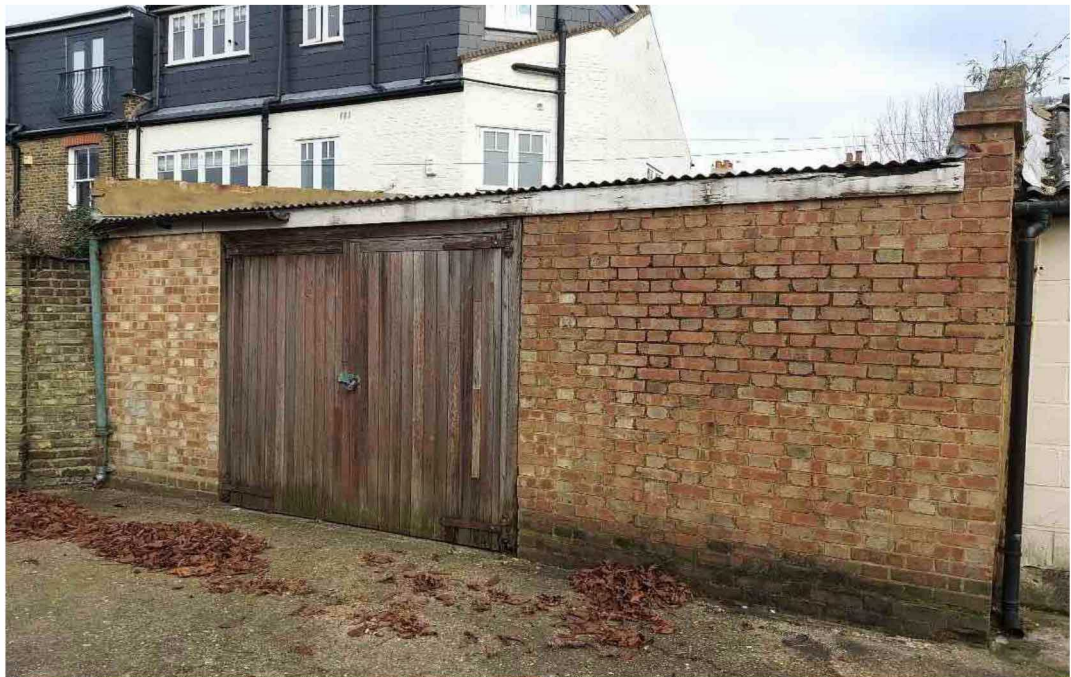
34. Frontage of unit 14 showing dilapidated rainwater goods and timber fascia.

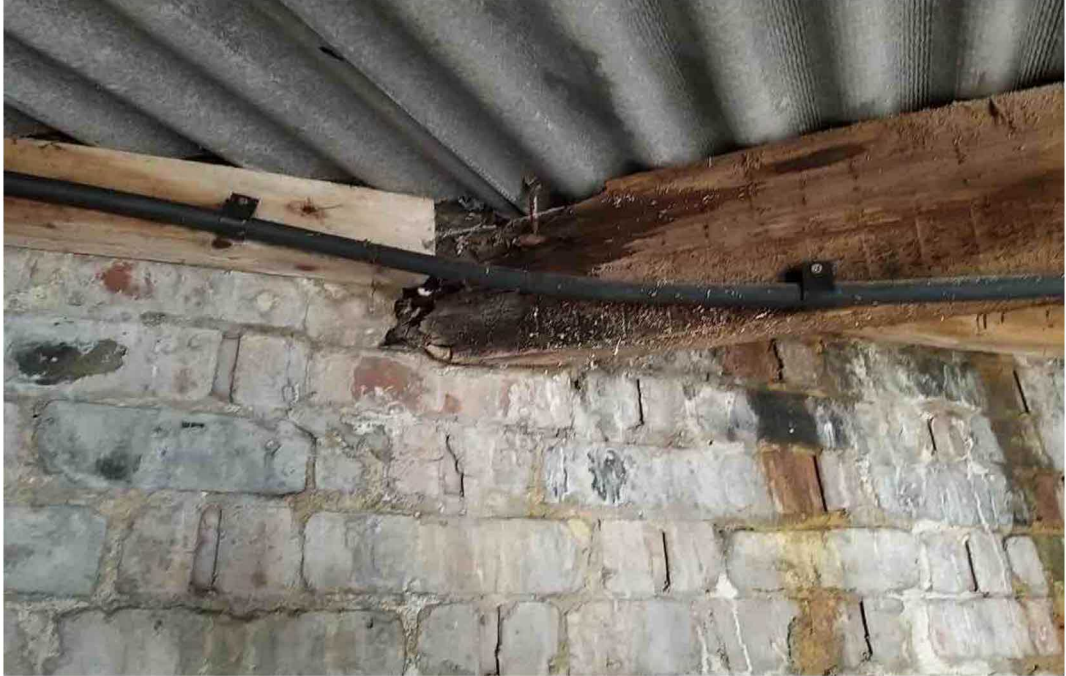
36. Interior of unit 14 showing damp staining, failing render and leaking compressor.

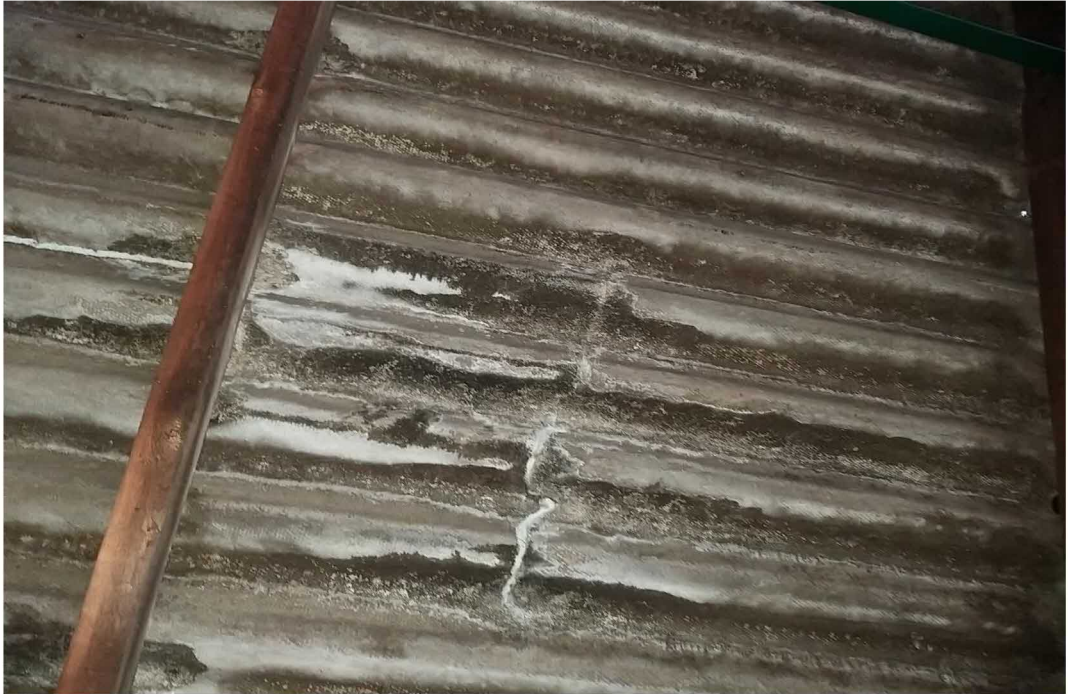
38. View within unit by office looking north, with unit 14 the other side of the end wall.

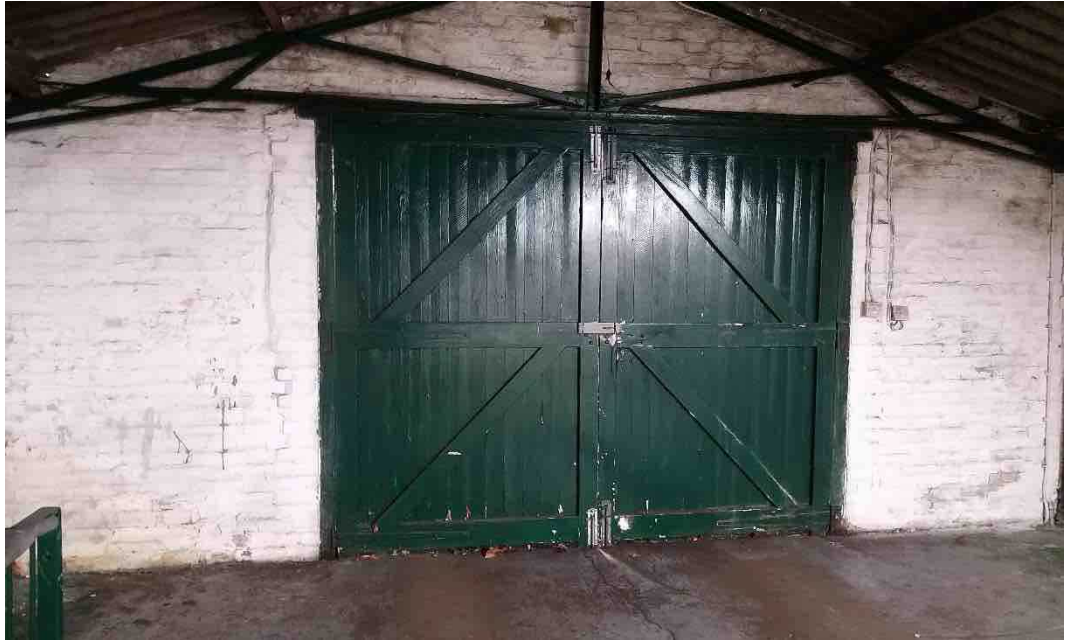
40. Cracking between front wall and side wall to unit by office, evident to both corners.

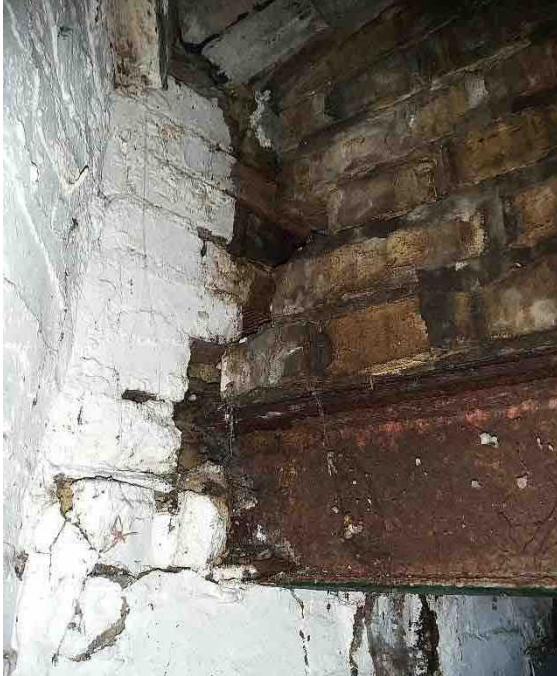
42. Water ingress, timber decay to east wall to unit by office due to failed parapet gutter.

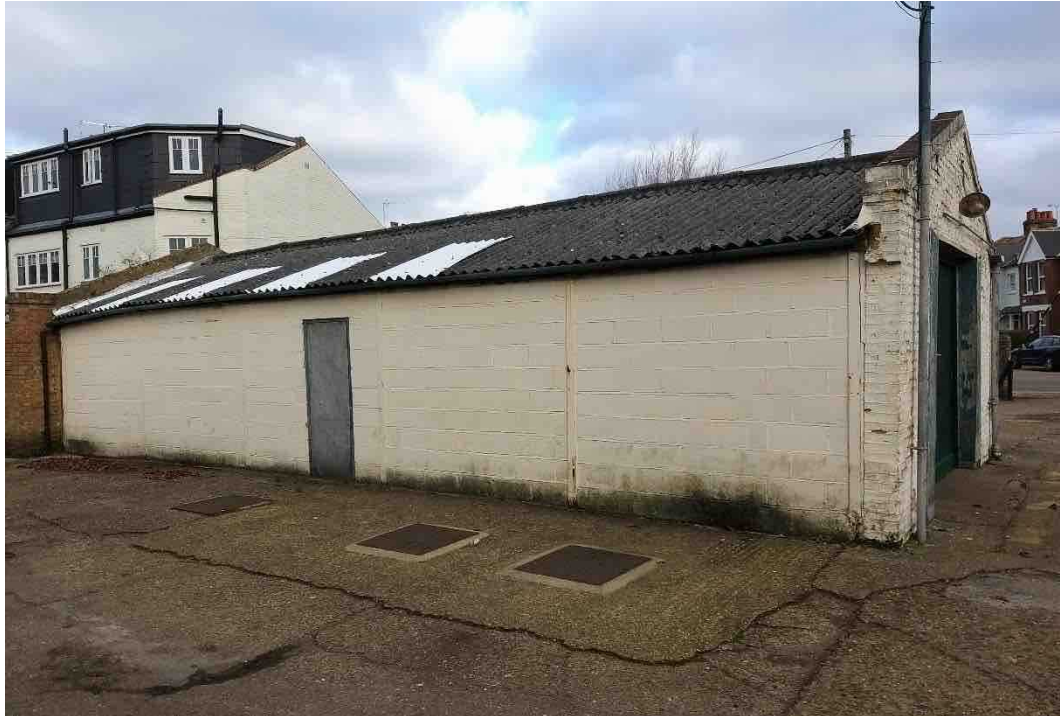
44. Leaning front wall to unit by office, with failing mortar joints evident across its area.

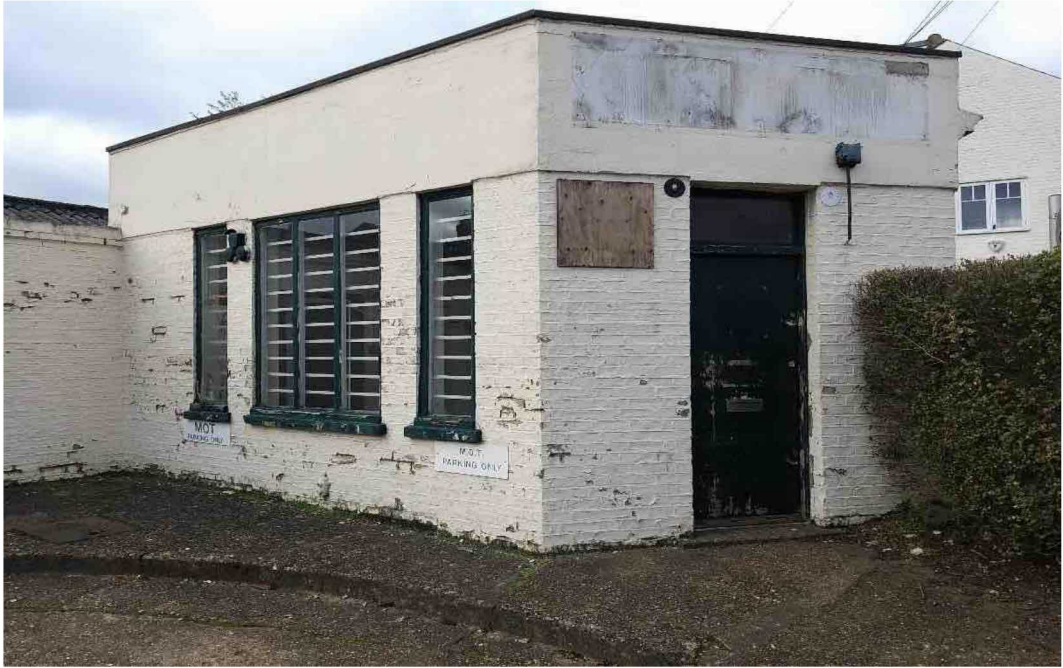
46. Damp ingress to rear (north) wall of office at low level in corner and to chimney.

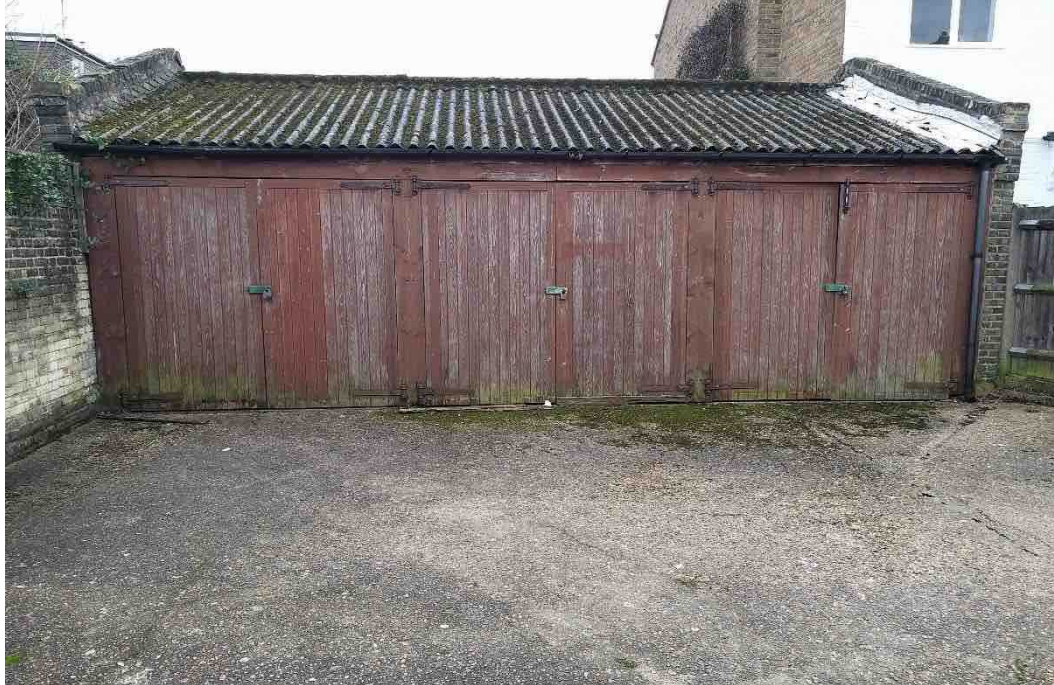
52. Rear wall of no.13 garden to between unit 6 to left and unit 13 to right.

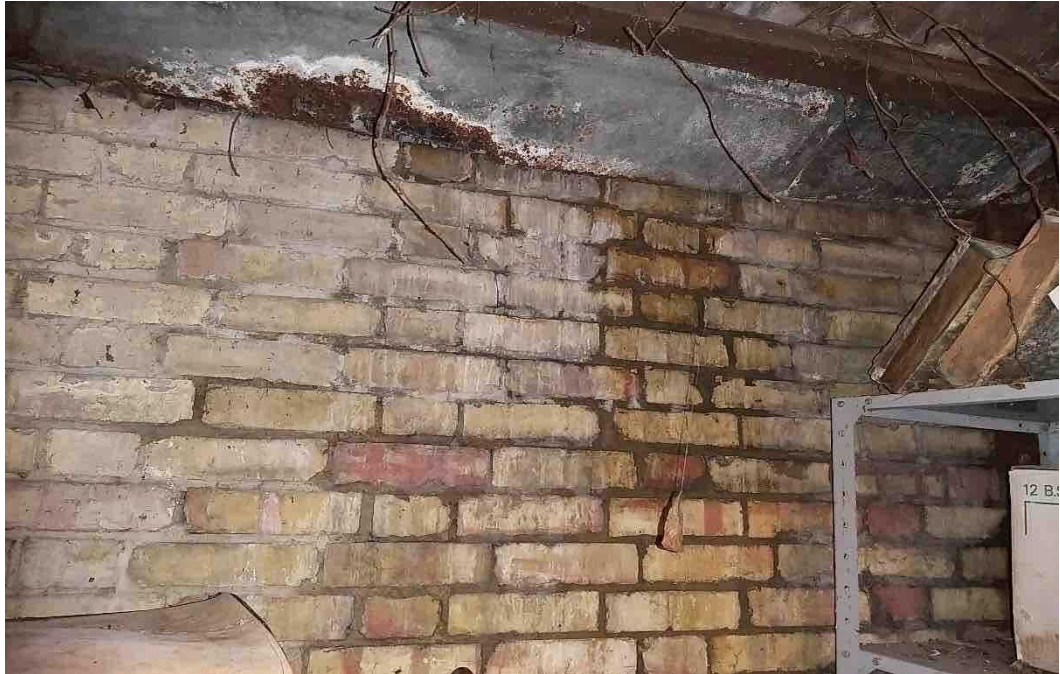
54. Failed steel frame connection to rear right hand (south west) corner of unit 11.

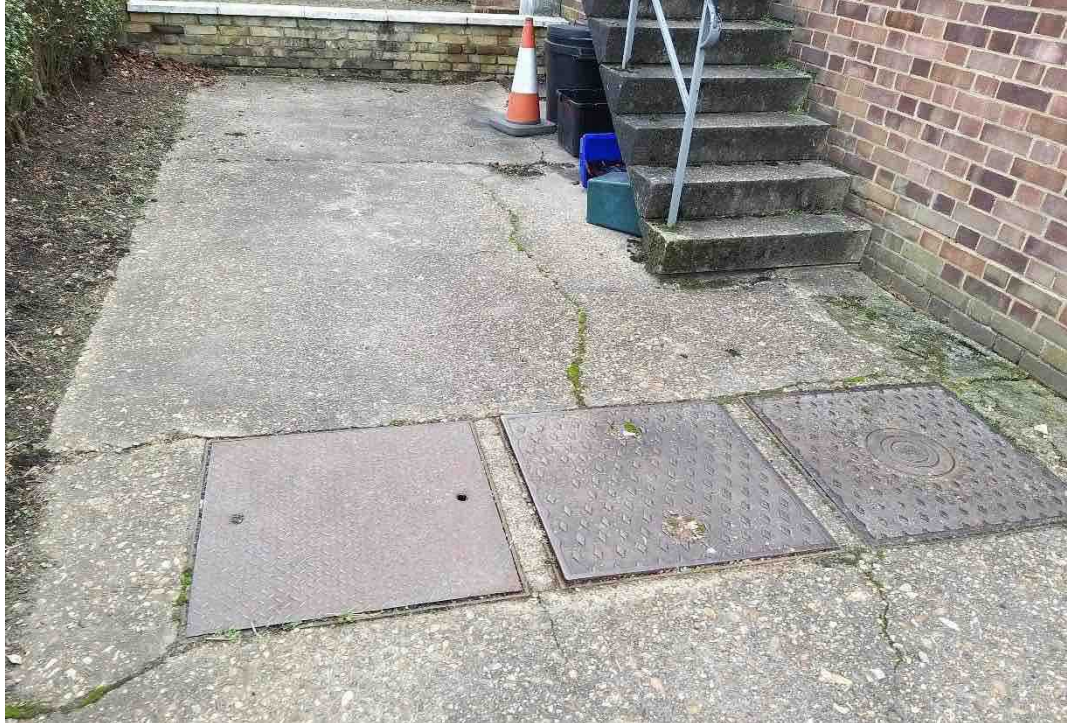
62. Cracked concrete surfacing to southern courtyard.

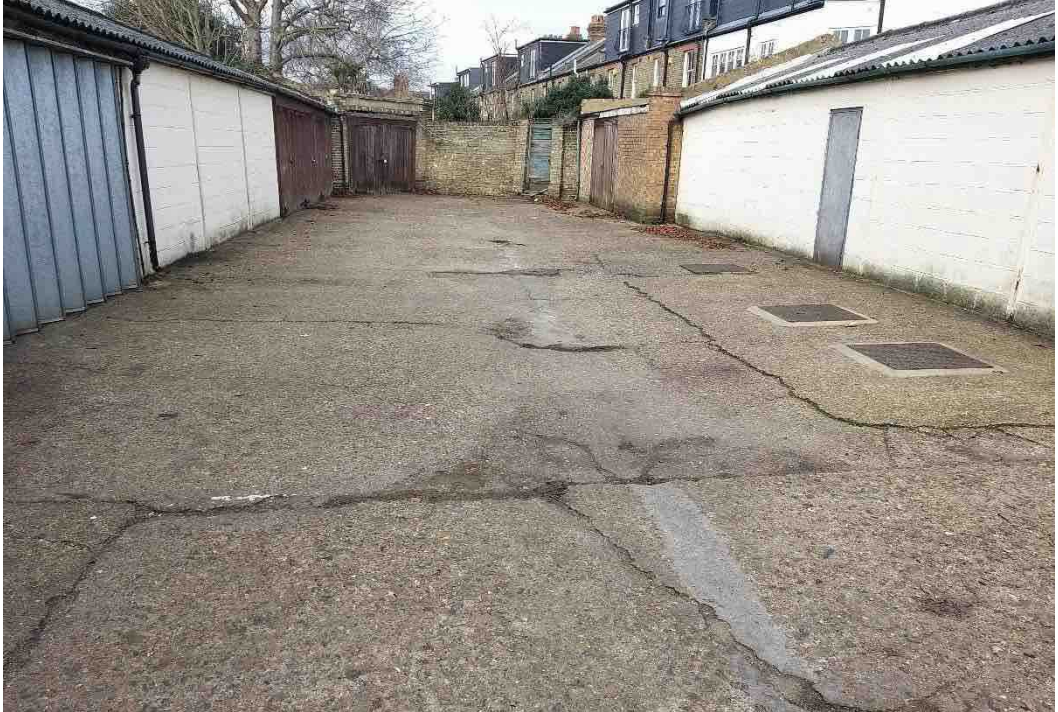
64. Leaning brickwork wall to north boundary between units 1 and 14.

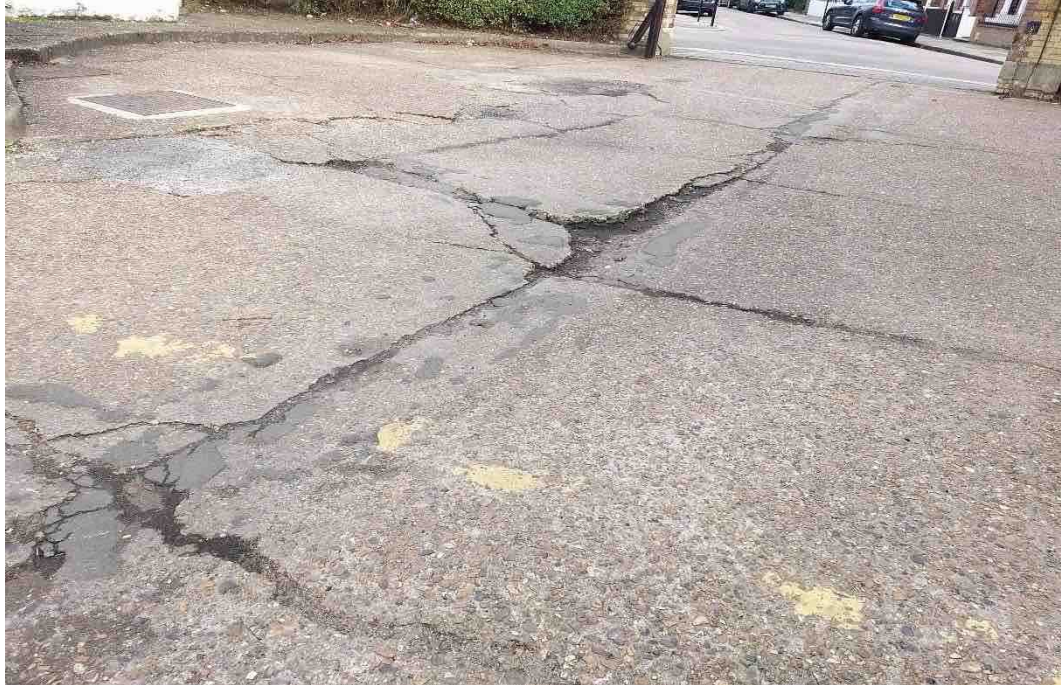
65. Heavily cracked, pitted concrete in front of office, with probable petrol tanks beneath.
