Arboricultural Method Statement & Tree Survey Report (BS5837:2012)

Proposed Construction of a Swimming Pool Building at Barnes Home Guard, Richmond Park Road, East Sheen, London, SW18 8LA

July 2019
Revision A 07.08.19

Date of Report: 3 July 2019
Report Reference: A4018 Revision A (07.08.19)
Issued by: MJB
Checked by: GM

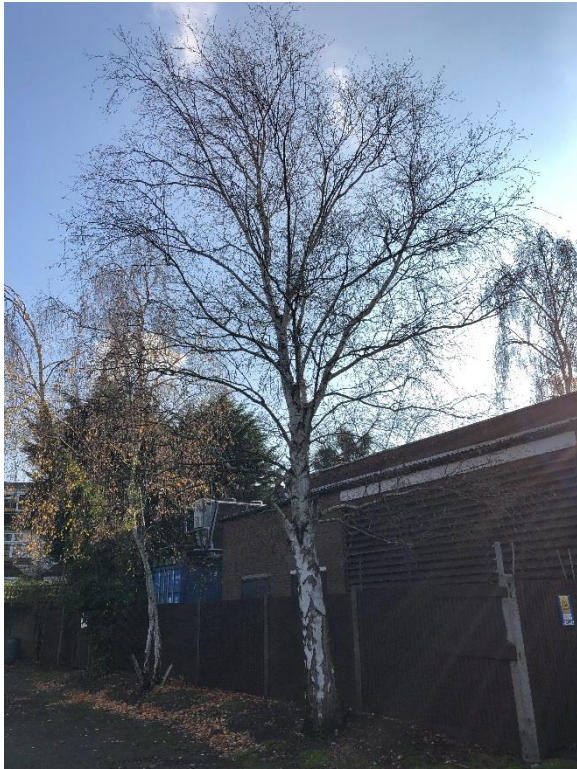
Based on the current proposed extension plans, no trees included in the survey will require removal to facilitate the work. However, the single silver birch tree (T1) of limited quality is proposed for removal. Some pruning of branches of the yew tree (T2) within the rear garden of an adjacent property will need to be cut back to prevent conflict with the new pool building.

Photo 1 - View of the Silver Birch (T1)

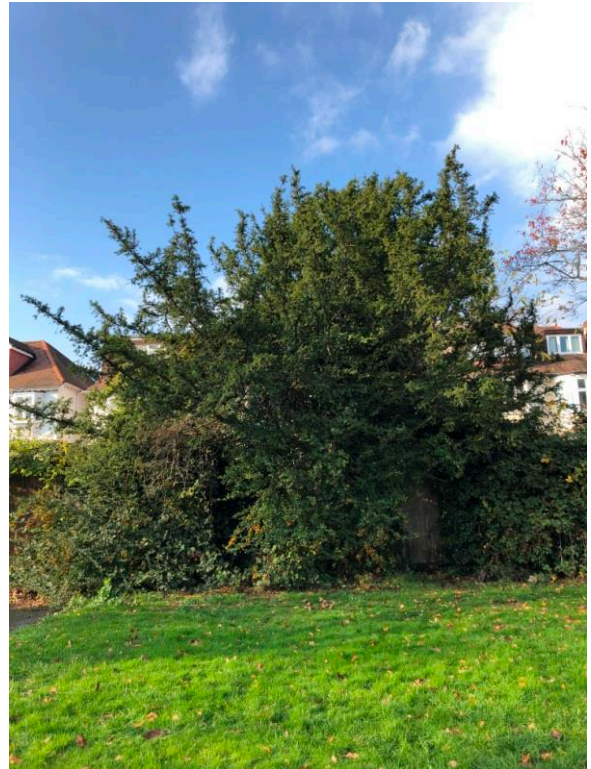
- 5.4 The footprint of the new pool and building encroaches into the RPA of T2 by 25% and T3 by 13%. BS5837:2012 states an encroachment of no more than 25% into the RPA should not be detrimental to the long term survival of the tree.

Photo 2 – View of the Yew Tree (T2) that is located off-site.

6.5 It is noted that the canopy from T2 and T3 may come in contact with the proposed roof which overhangs the building by a maximum of 300mm, therefore pruning of the

branches of the two trees is recommended prior to the construction works, in order to prevent contact between the trees and roof. In addition, T2 is also recommended for a crown lift to prevent contact with the roof of the building.

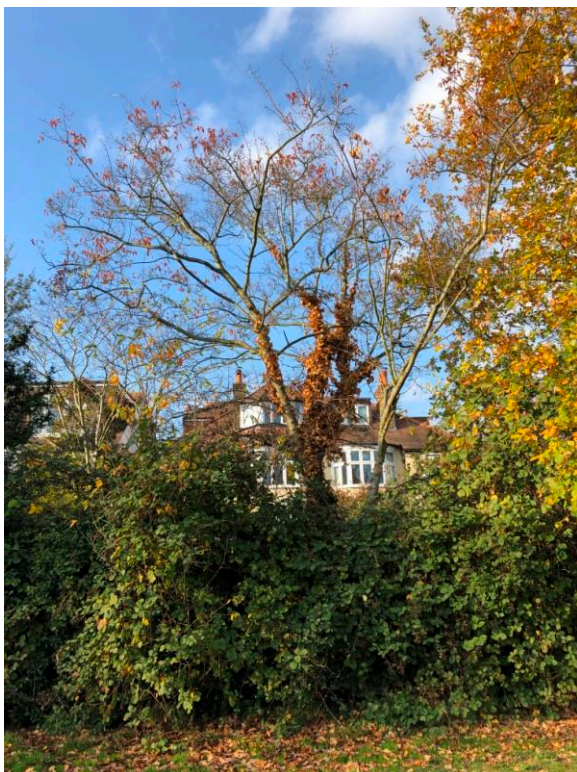
Photo 3 – View of T3, a Beech tree that is located off site.

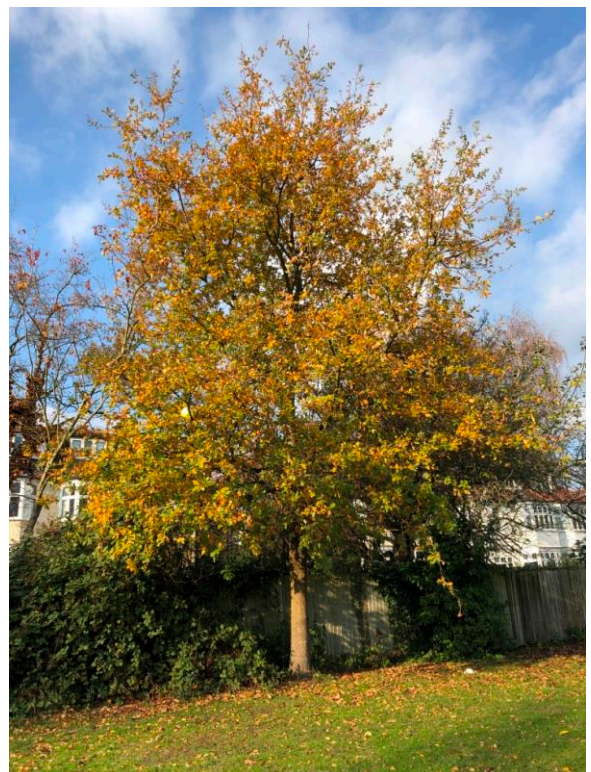
4.3 3 of these have been classified as category C2 i.e. trees of low quality. The fourth tree (English Oak, T4) has been categorised as B2 i.e. tree of moderate quality. There were no category U trees, i.e. trees which are dead, dying or with serious defects. There were no category A trees, ie high quality of particular visual importance.

Photo 4 – View of the category B English Oak (T4)
