Arboricultural Impact Integration Assessment Report: 58 Rosemont Road, Richmond, TW10 6QL

Report Date: 28th May 2024

Ref: WCEL/PEW/AIAR/0528:24

Arboricultural Report

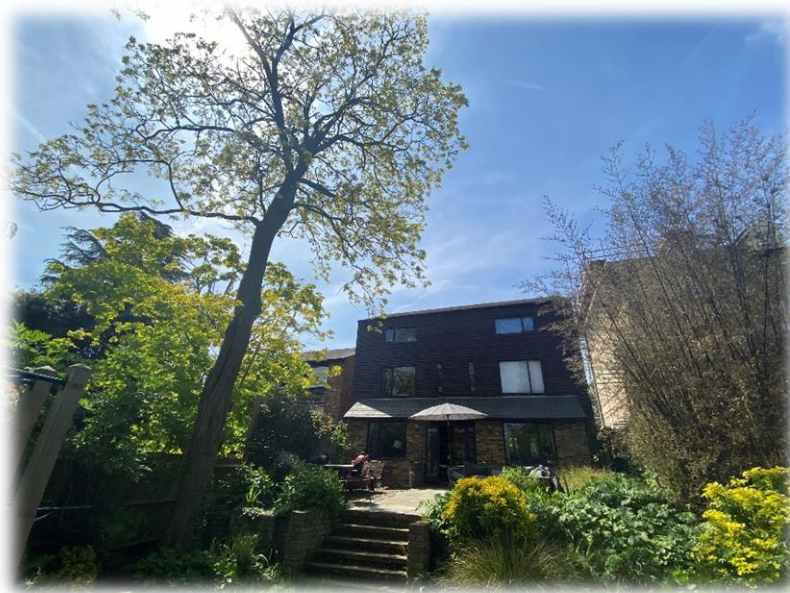
False Acacia (T1) Left Foreground in Rear Garden of Site &
Cappadocicum Maple (T2) Left Background in Neighbouring Rear Garden

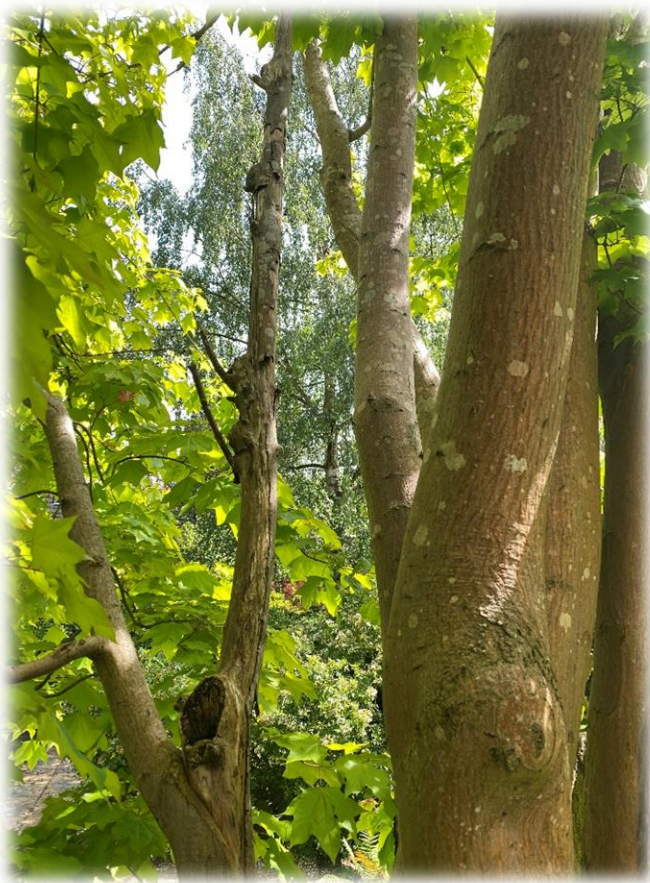
- 3.4 Both trees (T1&T2) have decay pockets or dead/disfunction surface roots and scaffold stub limbs which are, or can become, biomechanical weak points, these need to be monitored, just as a matter of good practice.

Maple (T2) Large Deadwood Trunk Stubs with Decay

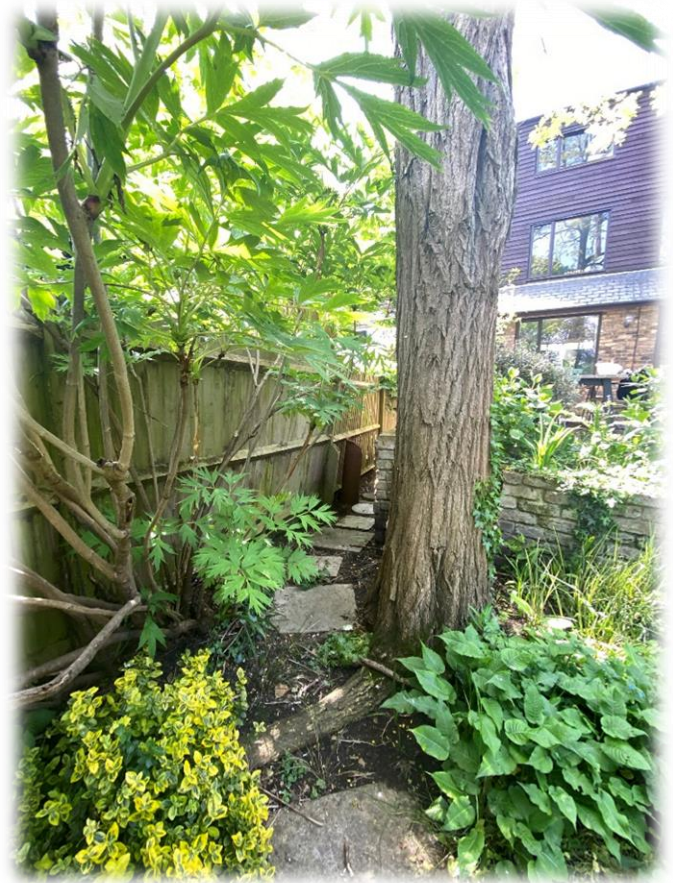
False Acacia (T1) Mature Surface Root with Upper Surface Damage and Decay

- ☛ No significant pruning of the tree is required for the proposed development works assessed as part of this report. The damaged surface roots are proposed to be protected as part of this assessment, but it is advised they should be monitored regularly in the future regardless of the development. However, the tree is of moderate amenity and will be protected throughout the development process.
