**Tree Survey and Arboricultural Impact Assessment
In Accordance with BS 5837:2012**

| Project No. 10872 | Avalon House, 72 Lower Mortlake Road, Richmond, TW9 2JY | | |
| Applicant: | | Barings Real Estate | |
| Date of Report: | 22nd May 2024 | Revision: | Original |

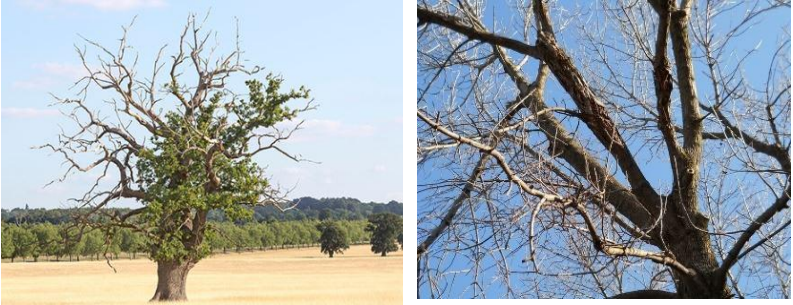
| Symptoms/damage type and cause: | This relates to dead branches in the crown of the tree. In most cases, this is caused by the natural ageing process of the tree or shading due to its close proximity to neighbouring trees. However, in some situations, it may be related to fungal, bacterial or viral infection. |
| Consequence: | Depending upon the location and mass of dead wood removal of the affected tissue may be necessary to prevent harm to persons or property as the wood will become unstable as it decays and in some circumstances is likely to fall from the tree with little or no warning. |

| Control: | Detailed monitoring should be undertaken on those trees showing signs of excessive deadwood production to identify the underlying cause. |

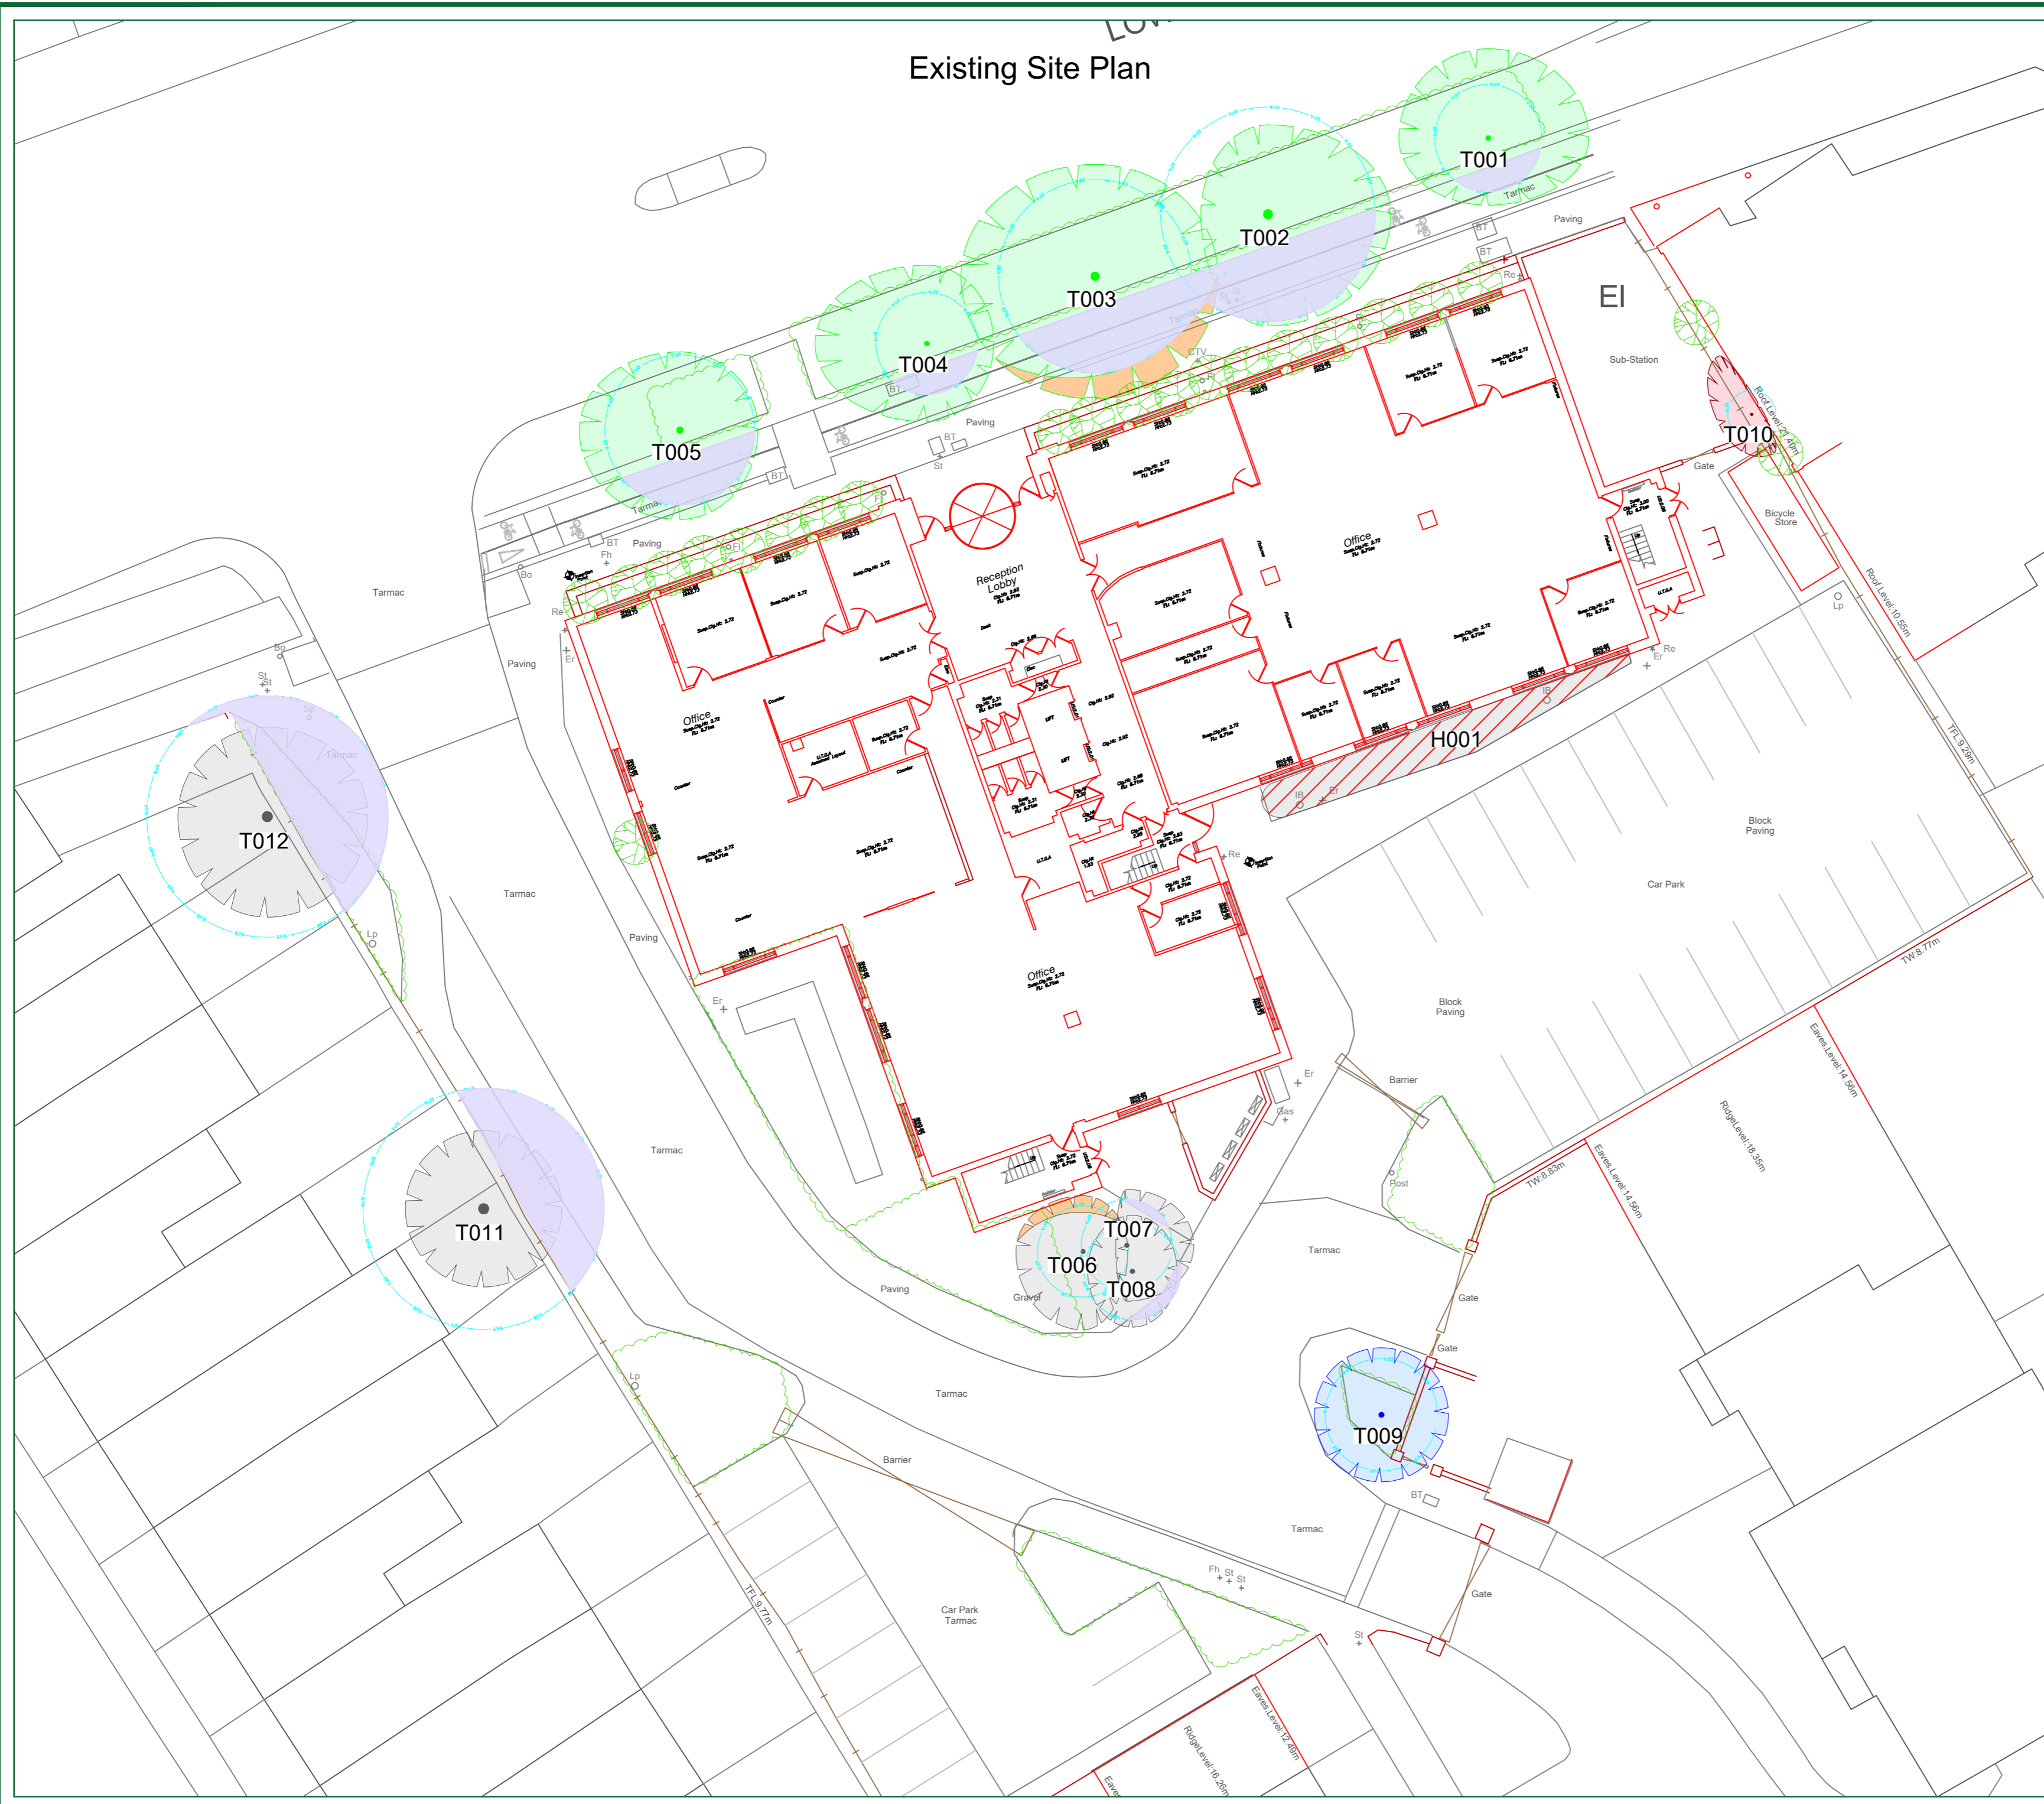
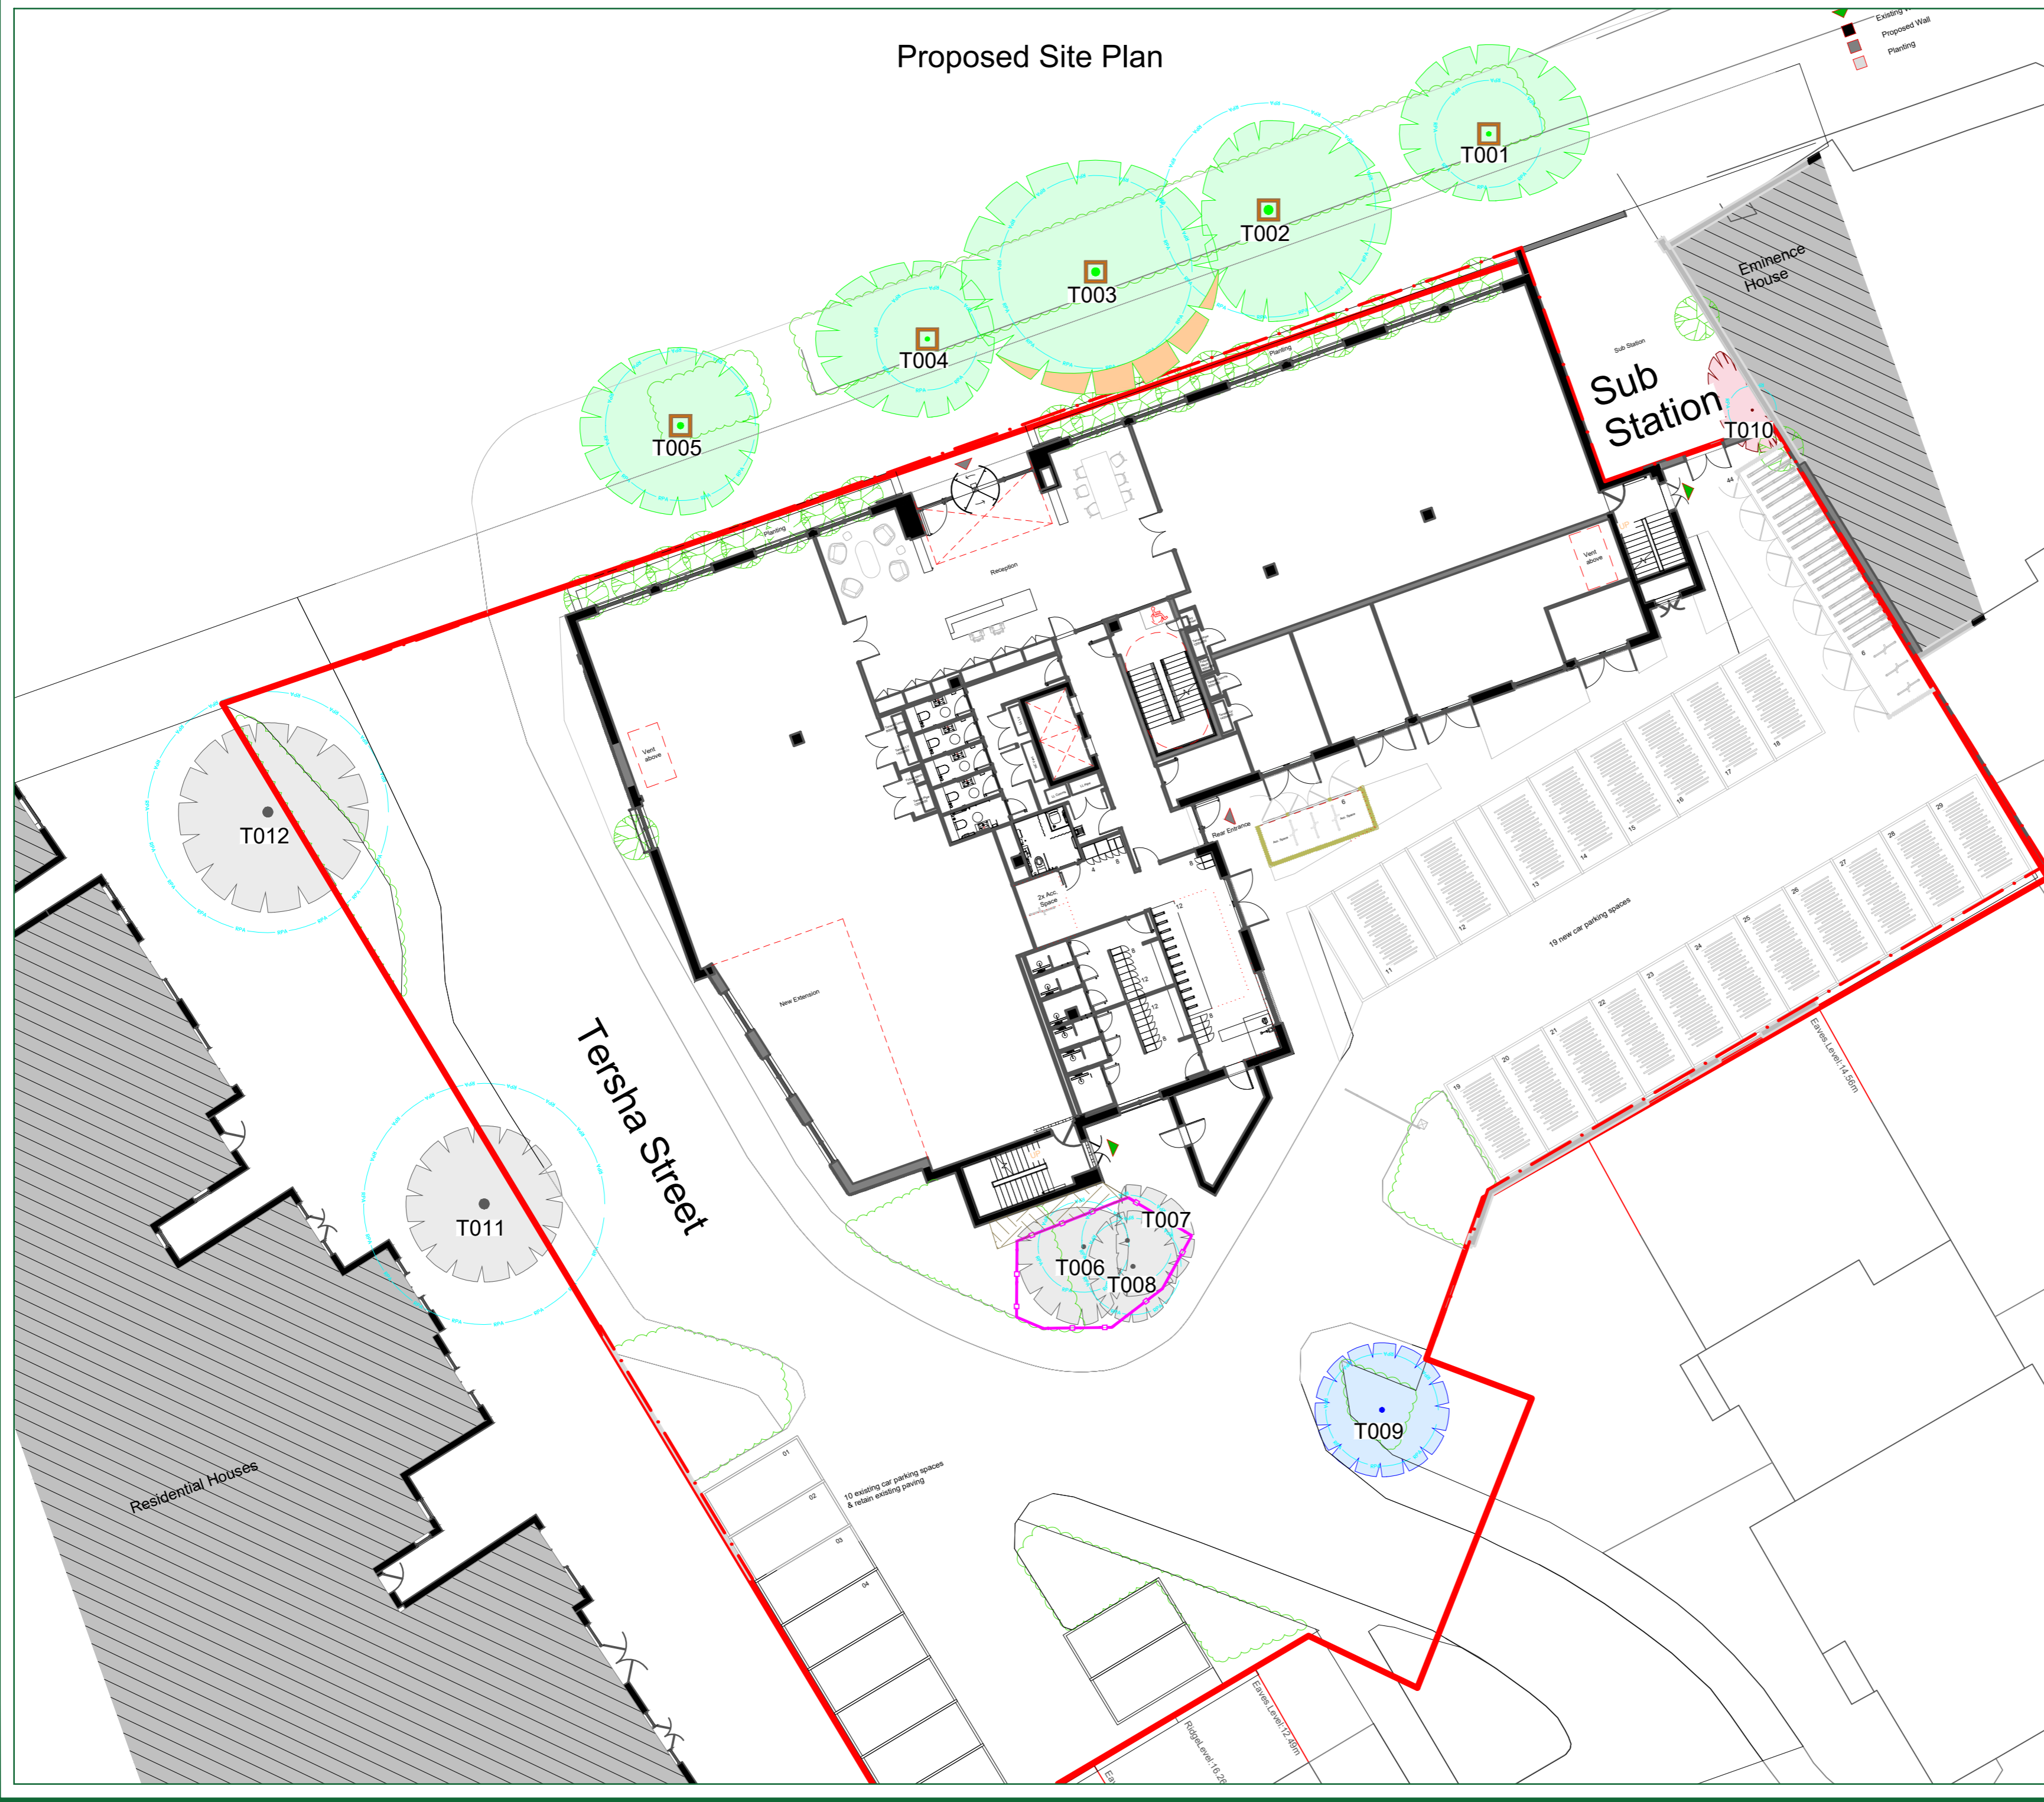
Client: Icen Planning Drawing Title: Prelim AIA

| Feature No | Surgery or Fell | Reason for Works | BS Category |
|---|---|---|---|
| T003 | Tip back crown on southern aspect by 1.5m, as shown on drawing no. 10872-D-AIA. | To facilitate installation of scaffolding. | A |
| T006 | Tip back crown on northern aspect by 1.5m, as shown on drawing no. 10872-D-AIA. | To facilitate installation of scaffolding and construction of rear stairwell. | C |
