REEVES ARBORICULTURAL SERVICES

Site: St. Osmund's Catholic Primary School Church Road Barnes London SW13 9HQ

Inspection details: Aerial inspection of T001- Cedar of Lebanon

Date of inspection: 10.01.24

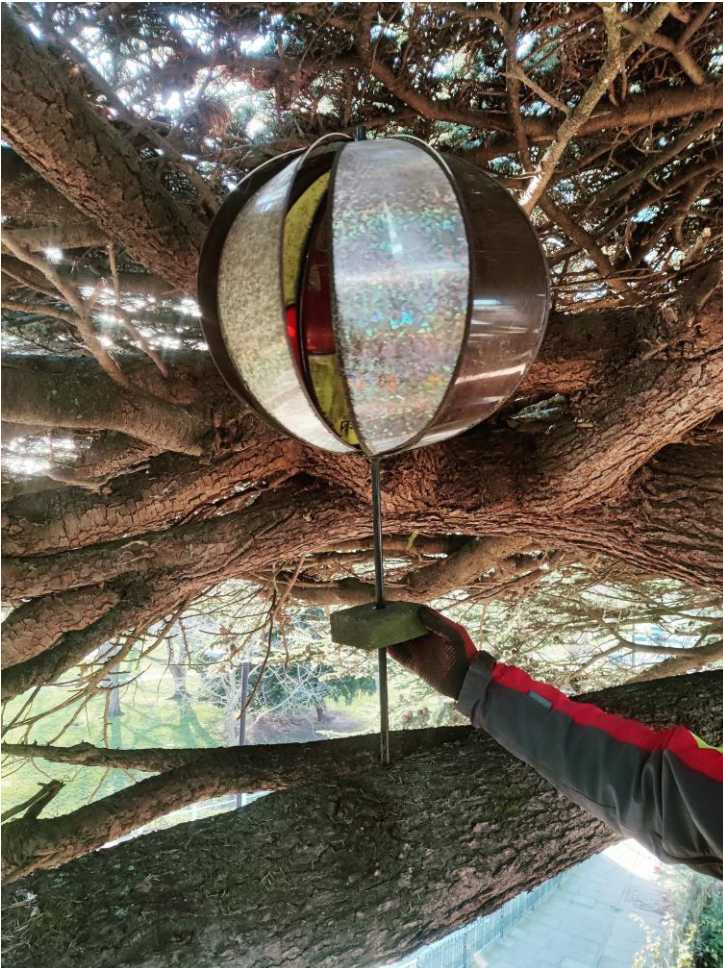
The previously installed bird scarer was secure in the tree. Reaction growth has engulfed the fixing point, and the connection was secure. Furthermore, on closer inspection it was noted that the materials of the item, are predominantly very lightweight plastic, almost film thickness. Therefore, there is very low risk associated with the bird scarer falling if it was to become less secure in the future. See picture 1.

Picture 1. Showing the secure bird scarer

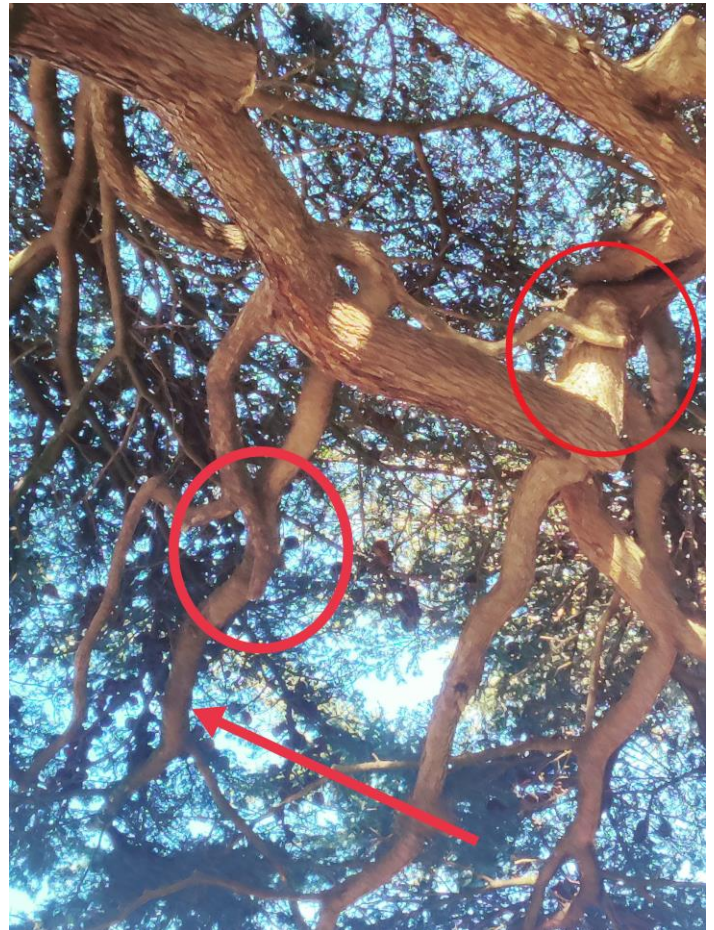
There were not many defects of note. One relatively small north heading branch was being partially supported by, or its movement limited by the deadwood stubs retained after the deadwood removal. However, this branch had been previously reduced and therefore was relatively limited both in wind exposure and weight. See picture 2.

Picture 2. A small branch partially supported by, or movement limited by remaining stubs in contact with other branches

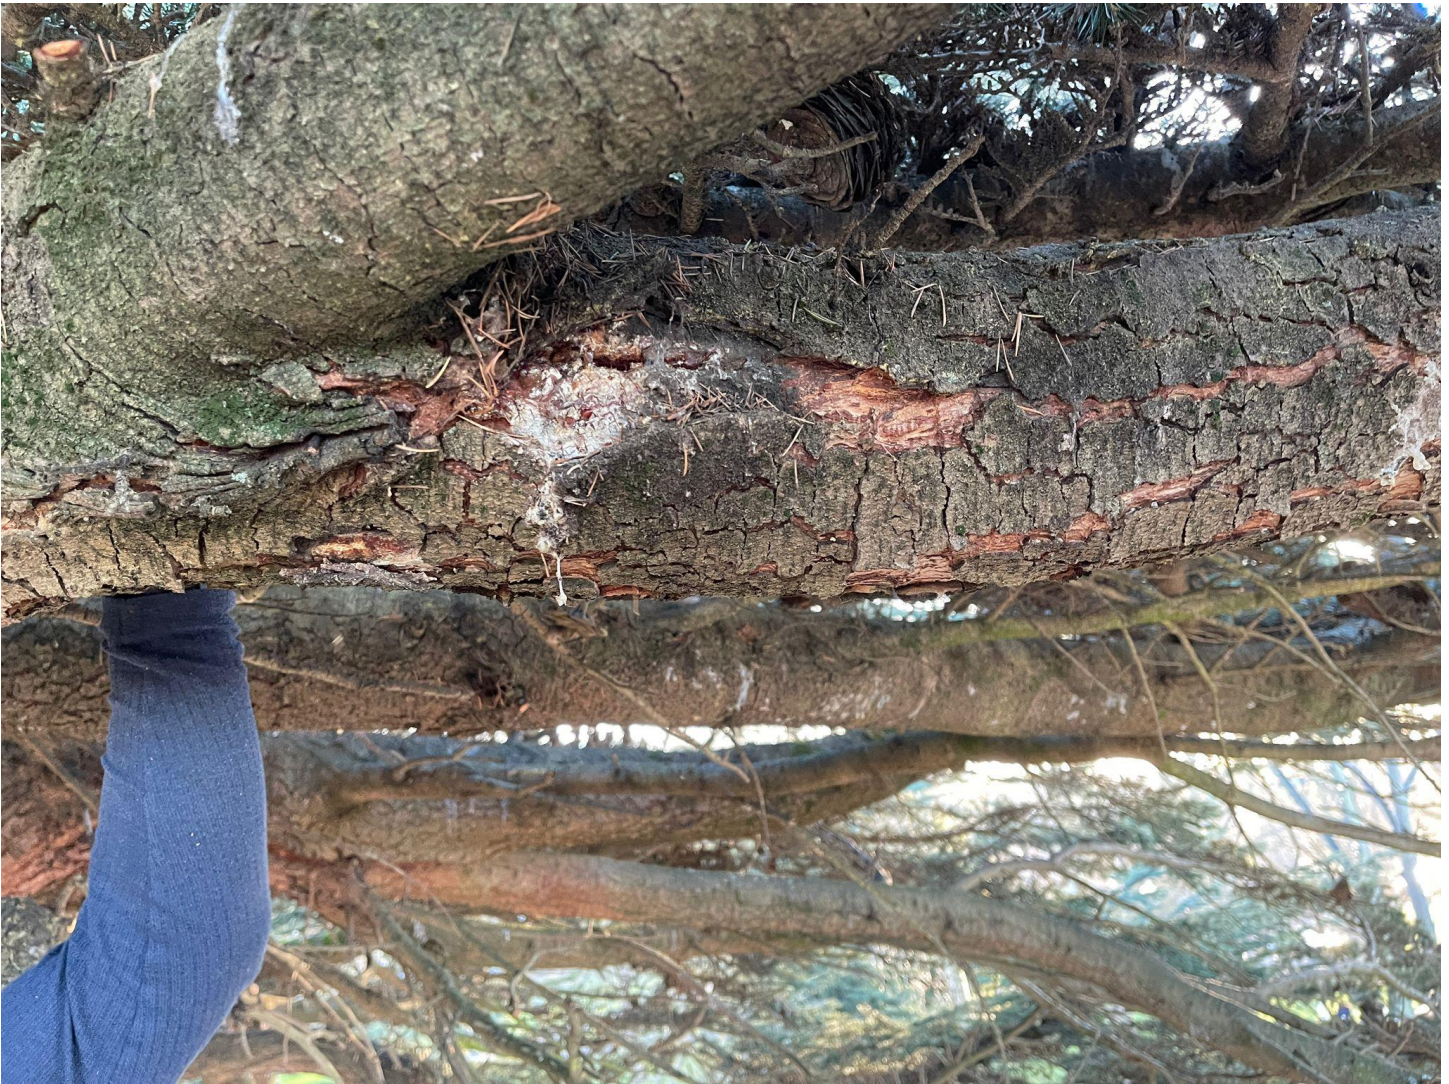
A small wound, potentially a historical longitudinal split or occluded longitudinal wound was evident on a NW heading branch in the inner N/NW canopy, which is not considered to be significant. See picture 3.

Picture 3. Showing a small wound, potentially a historical longitudinal split or occluded longitudinal wound

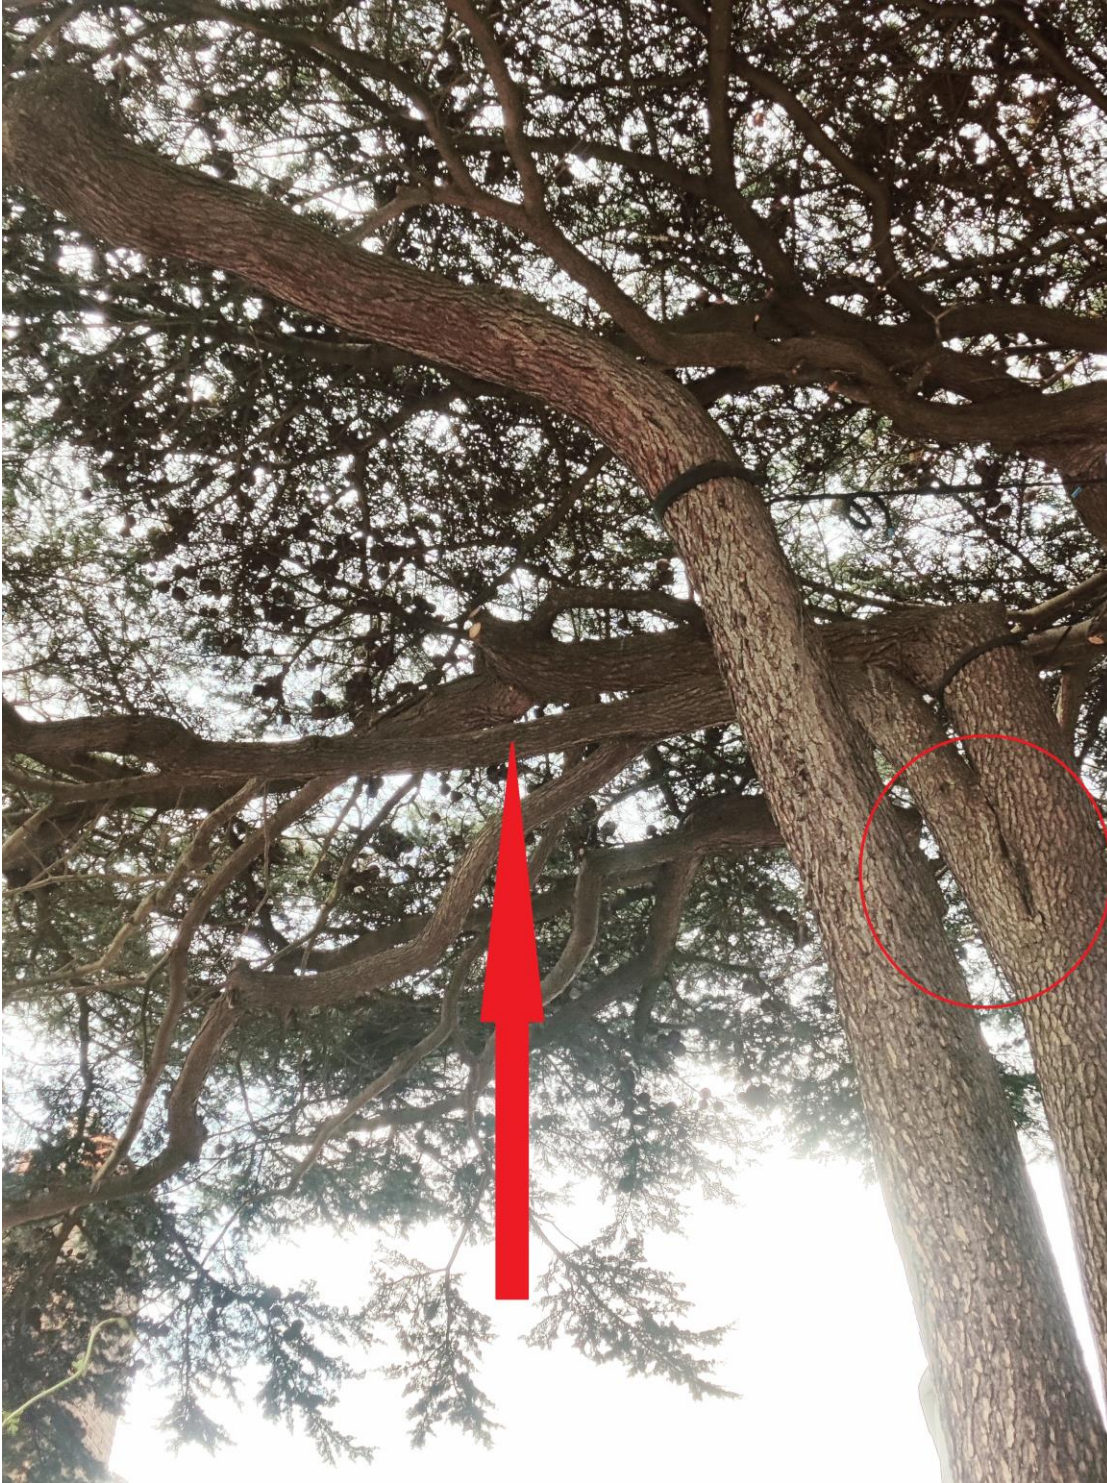
Picture 3. Showing a potentially weakened union and limb extending from this union.

The flexible bracing should be replaced, like for like with 4T Cobra® bracing, unless the stem diameter at the base of the stem to be braced requires 8T bracing. It should be located in as similar positions as possible as the existing bracing will have some impact on where the tree has put on reaction growth. In addition to the existing bracing, an additional section of bracing should be installed in the NW section of the canopy to provide some additional support beyond a potentially weakend union. See picture 4.
