PLANNING
PROJECT
8 Montpelier Row
Twickenham
TW1 2ND

DRAWING
PROPOSED PLAN REPAIRS: SHEET 2 OF 2
SECOND FLOOR & ROOF JOISTS

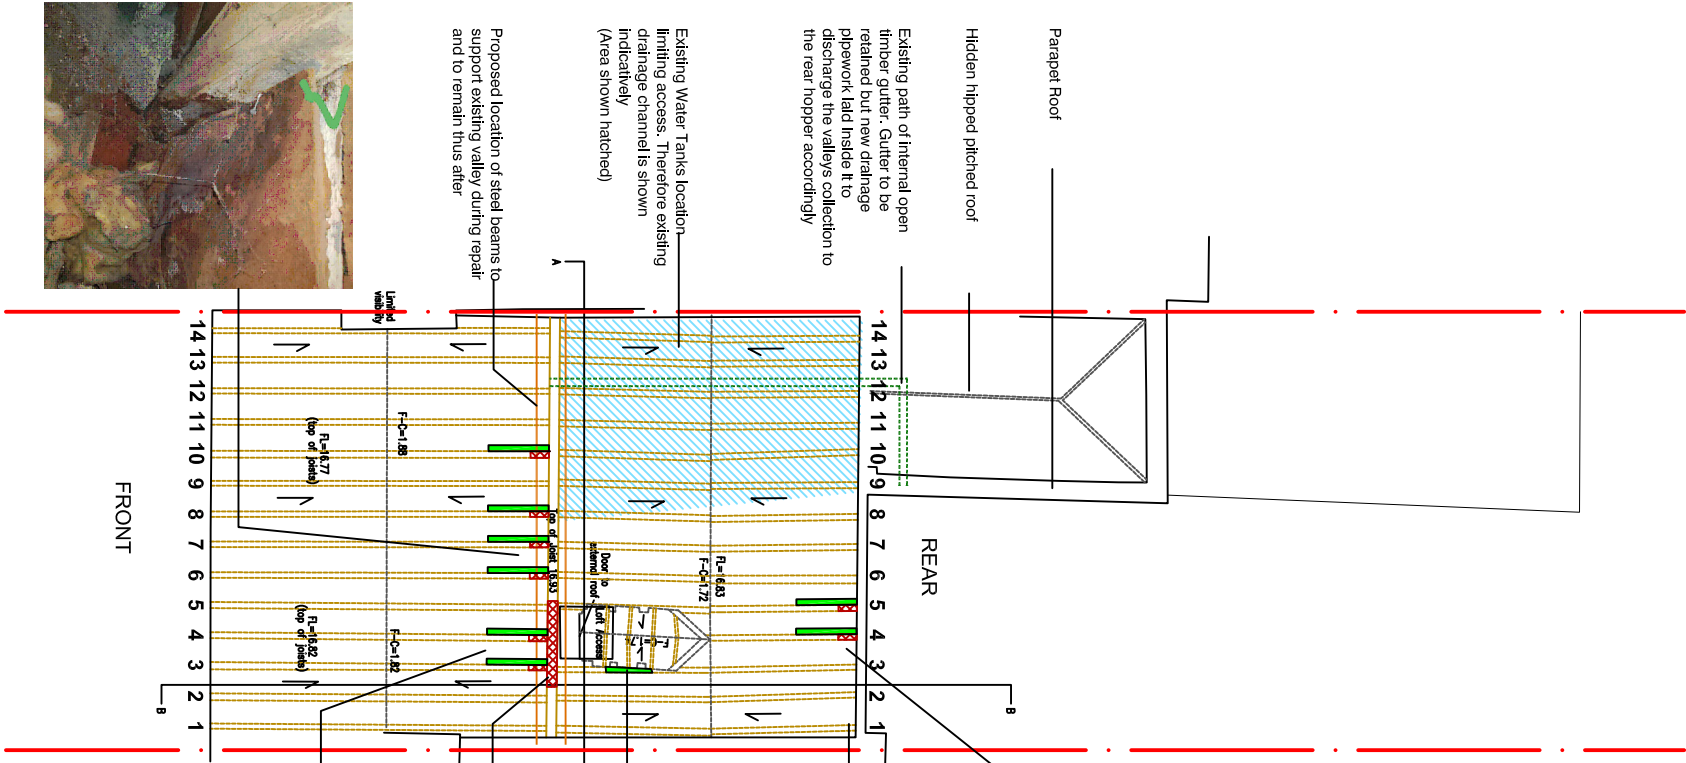
Proposed Roof Joist Plan
1:100@A3

Action required
Location of Parapet gutter causing water ingress and subsequent decay, ends of rafters providing minimal bearing. Localised spliced repairs required in accordance with survey

Action required
Localised spliced repairs required in accordance with survey

Immediate action required
Area of valley completely decayed, ends of rafters and ceiling joists currently providing zero bearing within red hatched area and minimal bearing elsewhere.

Existing path of internal open timber gutter. Gutter to be retained but new drainage pipework laid inside it to discharge the valley's collection to the rear hopper accordingly

Existing Water Tanks location limiting access. Therefore existing drainage channel is shown inductively (Area shown hatched)

Chimney treatment
To receive raking and repointing to all joints, following which all scalers and flashings to be renewed in code 4 leadwork in accordance with ISA guidelines

Proposed location of steel beams to support existing valley during repair and to remain thus after
