STRUCTURAL IMPACT ASSESSMENT

NORFOLK HOUSE, 8 MONTEPELIER ROW, TWICKENHAM TW1 2NQ PROPOSED ROOF REPAIRS

Job No: P1008
26th June 2024

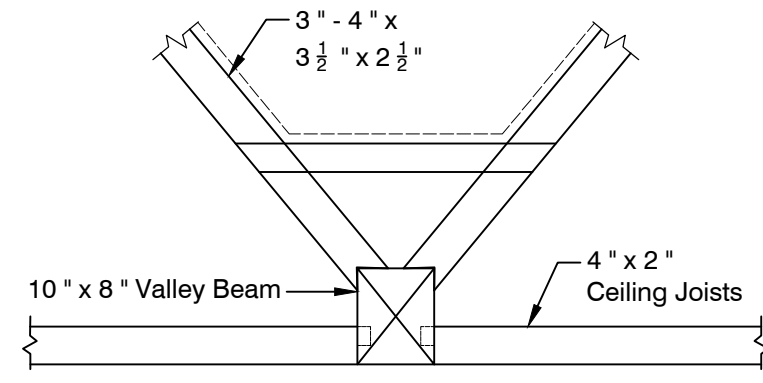
Section Through Valley Beam
(Scale 1:20)

- 4.5 **Valley Beam** - The original timber beam in on very poor condition with significant loss of section around midspan and the vicinity of the intermediate support post. A calculation check of the original condition indicates it would have been highly stressed from the time of construction and therefore should be replaced/strengthened/made redundant following a review of options available:

From a heritage standpoint we consider Option 3 to be the most favourable solution to provide suitable structural repairs sympathetic with the requirements for working on historic buildings.

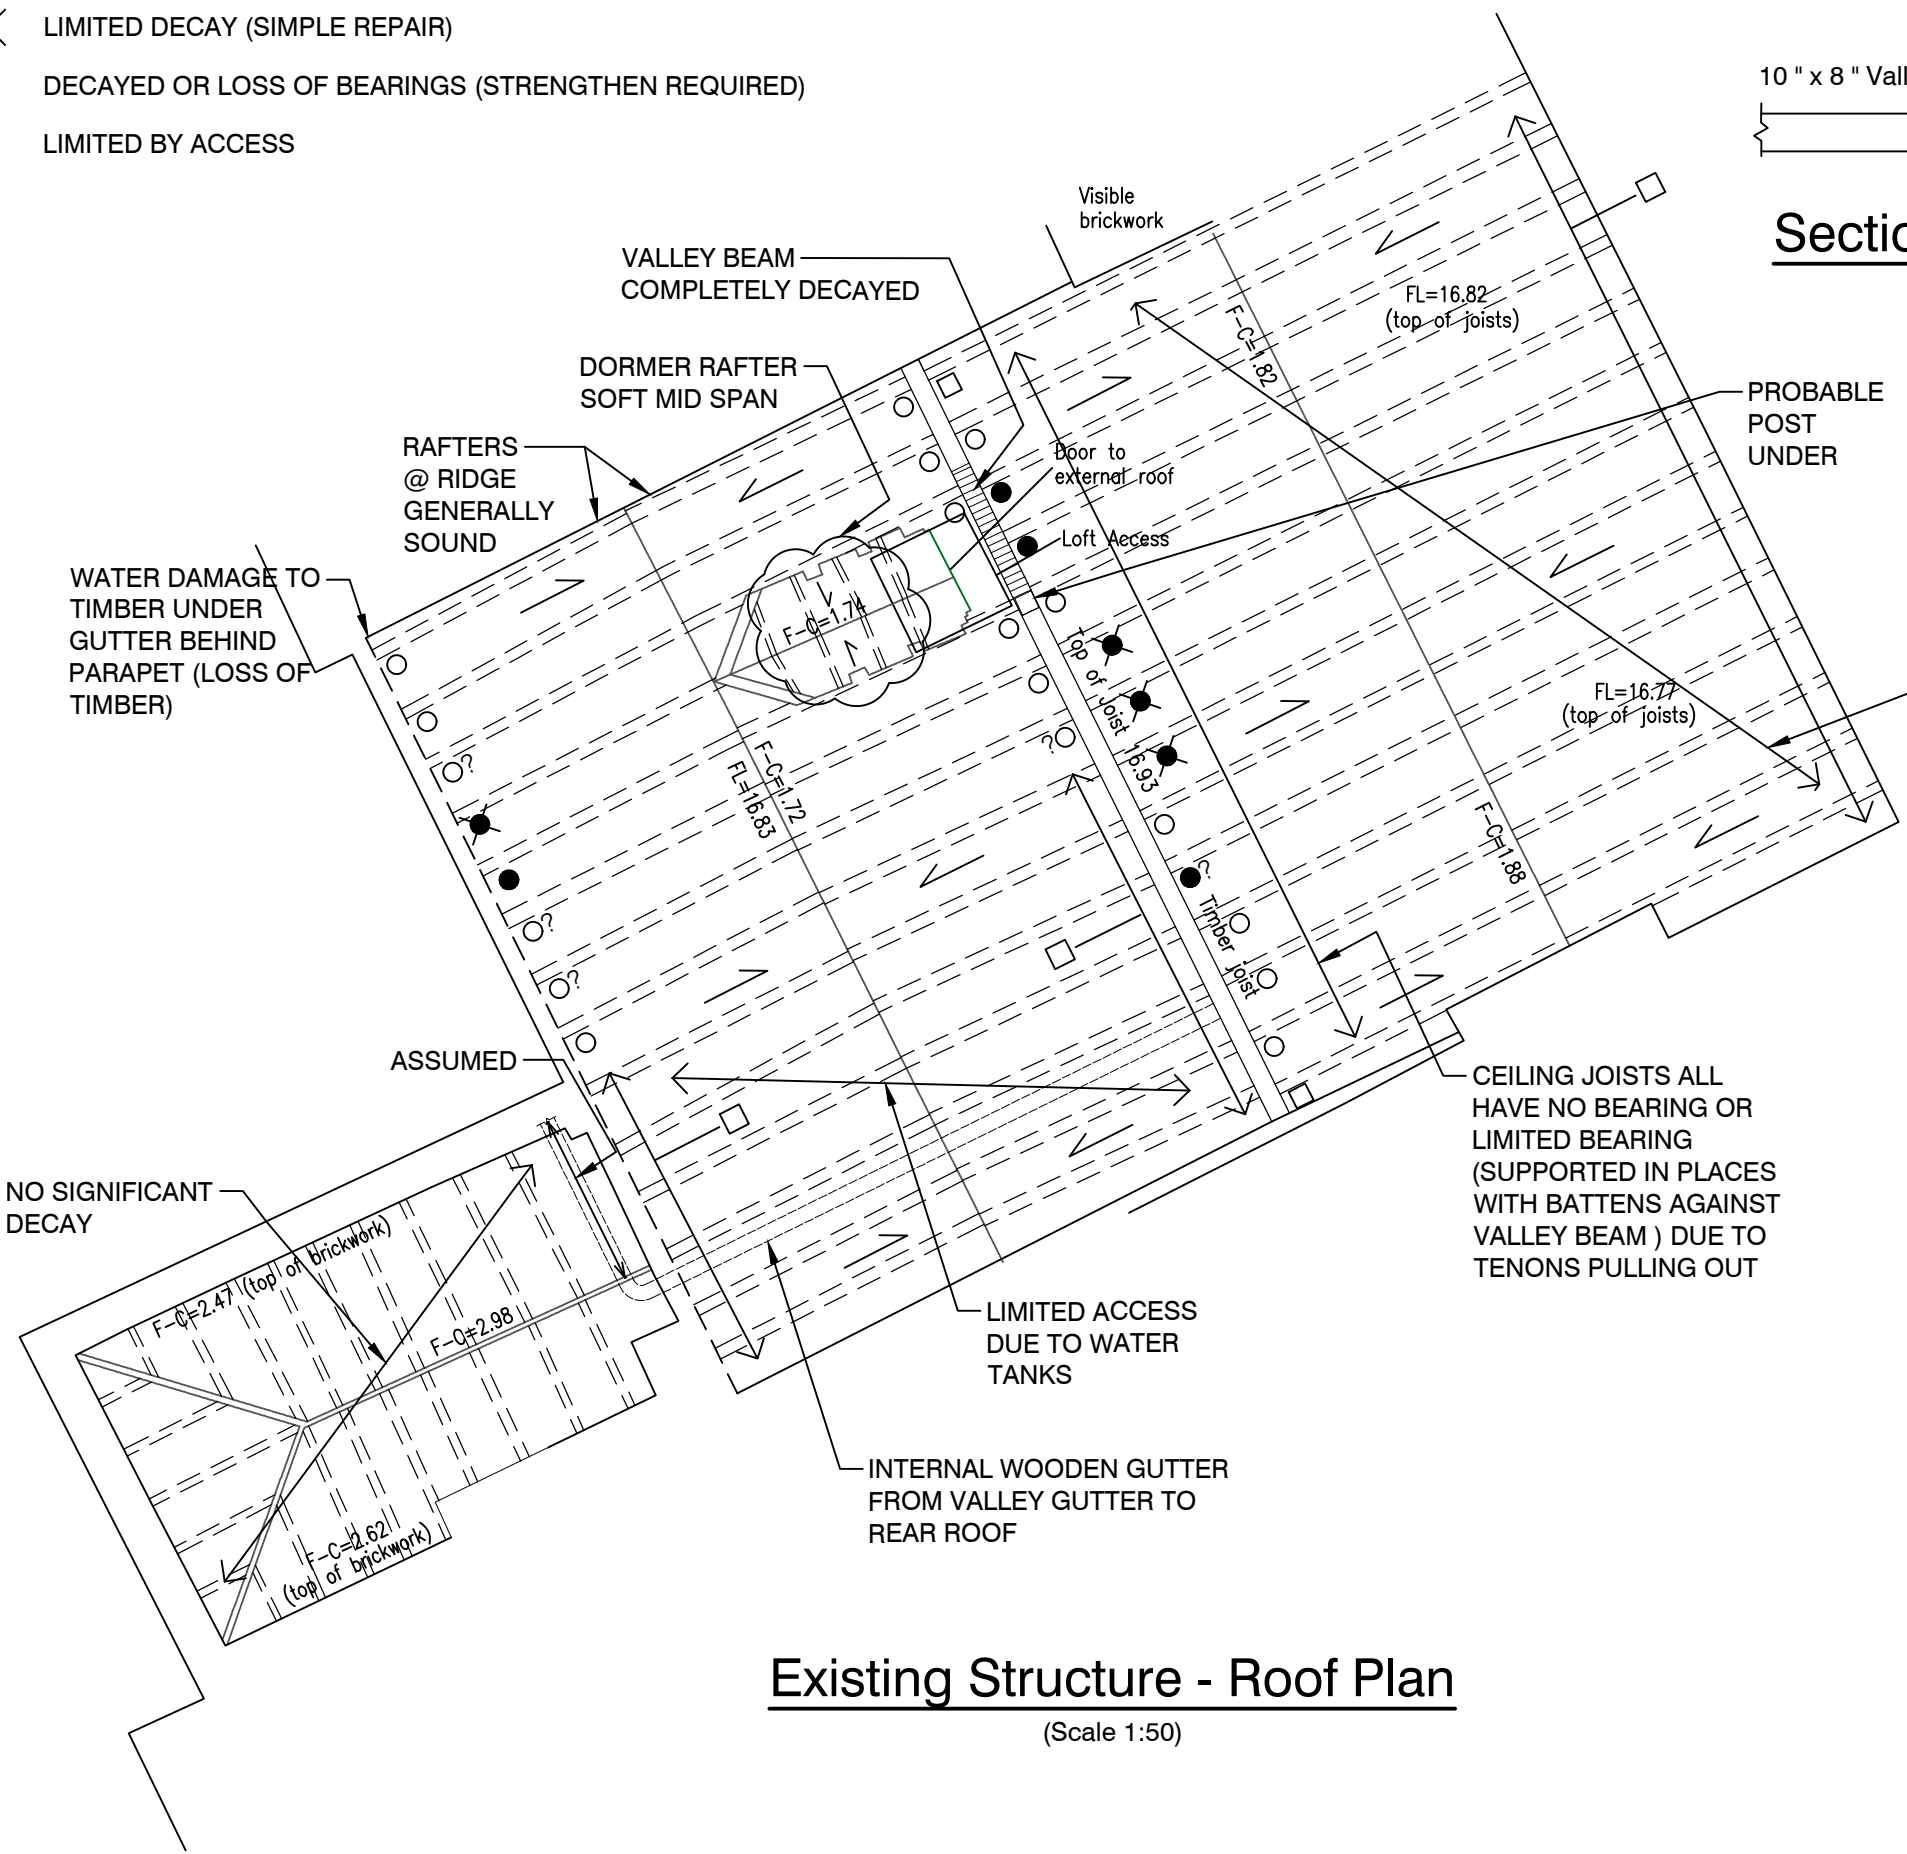
Existing Structure - Roof Plan
(Scale 1:50)

- 3.4 In summary, the main roof has the following structural areas of concern:
 - significant decay and loss of section to the central timber valley beam, particularly in the area of the dormer access/loft hatch, extending both sides of the intermediate support post

- Ceiling joists to one side of the valley beam pulled out (loss of bearing via tenon)
 - Ends of rafters at eaves with localised decay &/or loss of bearing

- Ends of ceiling joists at valley beam with localised decay
- 3.5 The Listed Building Timber Investigation [Appendix B] carried out by Tapco HomeDry identified areas within the roof where infestations of wood boring insects (woodworm) were found. In addition, wet rot was found affecting the box gutter timber wall plate and joist ends.

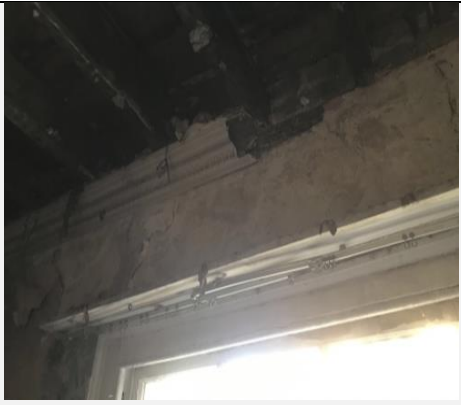
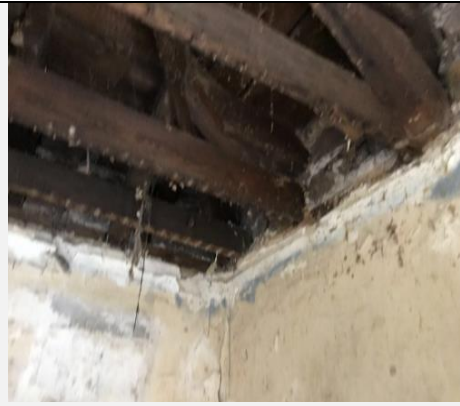
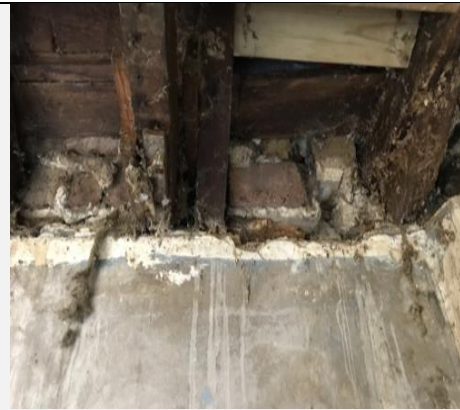
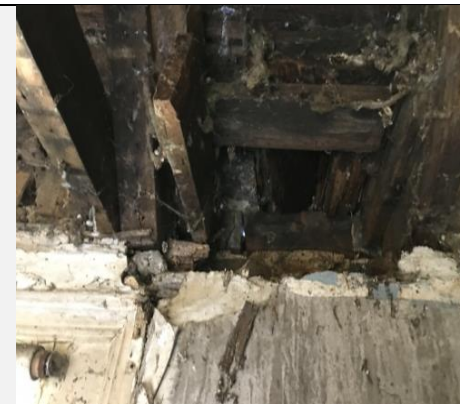
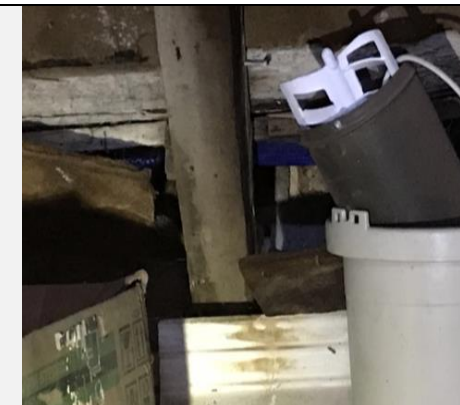
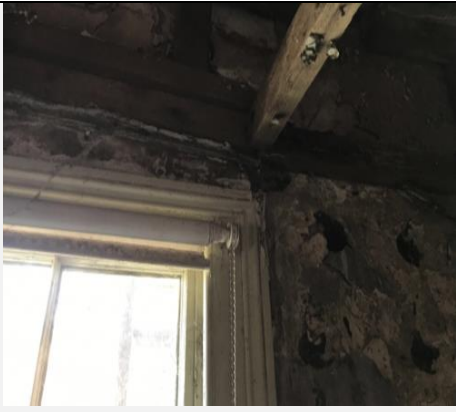
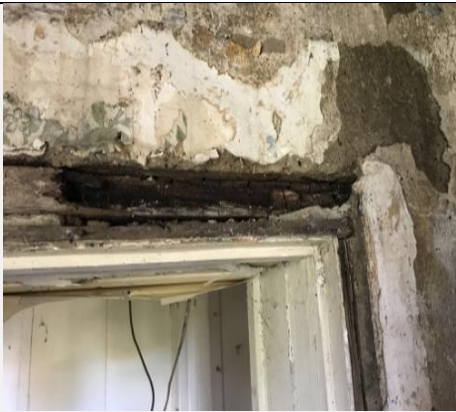
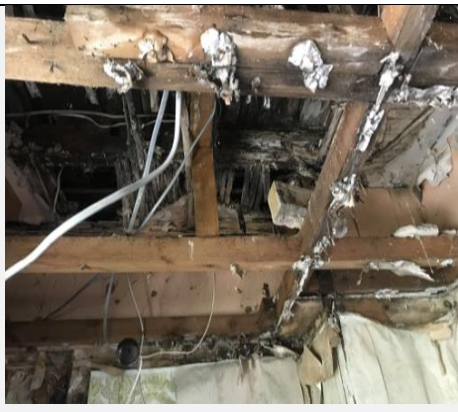
There is an attack of the **Wet-Rot Fungus (*Coniophora puteana*)** affecting the box gutter timber wall plate and joist ends. This could be due to defects with the roof coverings.

There is an attack of the **Wet-Rot Fungus (Coniophora puteana)** affecting the accessible floorboards, lintel over door and the subfloor timbers.

There is an attack of the **Wet-Rot Fungus (Coniophora puteana)** affecting the accessible floorboards to the rooms above. The weakened timbers are beyond treatment and need to be removed and replaced, using new pre-treated timber, in accordance with good building practice.

<p>Wet rot fungus to various areas of the property</p>

Our estimates are based on the treatment of the sound timbers only. All heavily affected timbers are to be renewed, using new pre-treated timber. by your own contractors
