PLANNING
PROJECT
8 Montpelier Row
Twickenham
TW1 2ND

DRAWING			
EXISTING ROOF SCHEMATIC			
SCALE	PAPER SIZE	DATE	DRAWN BY
1:50	A3	JUNE24	SH
DRAWING N ^o	REVISION		
24.02.270	00

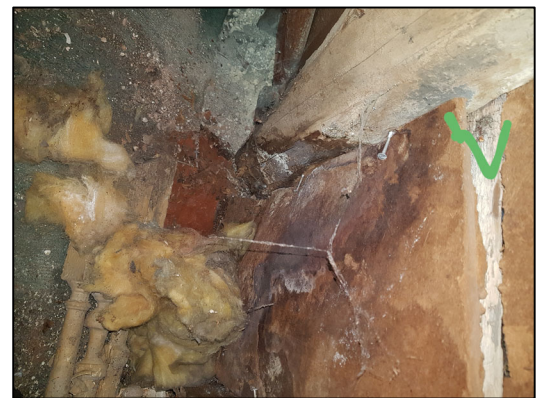
Picture taken in the roof void. Some of the bearing ends of the rafters are rotten/decayed and need to be supported.

- Rafters and joists. Rafters are joined at ridge with Mortice and Tenon Detail.
- Rafters (and beams) that are rotten or damaged
Rafters that are rotten, damaged will be repaired.
The same timber reclaimed, dating from a similar period will be used.
Reclaimed timber from 'antiquebuildings.co.uk'

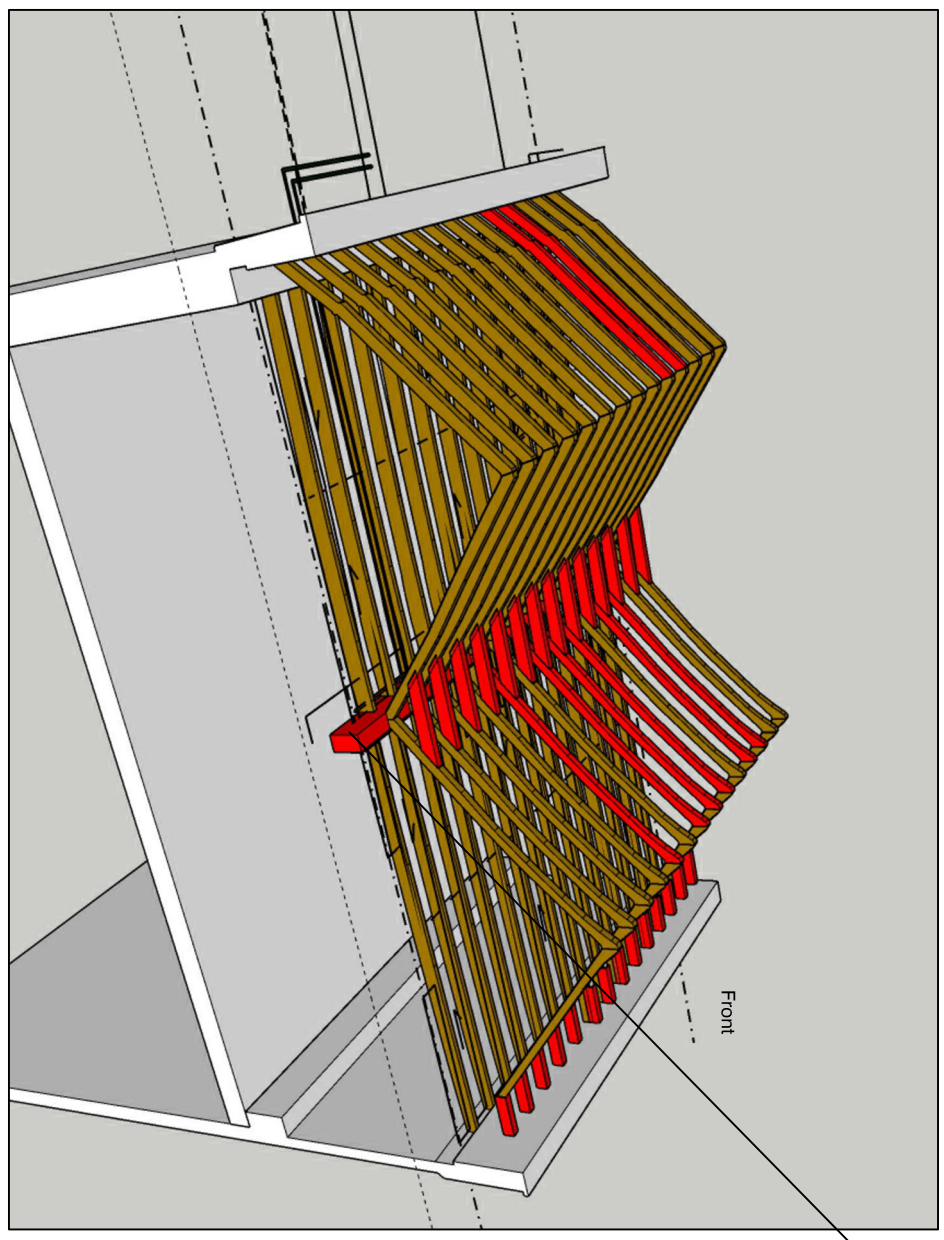
3D sketch showing existing joists and rafters (valley access dormer omitted here for clarity)
Red indicates poor condition of some timbers

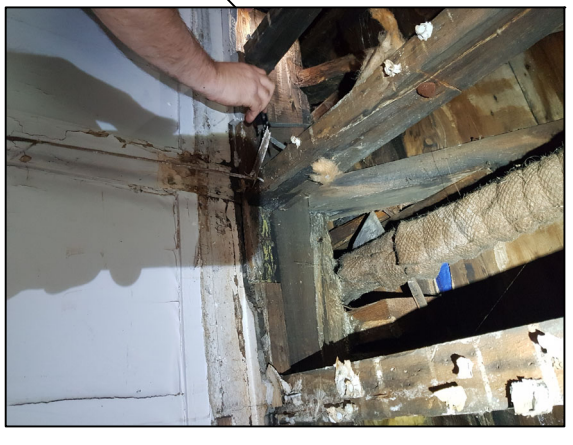
The valley beam is in very poor condition
