Condition Report

6 Waterloo Place, Richmond, TW9 1EB

May 2024

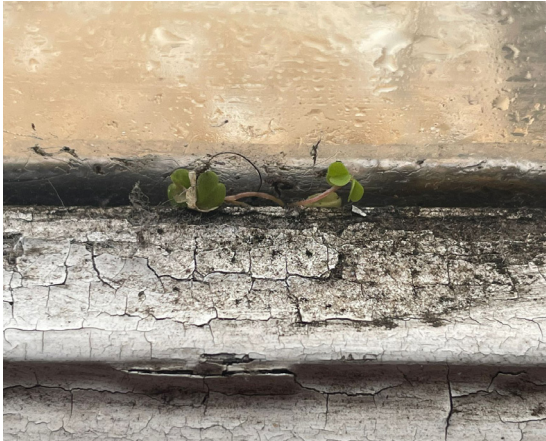
Front Elevation

Rot and mould on timber, condensation to glass, vegetation growing between glass and frame

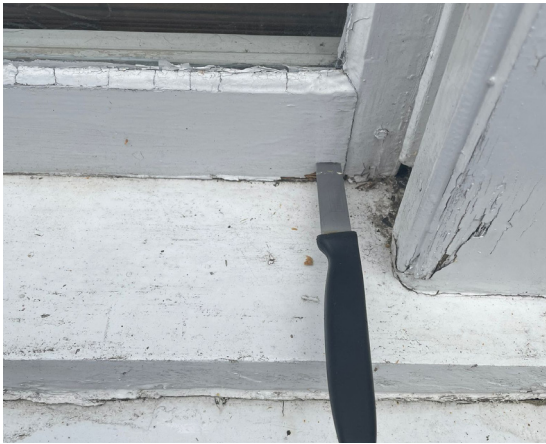
Front Elevation

Damaged and rotting bottom rail, signs of rot to sash window frame

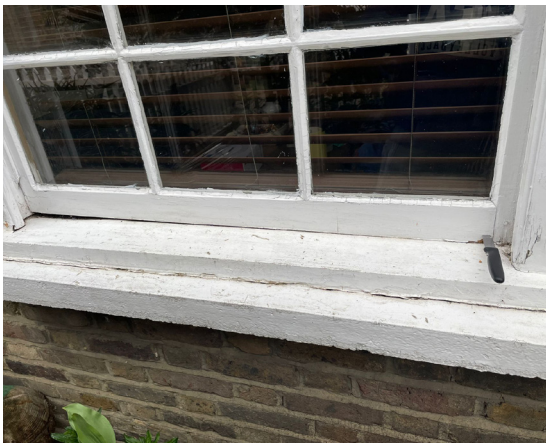
Front Elevation

Rot to sash frame, window does not close all the way down causing extreme draught

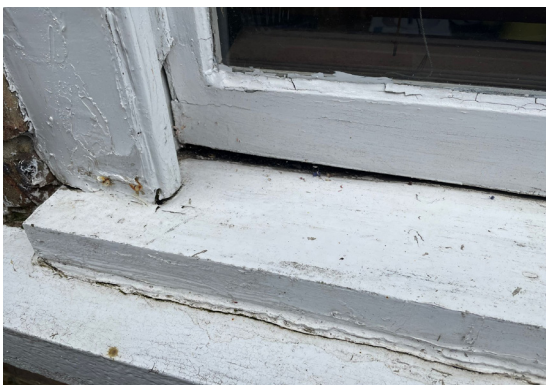
Front Elevation

Inefficient draughty sash window caused by defected window

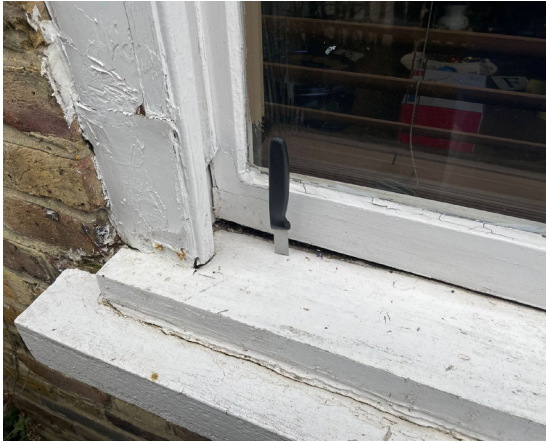
Front Elevation

Rot to sash window sill, draughty window

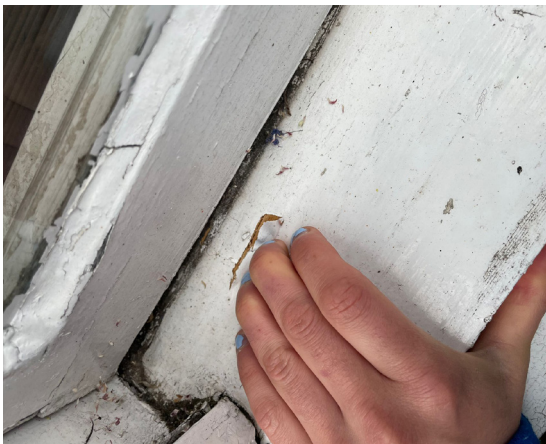
Front Elevation

Rot to sash window sill, signs of mould

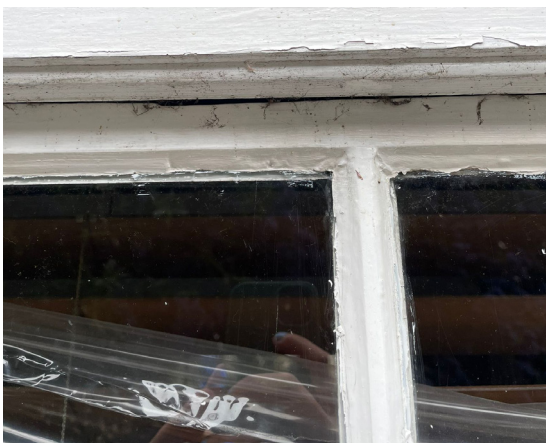
Front Elevation

Draught through top sash due to defected top rail

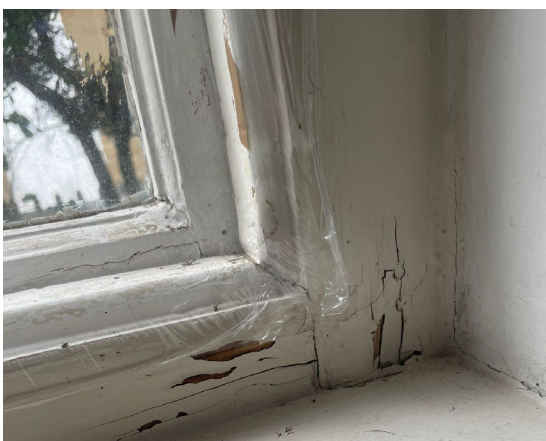
Front Elevation

Rot to sash window frames

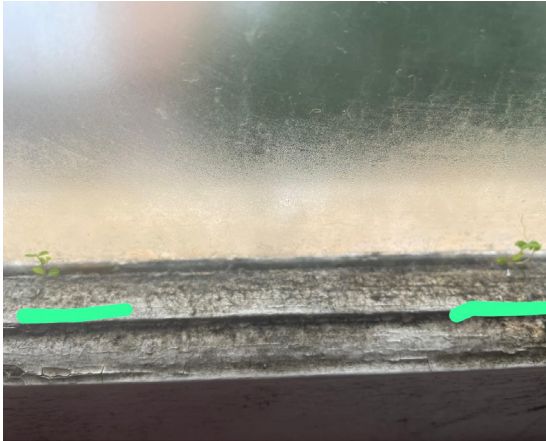
Front Elevation

Rot and intensive mould on timber, condensation to glass, vegetation growing between glass and frame

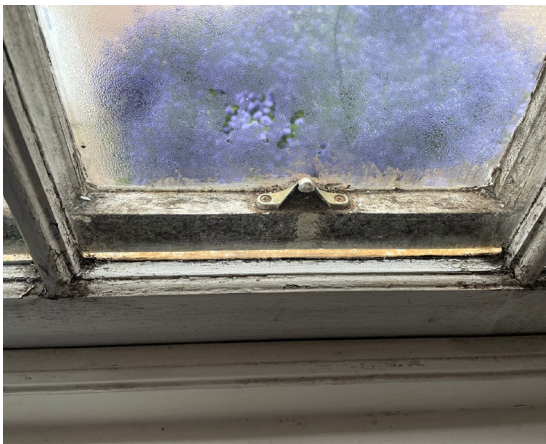
Front Elevation

Extensive mould to top and bottom sash frame and glazing bars junction, condensation to glass

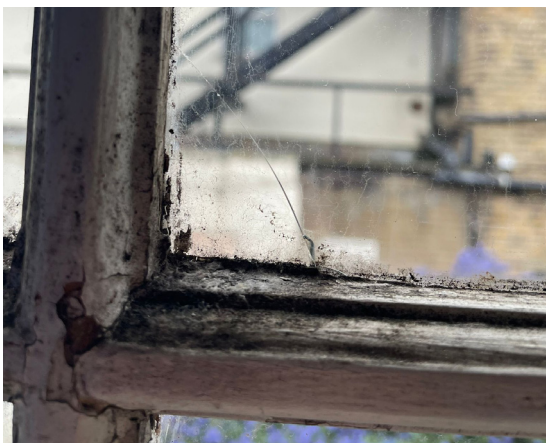
Front Elevation

Broken glass, rot and mould to glazing bar

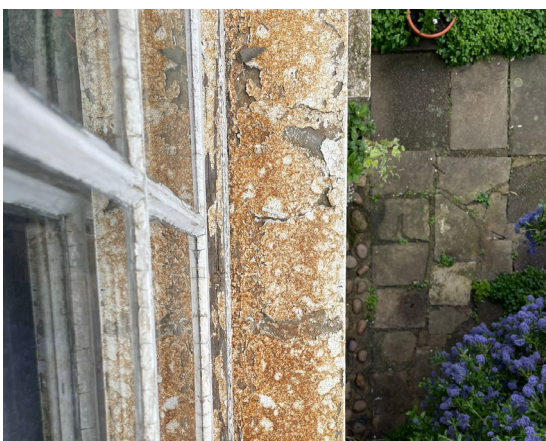
Front Elevation

Rot to sash window frames and sill

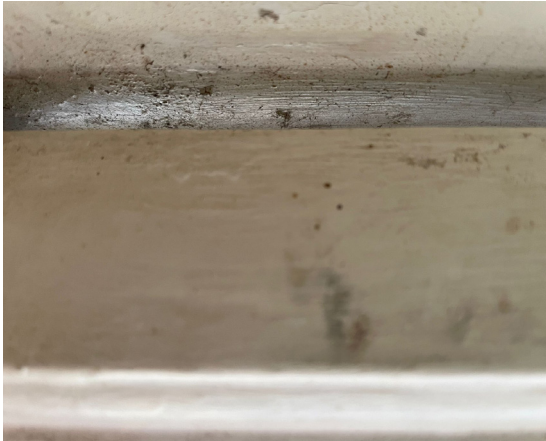
Front Elevation

Draughty window due to window not closing all the way up, signs of mould

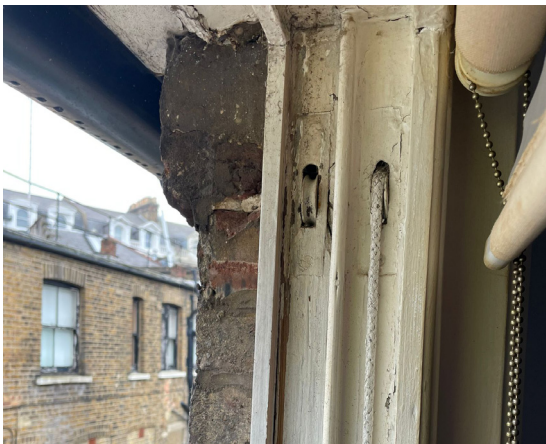
Front Elevation

Signs of mould and rot to sash window frame, defected sash window cord wheel makes it difficult to open and close
