04 September 2023

Our Ref: DLD/2377

**DRAMA ROOM - DRY ROT IN ROOF  
HAMPTON COURT HOUSE**

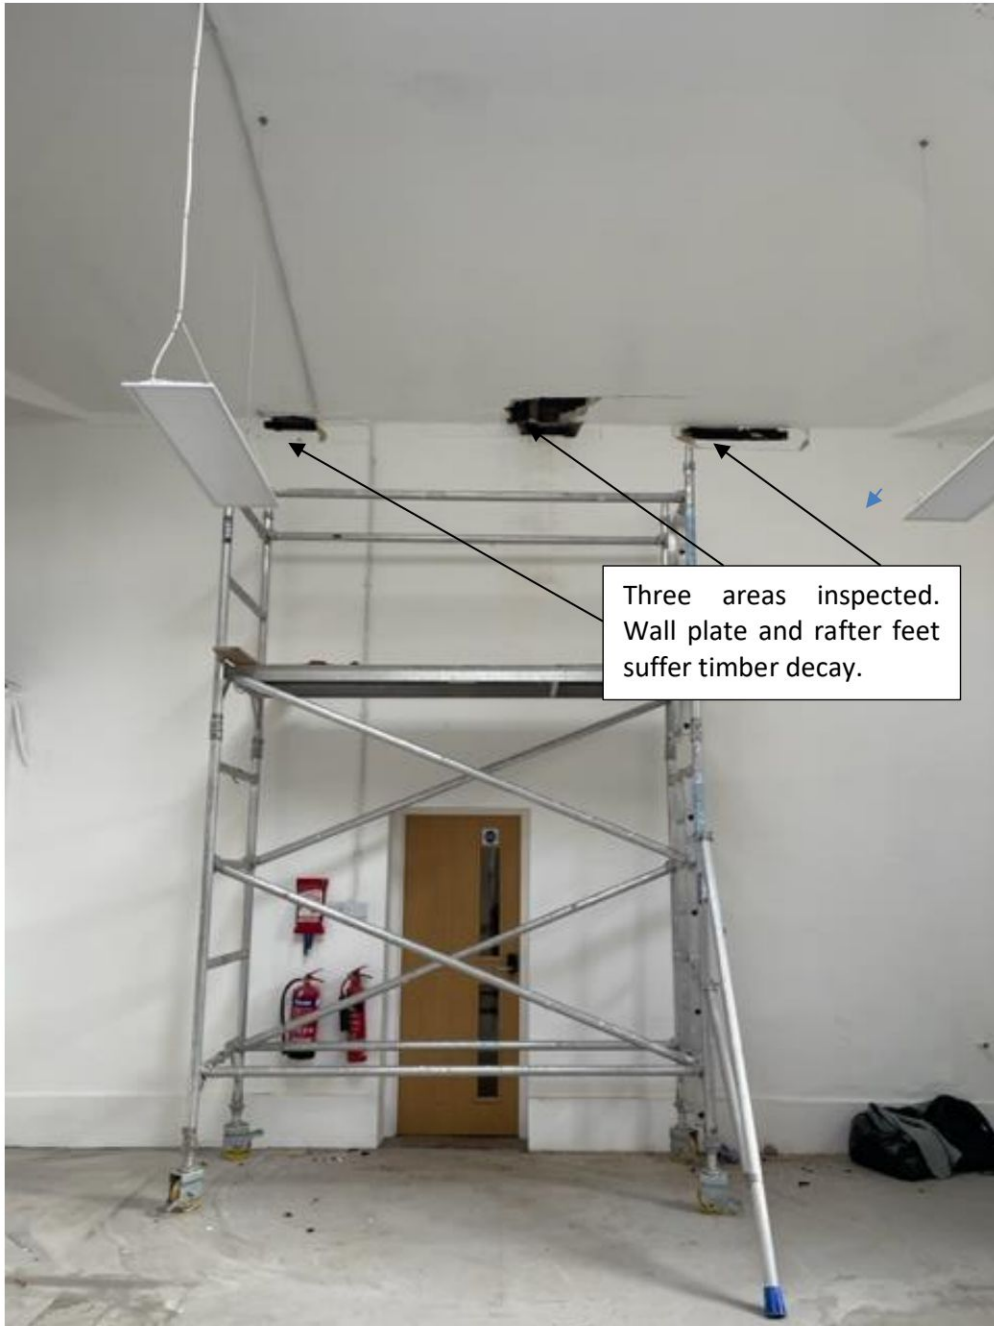
1. Decayed wall plates and rafter feet sitting on the perimeter wall adjacent to the taller external wall (north-east). *See photos 1-3*
2. Decayed wall plate close to the main roof hip supports (north end). *See photo 4.*
3. Deteriorated roof coverings forming rainwater gutter above area of dry rot infestation. *See photos 5-6.*

*Photo 1*  
*Inspection hole locations*

- A. Expose the remaining lengths of timber wall plate between the top of the supporting wall and under the roof gutter line. Include for removing the plaster board from the sloping ceiling to check the condition of the timber rafters.
- B. Commission a full timber treatment survey from a specialist company. Local companies include Tapco Home Dry, Timber Preservations Ltd, Timkon Co Ltd who may assist with this. Implement recommended repairs including structural strengthening/replacement of the worst affected timbers.
- C. Water test the roof gutter located above the damaged area, check for leaks and for any obvious defects in the waterproof coverings – allow for roof repairs.

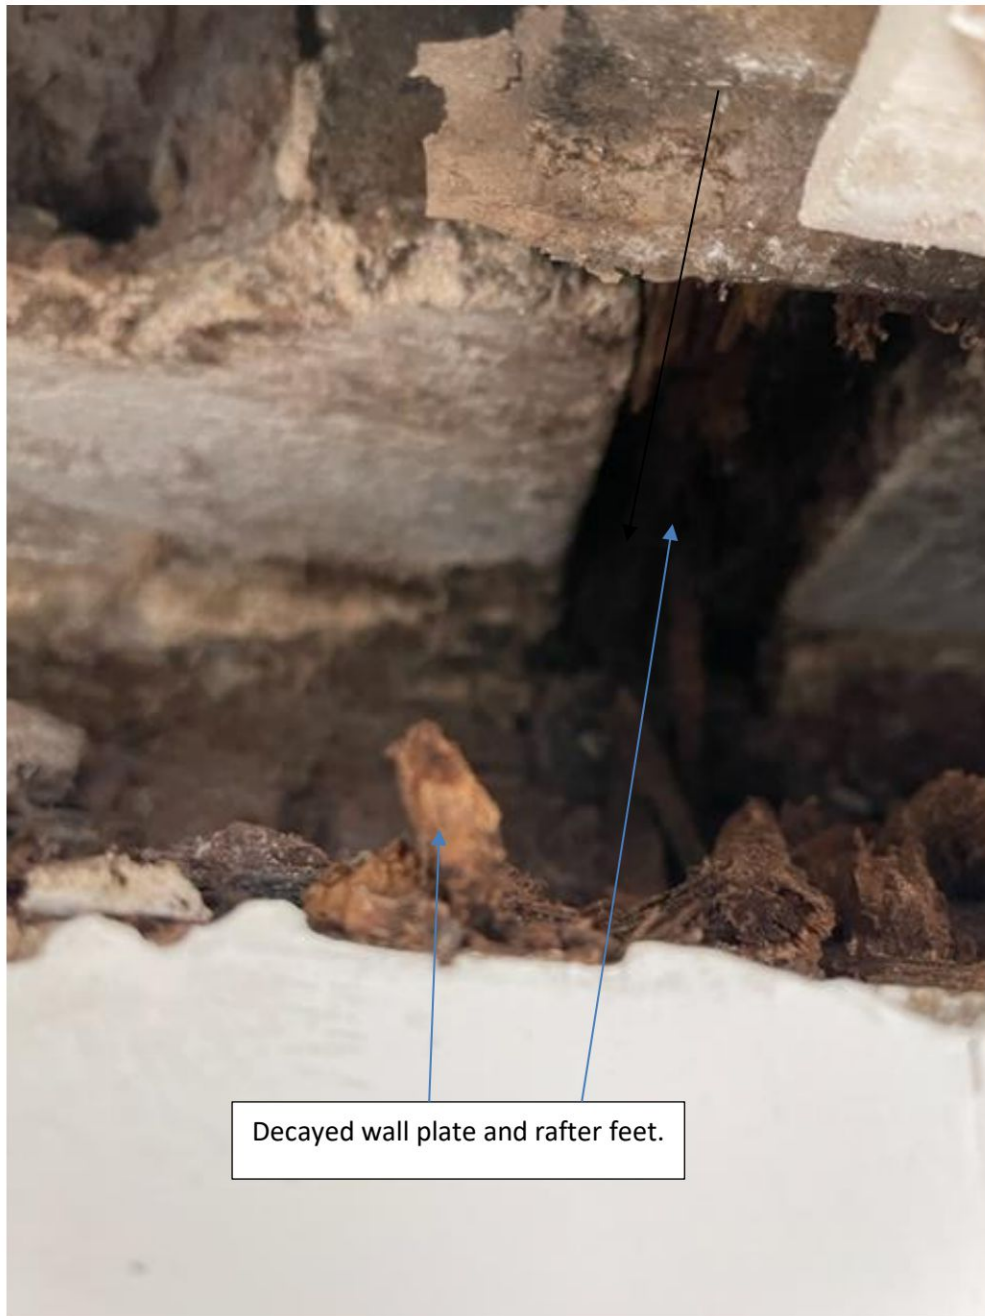
*Photo 2*  
*Close-up of decayed timbers*

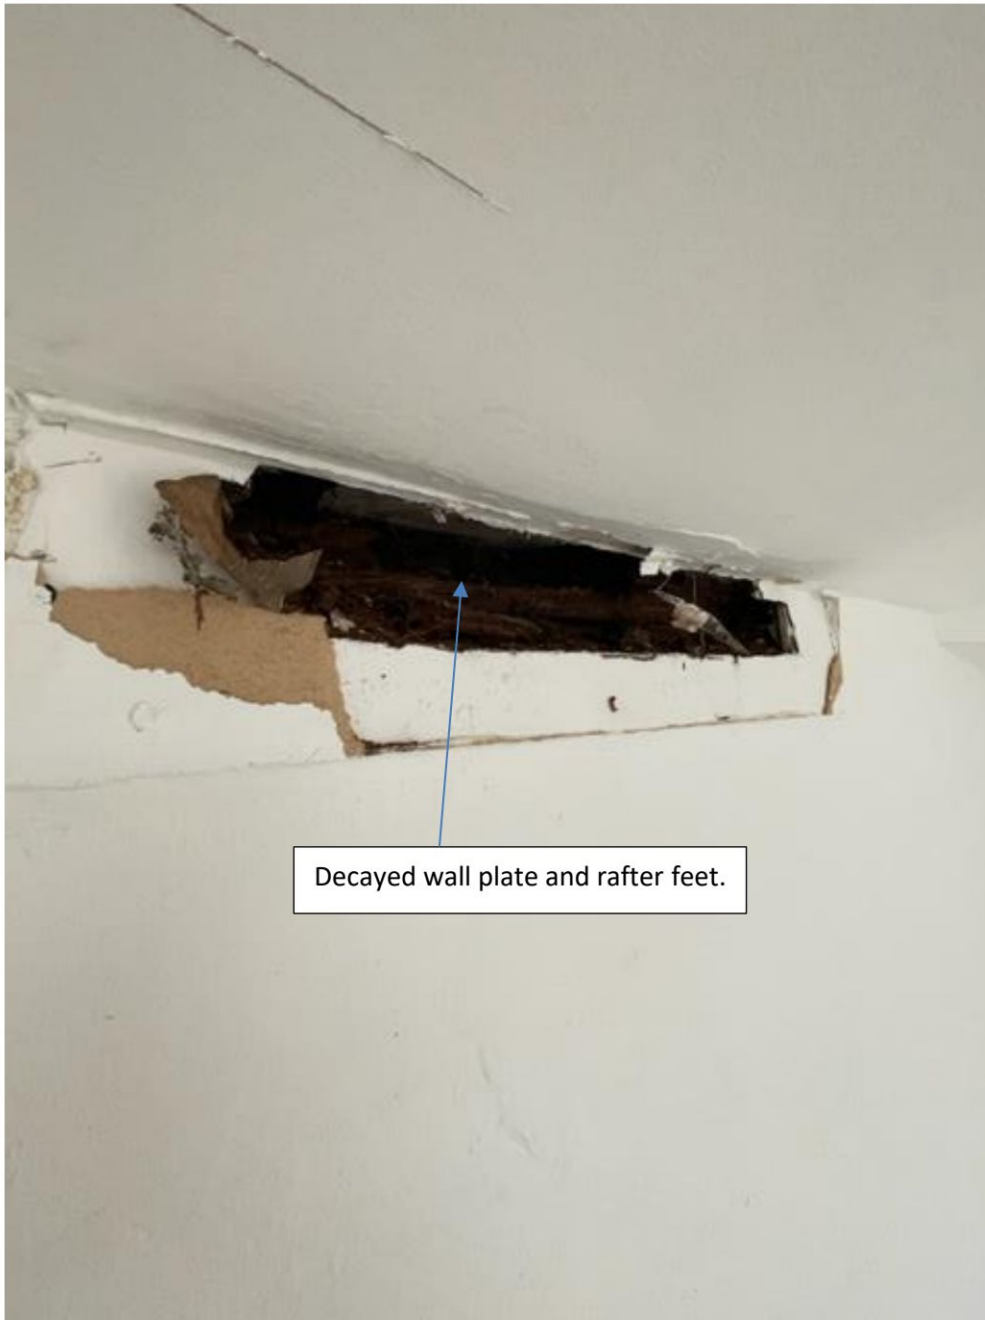
Decayed wall plate and rafter feet.

*Photo 3*  
*Close-up of decayed timbers*

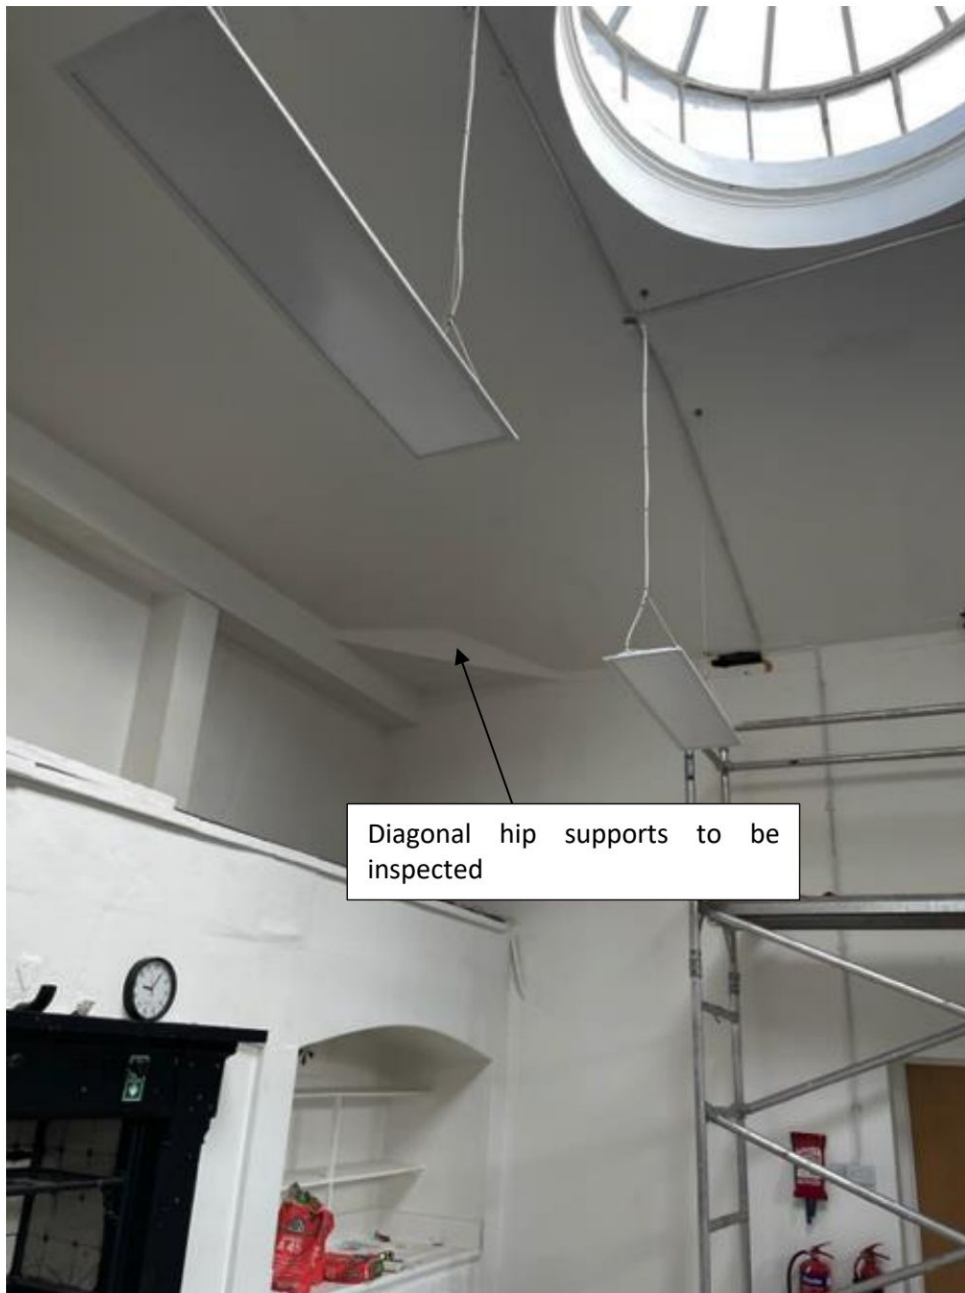
*Photo 4*  
*Area for further investigation*

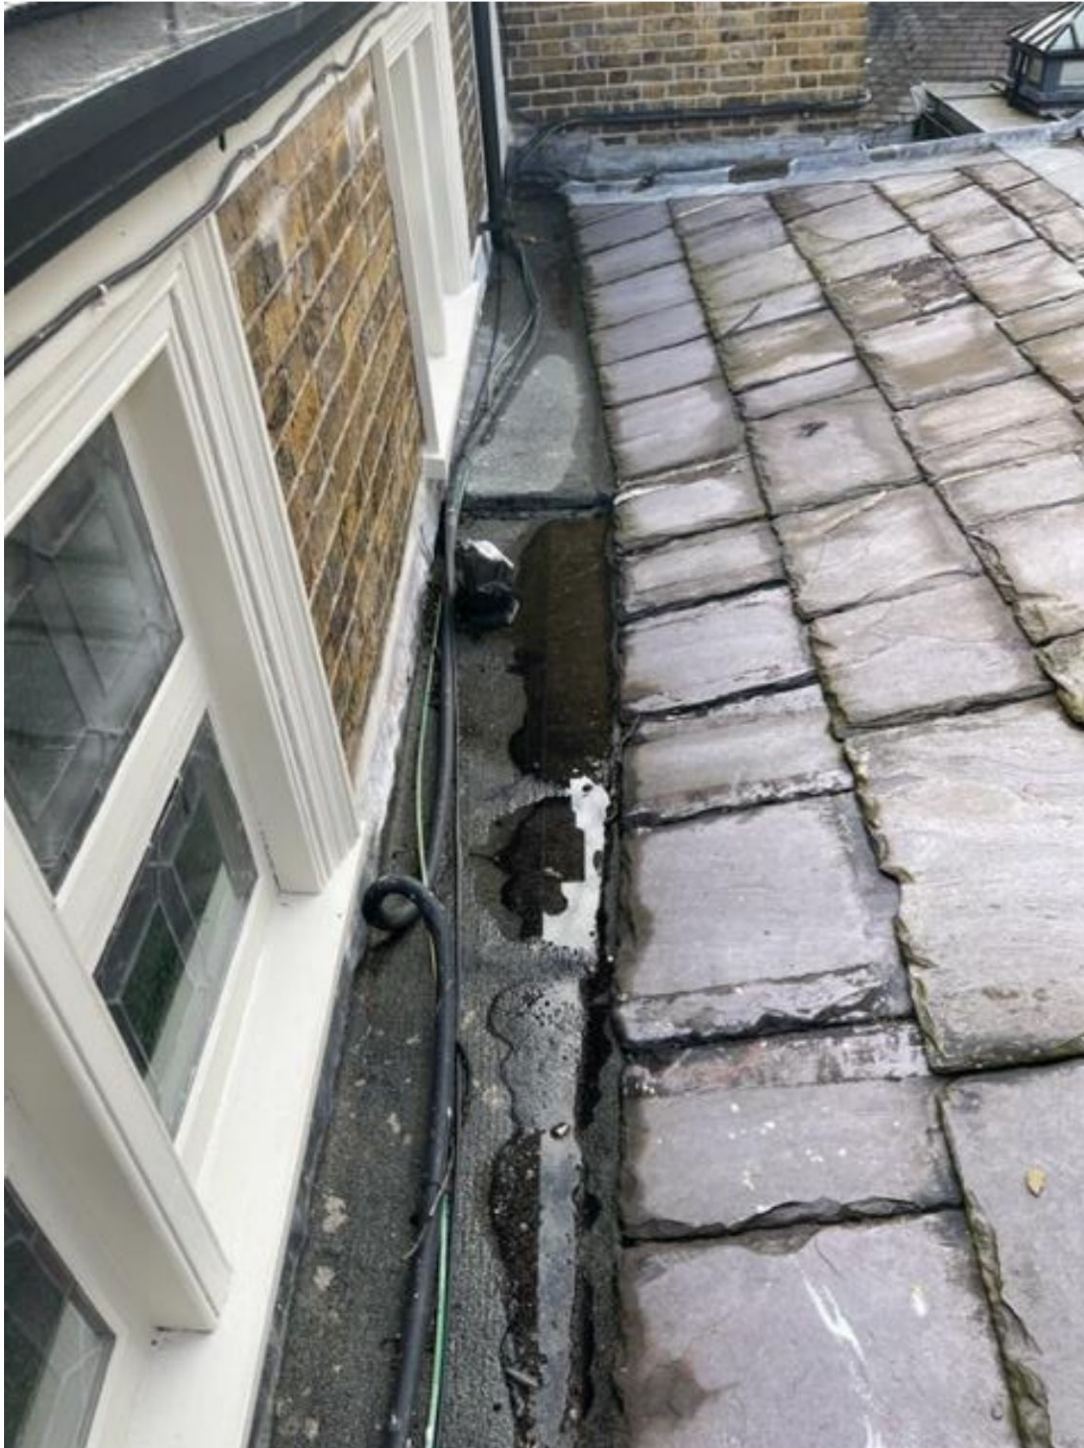
*Photo 5*

*Rainwater gutter above defective roof timbers*

*Note: Patch repairs and different waterproofing materials*

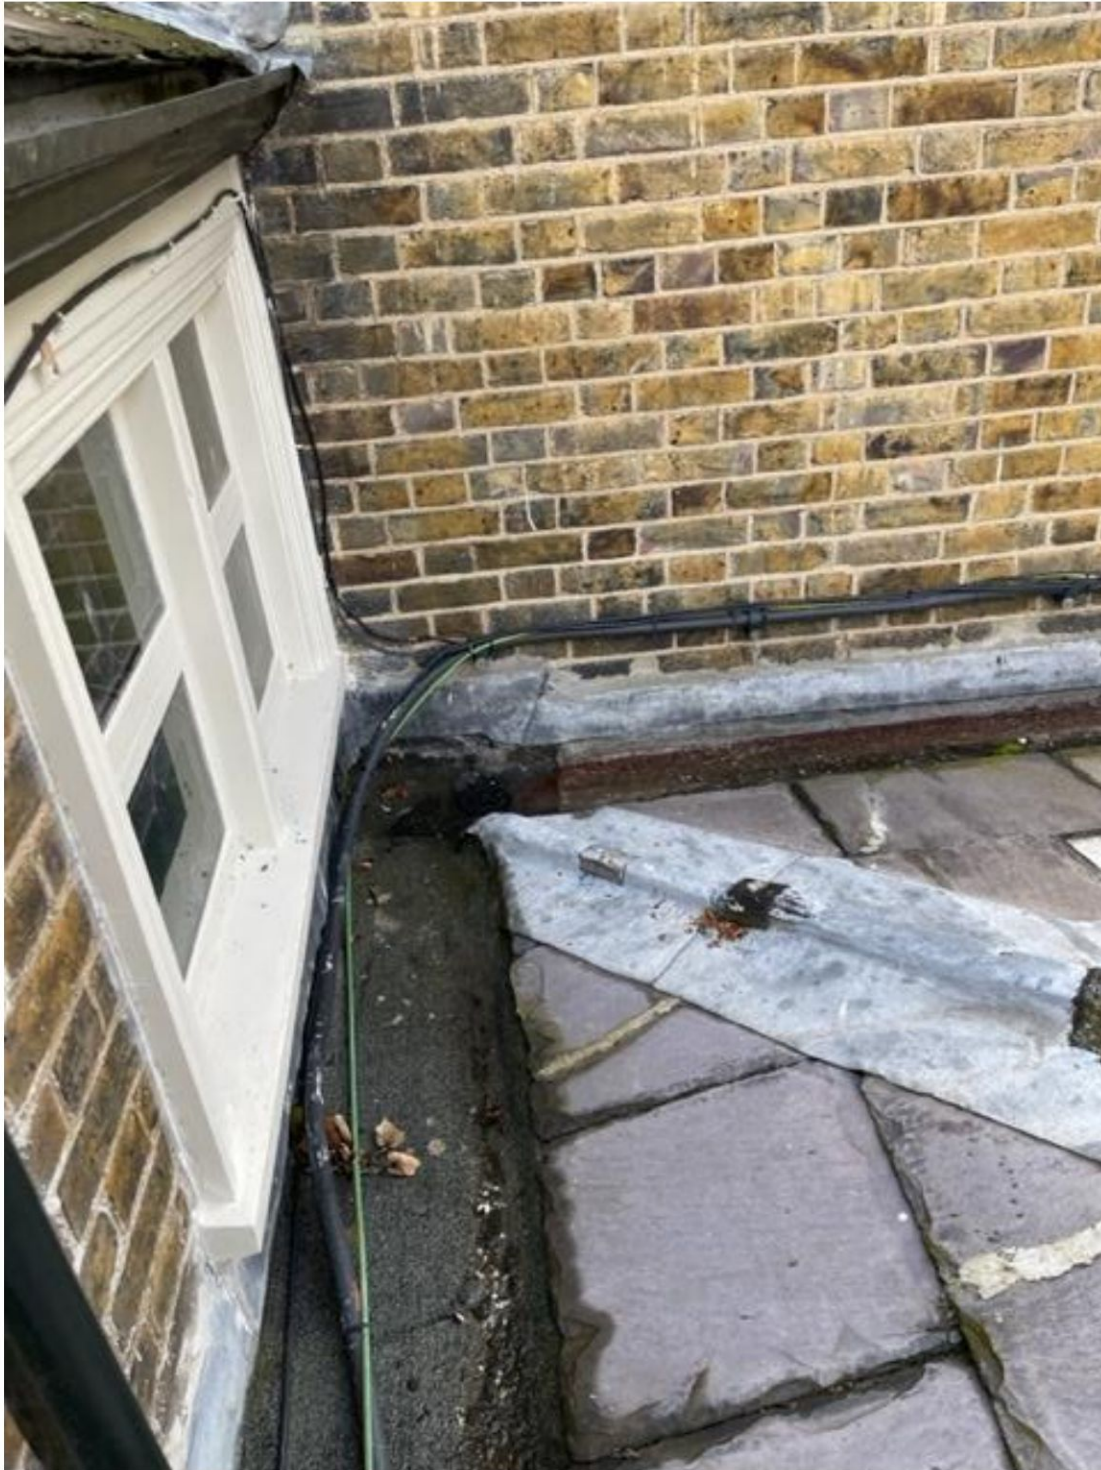
*Photo 6*  
*Rainwater gutter above defective roof timbers*
