Our Ref: DLD/2377

REPORT NO 2

DRAMA ROOM - DRY ROT IN ROOF HAMPTON COURT HOUSE

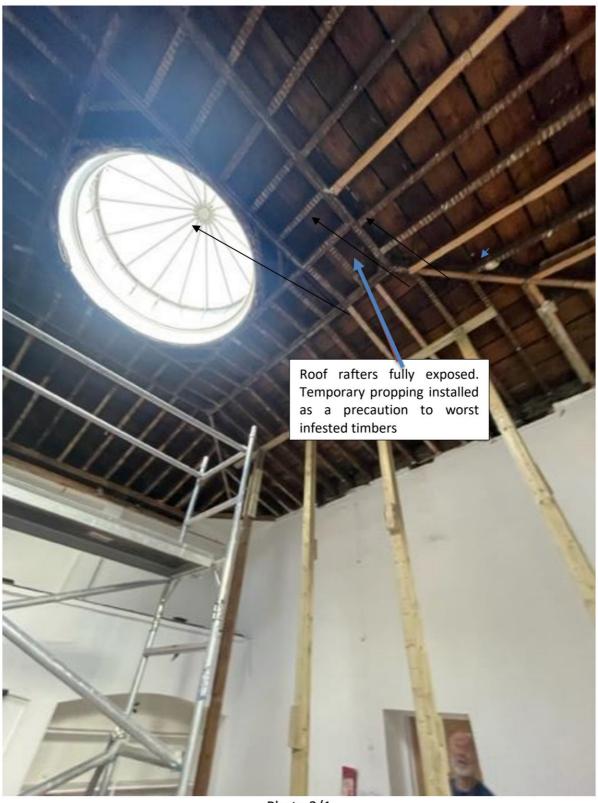
Photo 2/1 Main roof rafters

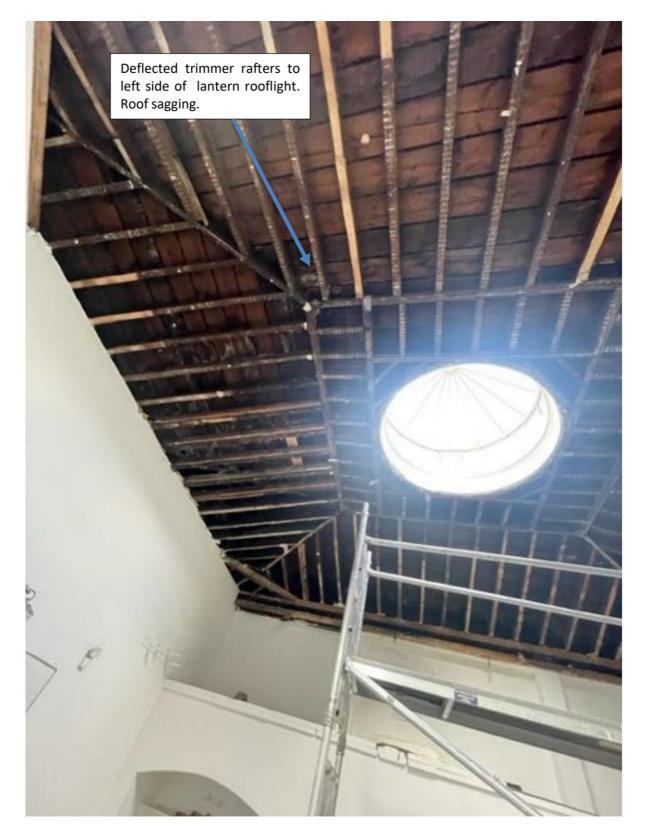
- · significant movement (sagging) of the lantern structure,
- splitting of the roof timber trimmers ,
- roof spread of the rafter feet on the external walls, and
- extensive lengths of decayed wall plates

Photo 2
Sagging roof trimmers around rooflight

- a. Replacing all defective timbers including wall plates and rafters and boards
- b. Undertaking localised repairs to the split timbers and dowel connections.
- c. Applying a ply-sheet diaphragm membrane layer to the roof underside to the sloping

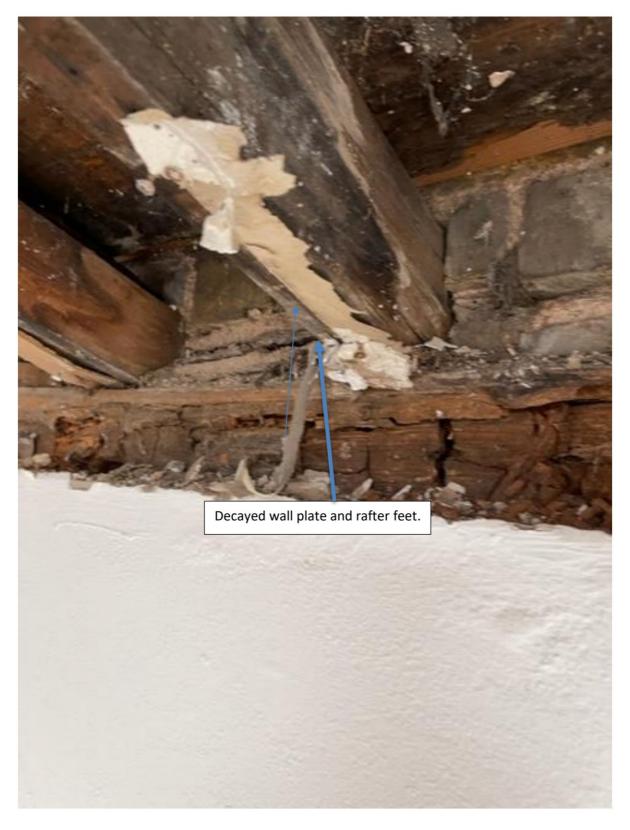
Photo 3
Close-up of decayed timbers

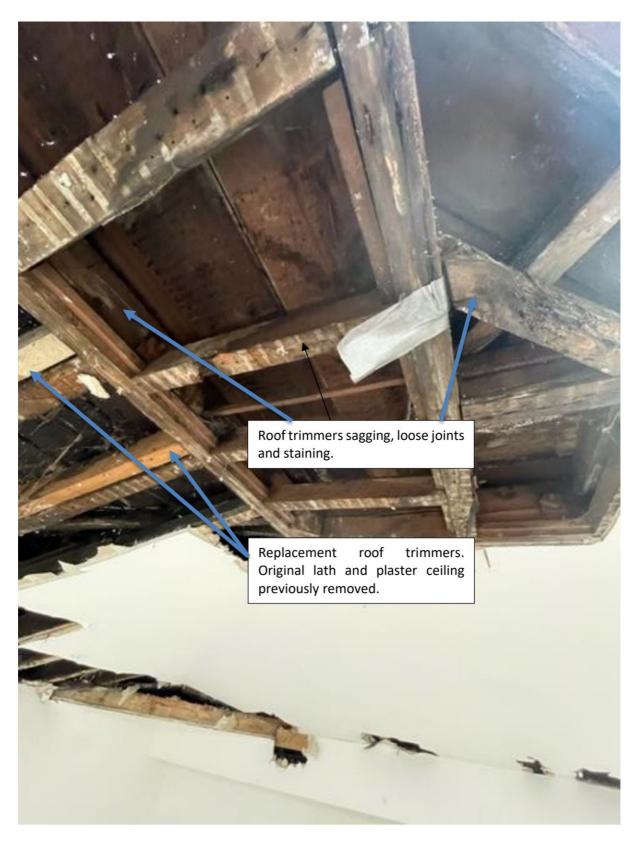
Photo 4
Poor condition of roof timbers
