Our Ref: DLD/2377

REPORT NO 3

DRAMA ROOM – DRY ROT IN ROOF HAMPTON COURT HOUSE

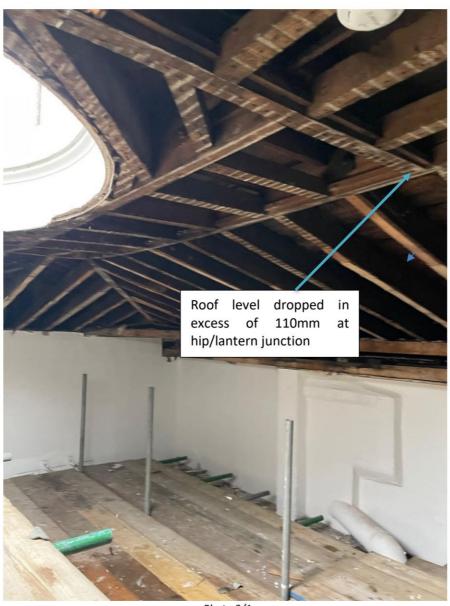
Photo 3/1 Main roof rafters

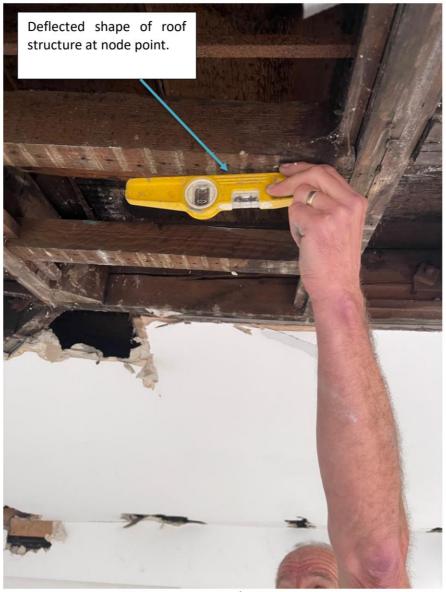
In addition to the reported findings in our previous reports, we carried out a basic level measurement survey of the roof structure. There is a dramatic drop in the roof level in excess of 110mm at the junction of the sloping hip and the upper horizontal central lantern roof structure.

Photo 3/2
Deflection at Junction

Having reviewed the latest survey evidence, we consider it now appropriate to provide new structural supports to the underside of the existing roof profile. Such supports would comprise profiled steel beams that will be suitably shaped to follow the existing ceiling profile and transfer the weight of the roof to the outer walls. The introduction of the steel beams will avoid the need for the full roof structure to be replaced.

We attach our updated structural drawings showing the recommended steel structure that should be constructed beneath the exiting ceiling profile.
