**Station Road Care Home  
Station Road  
Hampton  
Addendum Structural Report**

Scott White and Hookins  
Harman House  
Andover Road  
Winchester  
Hampshire  
SO23 7BS

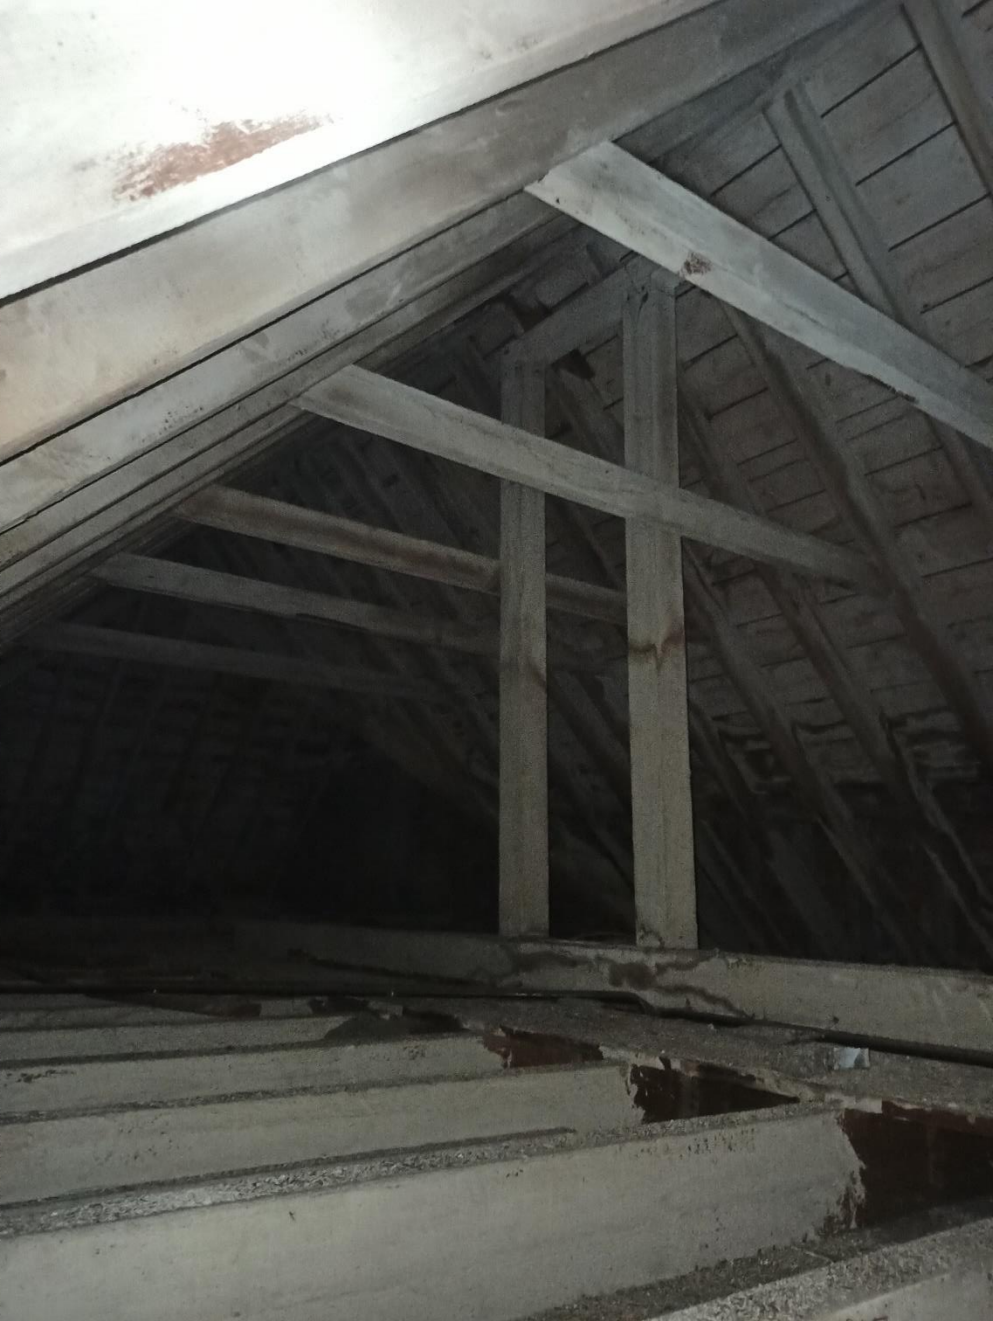
**Photo 2 – Timber members forming roof showing water staining.**

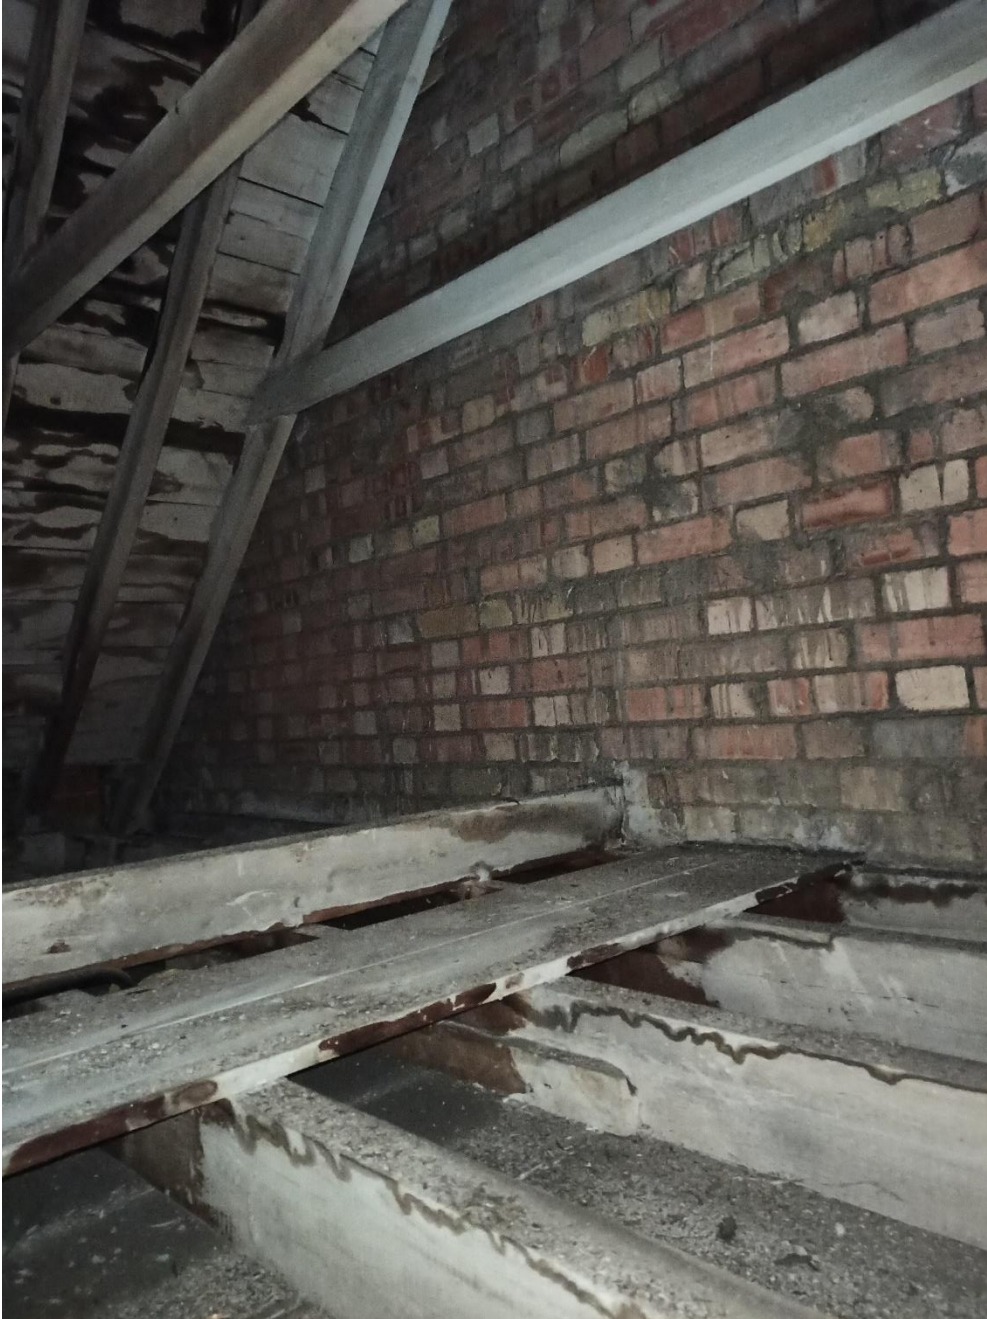
**Photo 3 – Steel beams supporting water tank in loft space.**

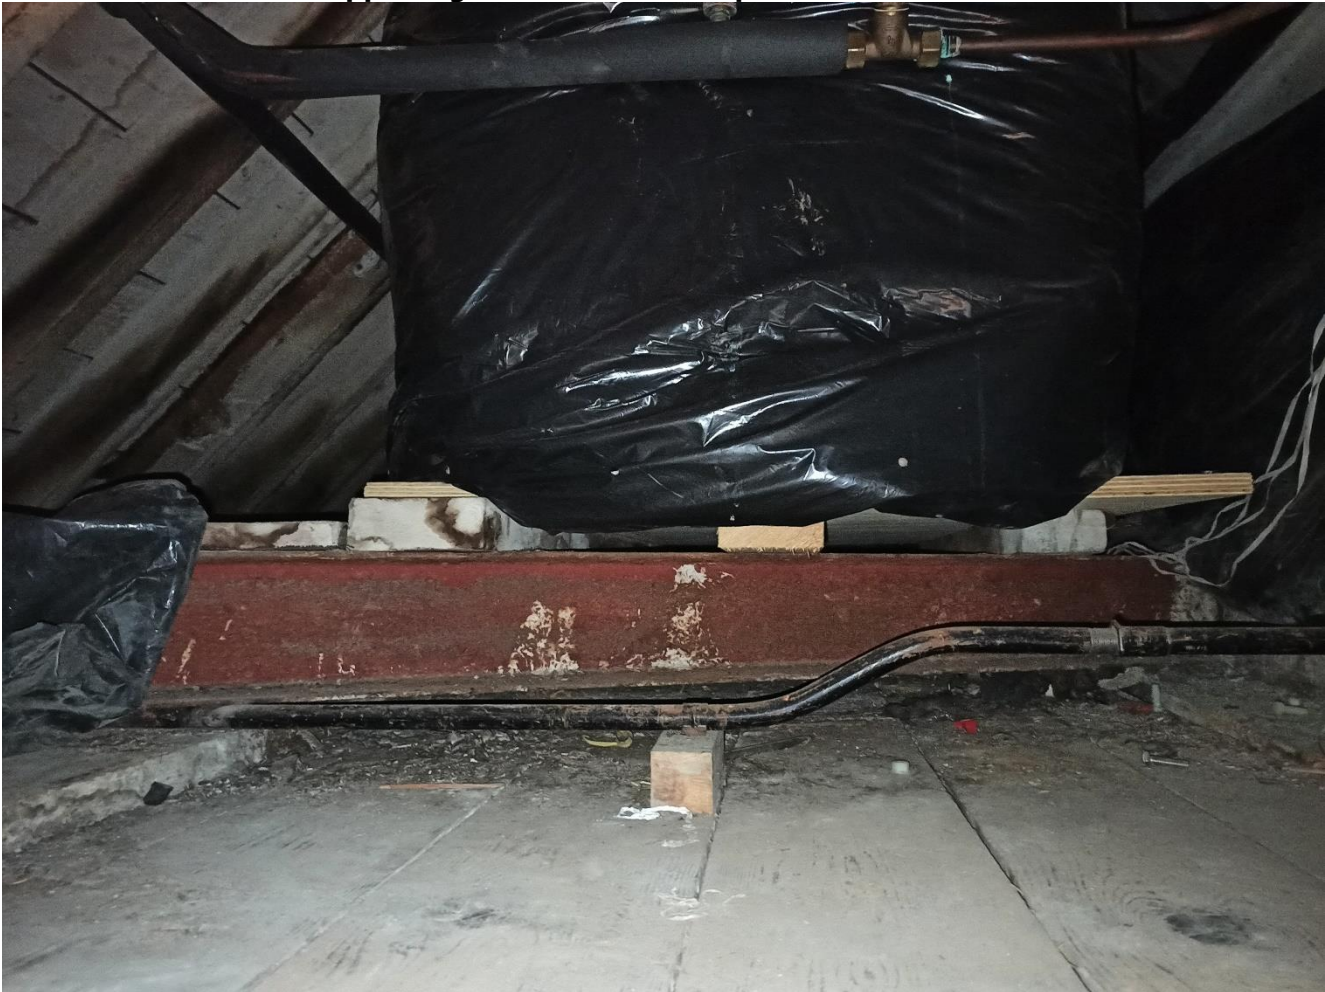
**Photo 4 – Boarded out and staining to loft space and timber members in reasonable conditioning, but showing water damage.**

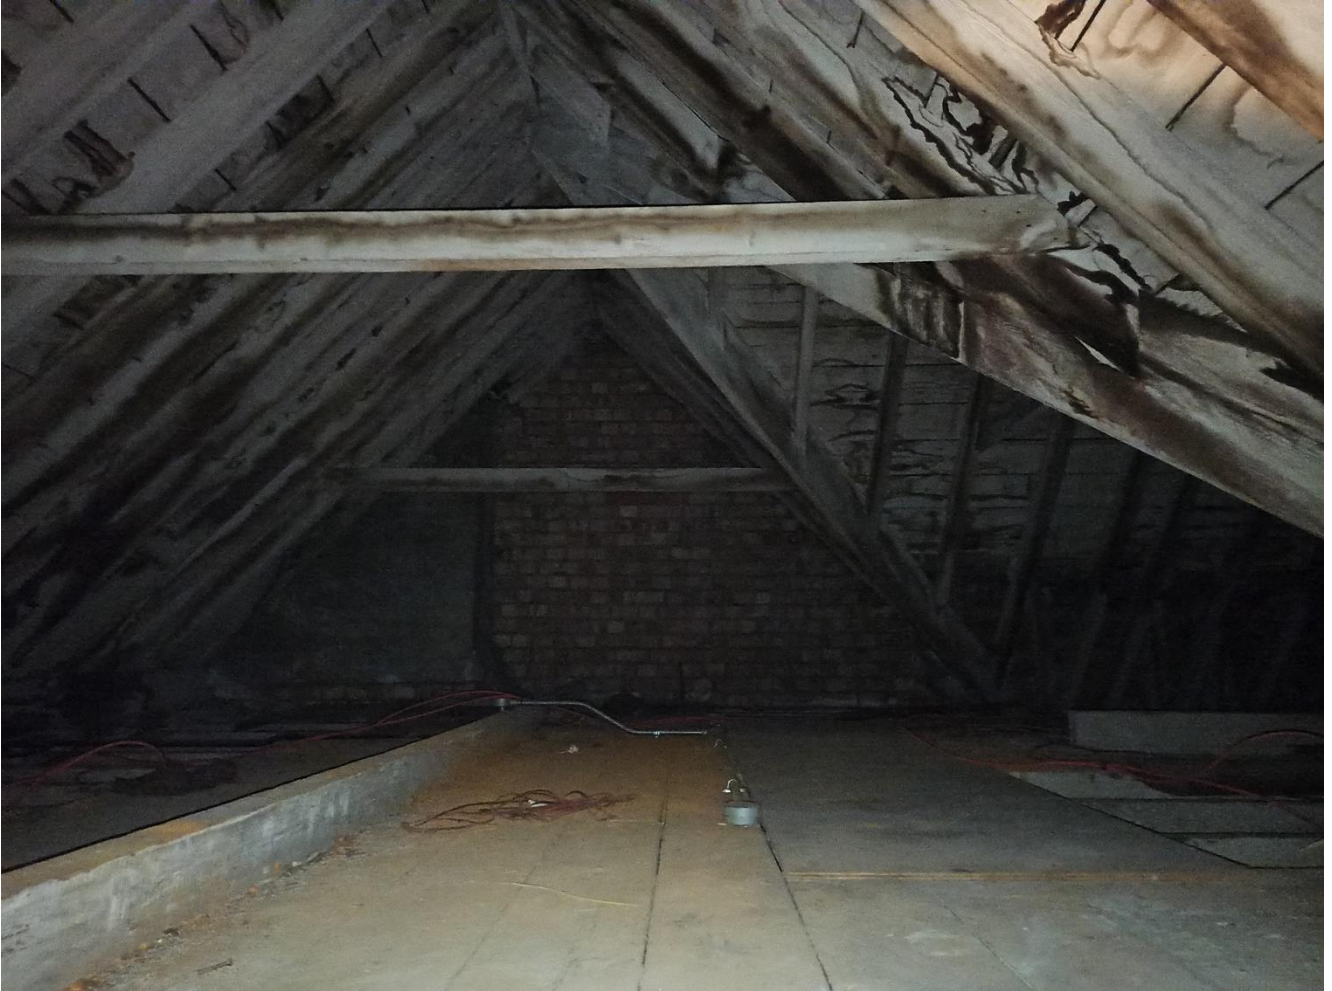
**Photo 5 – Hole in ceiling indicating timber roof rafters in reasonable condition.**

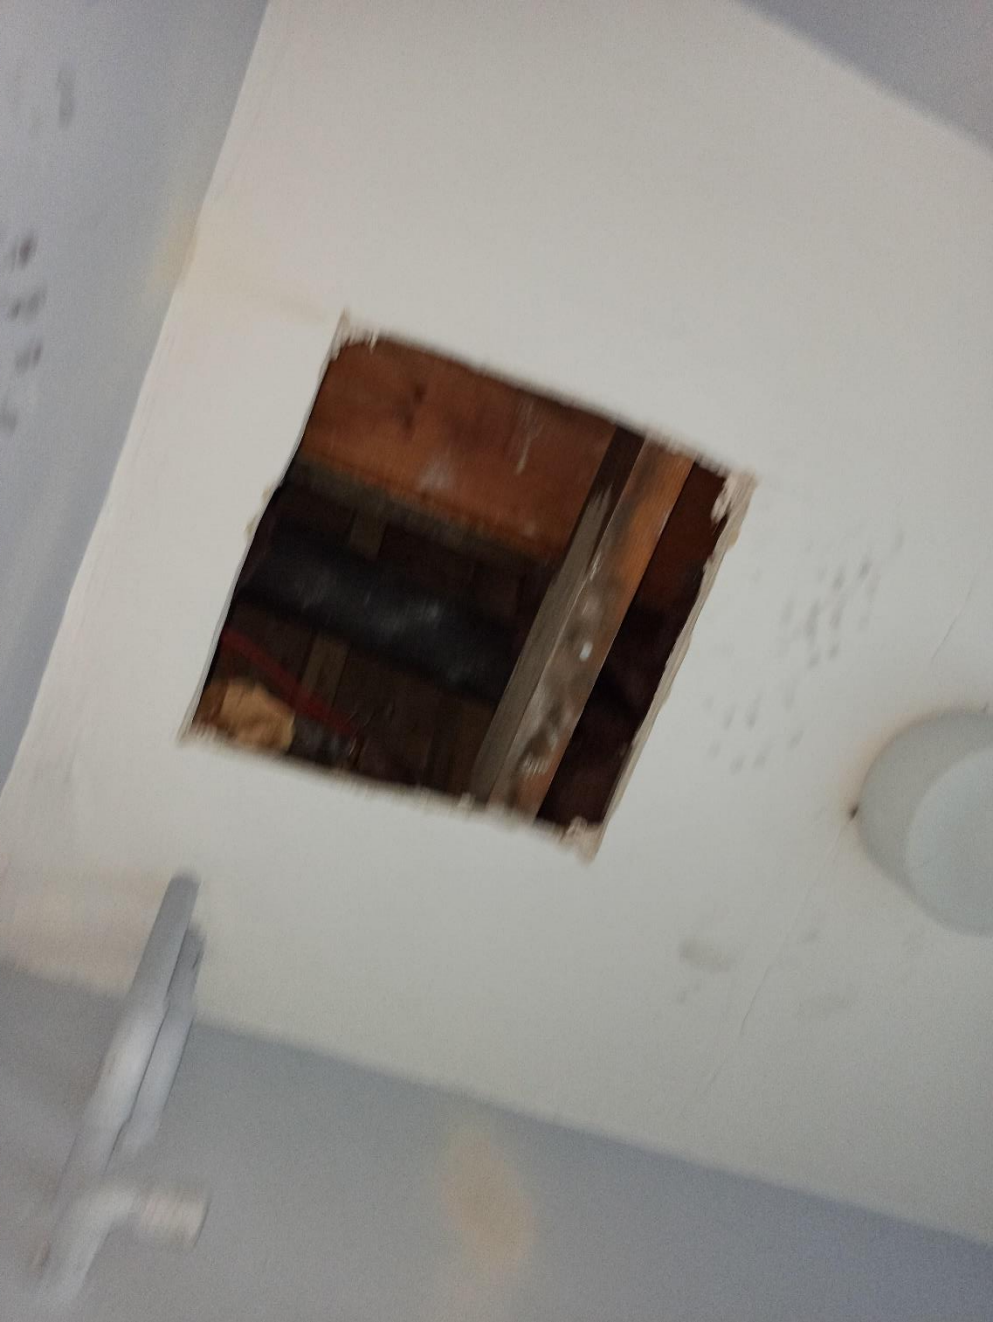
**Photo 6 – Hole in wall indicating mortar render over timber studwork.**

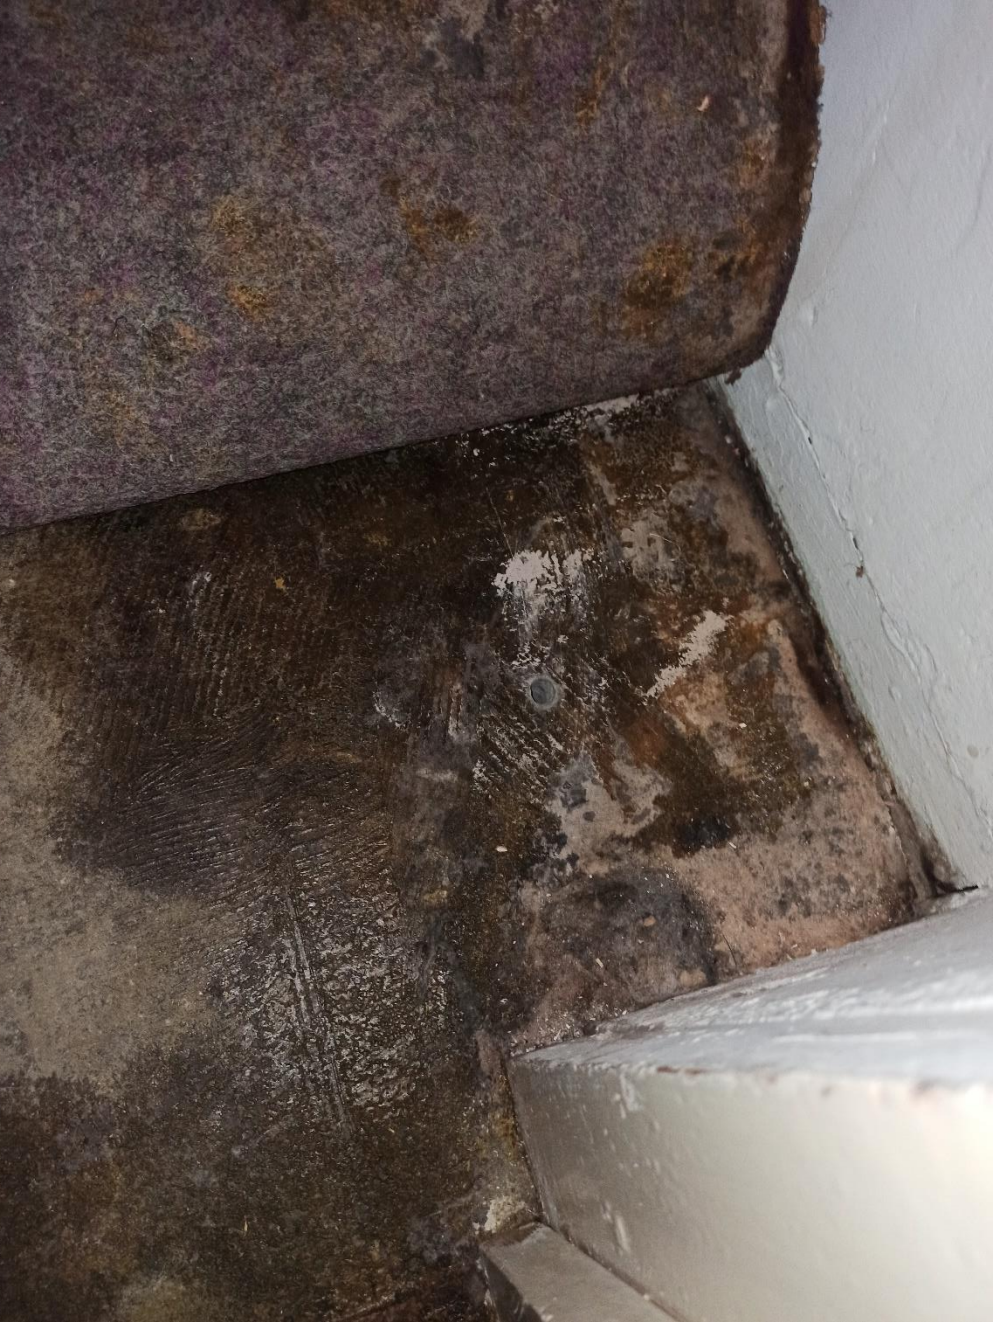
**Photo 12 – Ceiling opened to show corroded steel beams.**

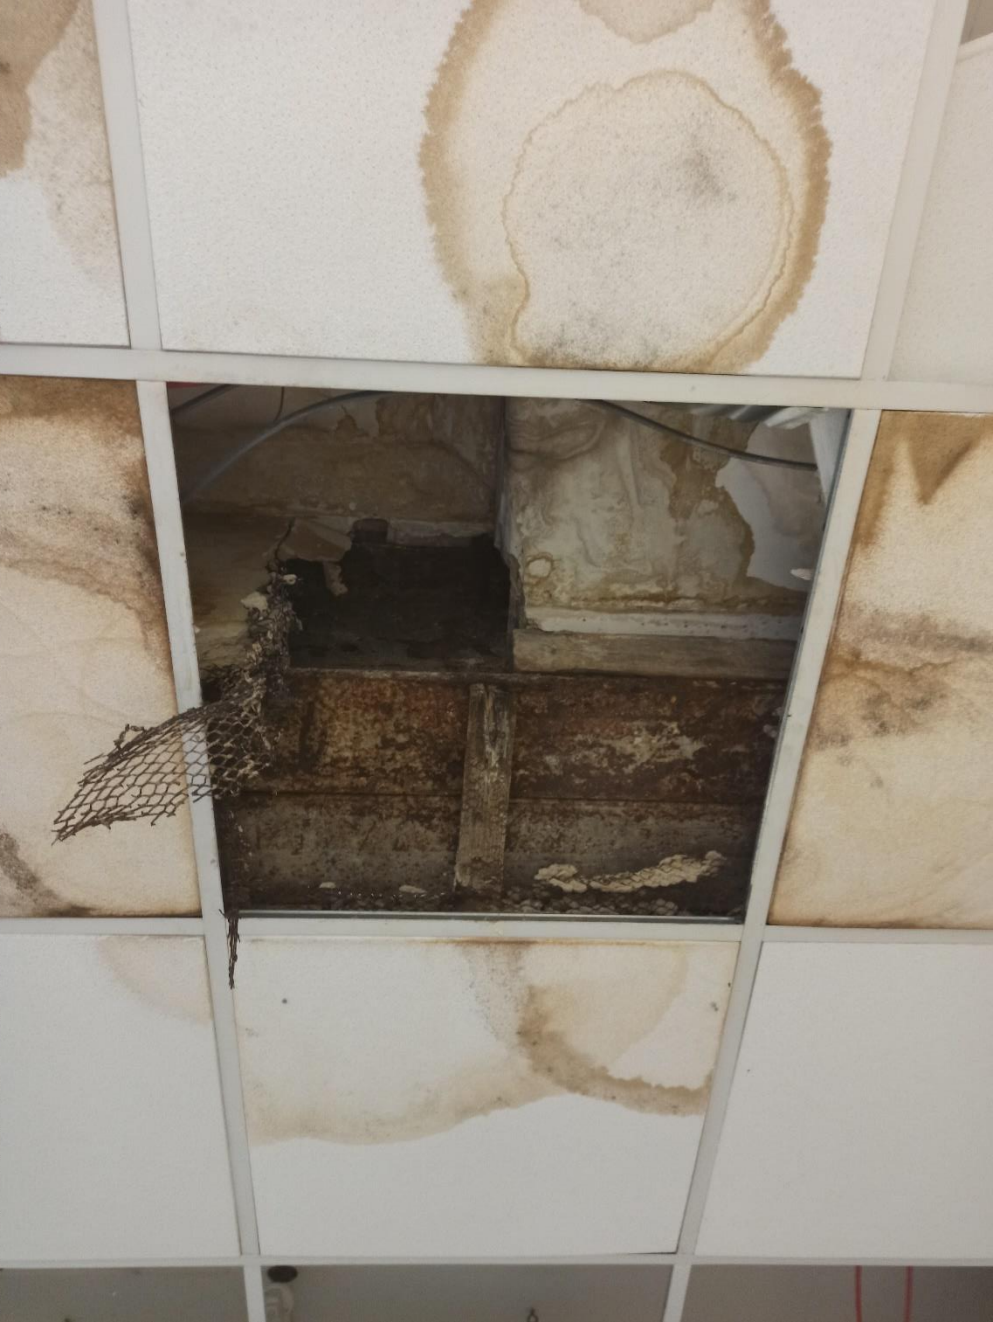
**Photo 13 – Steel beams supporting concrete slab.**

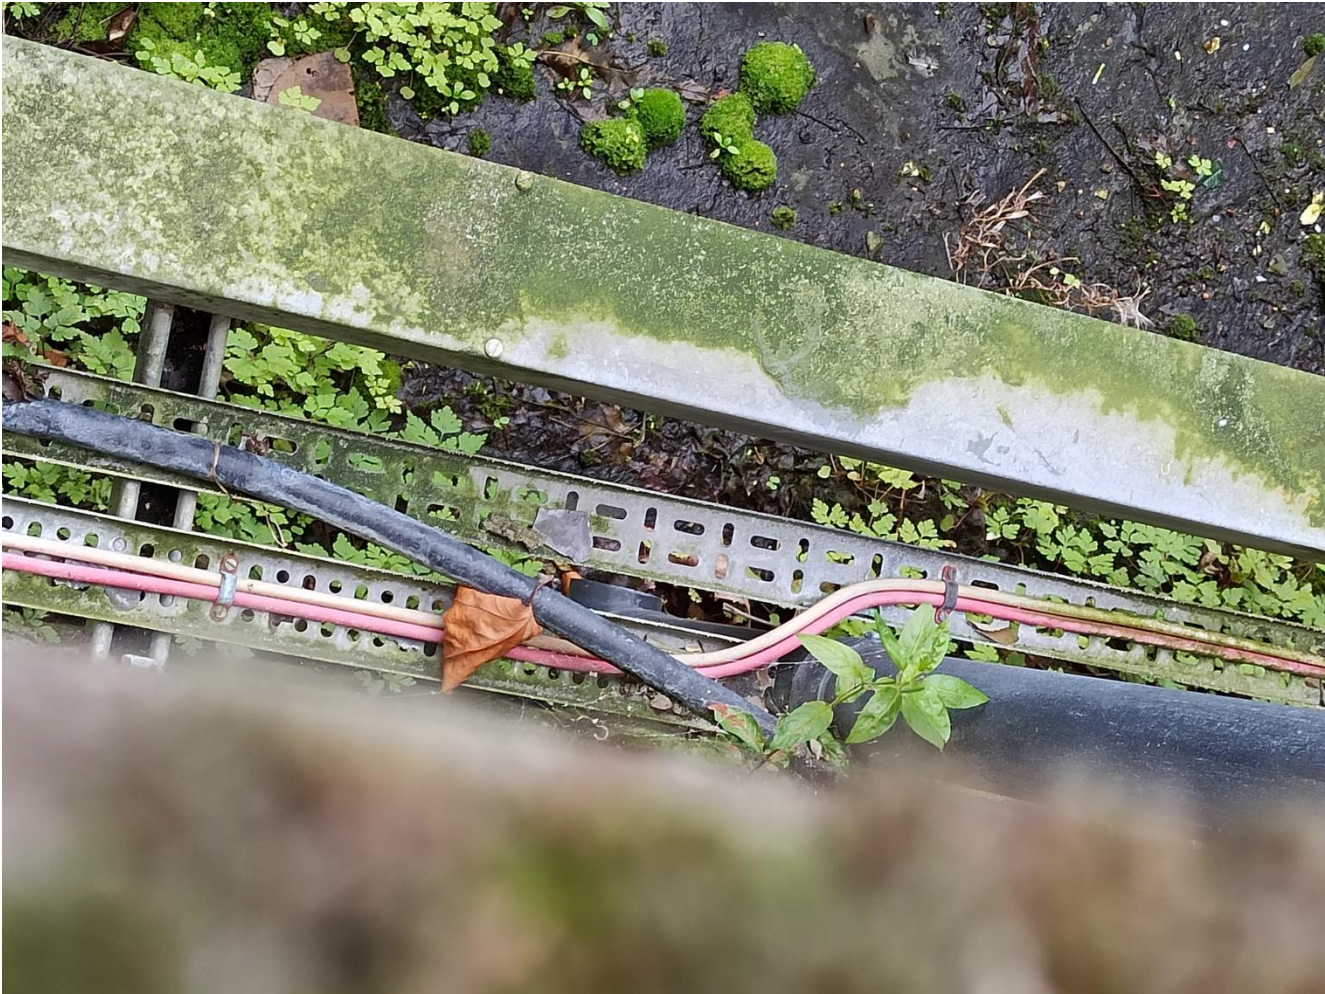
**Photo 16 – Crack in external brick façade.**

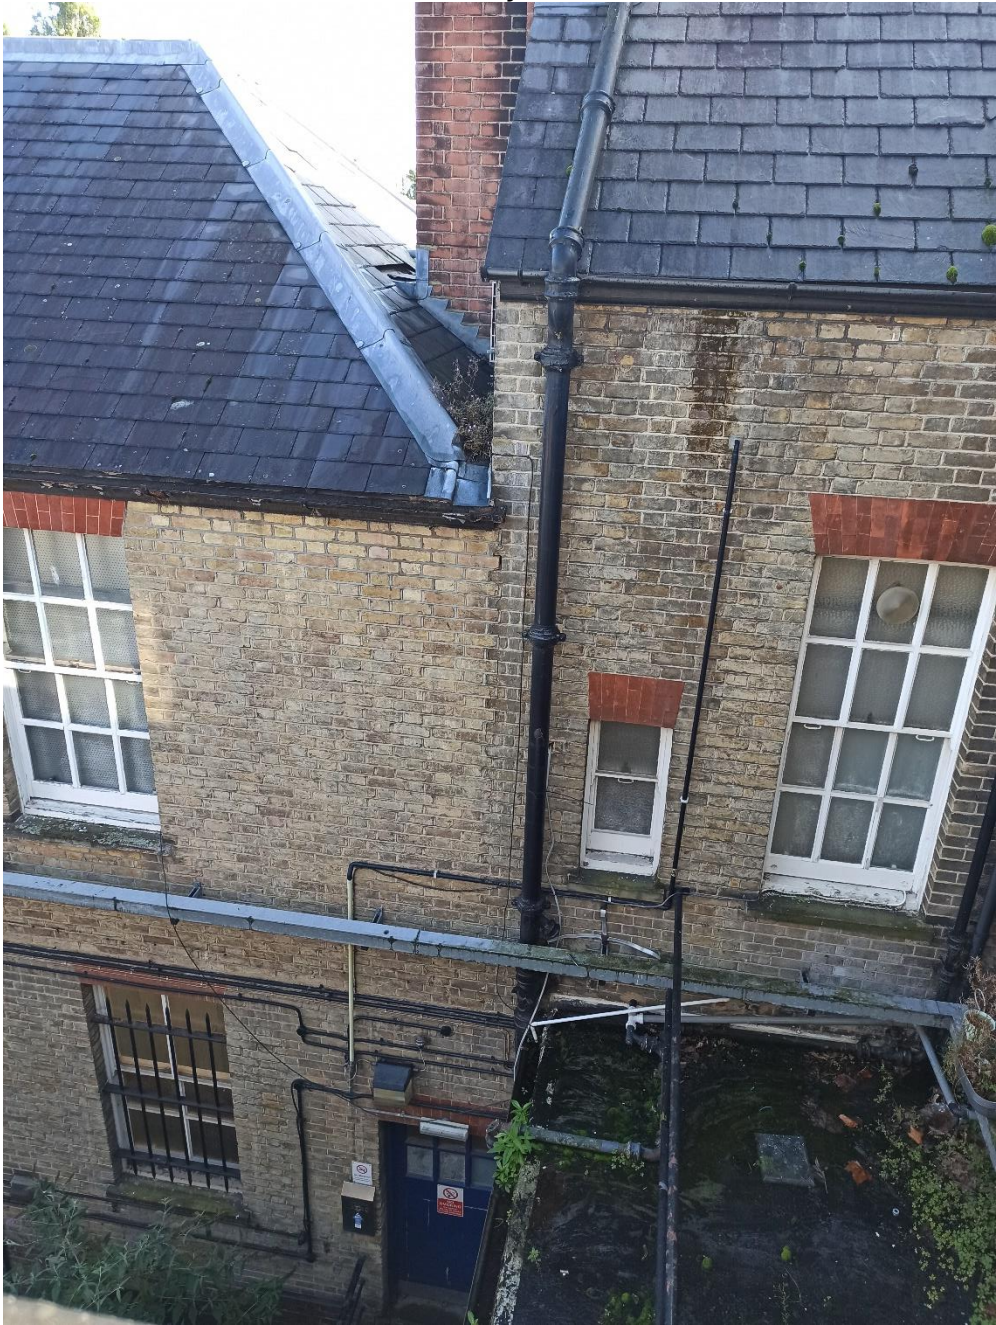
**Appendix B**  
**Location Plan**
