REPORT NO 4

**DRAMA ROOM - DRY ROT IN ROOF
HAMPTON COURT HOUSE**

**Investigation
Report and
Recommendations**

Re: Hampton Court House, East Molesey, KT8 9BS

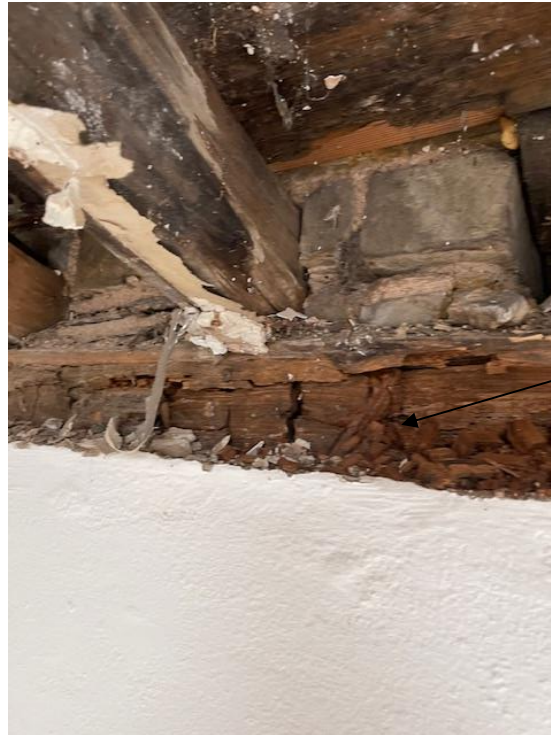
Photo 1
Rotted wallplate and rafter feet

Tapco HomeDry carried out an intrusive but limited timber survey of the roof rafters on 12 September 2023. A copy of their report is attached. The survey revealed extensive dry rot damage to embedded timber wall plates and rafter feet on Wall 1 (north-east). *See Photos 1 and 2.*

Dry rot decay of timber wallplate under raking rafters

Remedial works involve cutting away the affected timber elements one metre (1m) beyond the worst affected parts and splicing on new treated timber sections of a similar size to the side of the damaged element. The new and original sections are bolted together in a prescribed manner to ensure there is sufficient strength and rigidity for the spliced sections to work effectively. *See Photos 3 and 4.*

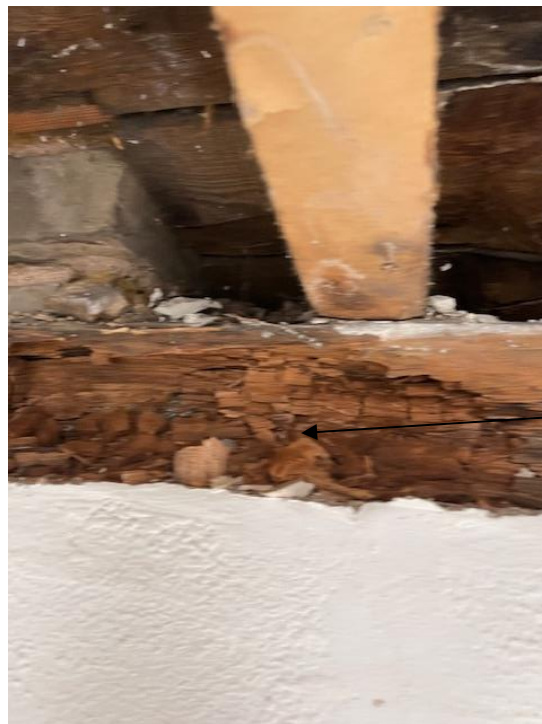
Photo 2
Close-up of decayed timbers

Further example of the aggressive nature of dry rot fungus

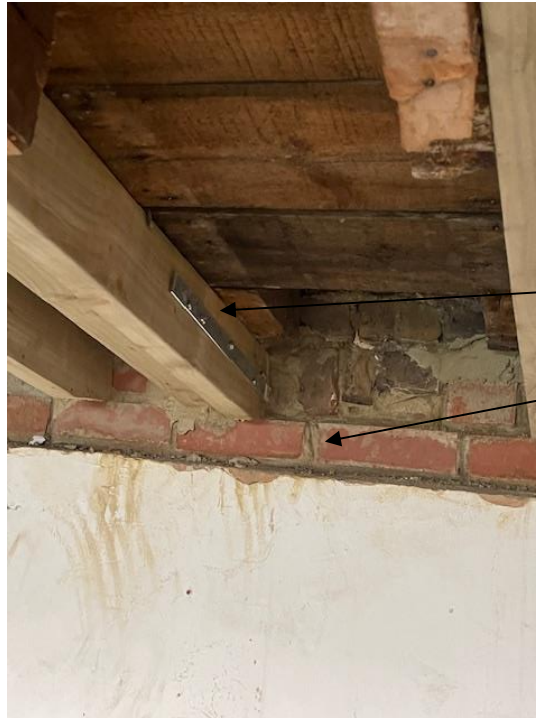
Photo 3

Rotten rafter feet replaced with treated timber.

Rotten wallplate replaced with engineering bricks.

Close-up of replacement timbers and brickwork

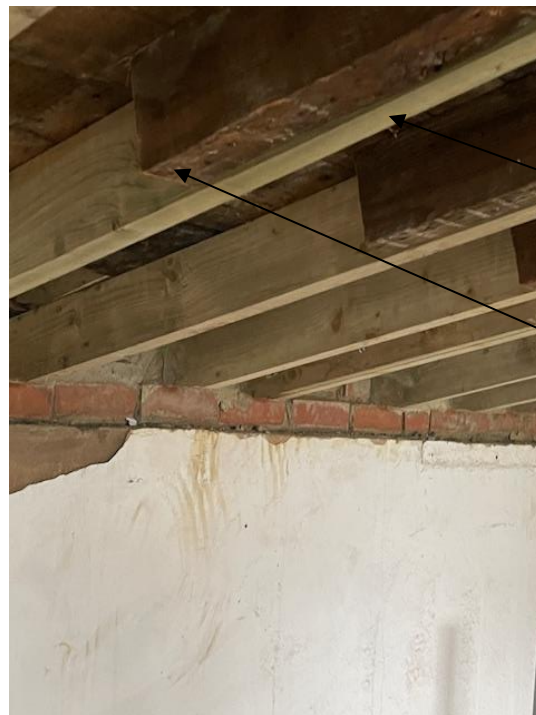
Photo 4

Rafter splice connection. New and original timber sections bolted together.

Original timber section cut 1m away from wallplate

Rafter Splice Connection

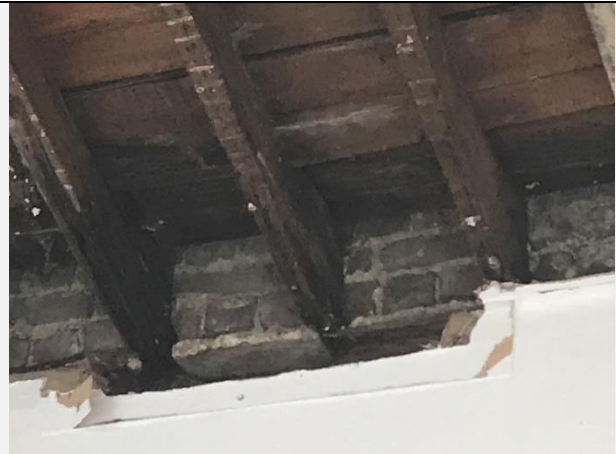
DRAMA ROOM

Heavy wet rot and dry rot attacks to the rear wall plates and rafter ends.

I suspect that recent/previous leaks to the valley, between the drama room roof, the rear windows and leaking guttering has caused the wet rot and the dry rot attacks. Your building maintenance contractor will be conducting all necessary repairs, as discussed.

- Carry out thorough eradication of *Serpula lacrymans* (dry-rot fungus) in accordance with our recommendations and quotations (within the areas shown in yellow on our floor plan.

We recommend that the wall plaster be removed from the ceiling down 1m. We propose to carry our Dry Rot masonry treatment to the rear walls and a fungicidal treatment to the exposed timbers, as discussed.

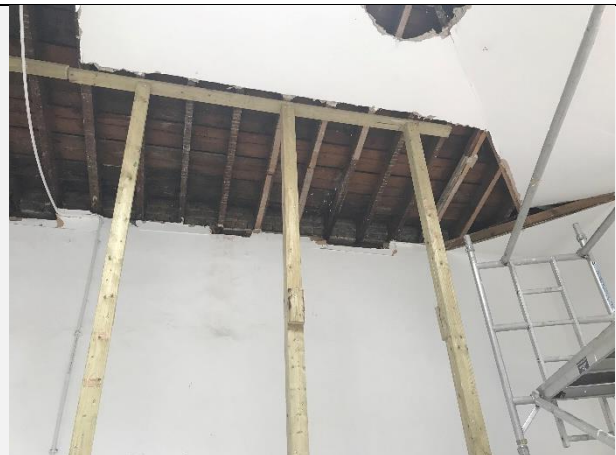
DRAMA ROOM

Heavy wet rot and dry rot attacks to the rear wall plates and rafter ends.
