**TREE SURVEY AND ARBORICULTURAL
IMPACT ASSESSMENT IN RELATION TO
PROPOSED DEVELOPMENT AT
50 THE VINEYARD,
RICHMOND,
SURREY,
TW10 6AT.**

October 2021.

Tree Survey and Arboricultural Impact Assessment in Relation to Proposed Development at 50 The Vineyard, Richmond, Surrey, TW10 6AT.

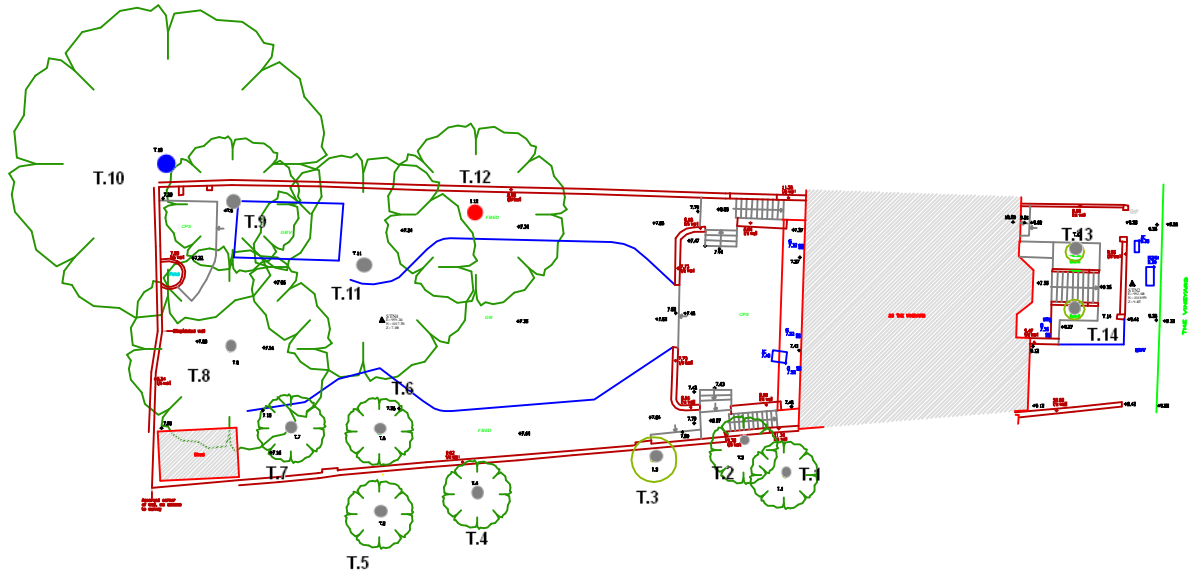
Appendix 'b'
Tree Locations.

3. I have been supplied with a copy of the Existing Site Plan and enclose an annotated copy of this drawing as appendix 'b' to this report which indicates the position of the trees with their respective identification numbers (Tree Location Plan).

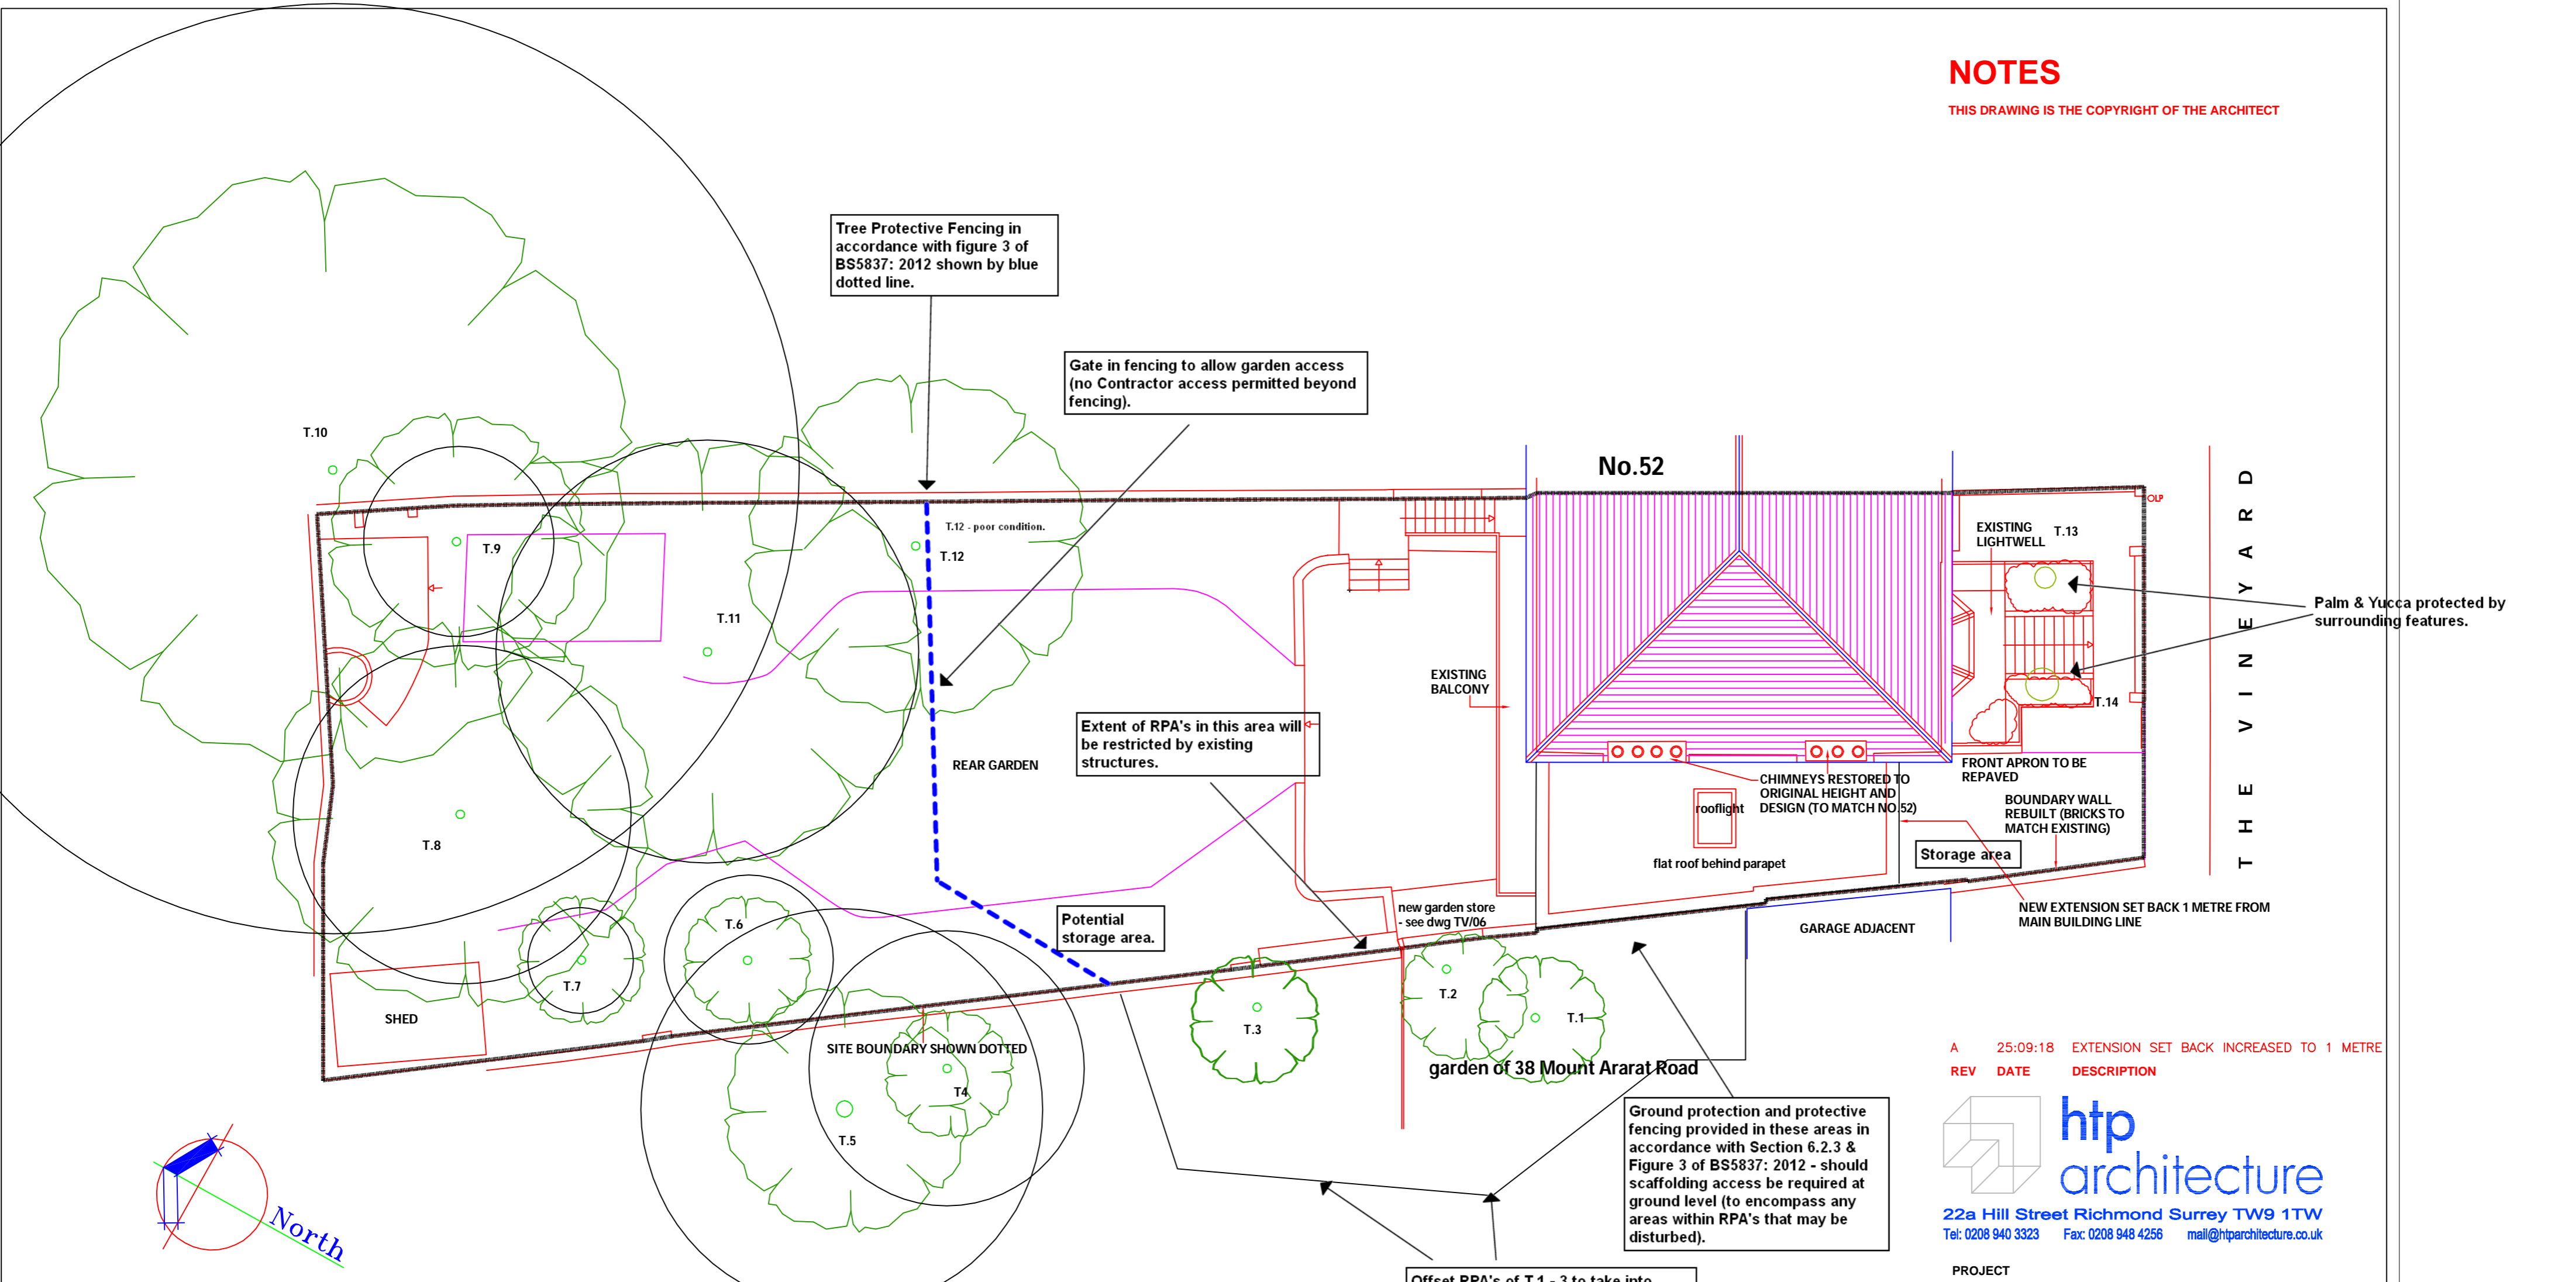
Appendix 'f'
Tree Protection Plan.

Extent of RPA's in this area will be restricted by existing structures.

Offset RPA's of T.1 - 3 to take into account impediment caused by structures.

Palm & Yucca protected by surrounding features.

Tree Protective Fencing in accordance with figure 3 of BS5837: 2012 shown by blue dotted line.

Gate in fencing to allow garden access (no Contractor access permitted beyond fencing).

Ground protection and protective fencing provided in these areas in accordance with Section 6.2.3 & Figure 3 of BS5837: 2012 - should scaffolding access be required at ground level (to encompass any areas within RPA's that may be disturbed).
