49 & 51 KEW GREEN

Parapet and Flank Wall repairs

July 2024

- 1.1 Martin Ashley Architects (MAA) have prepared the below document for remedial masonry and lead works at 49 & 51 Kew Green, on behalf of the Royal Botanic Gardens Kew.

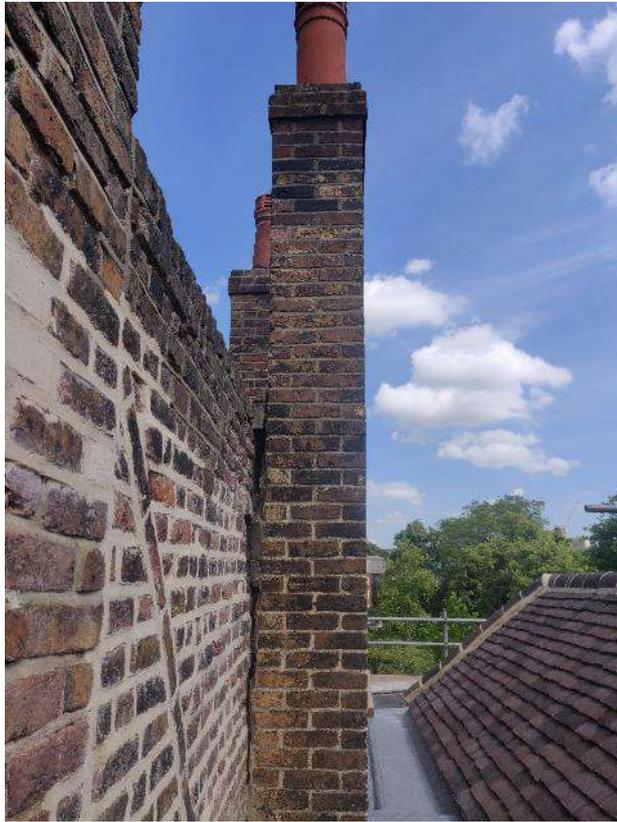
- 3.19 Once the reconstruction in Parapet Area B is complete the gap between this area and Stack 2 will be reviewed. It is envisaged that on reconstruction the gap will have reduced somewhat, but the joint will require deep packing and pointing up to prevent water ingress.

Chimney 2 – once reconstruction complete it is anticipated the opening vertical joint will reduce, but will still require deep packing and pointing, with a lead flashing detail over the gap between stack and parapet coping.

- 4.5 Allow to replace soakers and flashings to stacks 1 and 3.
- 4.6 Behind stack 2, allow to install a lead parapet capping over the reinstated detail to weather the junction of the stack and parapet wall, dressed, plugged and screwed into joints of stack and with a continuous copper clip on the parapet coping.

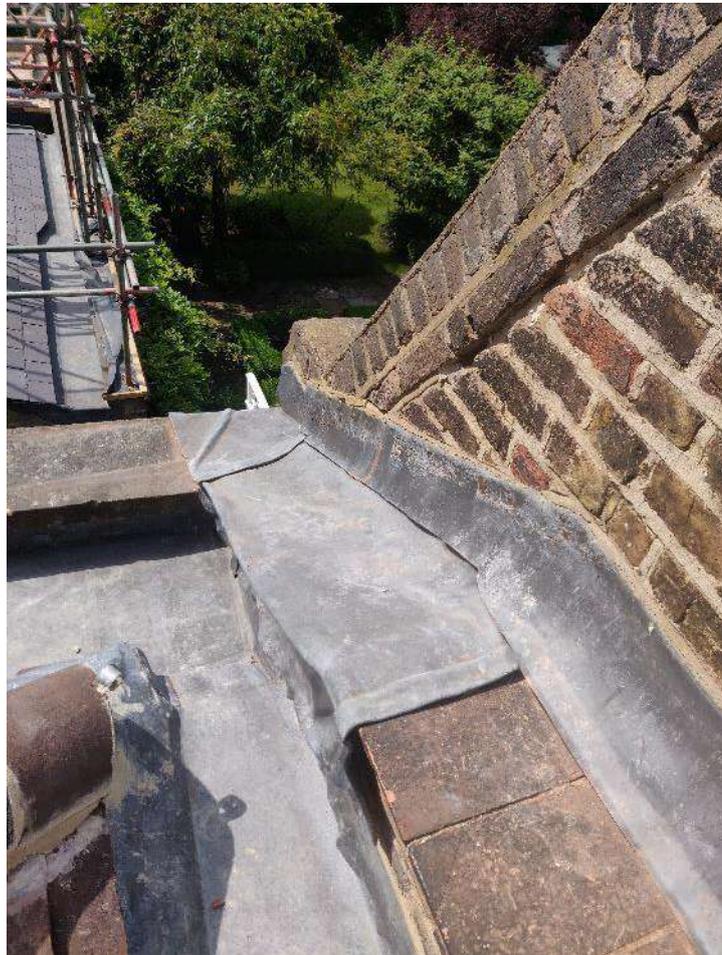
Flank wall to 51 – Awkward detail at south end which will require confirmation once parapet revision complete.

- 4.7 At the south end of the 51 Flank wall the lead capping of the low level tile creasing will require confirmation before commencement. Assume for tender purposes that the same detail runs through, but the exact weathering will require confirmation once the parapet reconstruction is complete.

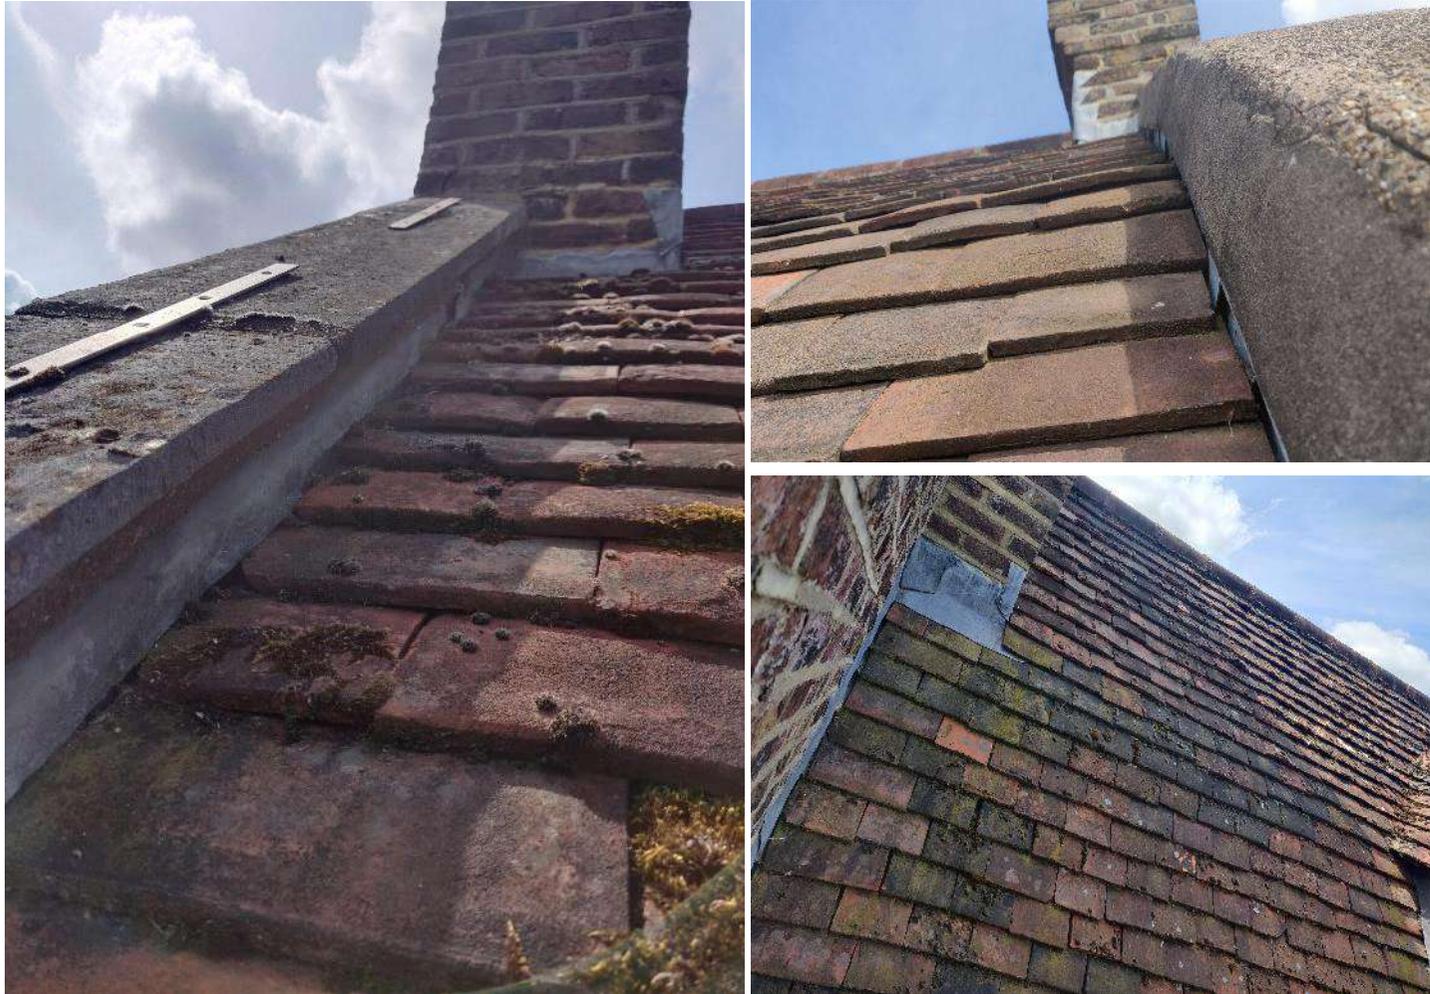
Left: Rear of parapet detail at detail A. **Top right:** Rear of parapet at Detail C. **Bottom Right:** Rear of parapet at Detail B.

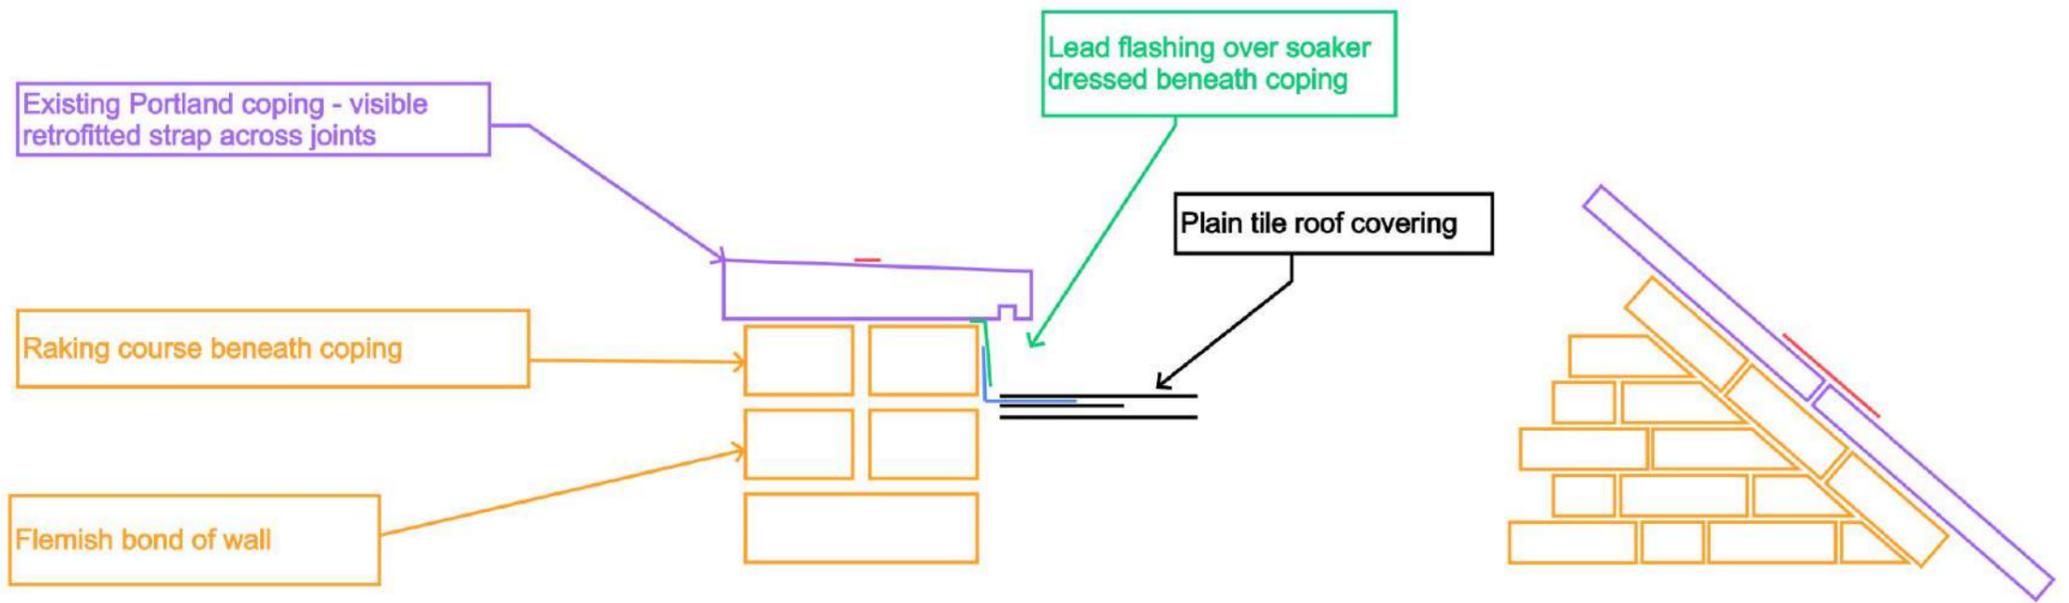
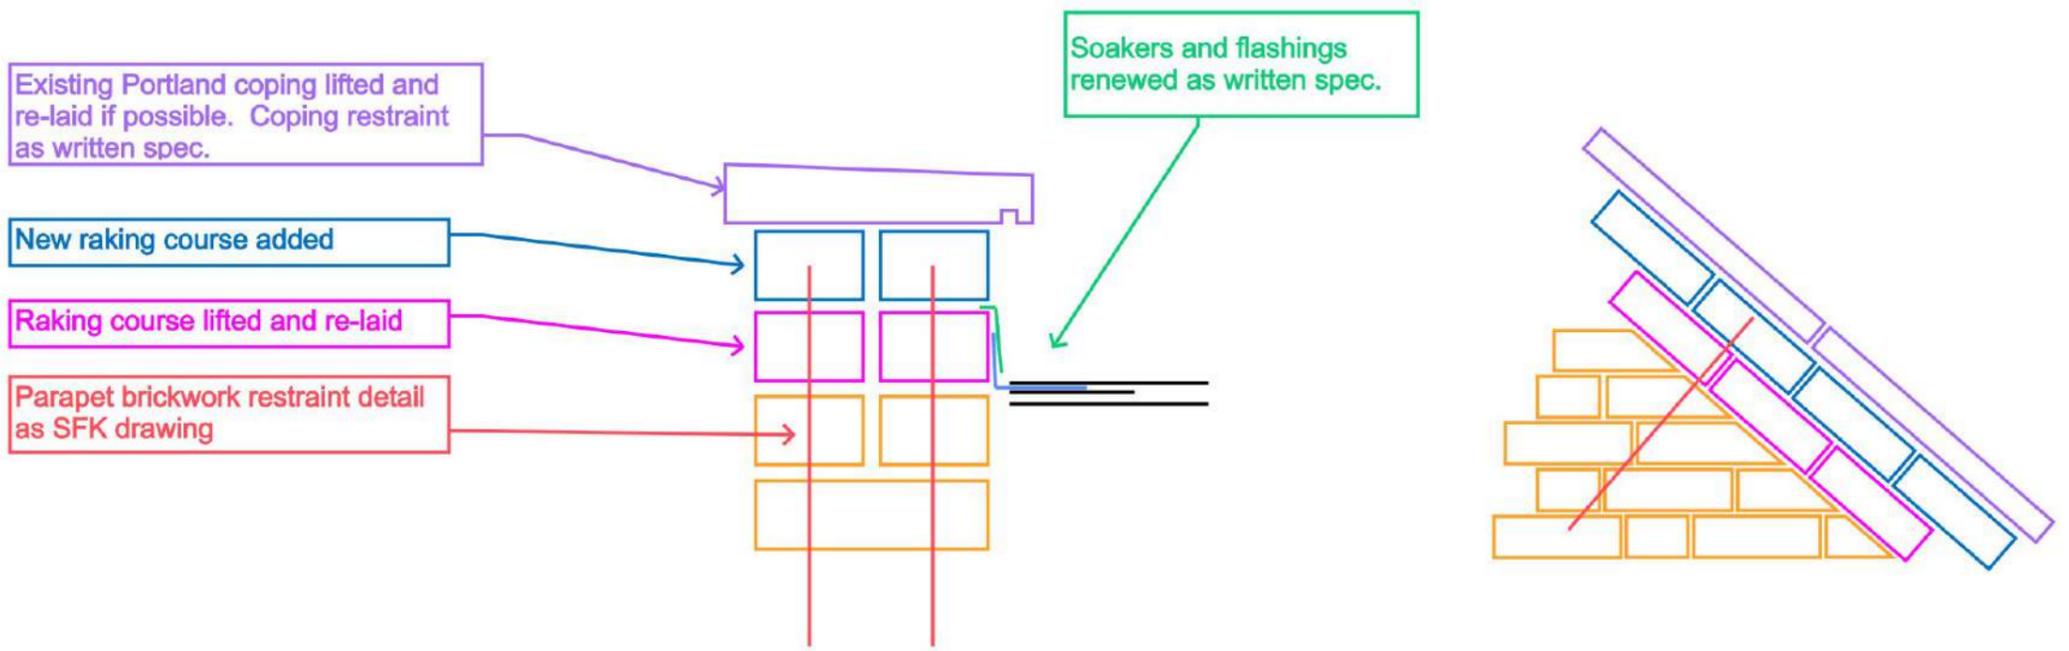
<p>MARTIN ASHLEY ARCHITECTS</p> <p>46-48 London Road, Twickenham, Middlesex, TW1 3RJ T +44 (0) 20 8948 7788 www.ma-arch.co.uk</p>	Title: Parapet detail A	
	Date: 12/07/2024	Drawn by: KK
Project: 49 & 51 Kew Green	Drawing Number: 2279-13-KK001

Parapet Detail A - As EXISTING - Section through and outer elevation

Parapet Detail A - As PROPOSED - Section through and outer elevation

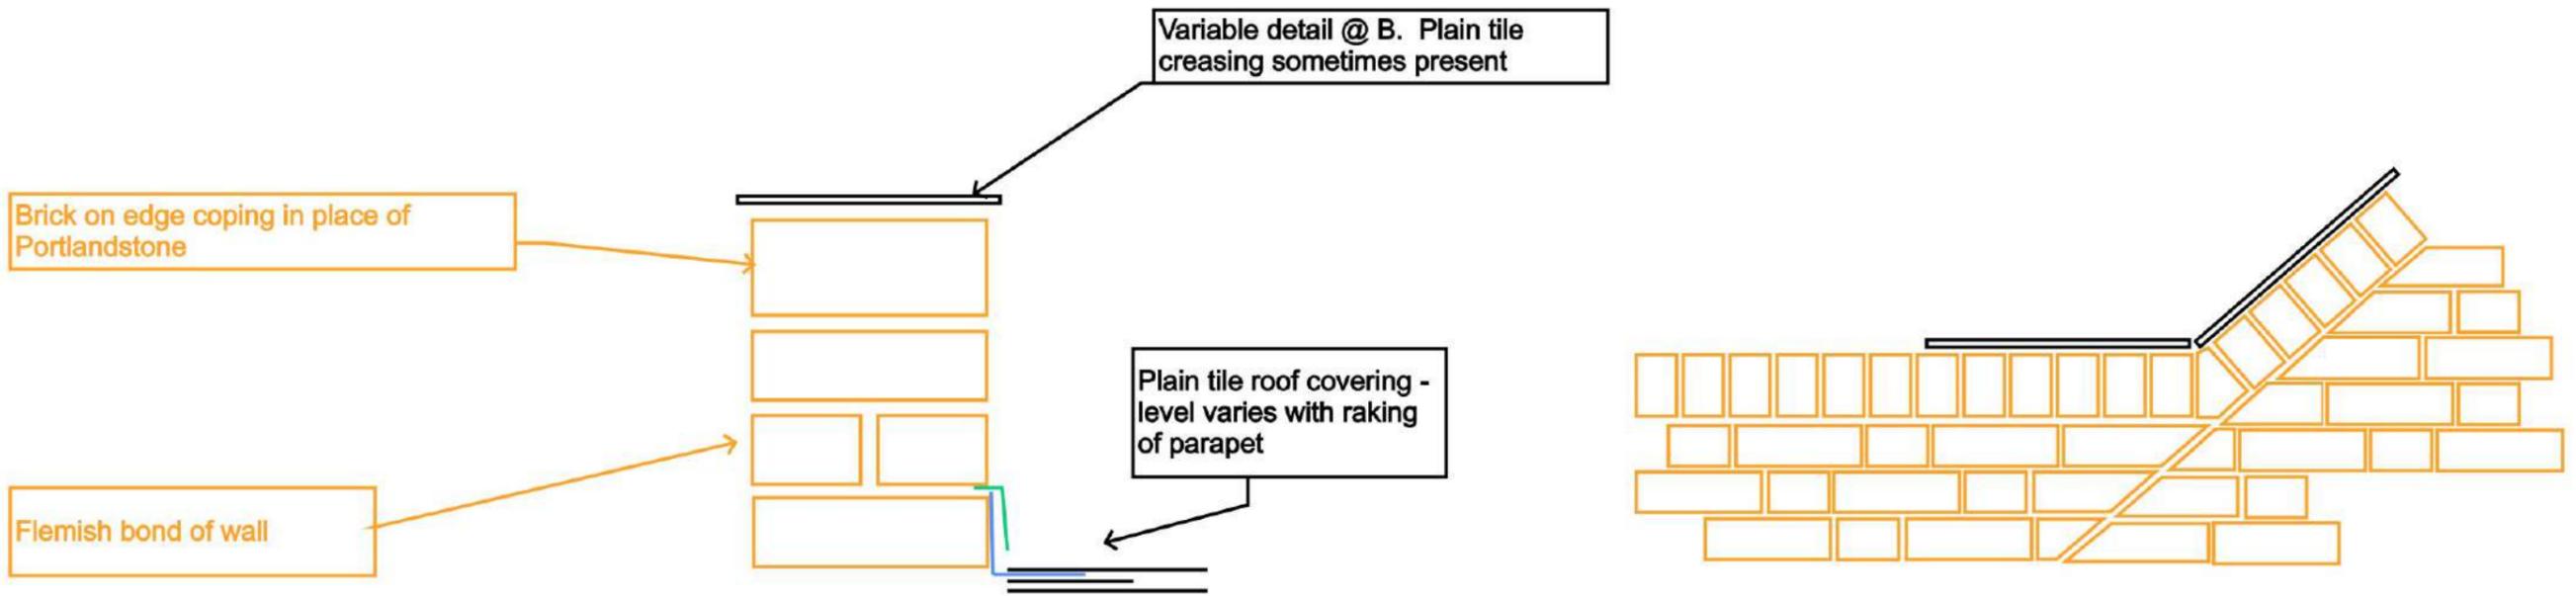
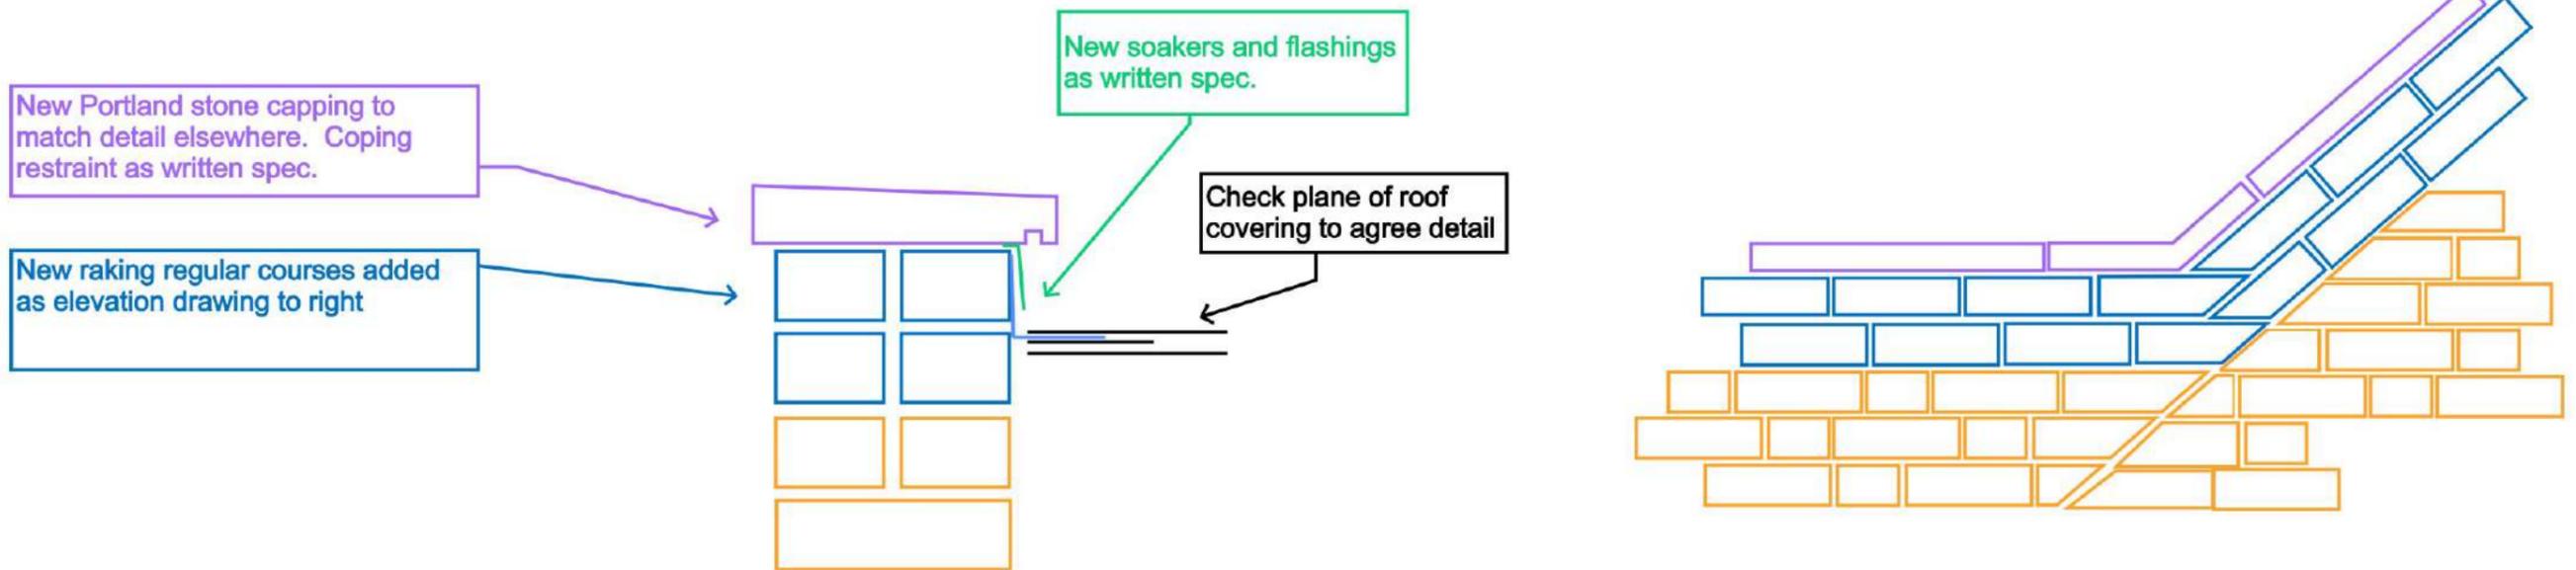
<p>MARTIN ASHLEY ARCHITECTS</p> <p>46-48 London Road, Twickenham, Middlesex, TW1 3RJ T +44 (0) 20 8948 7788 www.ma-arch.co.uk</p>	Title: Parapet Detail B	
	Date: 12/07/2024	Drawn by: KK
Project: 49 & 51 Kew Green	Drawing Number: 2279-13 - KK002

Parapet Detail B - As EXISTING - Section through and outer elevation

Parapet Detail B - As PROPOSED - Section through and outer elevation

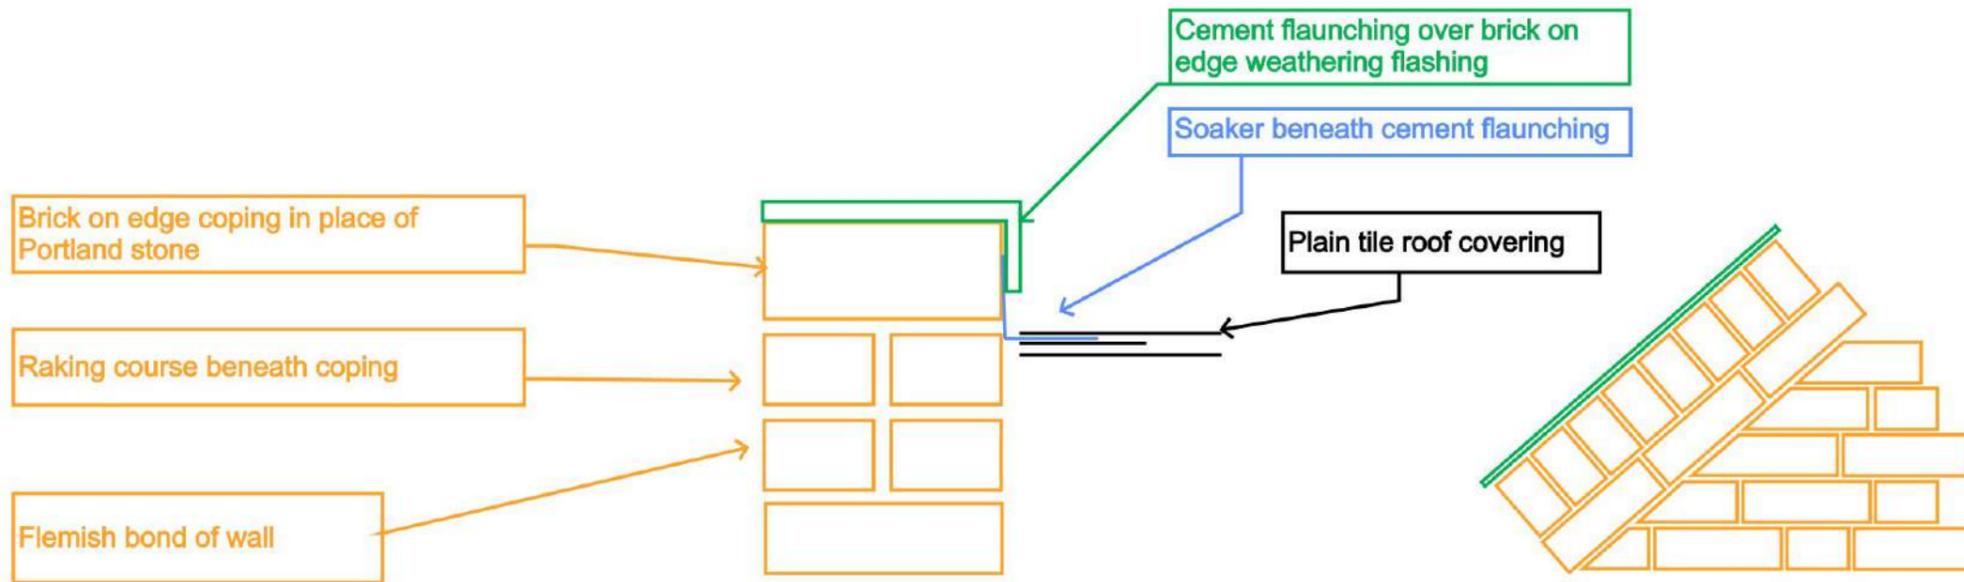
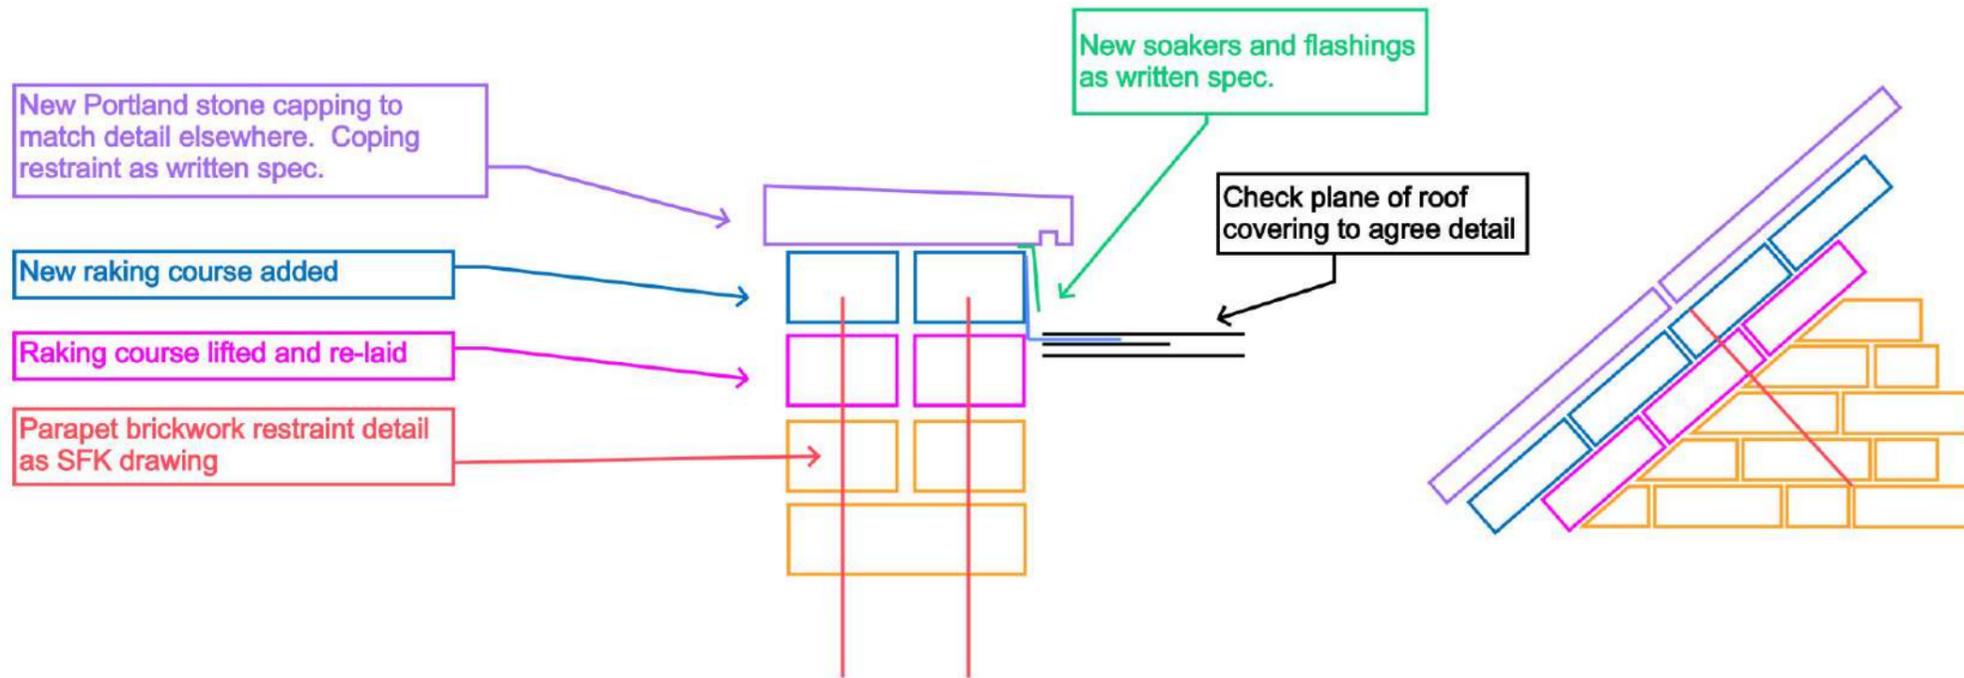
<p>MARTIN ASHLEY ARCHITECTS 46-48 London Road, Twickenham, Middlesex, TW1 3RJ T +44 (0) 20 8948 7788 www.ma-arch.co.uk</p>	Title: Parapet Detail C	
	Date: 12/07/2024	Drawn by: KK
Project: 49 & 51 Kew Green		Drawing Number: 2279-13 - KK003

Parapet Detail C - As EXISTING - Section through and outer elevation

Parapet Detail C - As PROPOSED - Section through and outer elevation

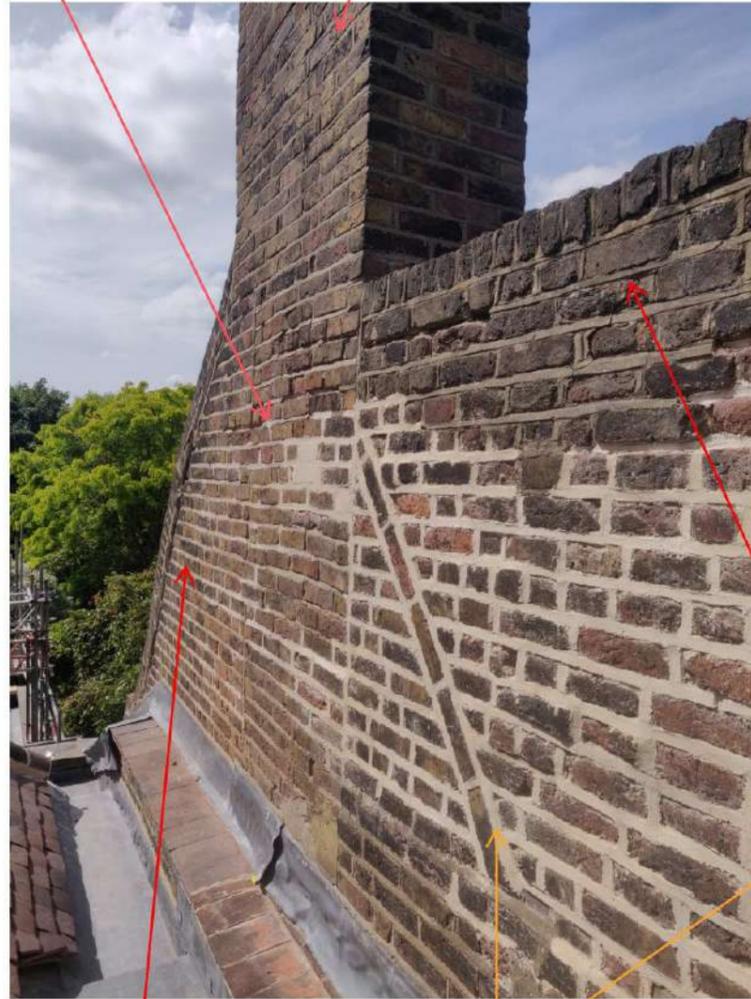
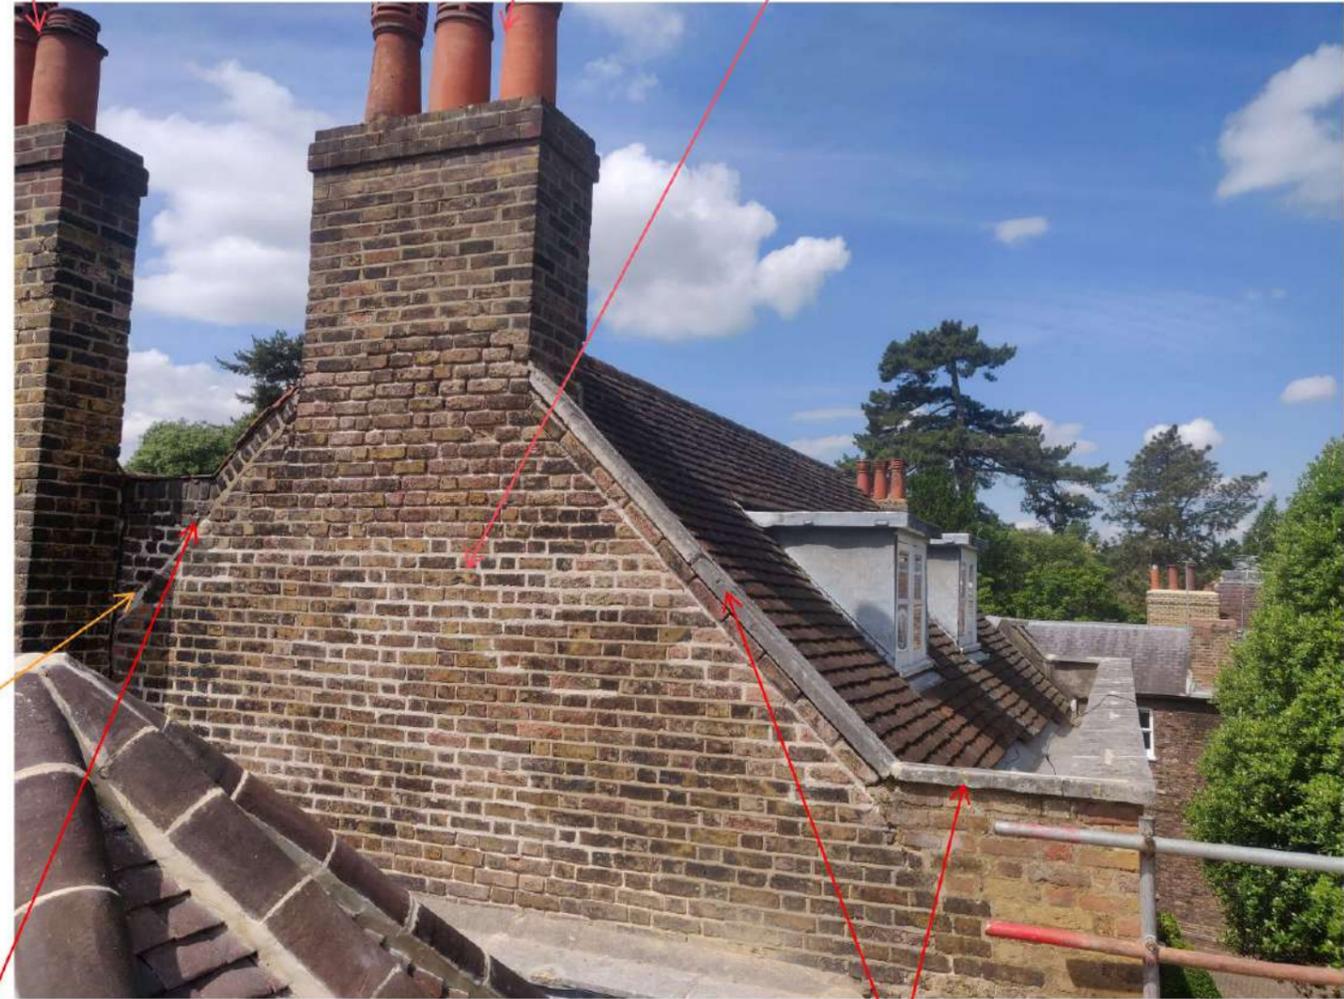
<p>MARTIN ASHLEY ARCHITECTS</p> <p>46-48 London Road, Twickenham, Middlesex, TW1 3RJ T +44 (0) 20 8948 7788 www.ma-arch.co.uk</p>	Title:	
	51 Kew Green wall photographs	
Project:	Date: 14/07/2024	Drawn by: KK
	Drawing Number:	
49 & 51 Kew Green	2279-13 - KK004

- 1.4 It is evident that 51 Kew Green used to form a M shaped pair of gables, following the line of the roof behind. Evidence exists in the wall for raking brickwork courses of the original gable line. Alterations have evidently been undertaken, including it is assumed the replacement of Portland copings with brick on edge details. These alterations have questionable weathering details and the brickwork in the areas of Parapet detail B and C are both live and unsound.

Historic raking course/line where previous gable ends infilled

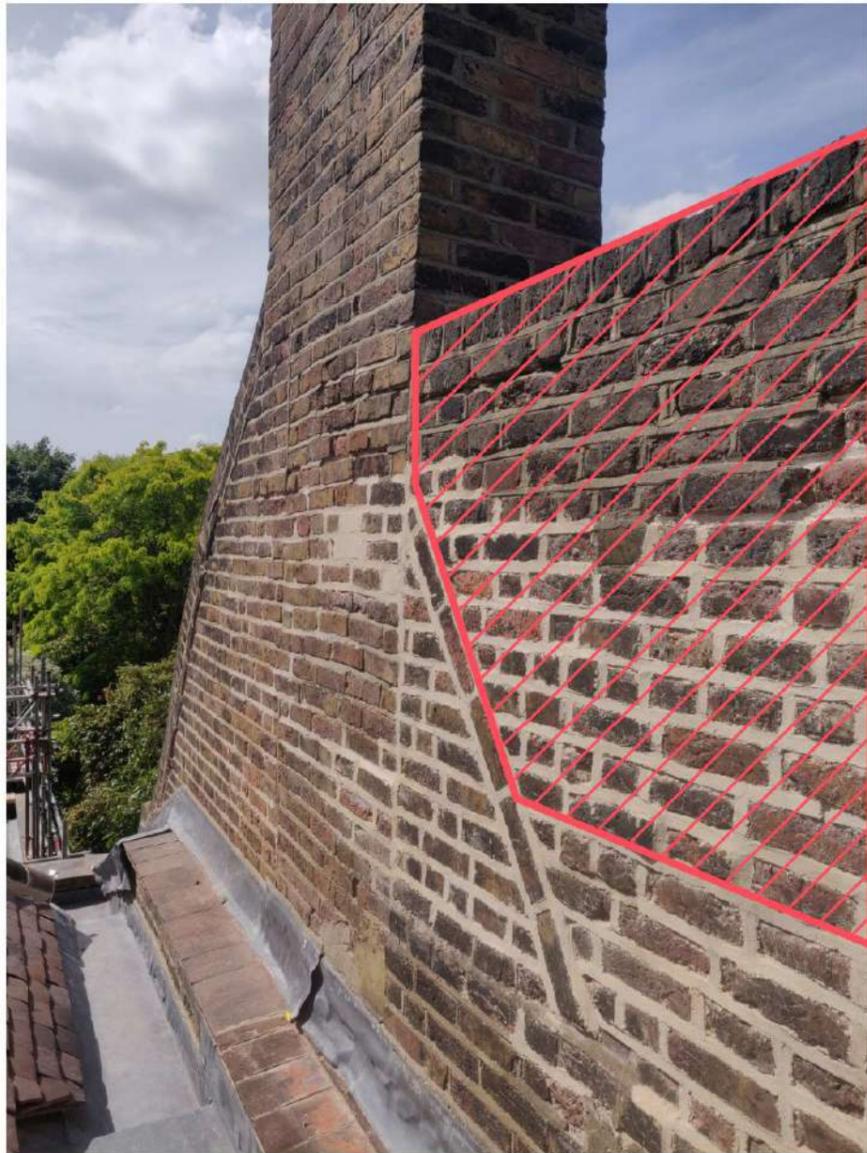
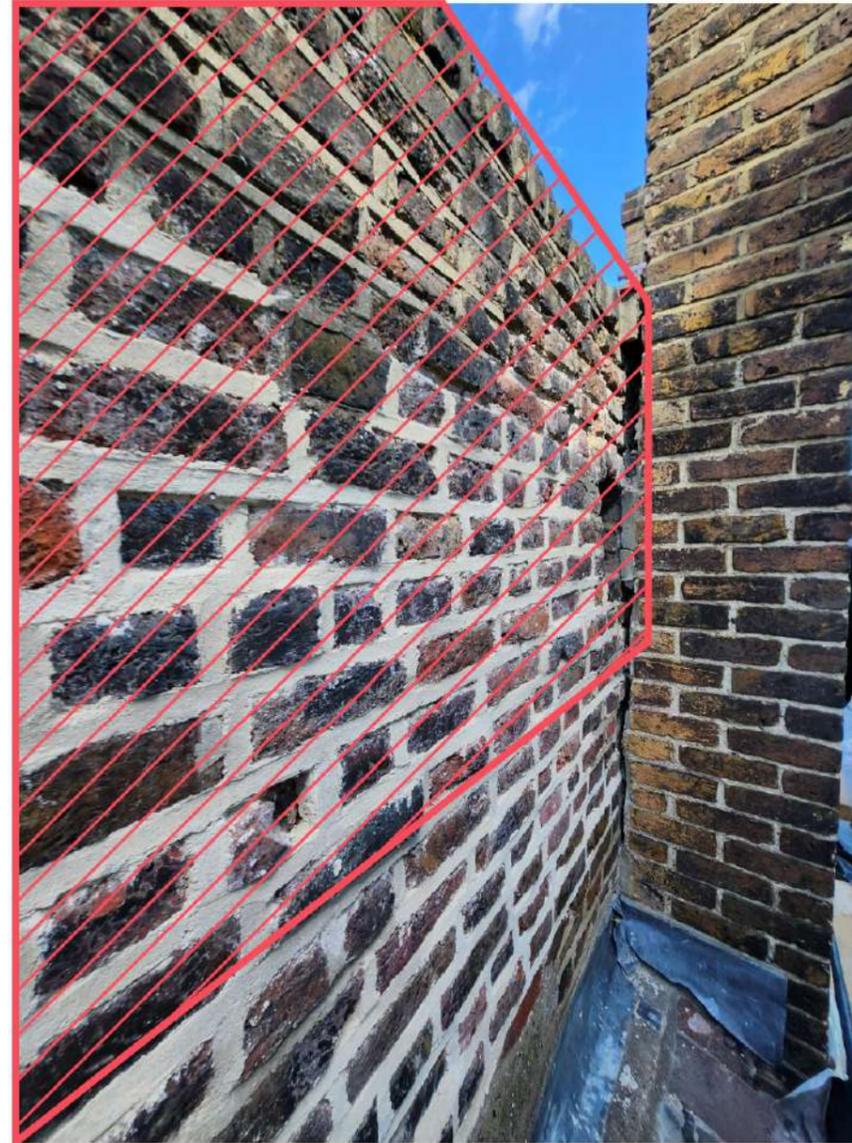
MARTIN ASHLEY ARCHITECTS 46-48 London Road, Twickenham, Middlesex, TW1 3RJ T +44 (0) 20 8948 7788 www.ma-arch.co.uk	Title: Reconstruction extent to 51	
	Date: 14/07/2024	Drawn by: KK
Project: 49 & 51 Kew Green	Drawing Number: 2279-13 - KK005

Reconstruction of infill between gables 1 and 2 - In area of Parapet detail B

Take down carefully, clean mortar from bricks and reconstruct - cap with Parapet detail B as proposed

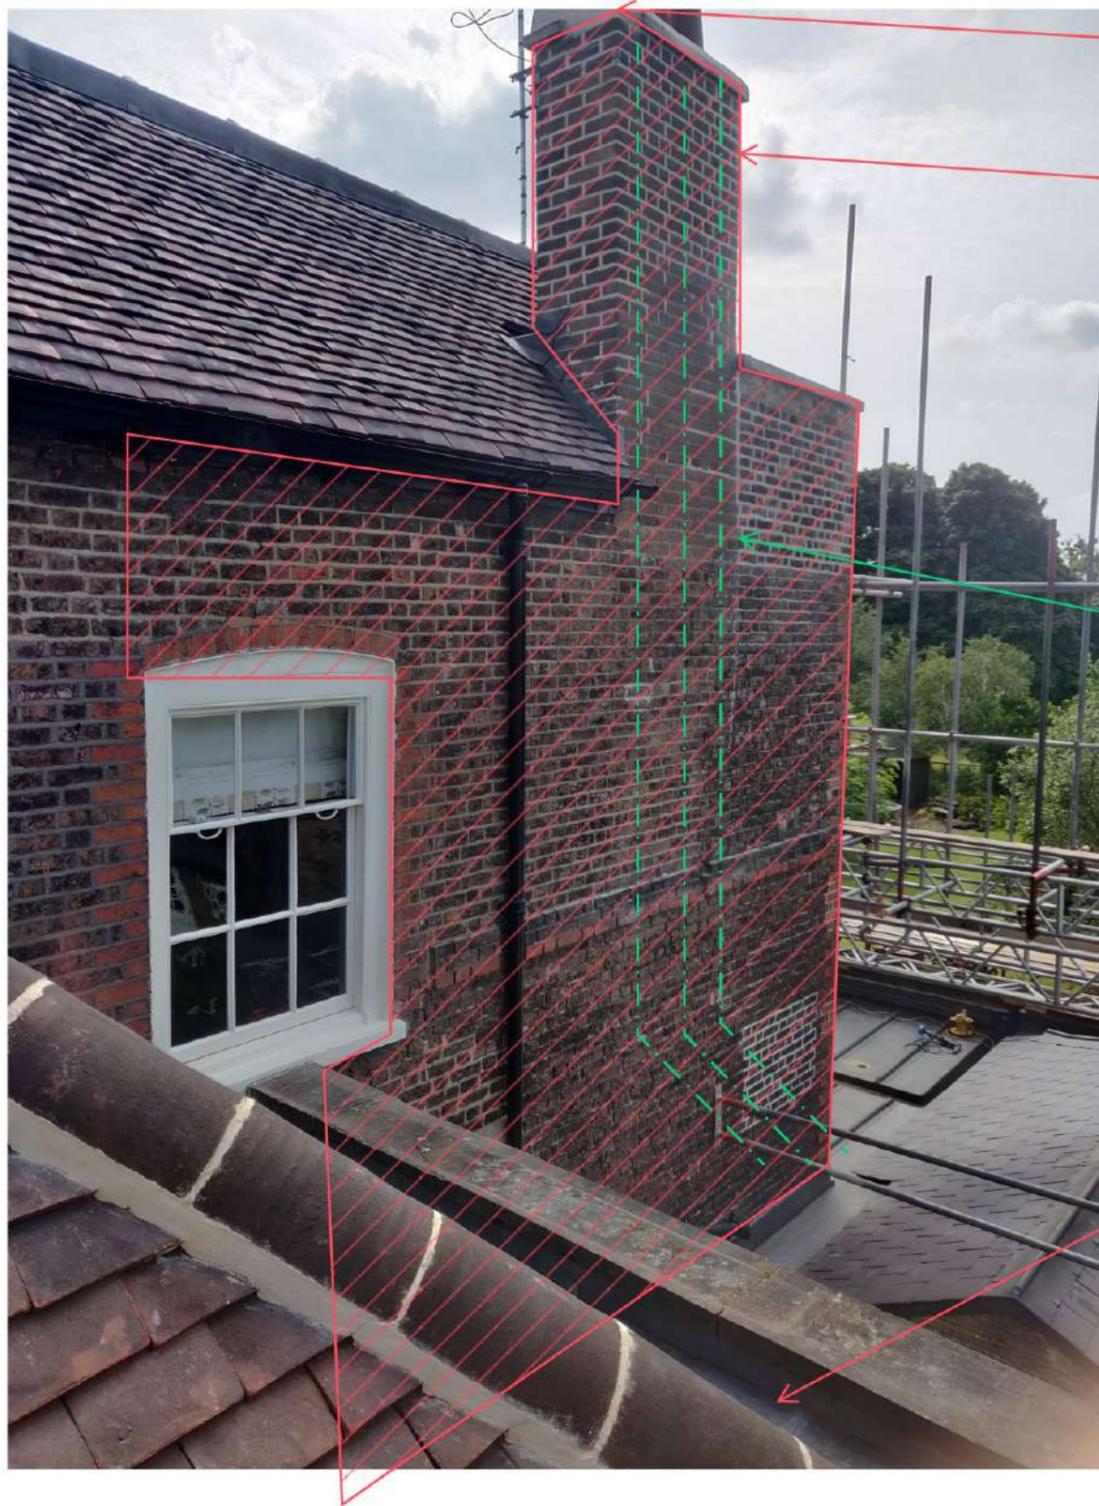
MARTIN ASHLEY ARCHITECTS 46-48 London Road, Twickenham, Middlesex, TW1 3RJ T +44 (0) 20 8948 7788 www.ma-arch.co.uk	Title:	
	49 Kew Green Flank Wall	
Project:	Date: 14/07/2024	Drawn by: KK
	Drawing Number:	
49 & 51 Kew Green	2279-13 - KK007

Line of flues with half brick cover. See SFK repair detail. Assume SFK repair detailed needed for full length of flue until stack reaches eaves. Call MAA and SFK as soon as scaffold access is in place for careful survey of elevation.

Complete indent repair to chimney capping

Rake out carefully by hand and repoint

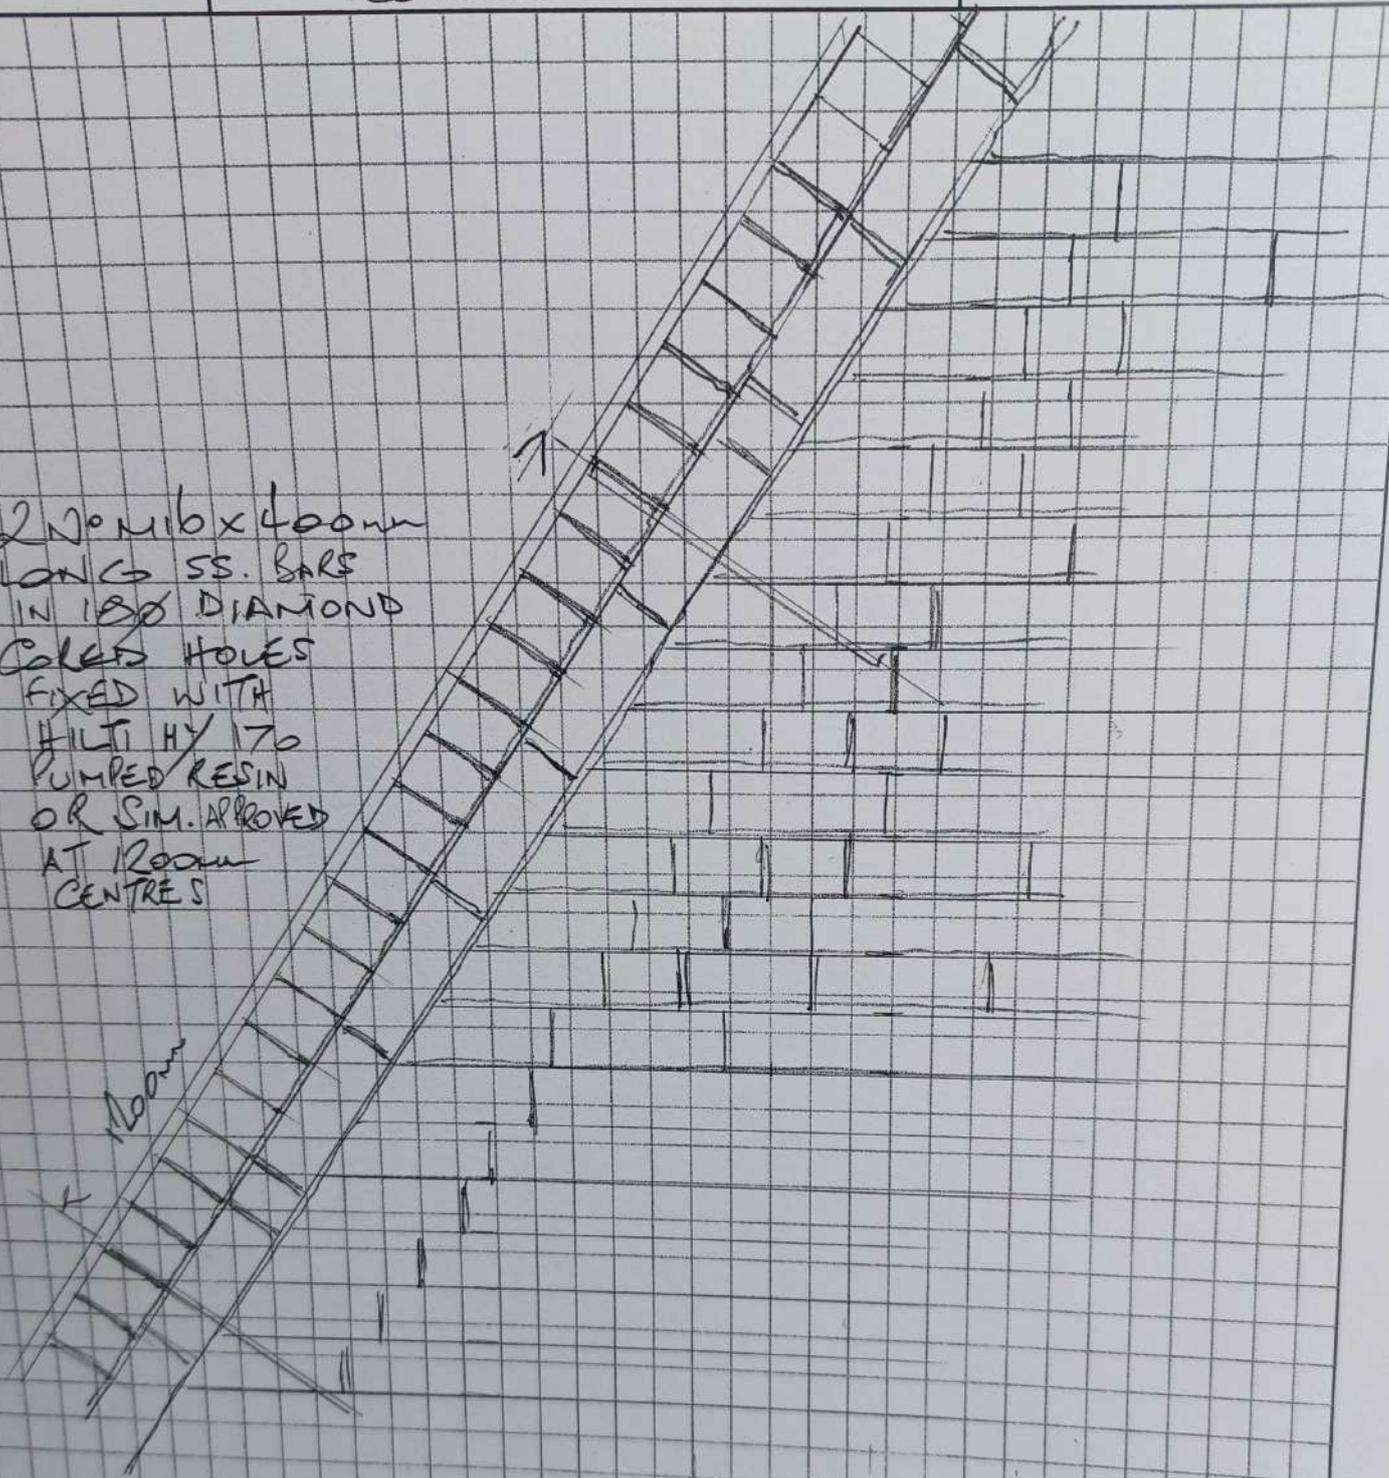
BRICKWORK CHIMNEY
EXACT INTERNAL PROFILE UNKNOWN. IT IS TO BE DETERMINED ON SITE BY CONTRACTOR

2 No M16 SS
BARS X 400mm
LONG
IN 180 DIAMOND
COLED HOLE
FIXED WITH
HILTI HY 170
RESIN OR
SIM. APPROVED

HORIZONTAL BEDJOINT REINFORCEMENT @ 4 BRICK COURSES. MIN. 300mm EMBEDMENT BEYOND CHIMNEY. USE HELIFIX HELIBARS SET IN HELIBOND CEMENTITIOUS GROUT.

3No. EACH SIDE STITCH REPAIR HELIBARS SET IN HELIBOND CEMENTITIOUS GROUT @ 300 VERTICAL CENTRES. EXACT DEPTH TBC ON SITE.

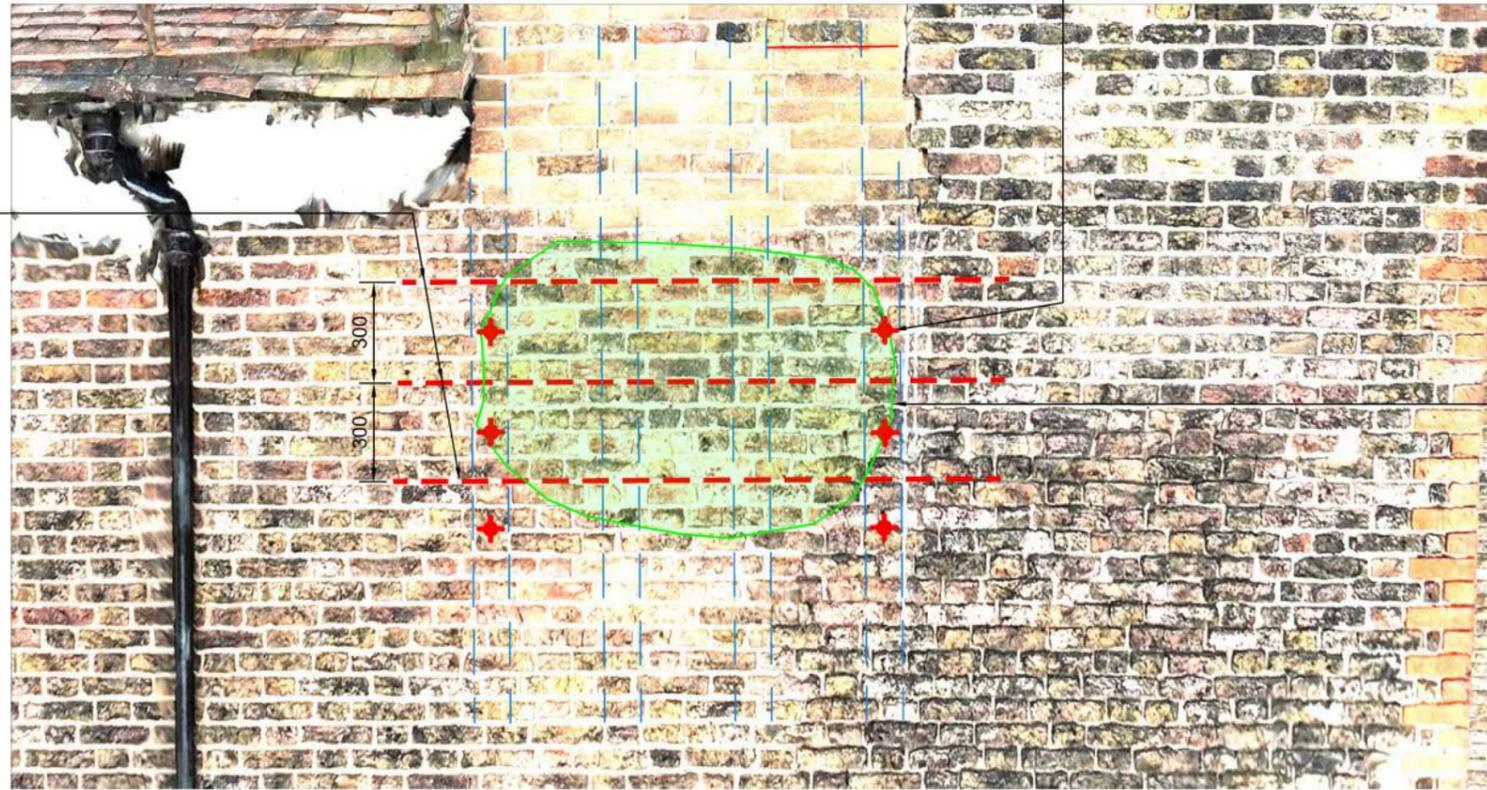
ELEVATION
NTS

EXTENT OF BULGING BRICKWORK
