49 & 51 KEW GREEN

Parapet and Flank Wall repairs

July 2024

Address: 49 & 51 Kew Green

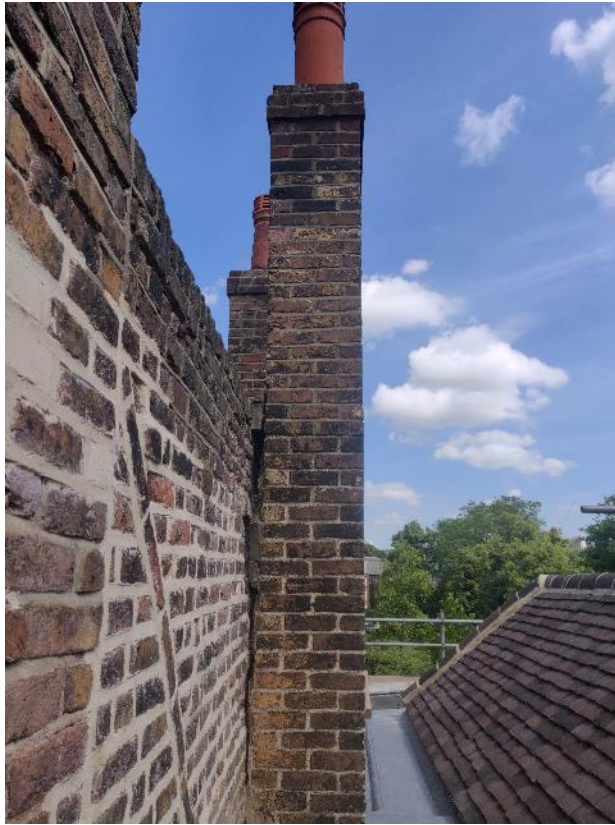
Chimney 2 – once reconstruction complete it is anticipated the opening vertical joint will reduce, but will still require deep packing and pointing, with a lead flashing detail over the gap between stack and parapet coping.

- 3.19 Once the reconstruction in Parapet Area B is complete the gap between this area and Stack 2 will be reviewed. It is envisaged that on reconstruction the gap will have reduced somewhat, but the joint will require deep packing and pointing up to prevent water ingress.

- 4.5 Allow to replace soakers and flashings to stacks 1 and 3.
- 4.6 Behind stack 2, allow to install a lead parapet capping over the reinstated detail to weather the junction of the stack and parapet wall, dressed, plugged and screwed into joints of stack and with a continuous copper clip on the parapet coping.

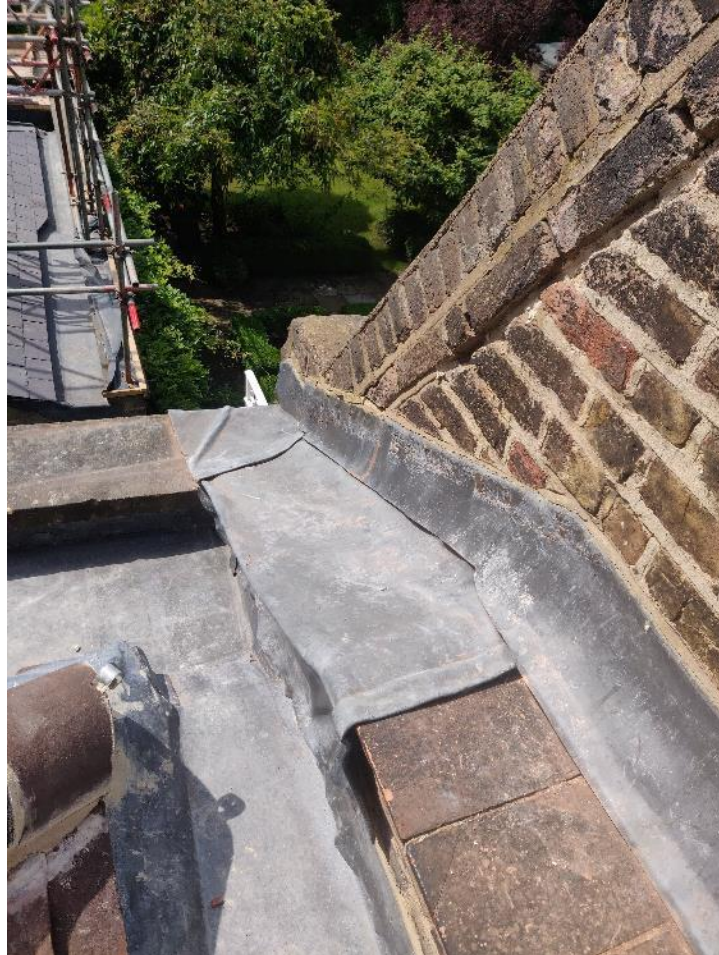
Flank wall to 51 – Awkward detail at south end which will require confirmation once parapet revision complete.

- 4.7 At the south end of the 51 Flank wall the lead capping of the low level tile creasing will require confirmation before commencement. Assume for tender purposes that the same detail runs through, but the exact weathering will require confirmation once the parapet reconstruction is complete.

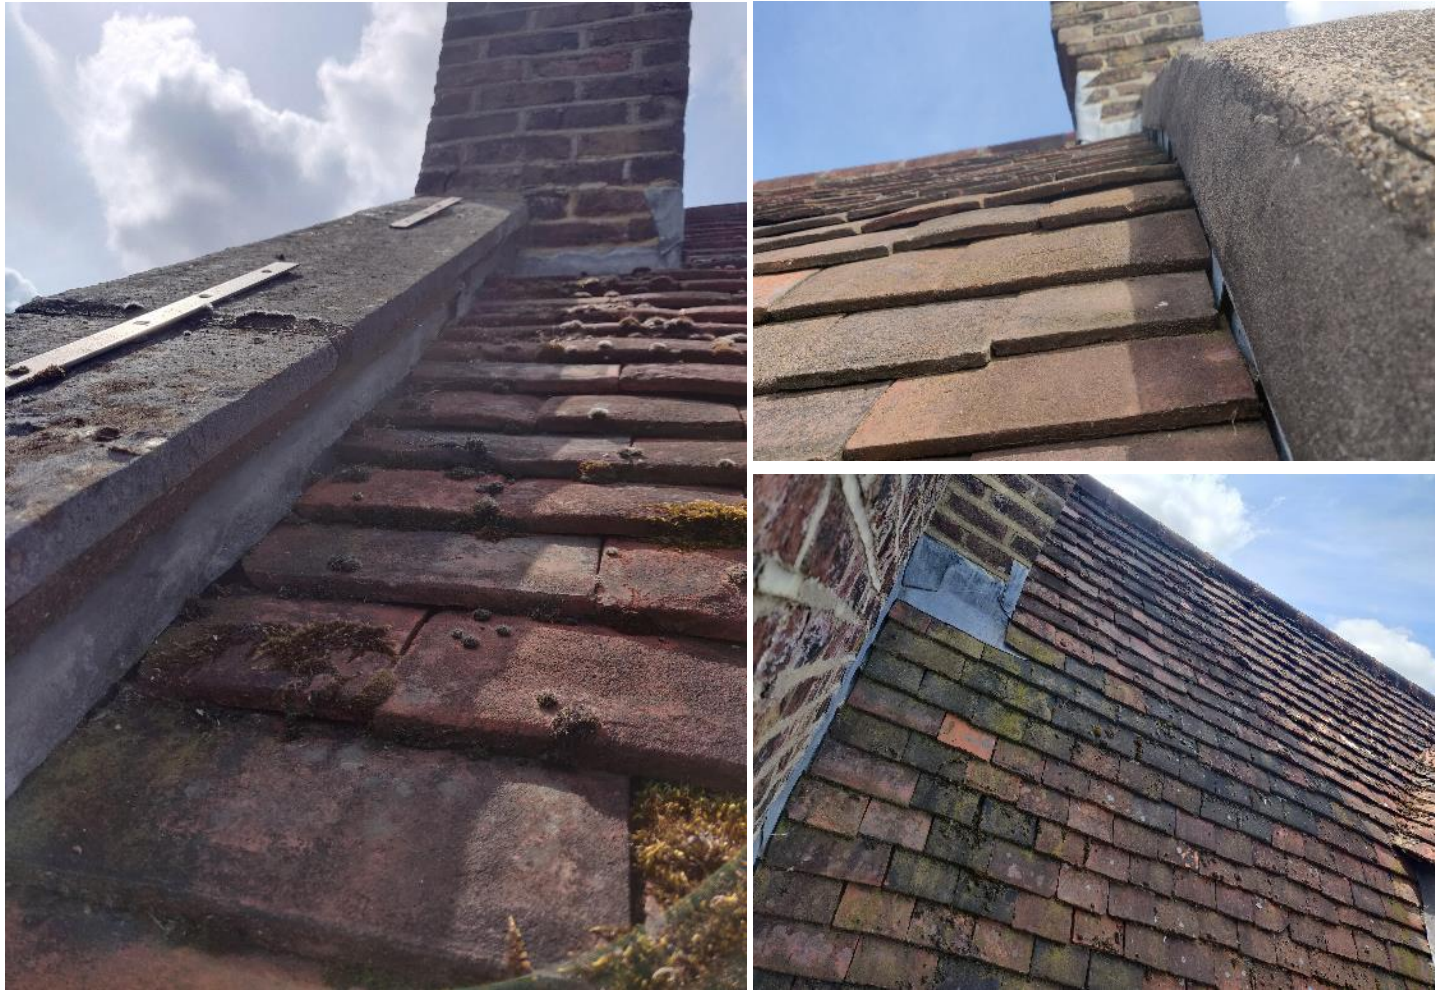
Left: Rear of parapet detail at detail A. **Top right:** Rear of parapet at Detail C. **Bottom Right:** Rear of parapet at Detail B.

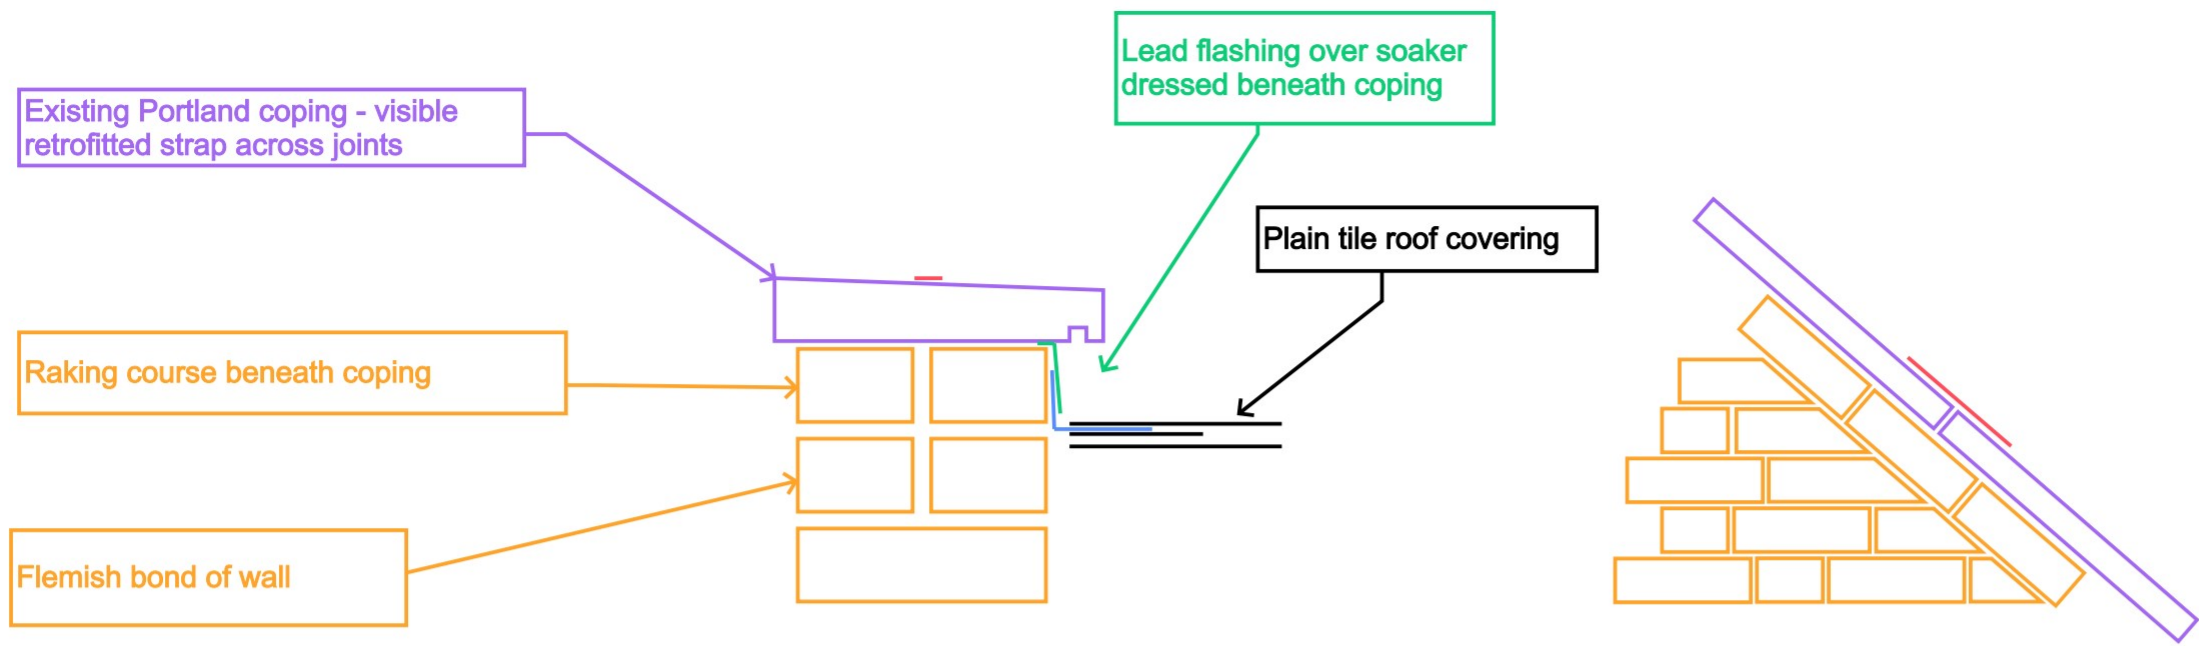
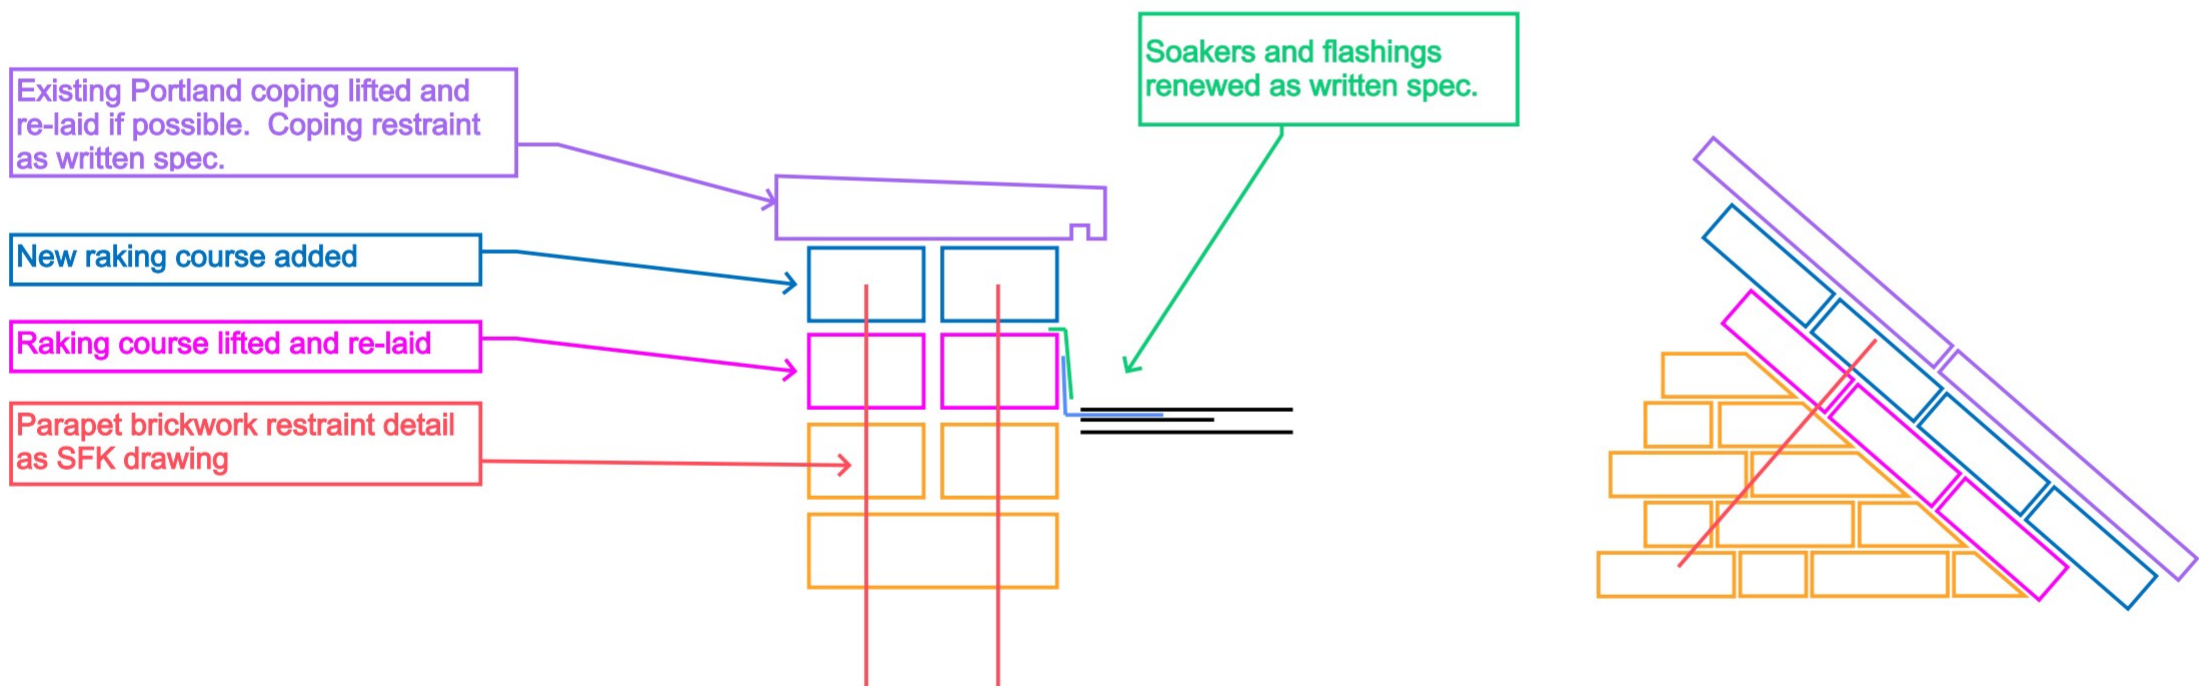
Parapet Detail A - As EXISTING - Section through and outer elevation

- 1.4 It is evident that 51 Kew Green used to form a M shaped pair of gables, following the line of the roof behind. Evidence exists in the wall for raking brickwork courses of the original gable line. Alterations have evidently been undertaken, including it is assumed the replacement of Portland copings with brick on edge details. These alterations have questionable weathering details and the brickwork in the areas of Parapet detail B and C are both live and unsound.

- 3.1 The extent of works is as shown on MAA drawings.
- 3.2 The existing parapet detail to the gable walls of 51 is to be taken down and reconstructed for its full length as shown on MAA drawings KK001, KK002 and KK003. More extensive reconstruction is required between Gable 1 and Gable 2 as shown on KK005. General repointing will be undertaken.
- 3.3 Remedial works and pointing are required to the flank wall of 49 as shown on drawing KK007.

Parapet Detail A - As PROPOSED - Section through and outer elevation

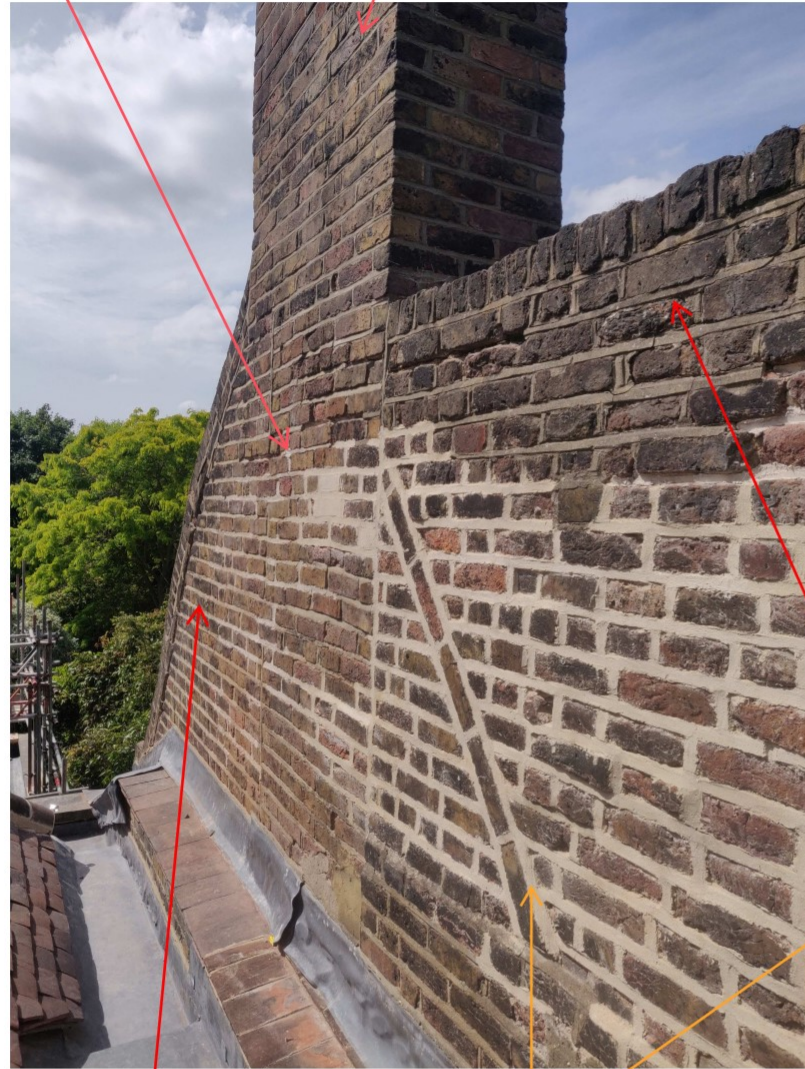
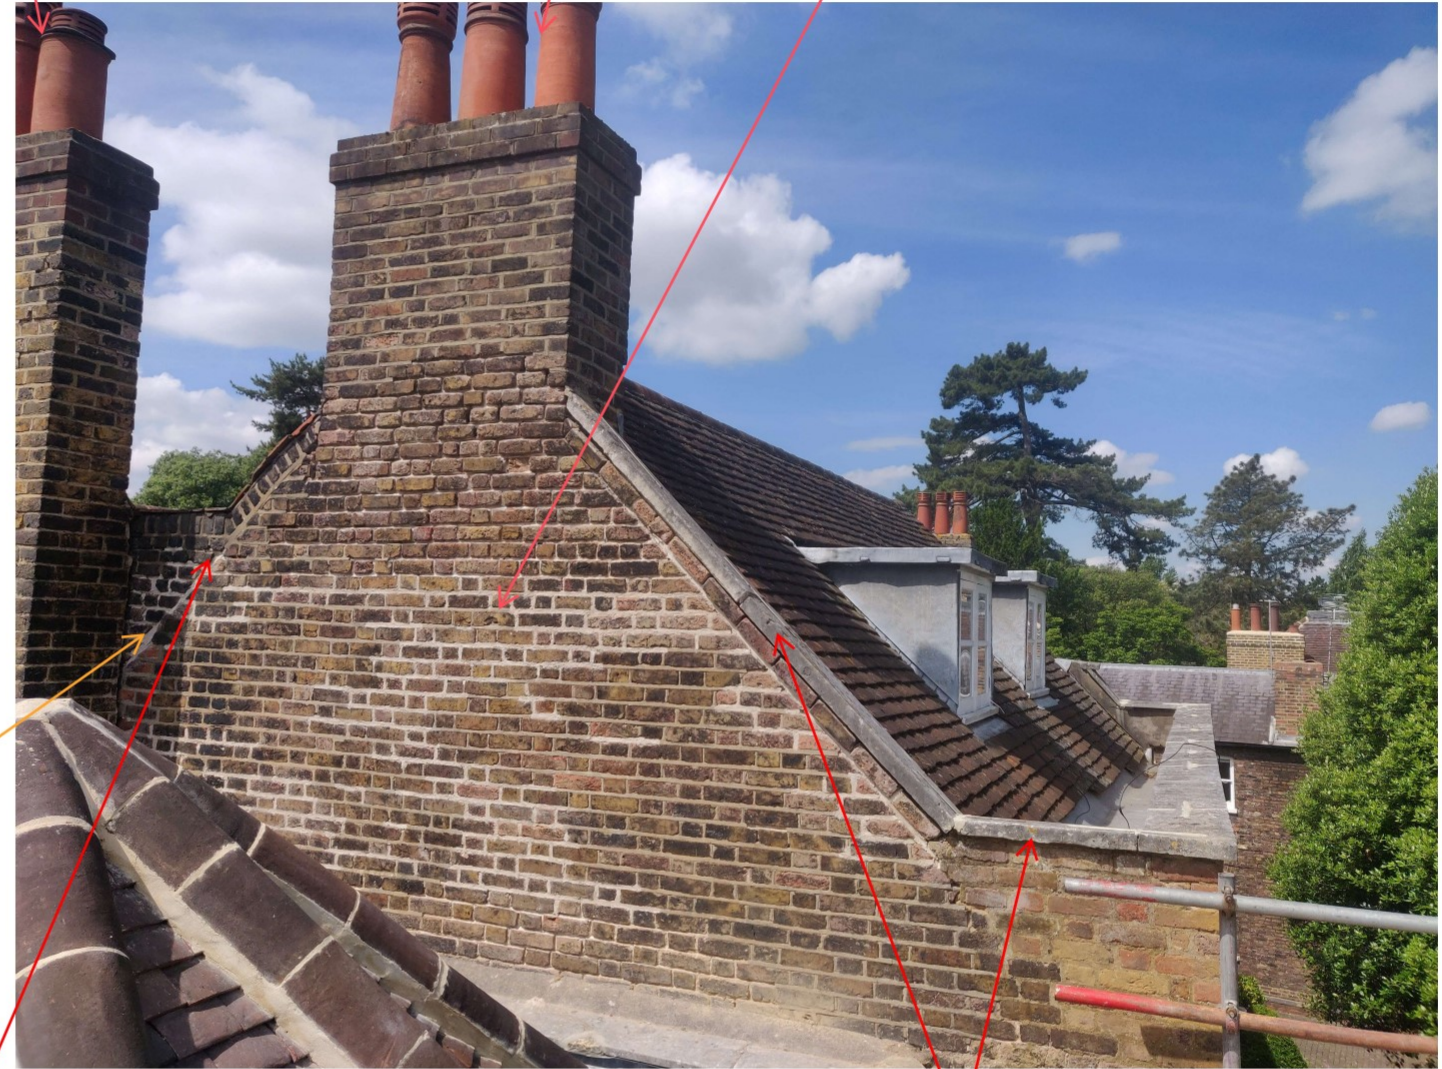
Historic raking course/line where previous gable ends infilled

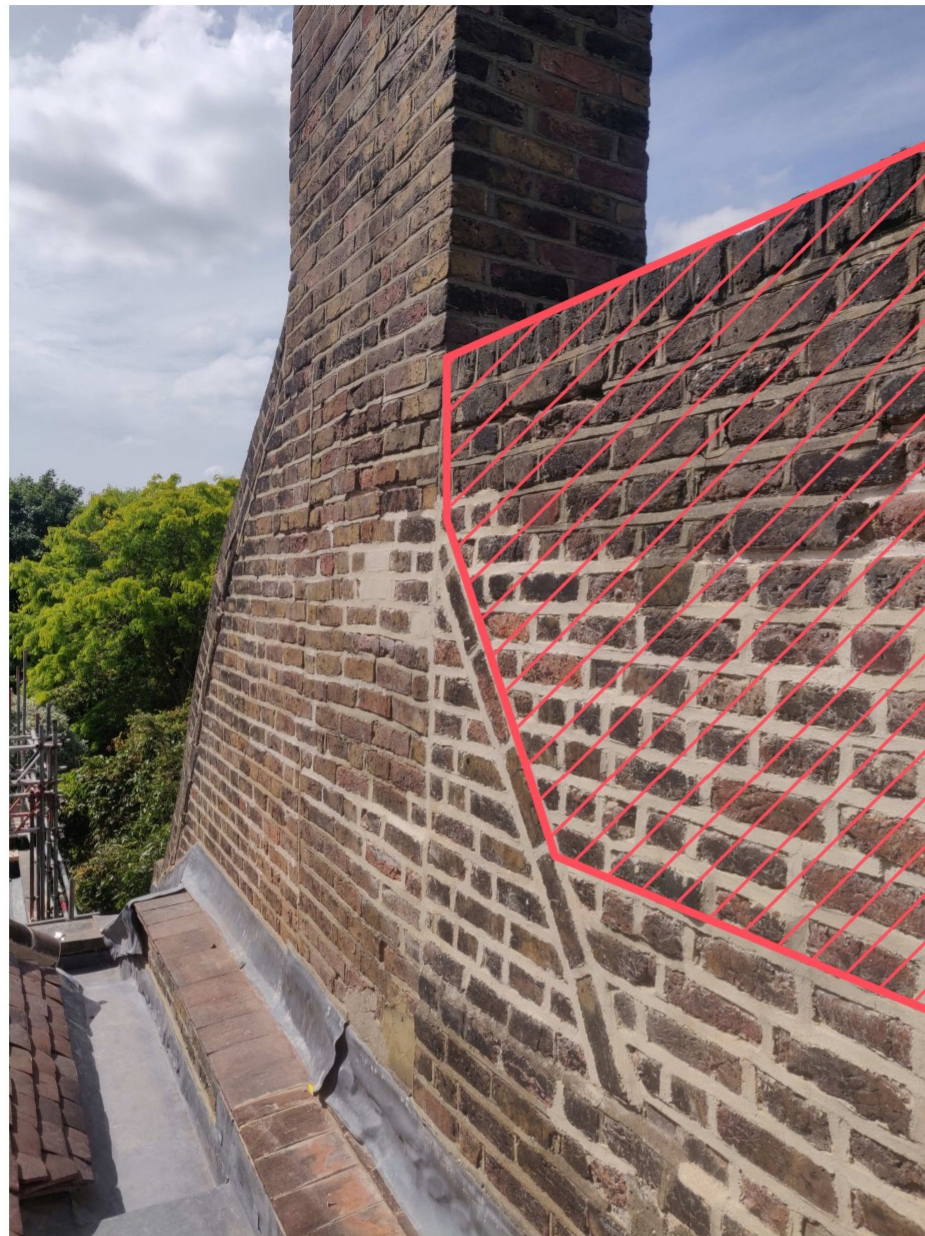
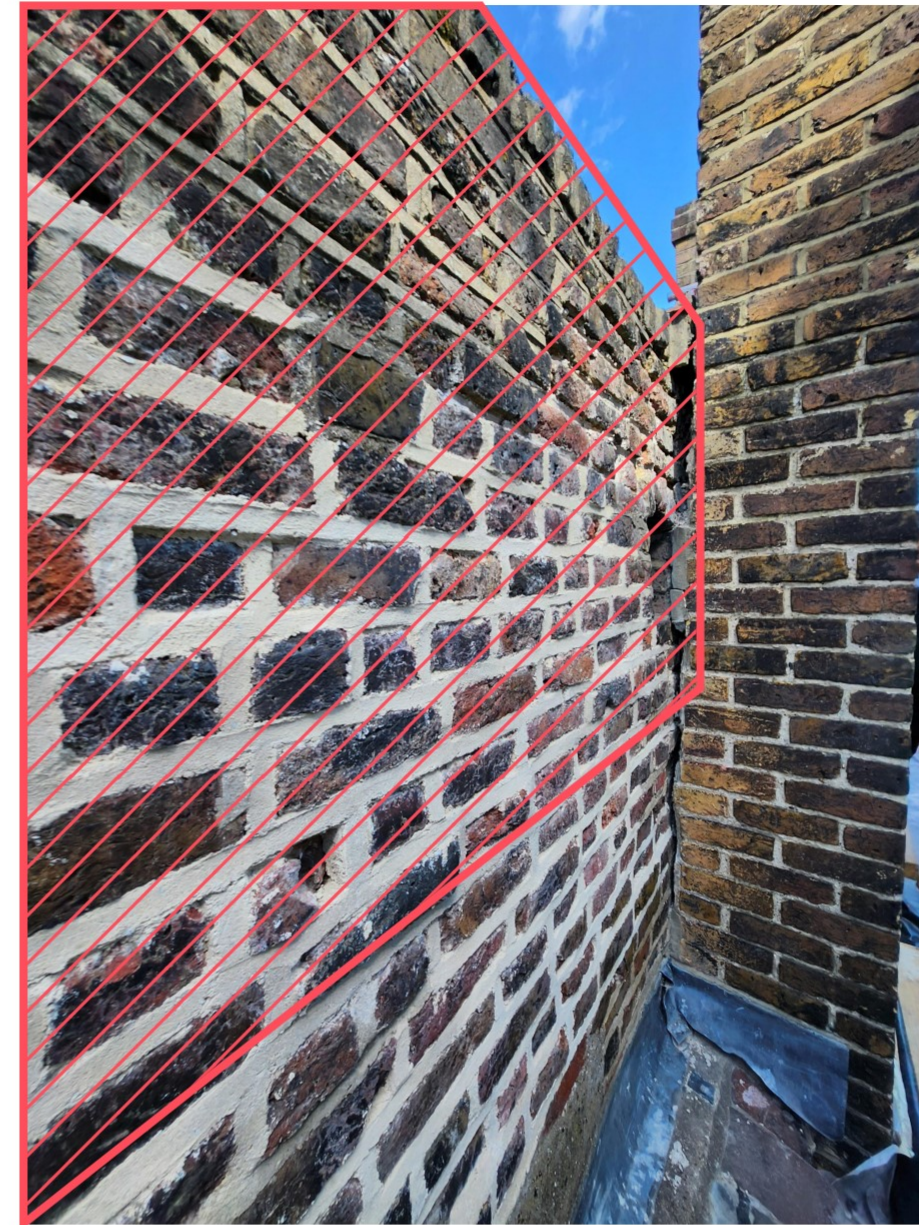
Reconstruction of infill between gables 1 and 2 - In area of Parapet detail B

Take down carefully, clean mortar from bricks and reconstruct - cap with Parapet detail B as proposed

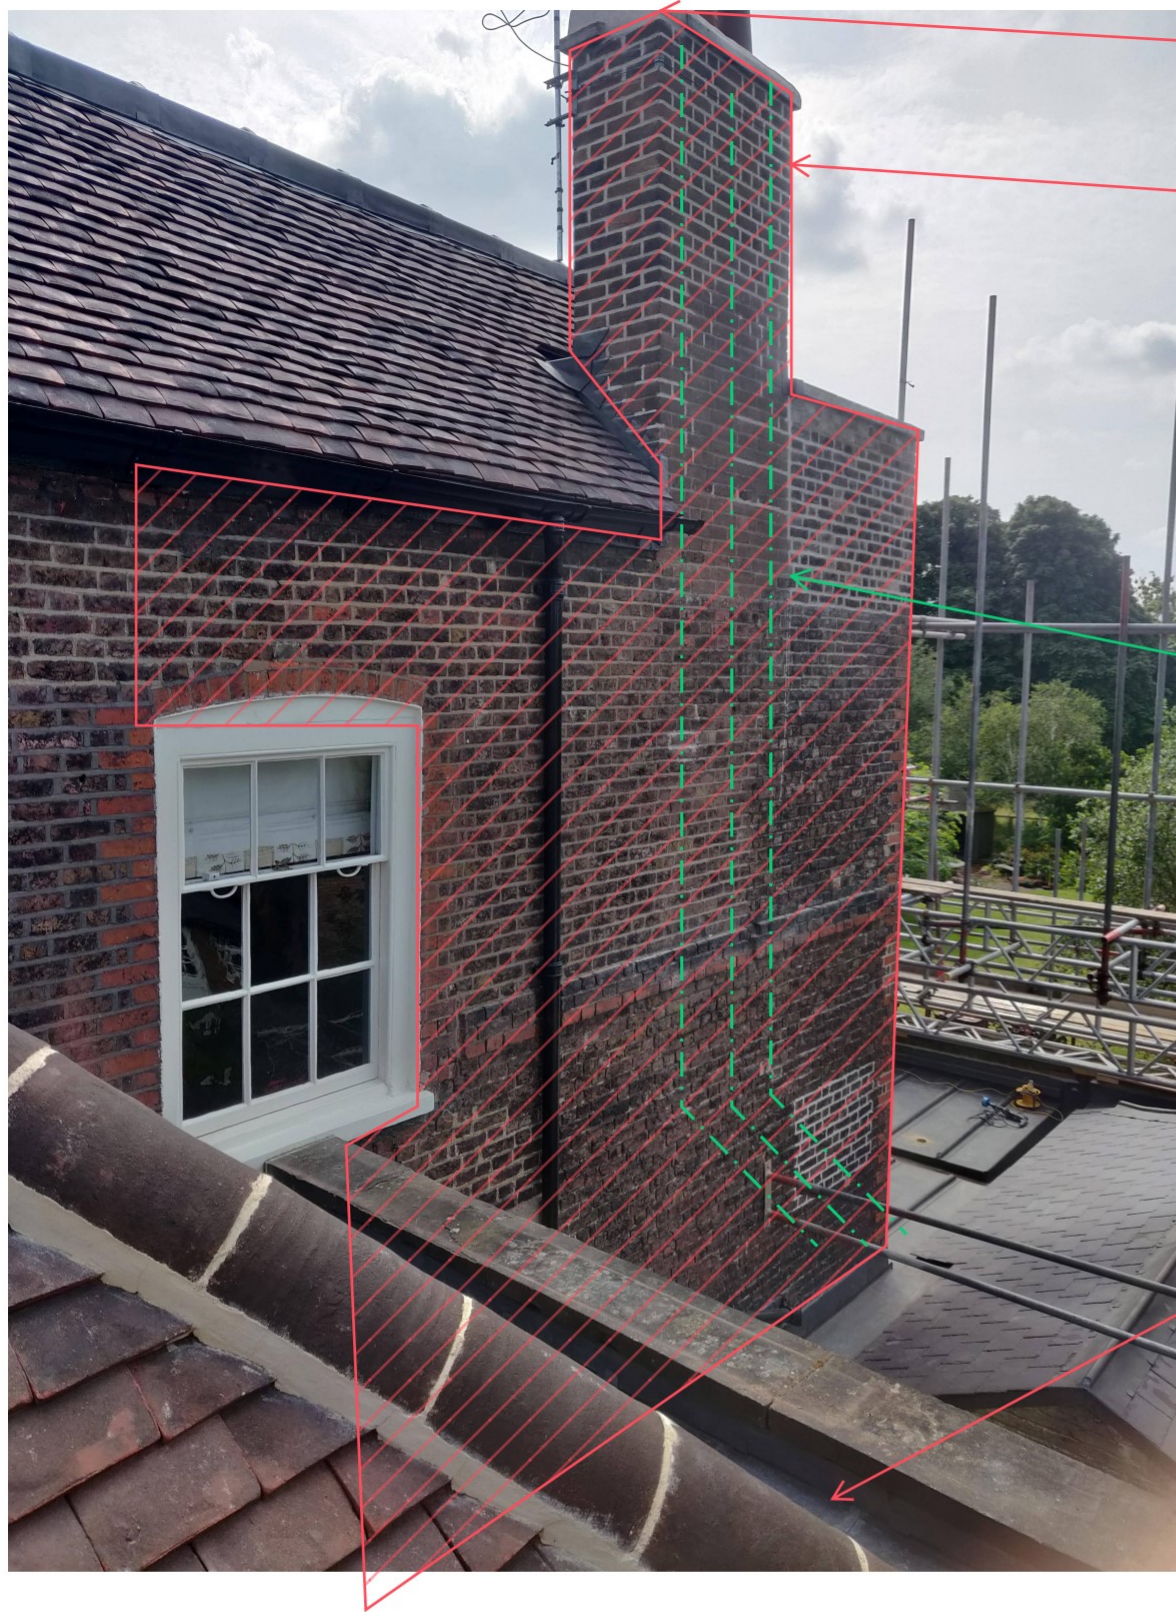
Line of flues with half brick cover. See SFK repair detail. Assume SFK repair detailed needed for full length of flue until stack reaches eaves. Call MAA and SFK as soon as scaffold access is in place for careful survey of elevation.

- 3.4 The hatched area on KK007 will be repointed on the flank wall of 49.
- 3.5 The entire flank wall of 51 (facing 49) is to be raked out and repointed.

Complete indent repair to chimney capping

Rake out carefully by hand and repoint

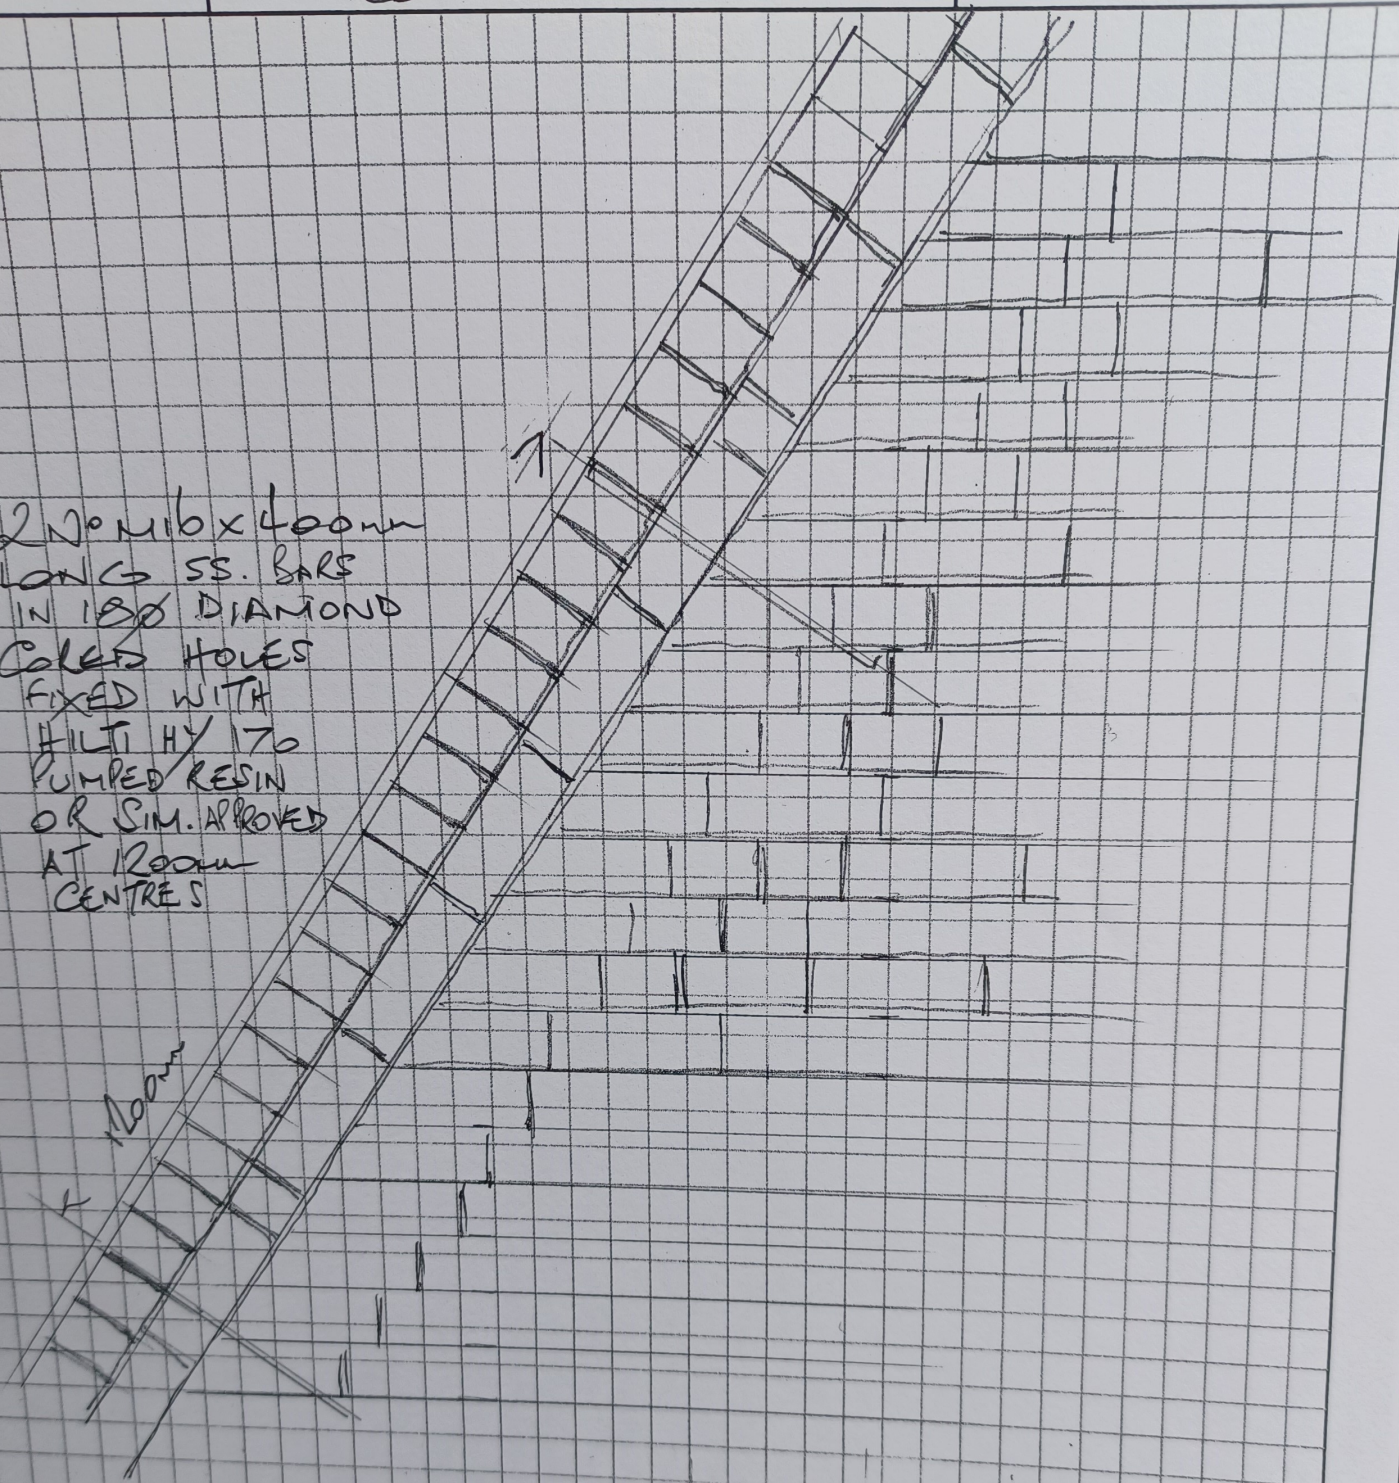
BRICKWORK CHIMNEY
EXACT INTERNAL PROFILE UNKNOWN. IT IS TO BE DETERMINED ON SITE BY CONTRACTOR

2 No M16 SS
BARS x 400mm
LONG
IN 180 DIAMOND
COLED HOLE
FIXED WITH
HILTI HY 170
RESIN OR
SIM. APPROVED

HORIZONTAL BEDJOINT REINFORCEMENT @ 4 BRICK COURSES. MIN. 300mm EMBEDMENT BEYOND CHIMNEY. USE HELIFIX HELIBARS SET IN HELIBOND CEMENTITIOUS GROUT.

3No. EACH SIDE STITCH REPAIR HELIBARS SET IN HELIBOND CEMENTITIOUS GROUT @ 300 VERTICAL CENTRES. EXACT DEPTH TBC ON SITE.

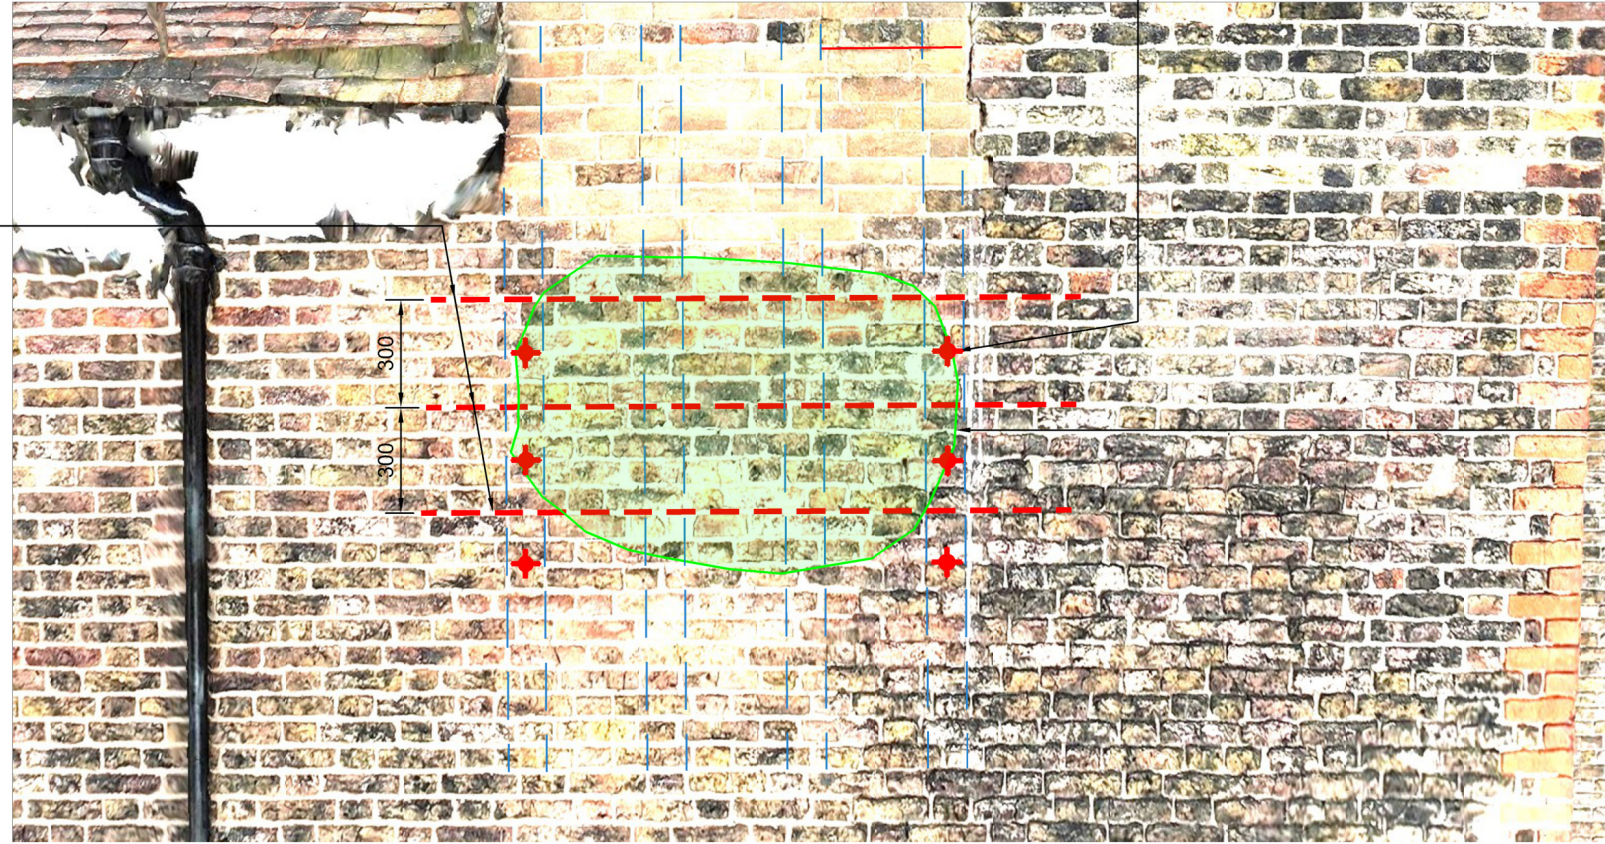
EXTENT OF BULGING BRICKWORK
