Structural Engineer's Report

64 The Green

Twickenham TW2 5AG

April 2024

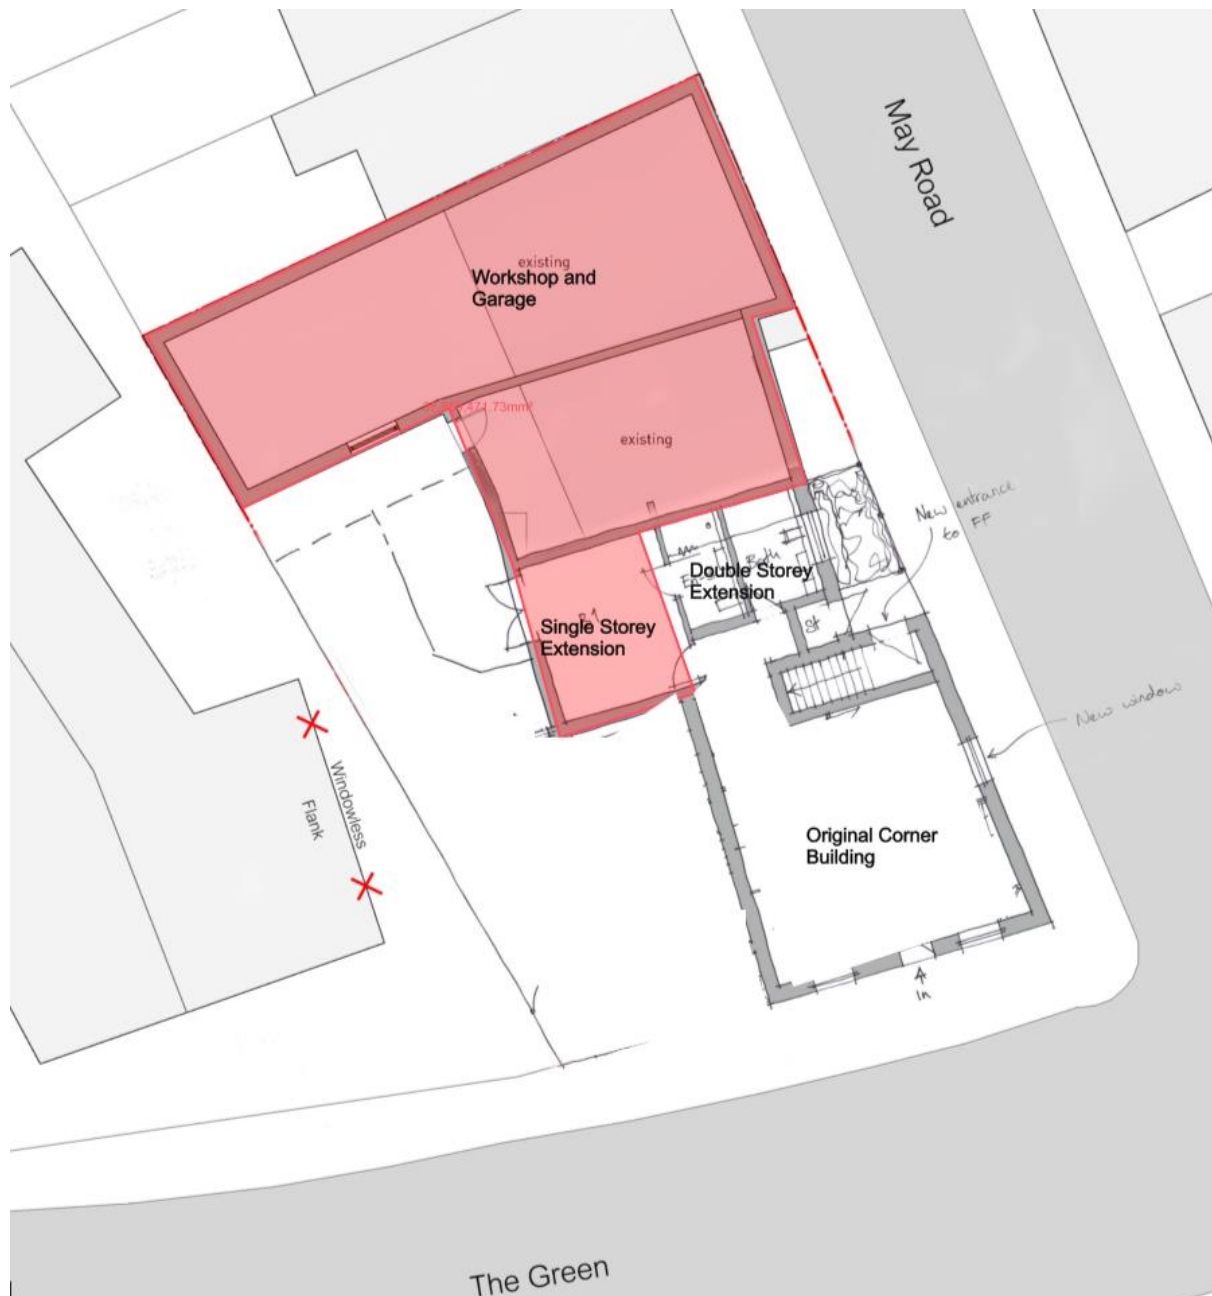
Figure 1 Extent of proposed demolition shown in red

2.6 There is a markup in the Annex which shows the extent of the proposed demolition. These areas can be rebuilt like for like in a sound construction compliant with current building regulations.

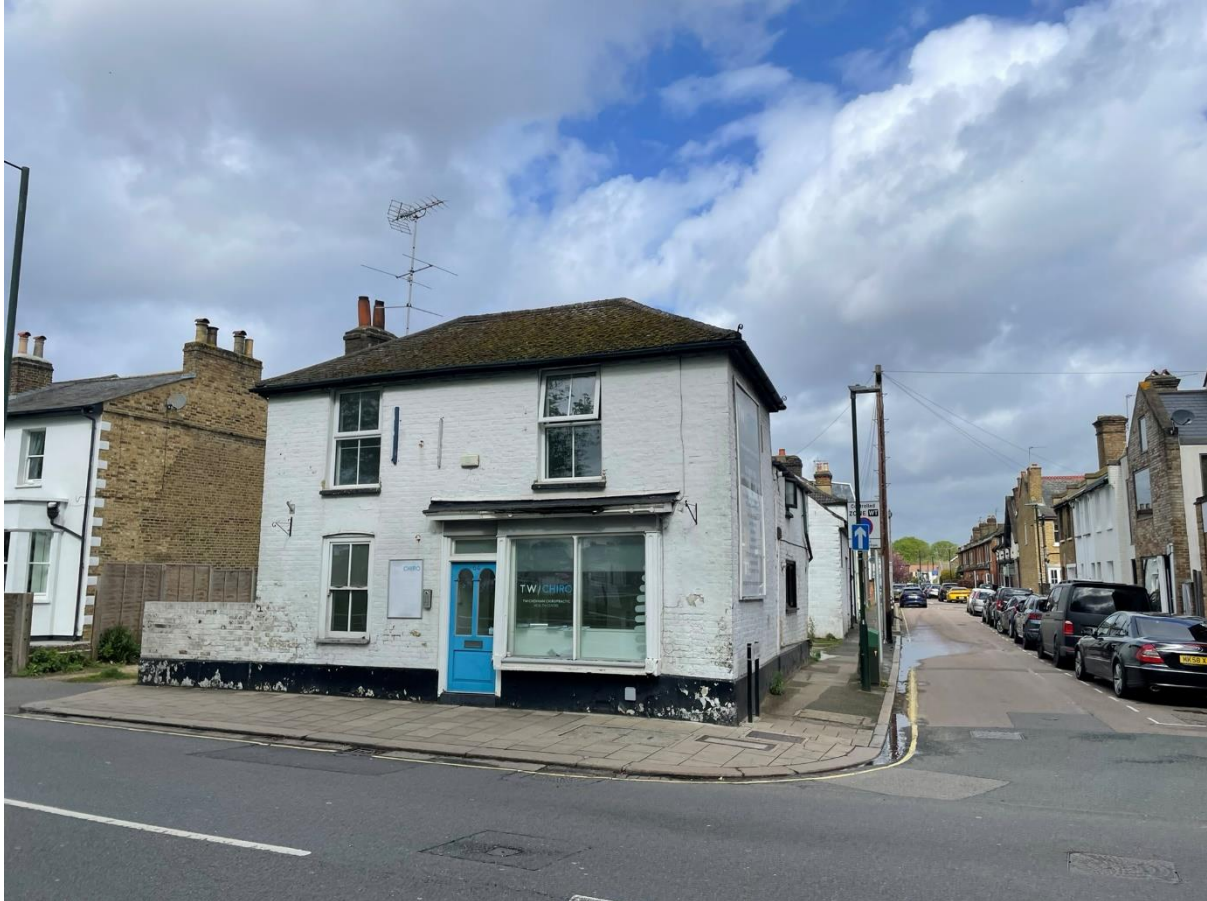
4.1 External examination of the front and side elevations shows no significant signs of structural concern (see photo record). The elevations appeared to be plumb with no signs of bowing which suggests that there may be adequate restraint between the walls and floors.

4.2 The front elevation and side elevation requires aesthetic works including re-pointing and decoration but nothing major. The peeling paintwork could be a result of moisture and damp issues but a damp specialist would be required to provide a report to that effect.

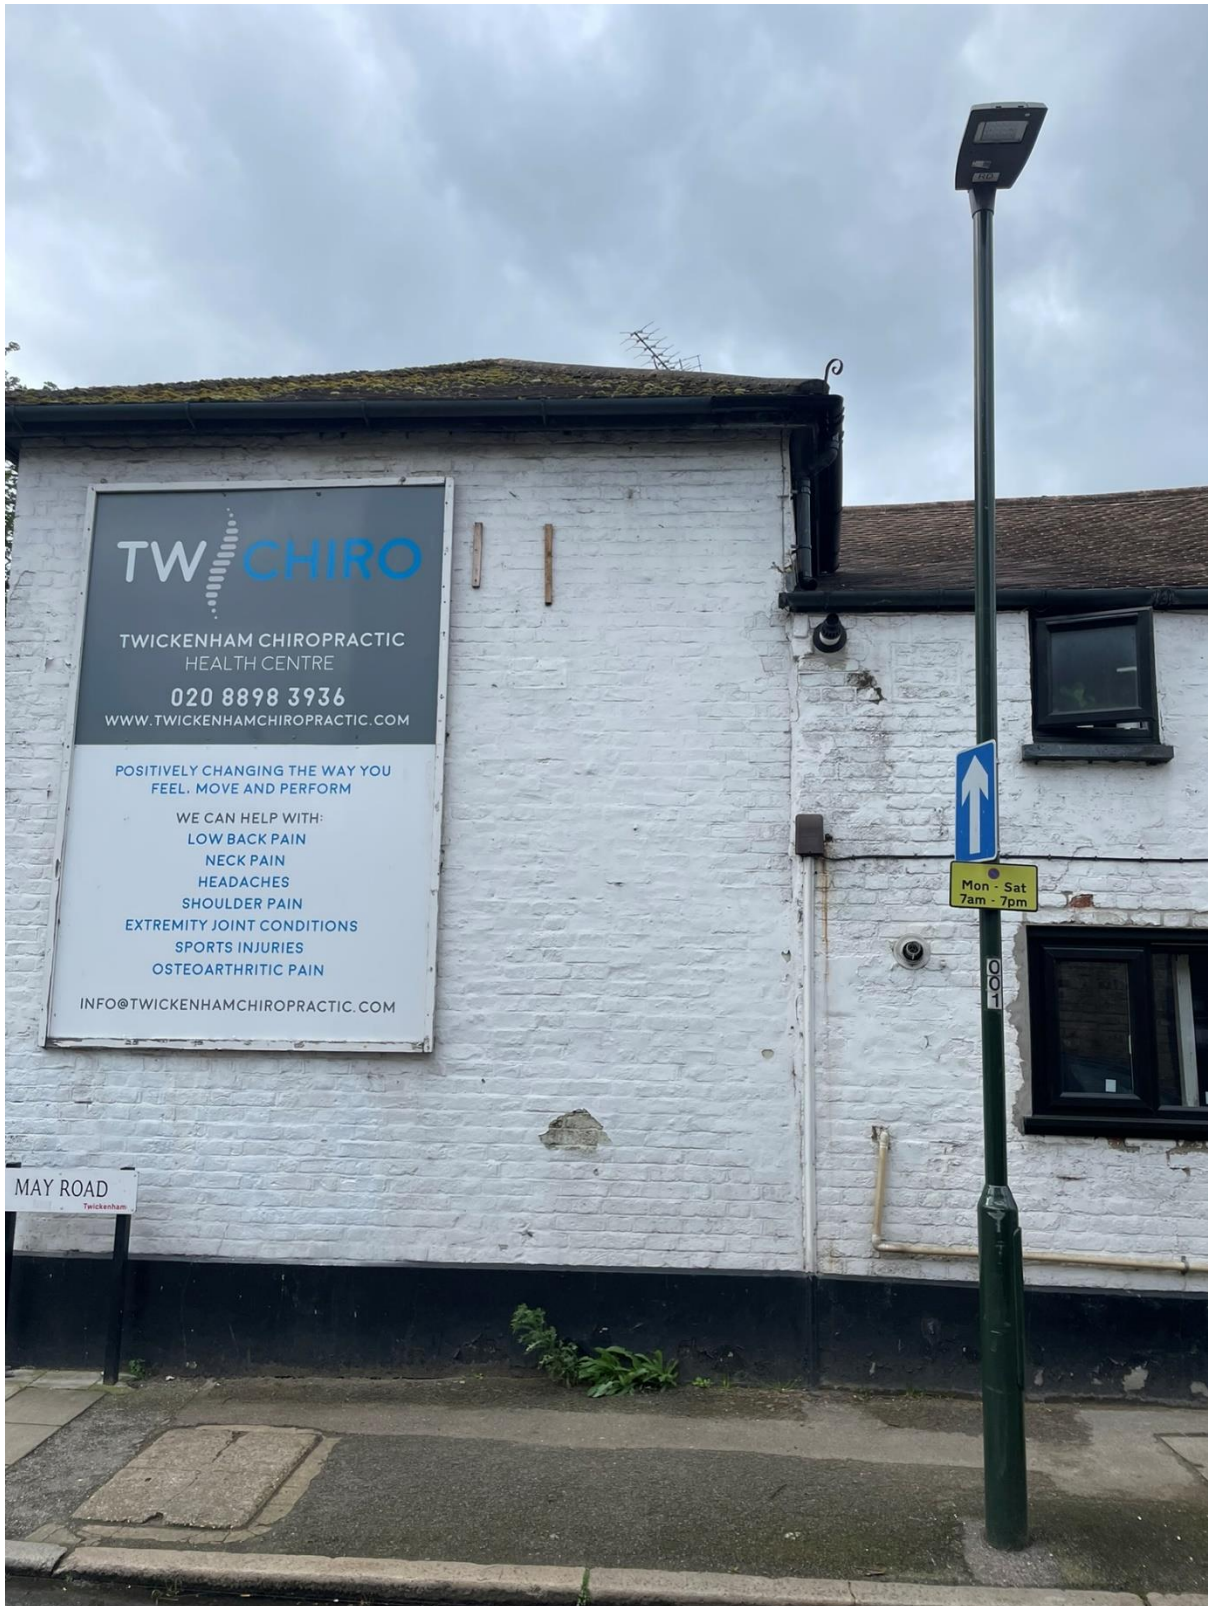
4.3 The pitched roof to the main house shows signs of undulation and missing tiles. The condition of the rafters could not be inspected due to the underside of roof completely covered by flat ceiling boards viewed from inside.

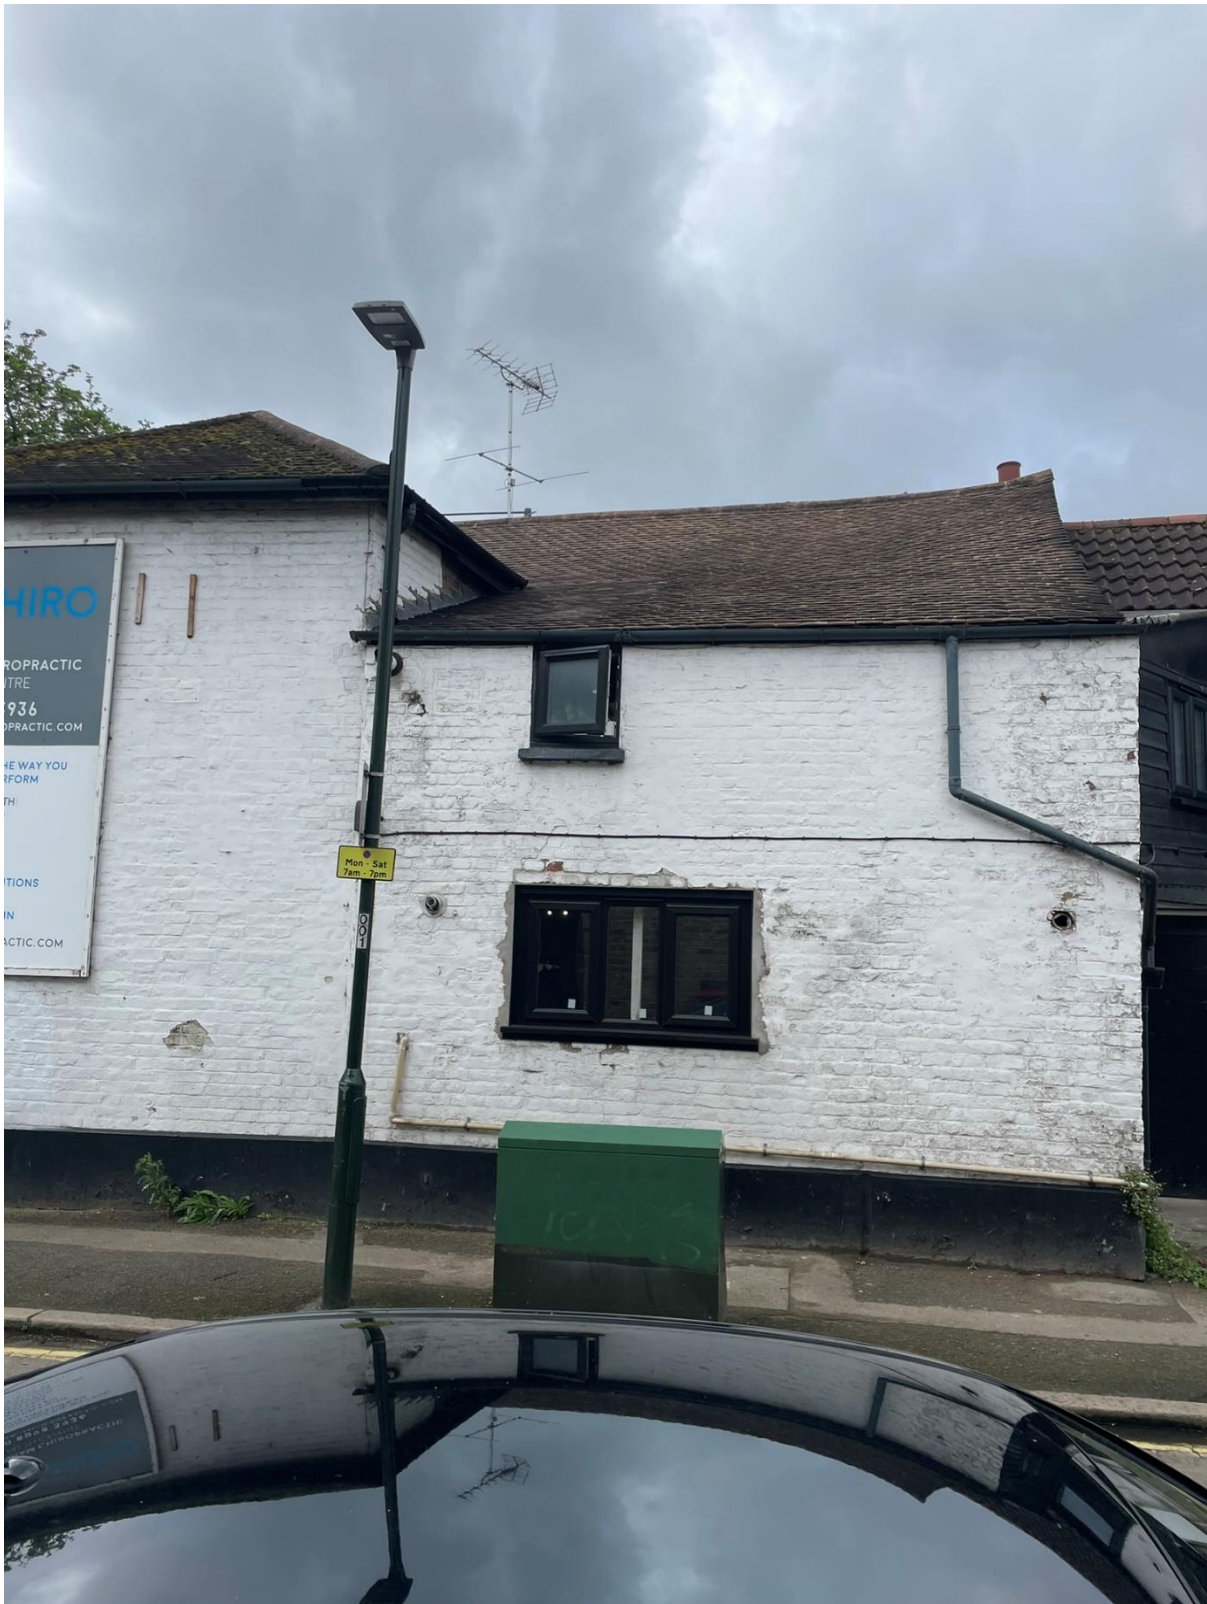
4.5 The two storey extension along May Road also does not raise any significant structural concerns apart from the roof. There seems to be issues of moisture around that elevation which could be due to condensation from internal insulation but a damp specialist will be able to provide more information.

4.6 There are also larger undulations along the roof tiles which would need to be explored. The rafters would need to be checked to see if they are fit for purpose or need replacing.

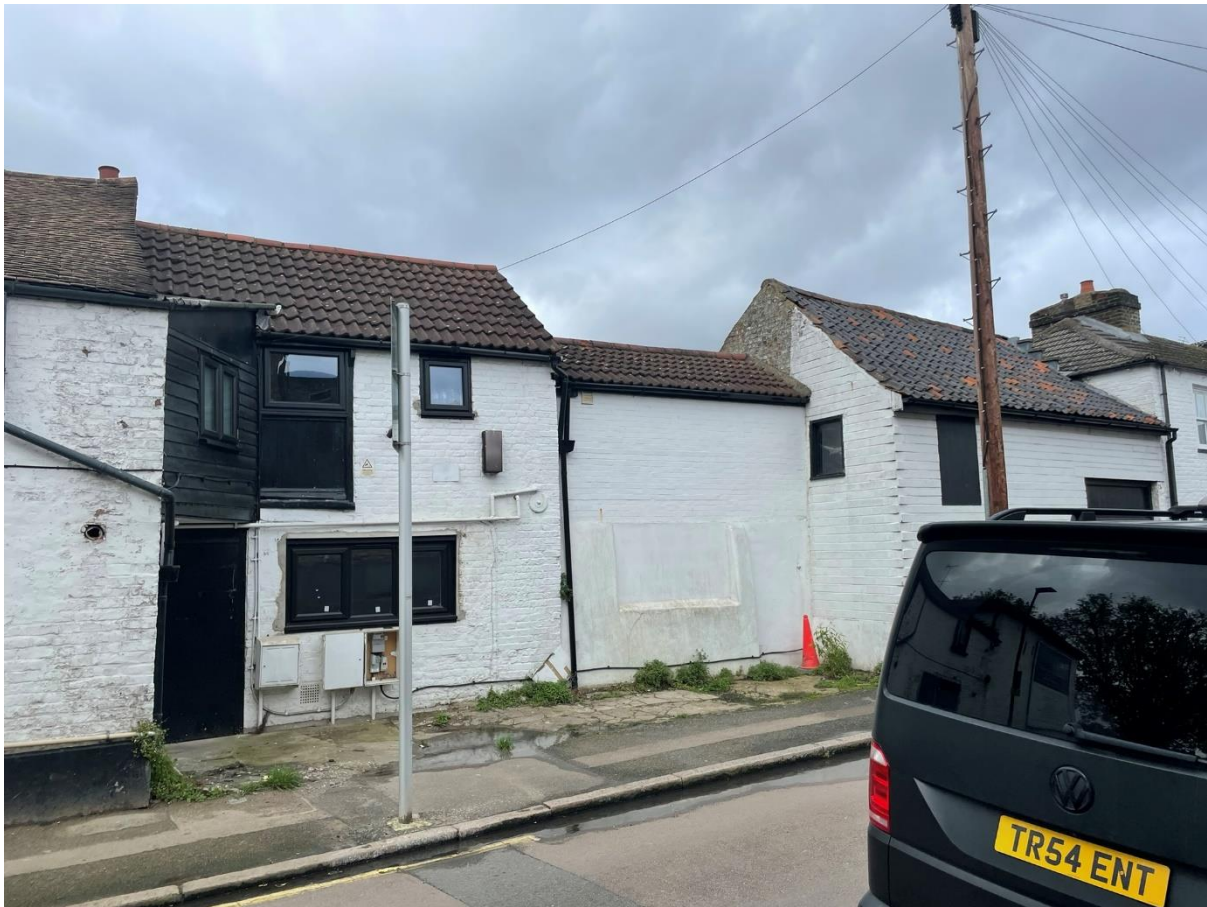
4.8 A newer extension has been added further along the elevation with a new roof. This roof does not seem to have any structural concerns as well as the masonry structure. The DPC was not evident along the external wall.

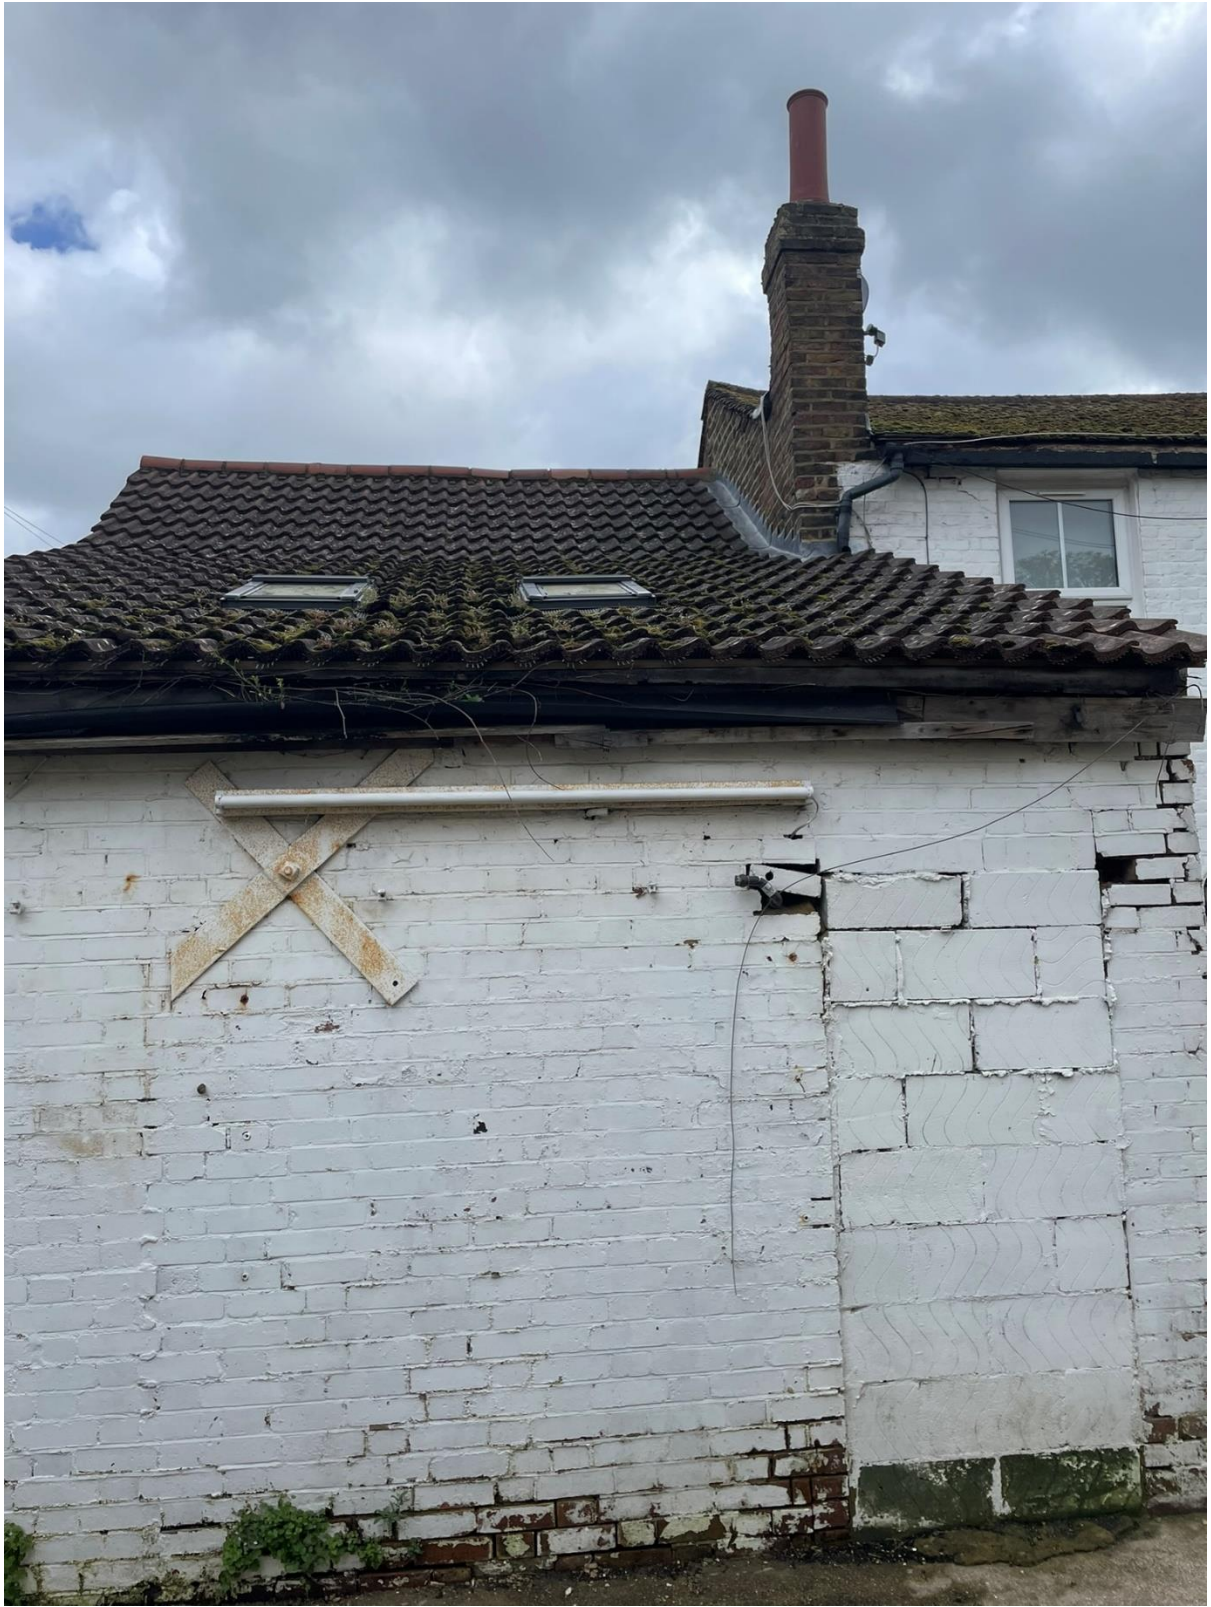
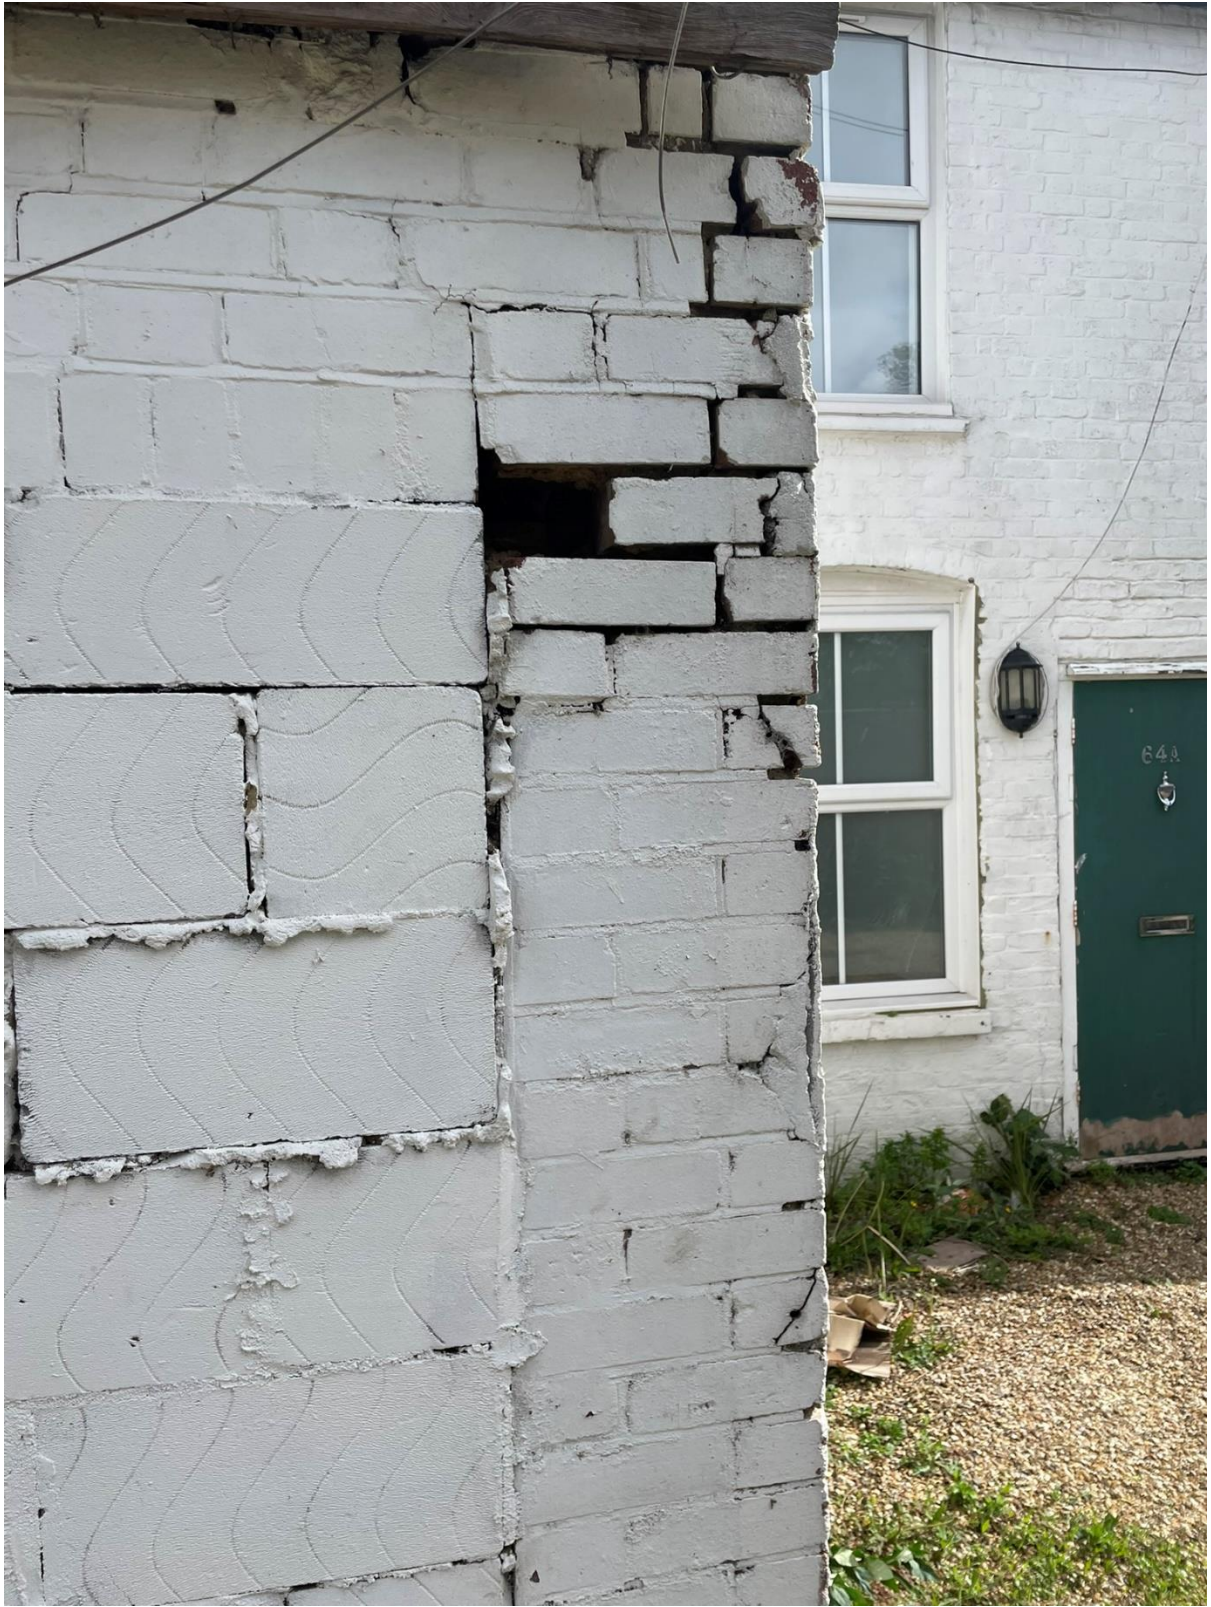
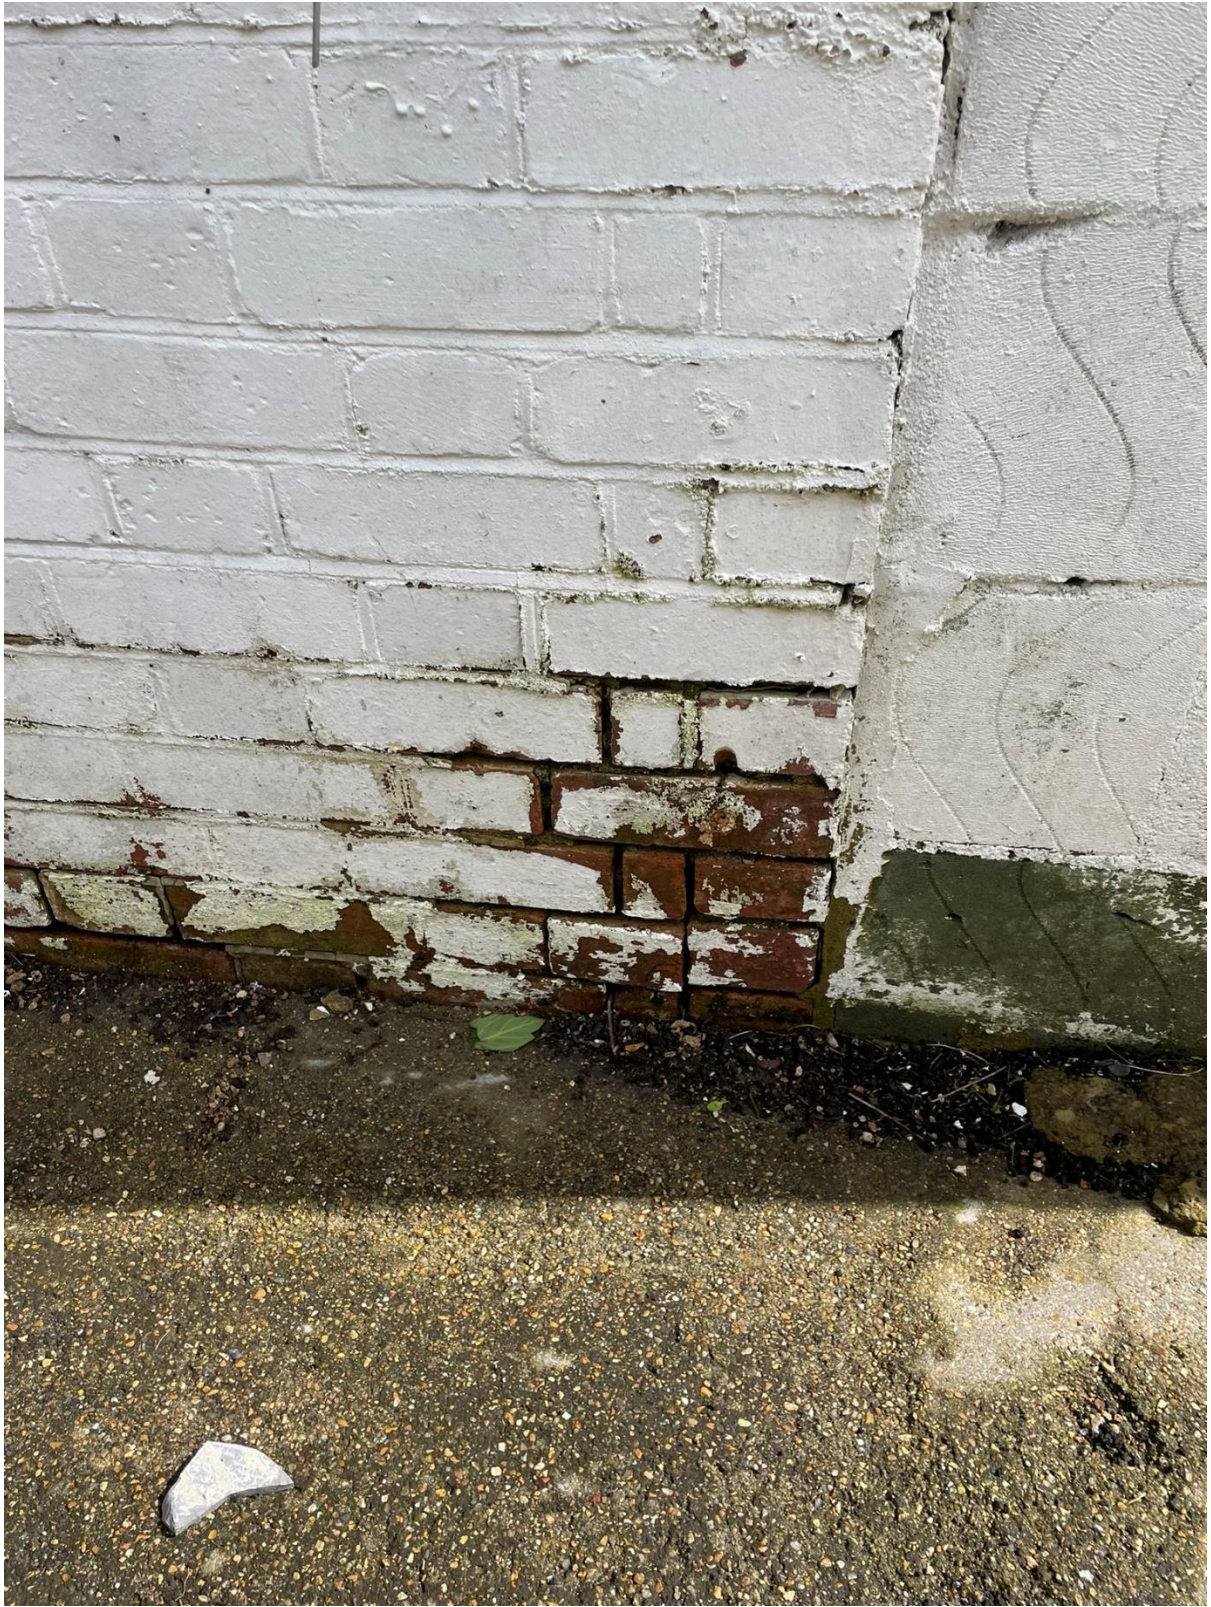
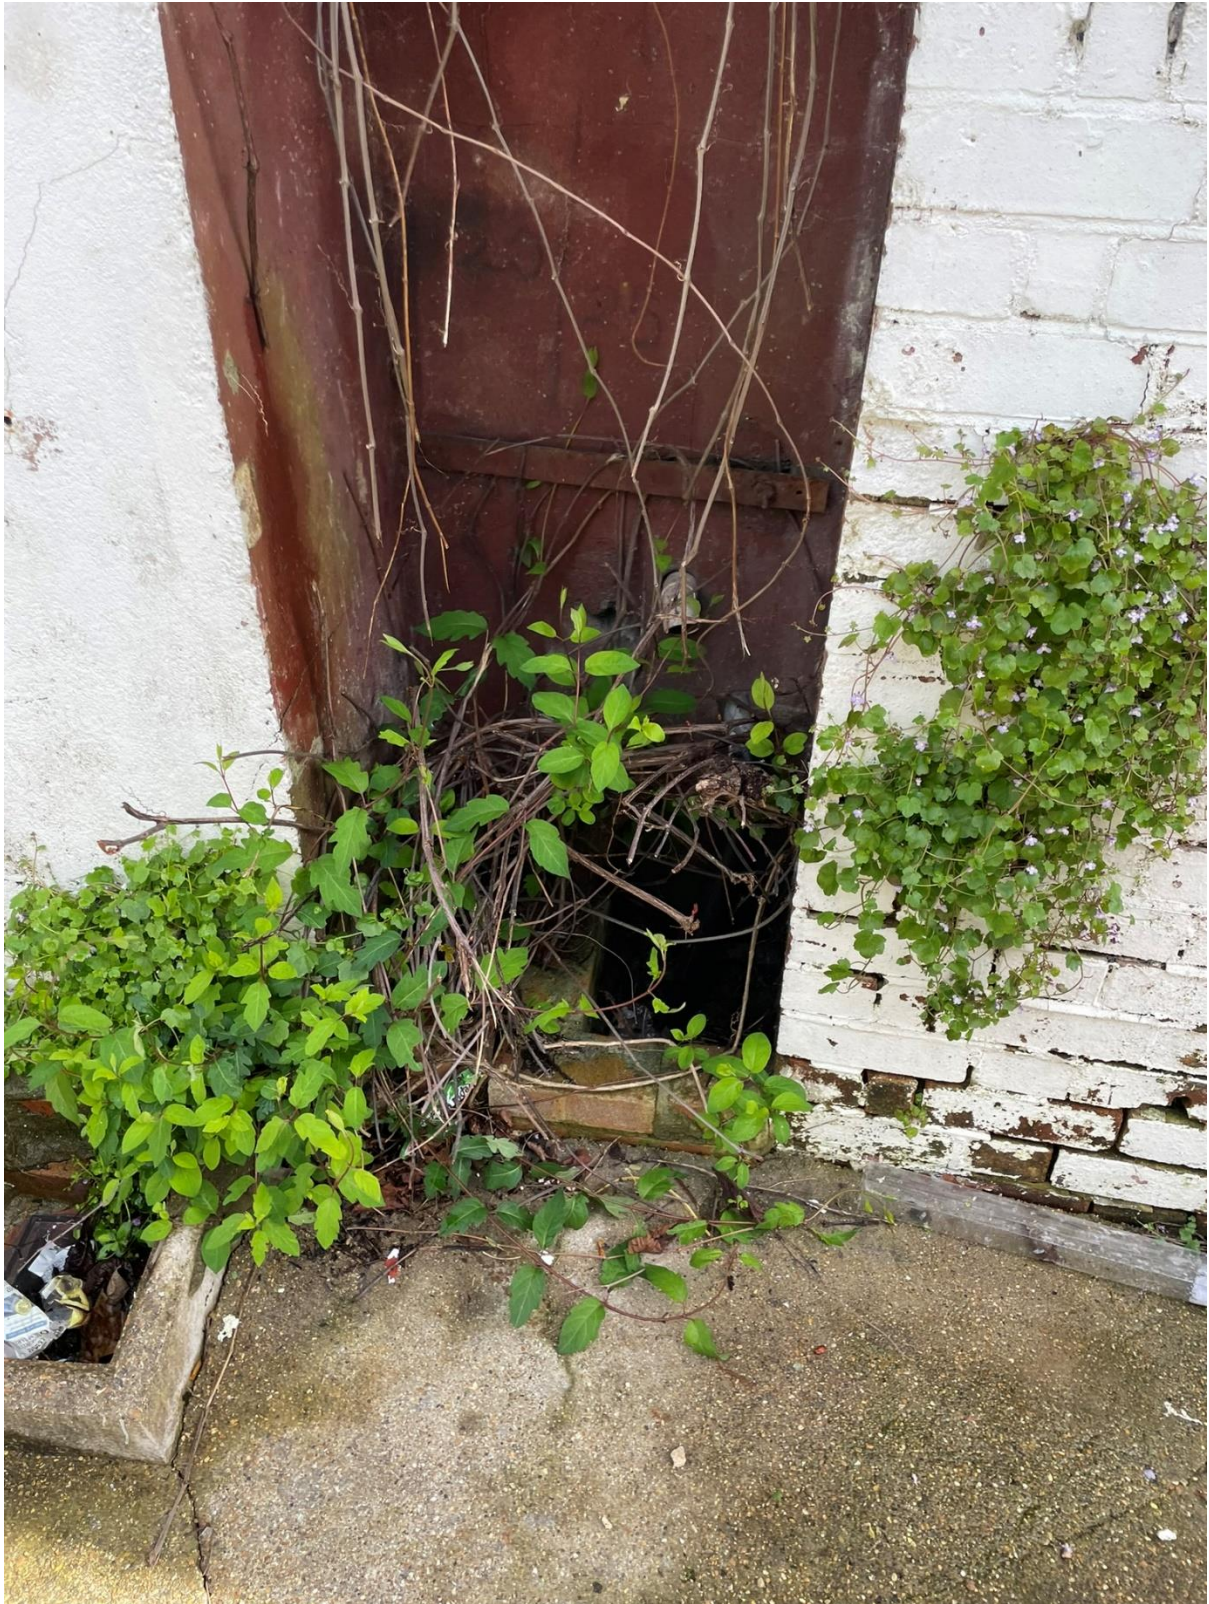
4.10 The single storey extension along the car park is of solid wall construction, however, this is where there are structural concerns with the building. The walls highlight structural movement, the most evident sign being the steel tie passing through the building to hold the wall in place. Bricks have come loose and fallen away from the construction and areas have been in-filled with concrete blocks. The mortar has come loose towards the bottom and sides of the construction and moisture has entered which is evident by the growth of plants along the wall. No DPC present in the construction.

4.11 The roof also appears to be undulating and dipping which highlight structural concern with the timber roof members. This was not evident internally due to the ceiling covering but an intrusive investigation would be required to provide advice on the structural integrity of the roof. The wall plates appear to be rotting and coming loose and would need to be addressed.

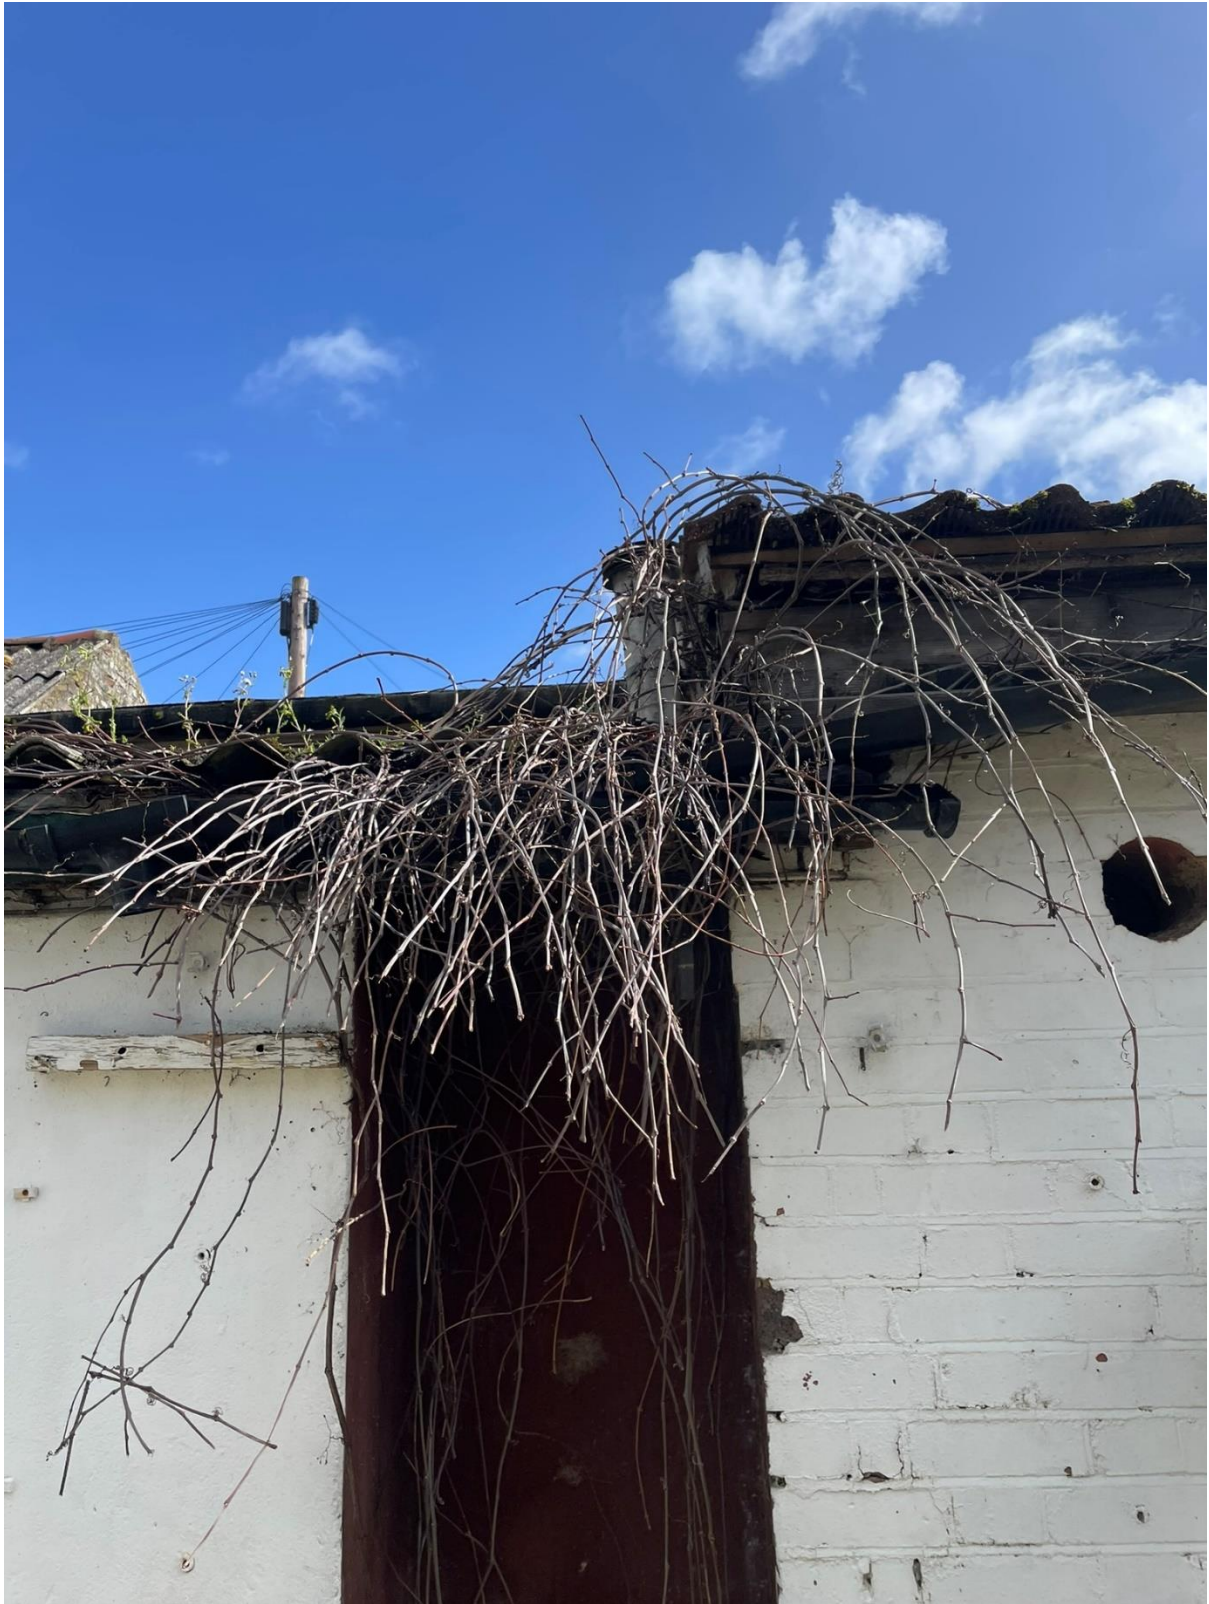
4.12 The gutters and drains have been blocked for a considerable period and there is vegetation growing in and around the structure. This can cause structural movement and have may an impact on the foundations of the property. The vegetation should be cleared away, the drains unblocked and a CCTV carried out to ensure that there are no cracks within the drainage system.

4.13 The structural concerns with the single storey extension are significant and would require the masonry walls and timber roof structure to be re-built. The foundations do appear to be sufficient to meet the current building regulations requirement and should be investigated. It is our opinion that there is no merit in retaining this structure as it would need significant remediation.

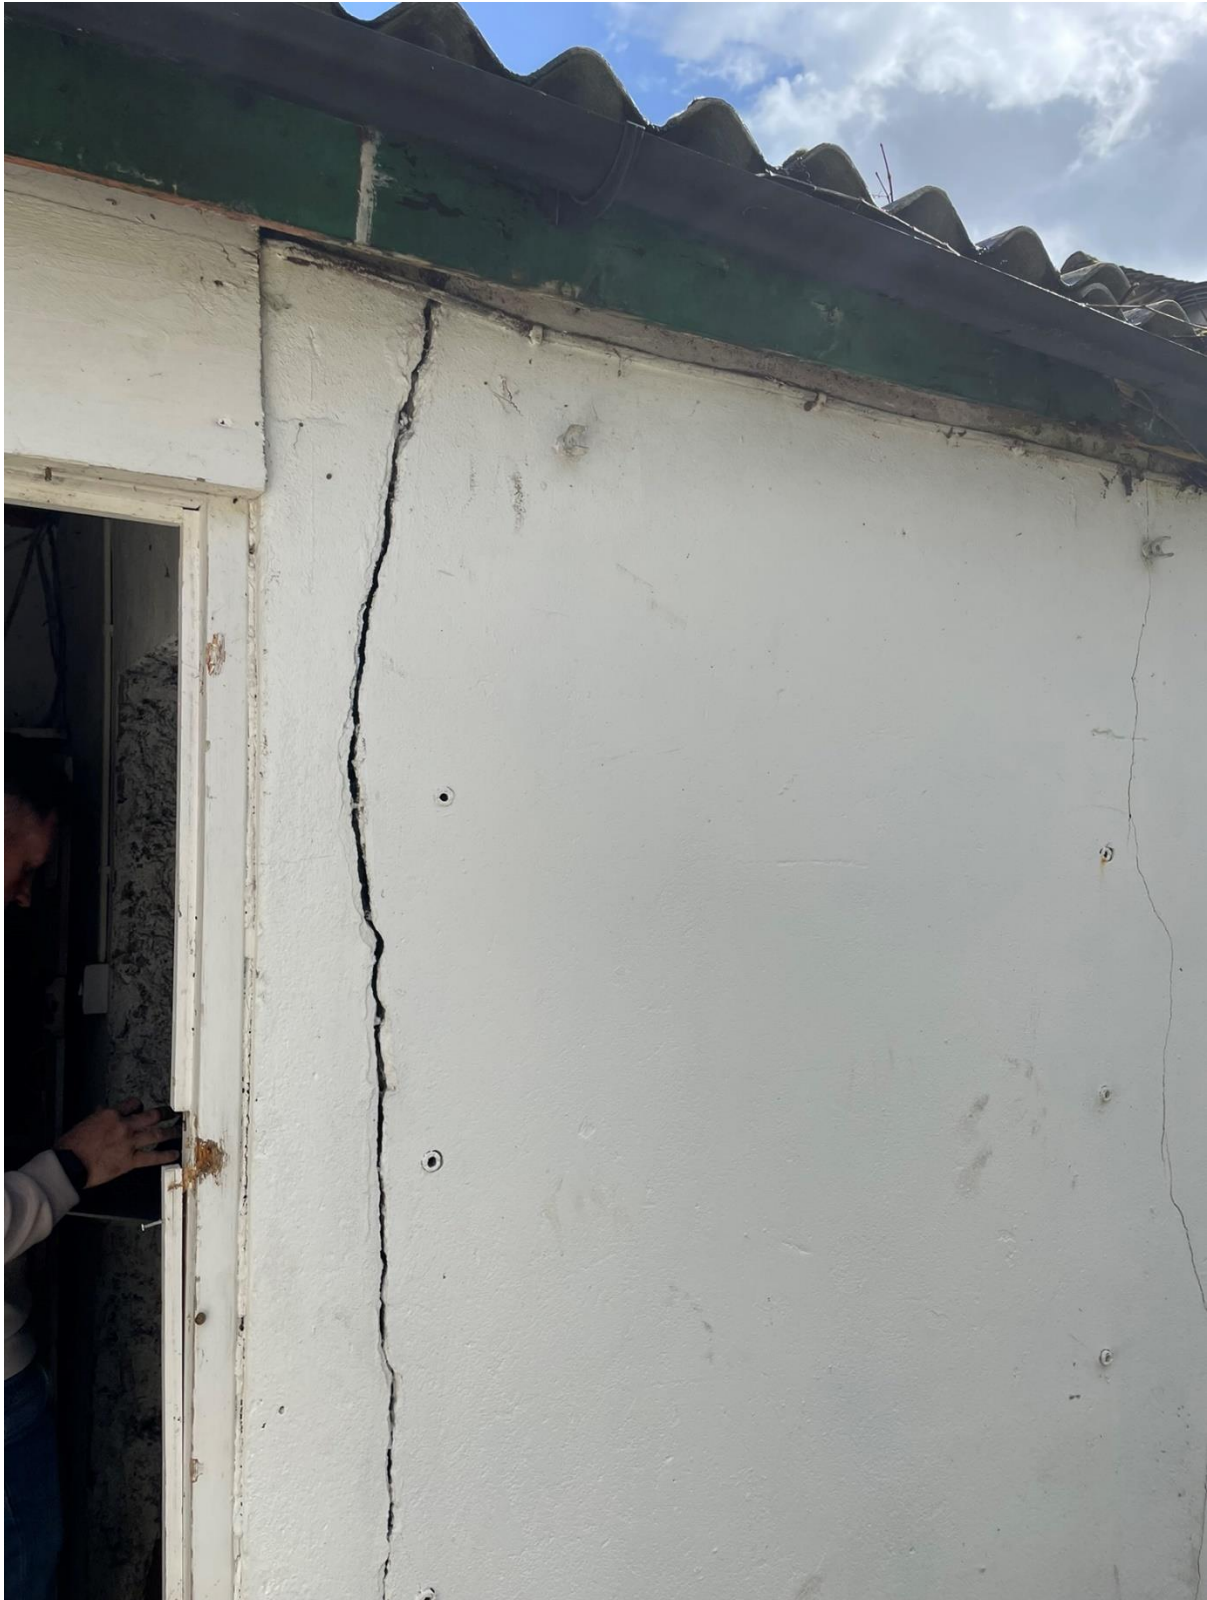
4.14 The workshop and garage area appear to be run down and dilapidated. The construction seems to be a mix of masonry brickwork and blockwork. There is a large crack coming down the west façade which seem to indicate structural movement. Further investigation is required to understand the cause of the movement.

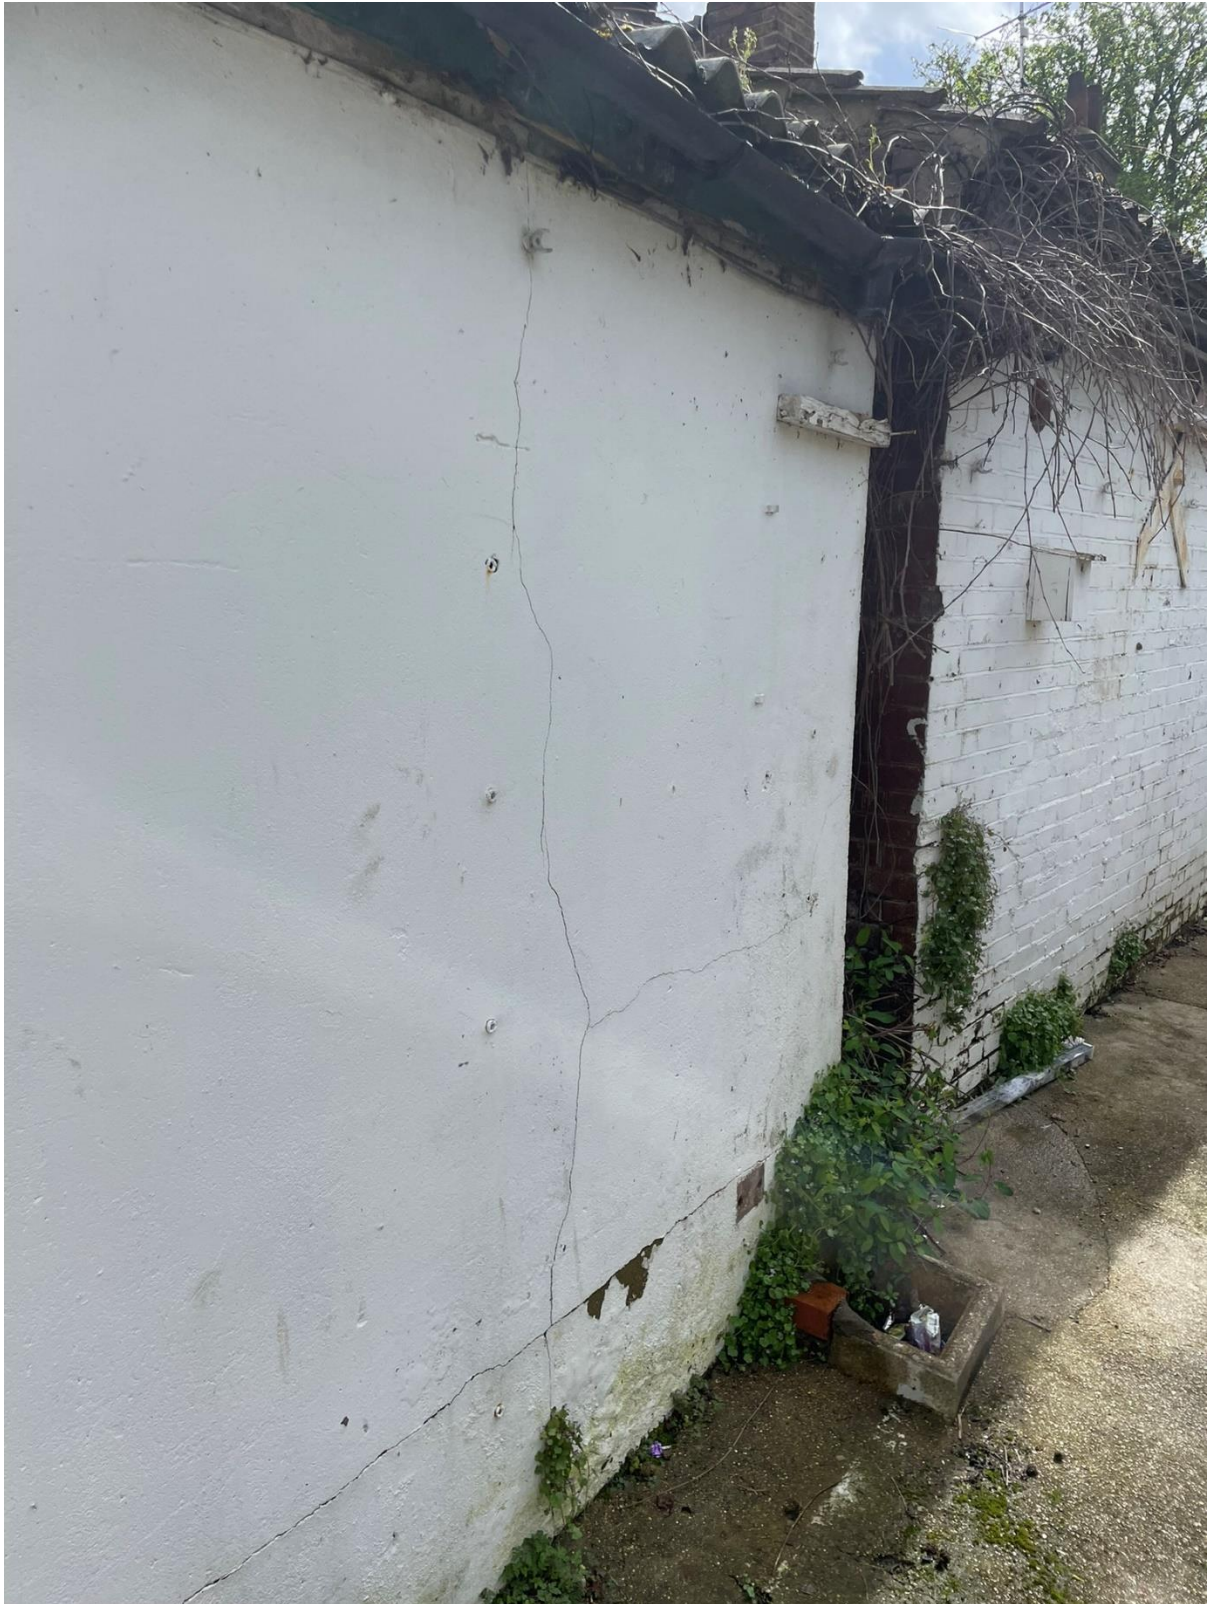
4.15 Similar to the extension façade, there are issues with moisture and damp. This is evident by the vegetation growing within the structure. The vegetation must be cleared out and the render stripped back to understand the condition of the brickwork. There are more cracks along the wall but these seem to be consistent with thermal and moisture movement.
