Structural Engineer's Report

64 The Green

Twickenham TW2 5AG

April 2024

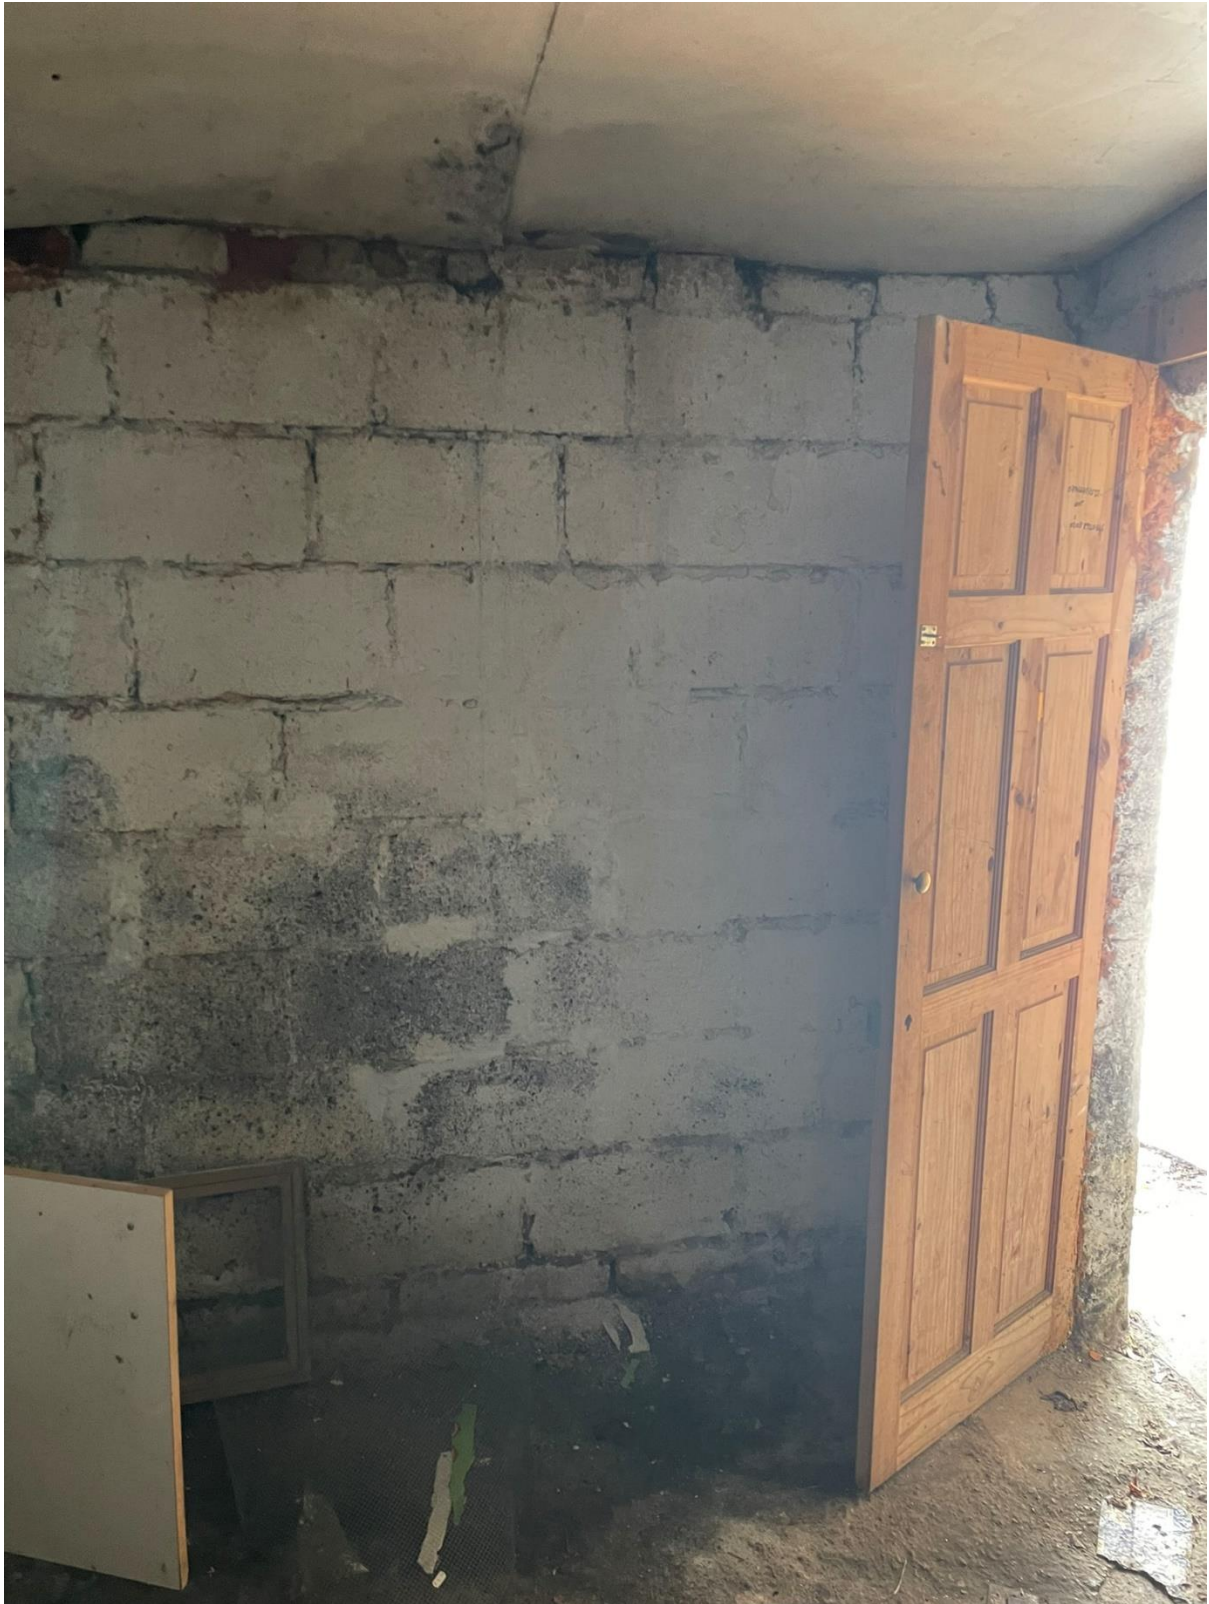
4.16 The wall is of masonry blockwork construction but there are issues with the quality and workmanship of the blockwork and the mortar. Significant work will need to be done to ensure that it is suitable for the proposed building. There is also damp and mould which may affect the structural integrity of the blocks and these will need to be stripped back and checked.

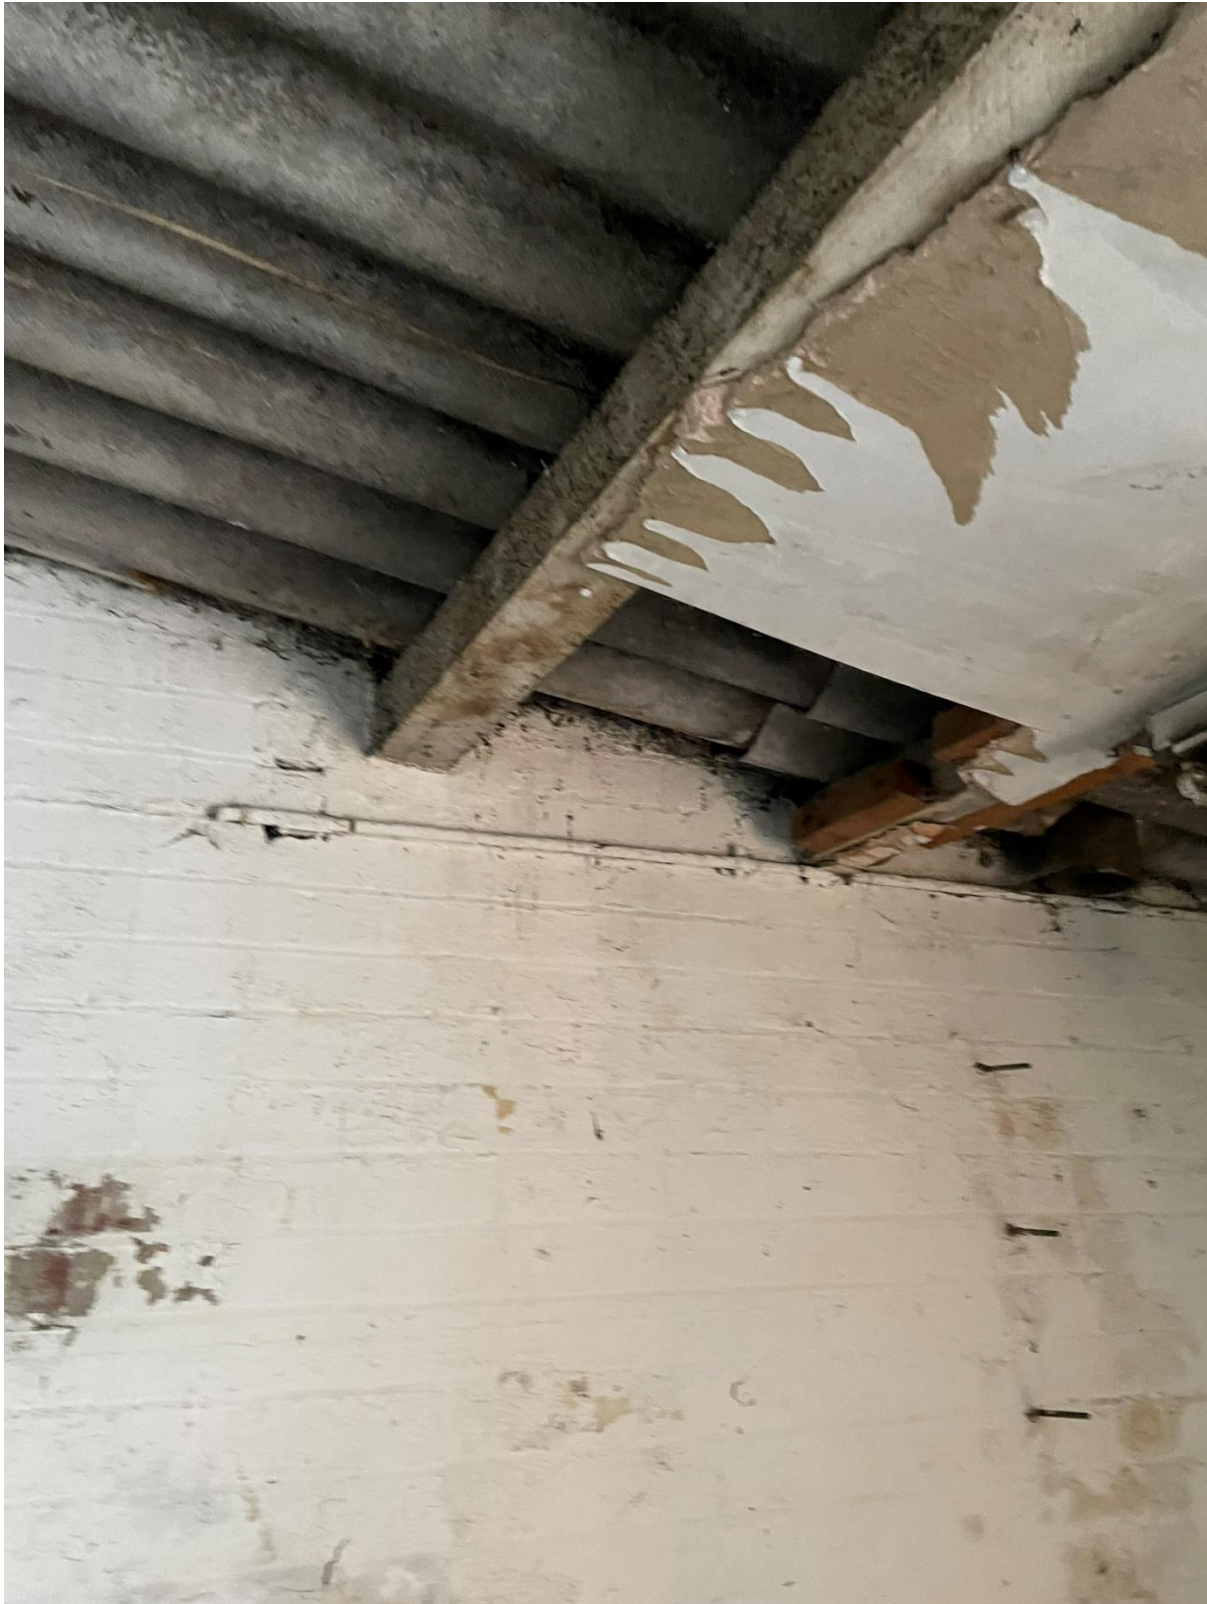
4.17 The timber along the existing roof structure needs replacing as well as the cement roof sheets which have been flagged to contain asbestos and are a hazard. Therefore, it would be recommended to replace the full extent of the roof of the workshop and garage.

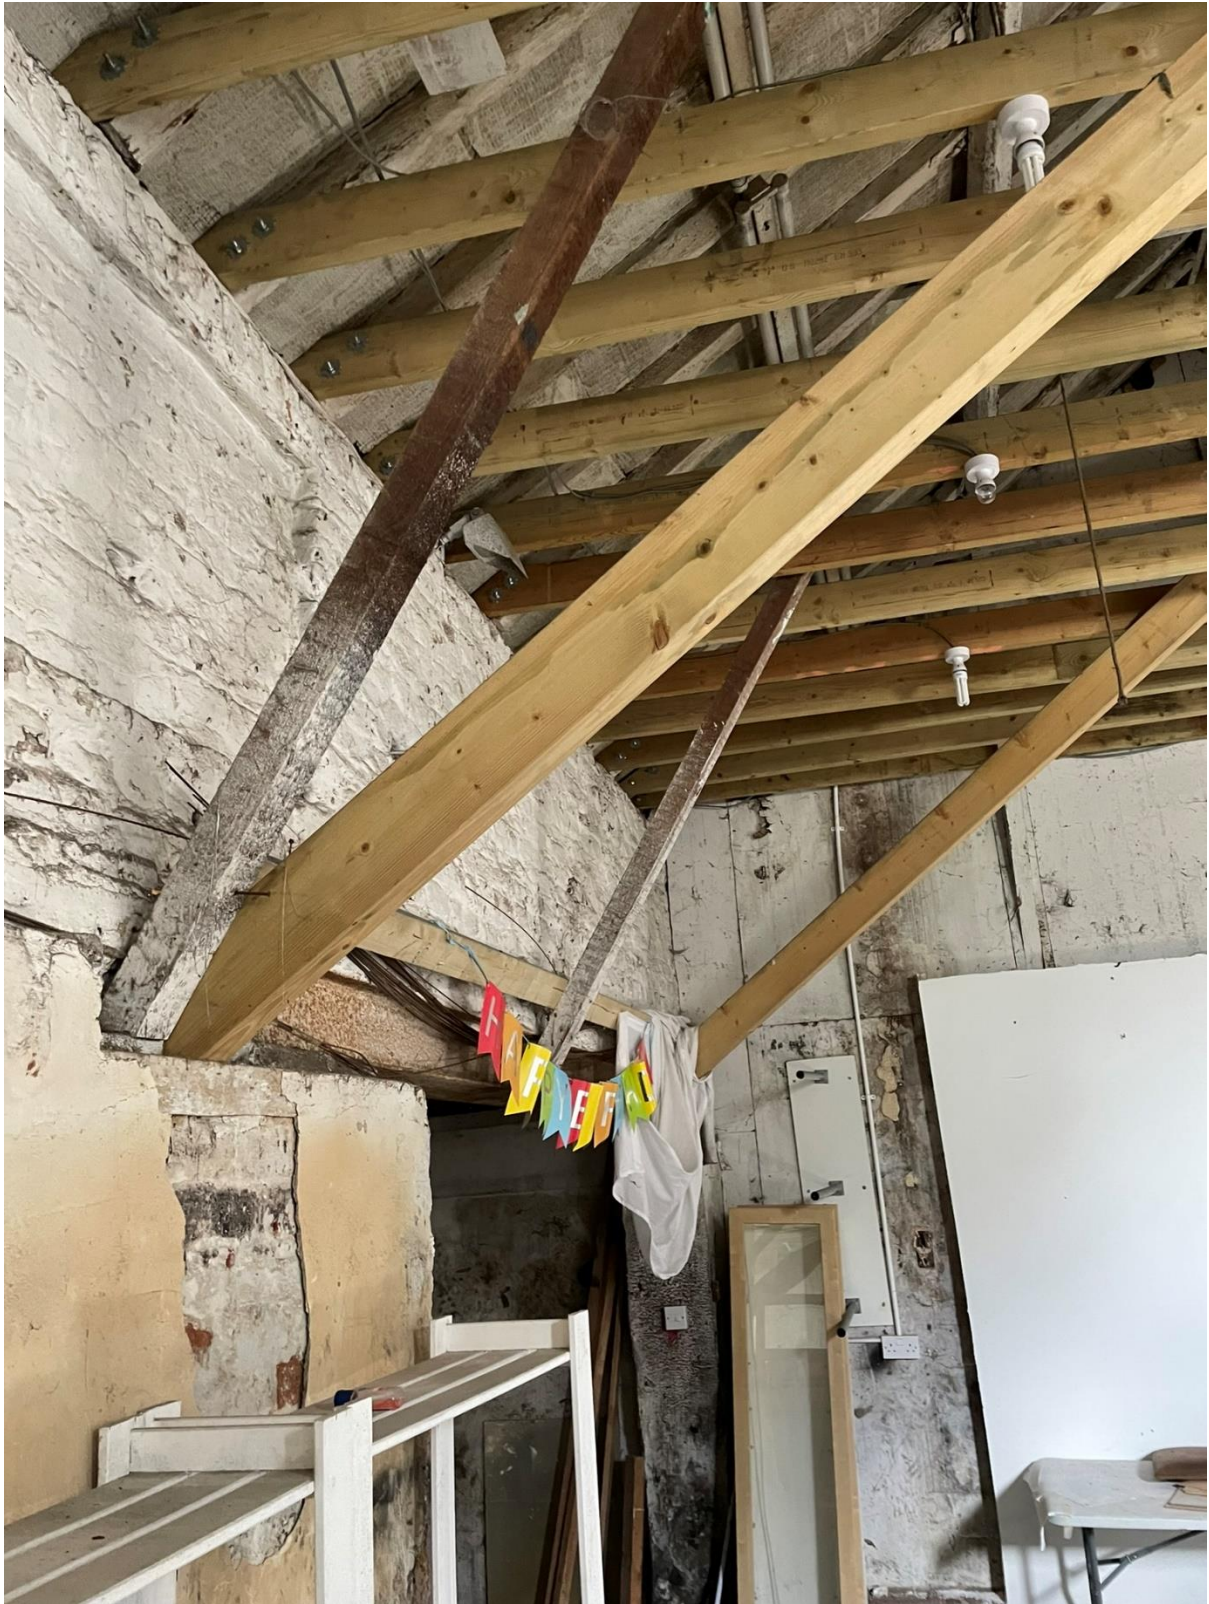
4.18 The roof has been additionally supported in several areas but without adequate wall plates which would need to be added to them. The ah hoc placement of roof supporting members would not be fit for purpose and would need to be altered or re-designed and placed appropriately within the roof space.

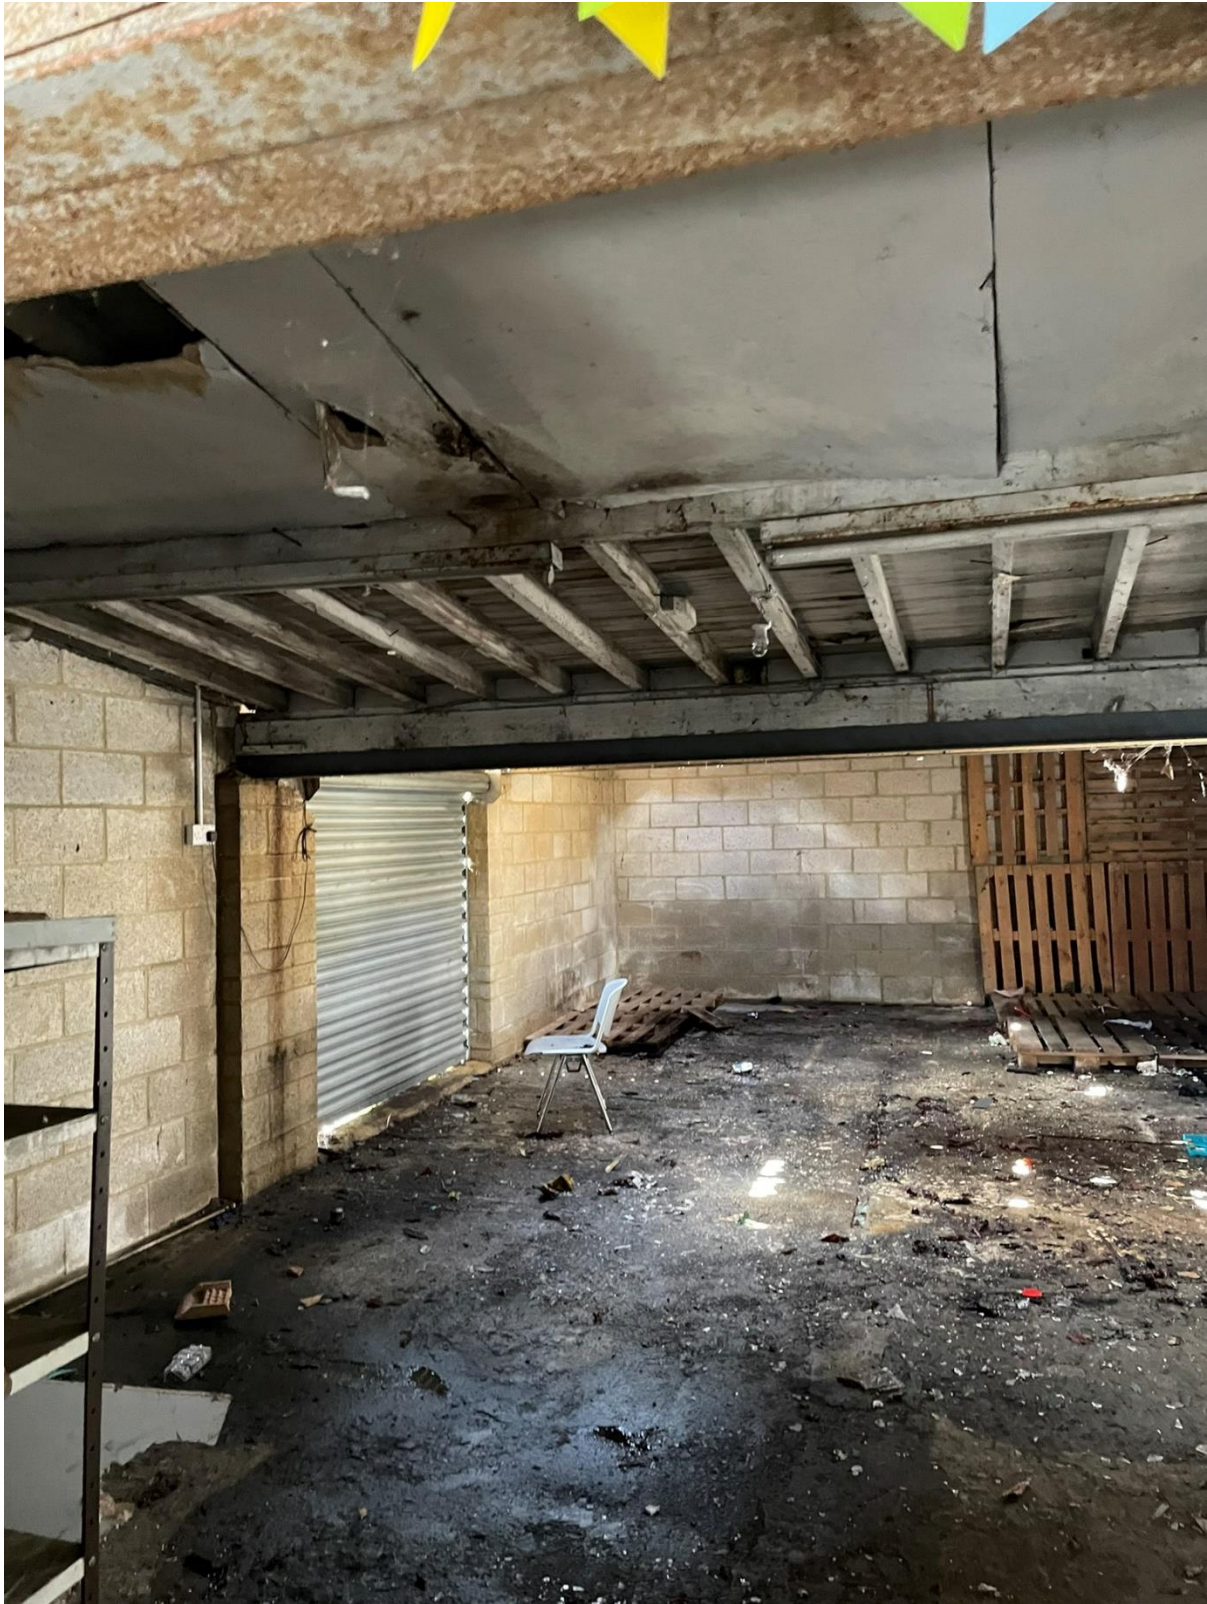
4.19 While the roof would need to be replaced, the floor too does not appear to have been built with sound construction. There is a concrete slab which is cracked in several places that appears to have moved. The floor look damaged and appear to have had some chemical reactions from interactions with different materials. A trail pit will have to be carried out to determine the suitability of the floor. The floor would be best demolished and re-laid to maintain the current building regulations.

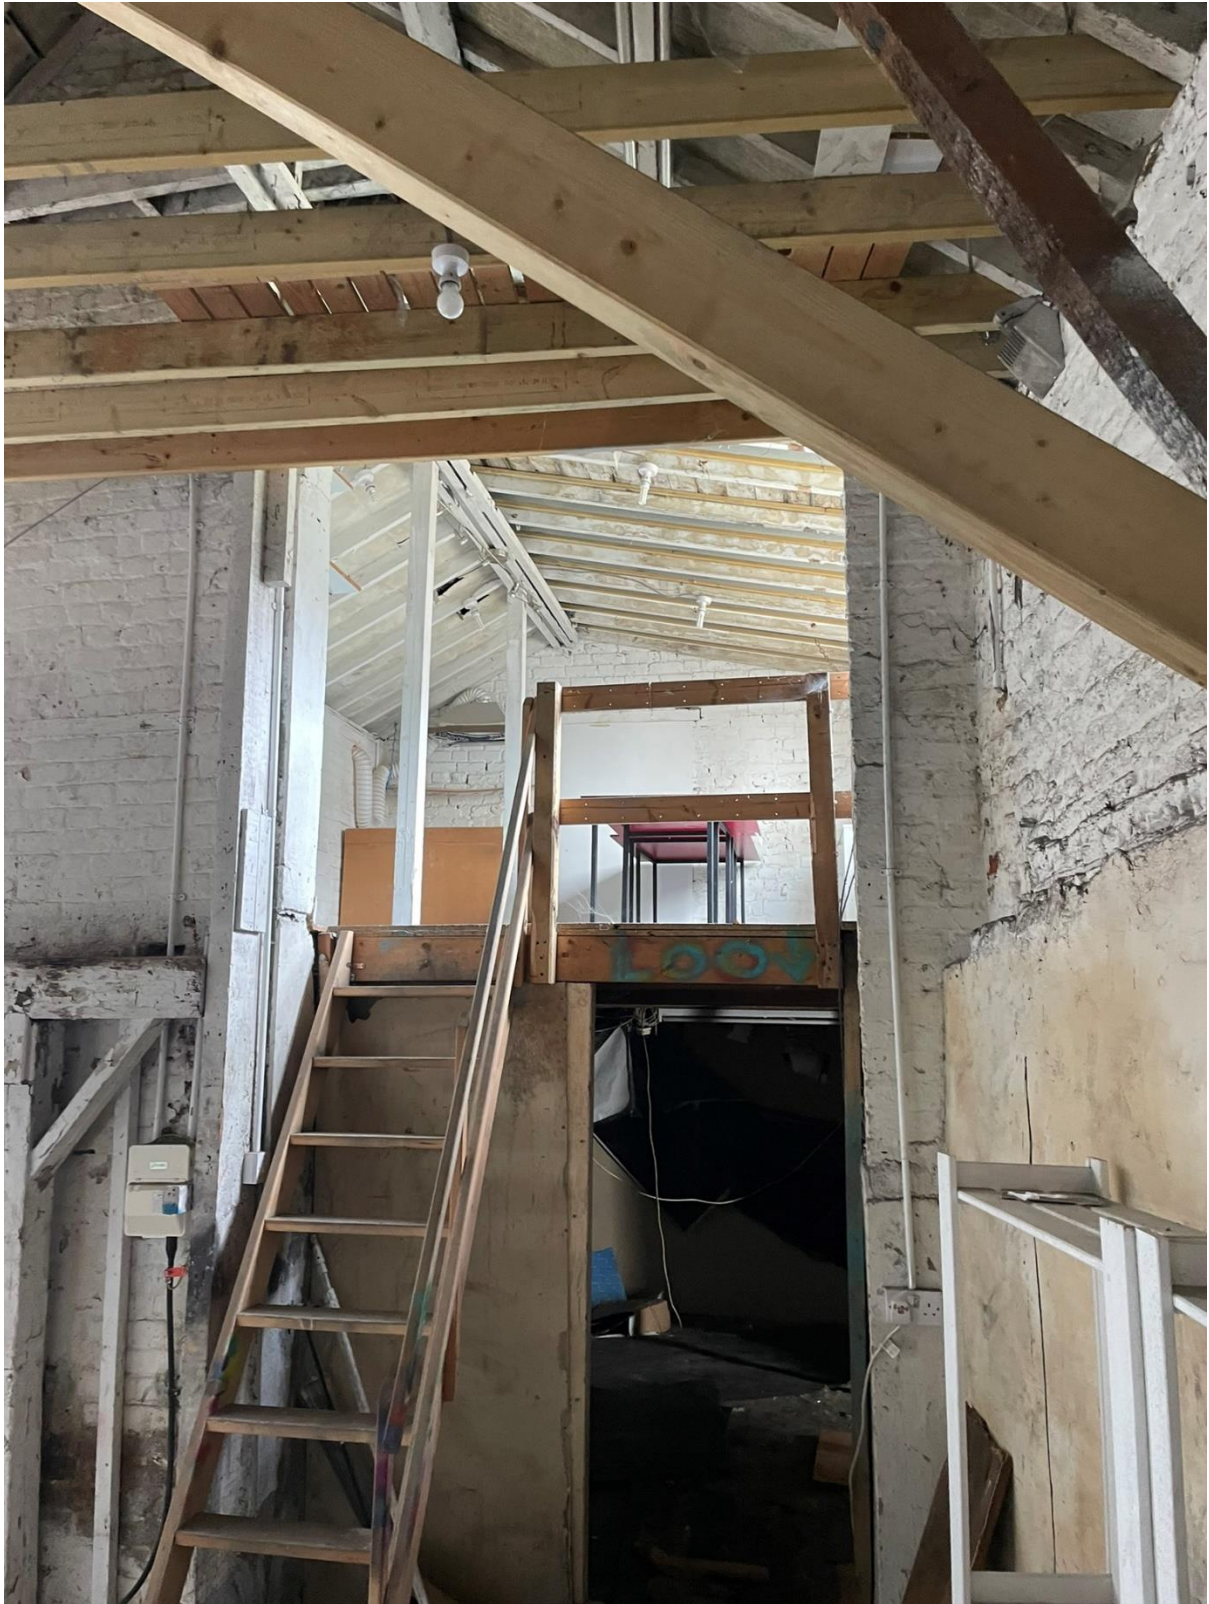
4.20 The makeshift mezzanine layer of the workshop appears to have been built without a consideration for modern load requirements. While the timbers are relatively newer than most of the roof structure, they are smaller in size and would not be compliant for a residential floor due to strength and vibration.

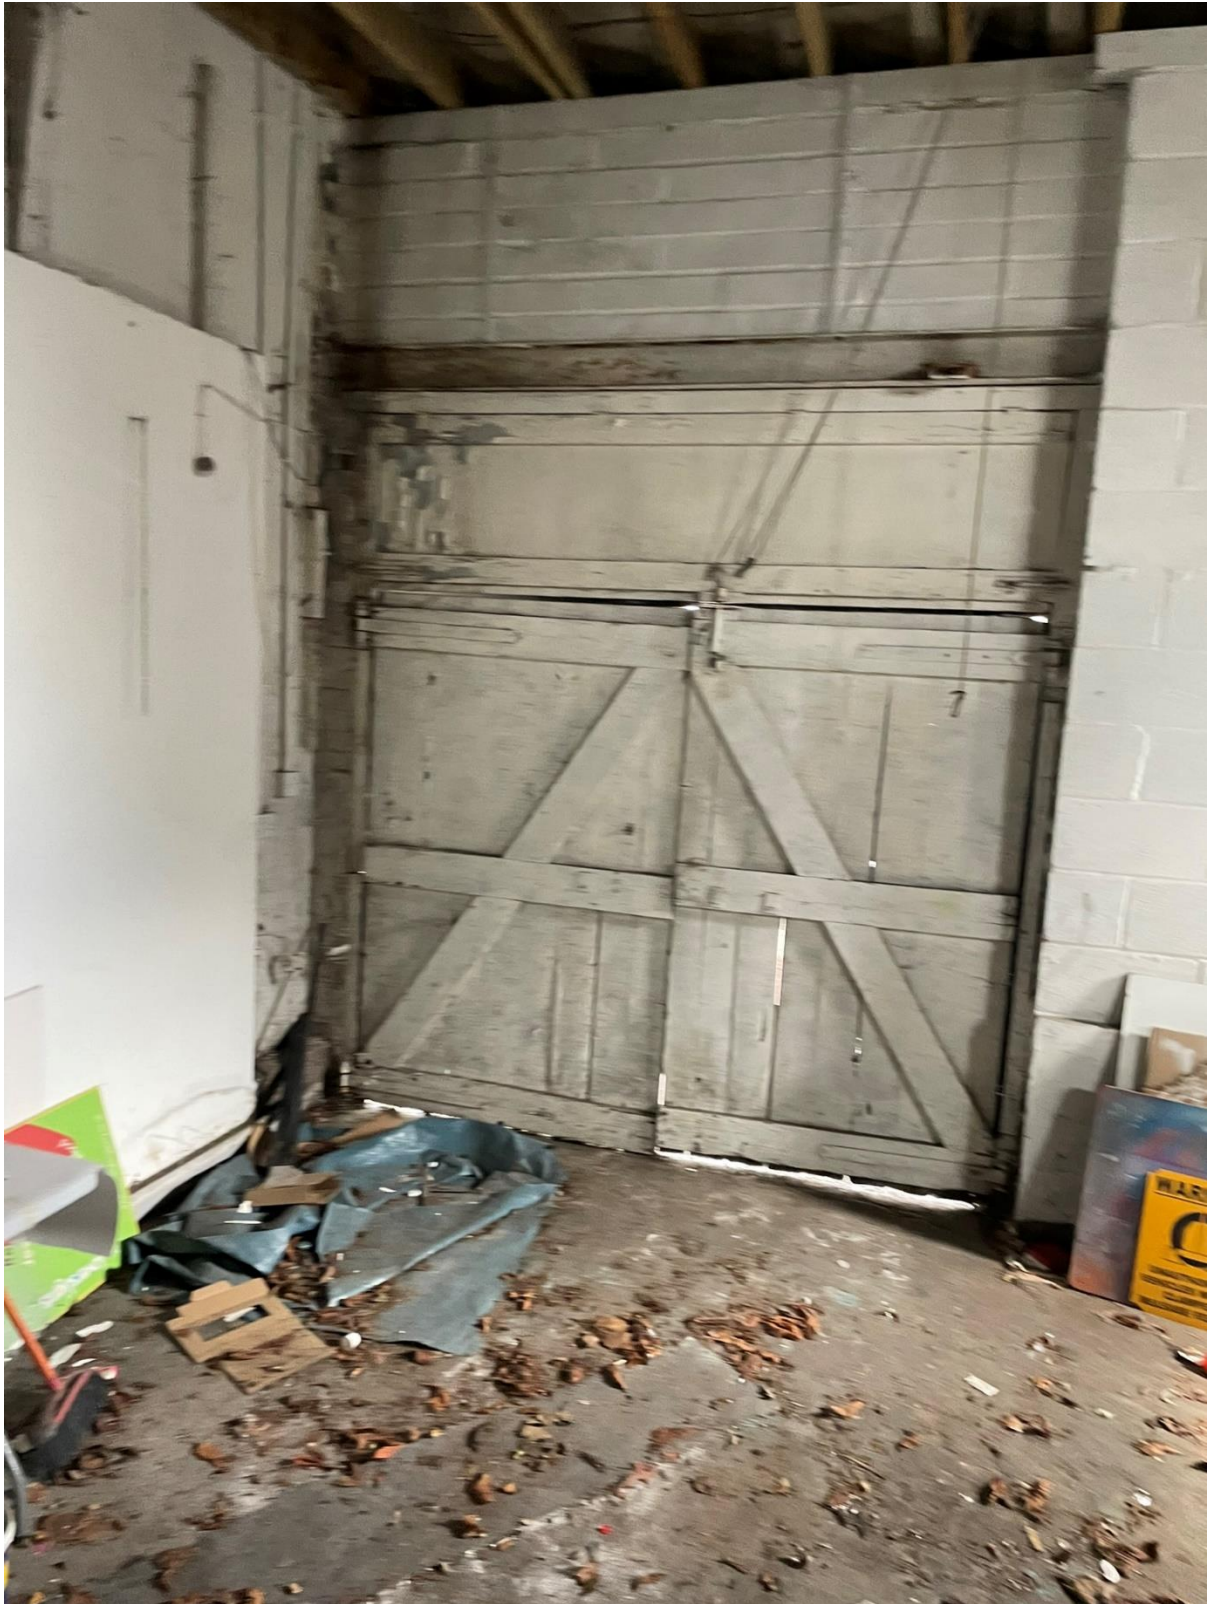
4.21 The front of the workshop along May Road appears cleaner than the back of the site but the concrete slab on the floor needs to be investigated for its structural integrity. There are cracks and depressions which highlight movement and it would need to be investigated, reduced in level and re-cast as a residential structural floor.

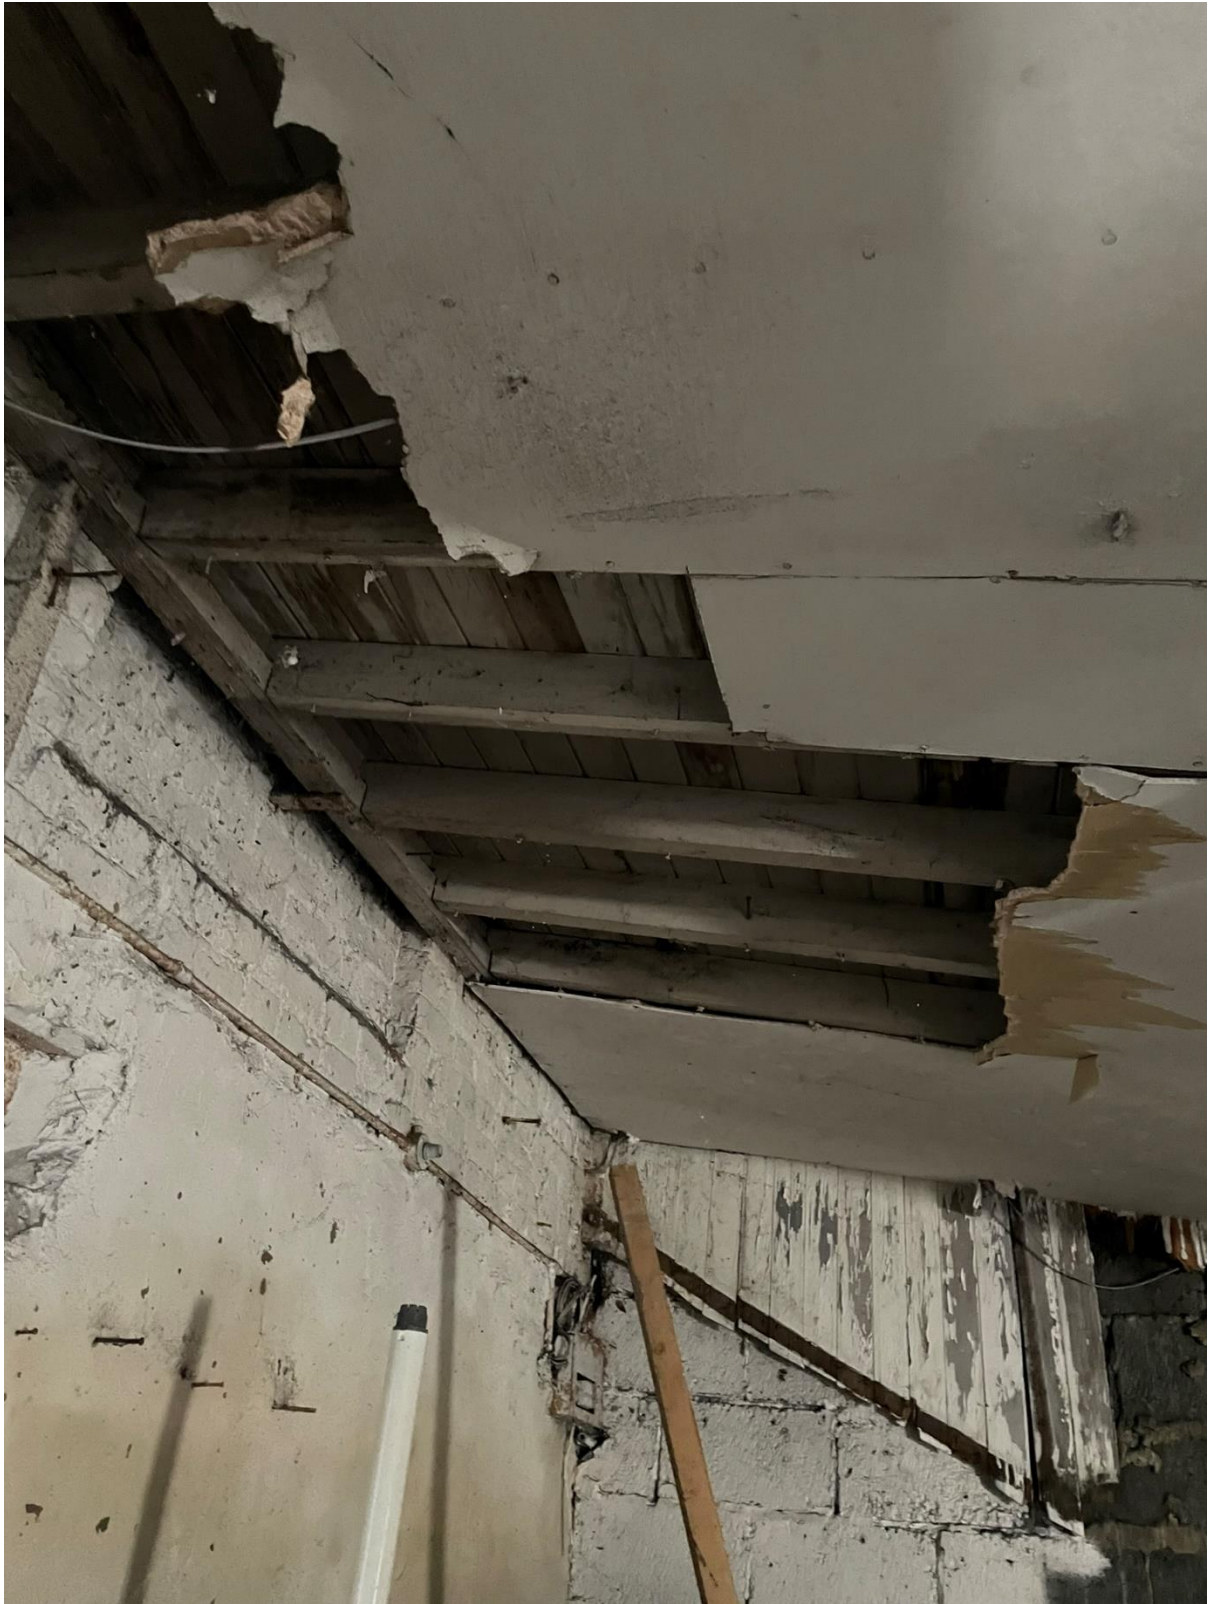
4.22 As we have seen the roof timbers are not fit for purpose and would need to be replaced. The connections to the masonry are poor and there is moisture and damp that has penetrated into the building.

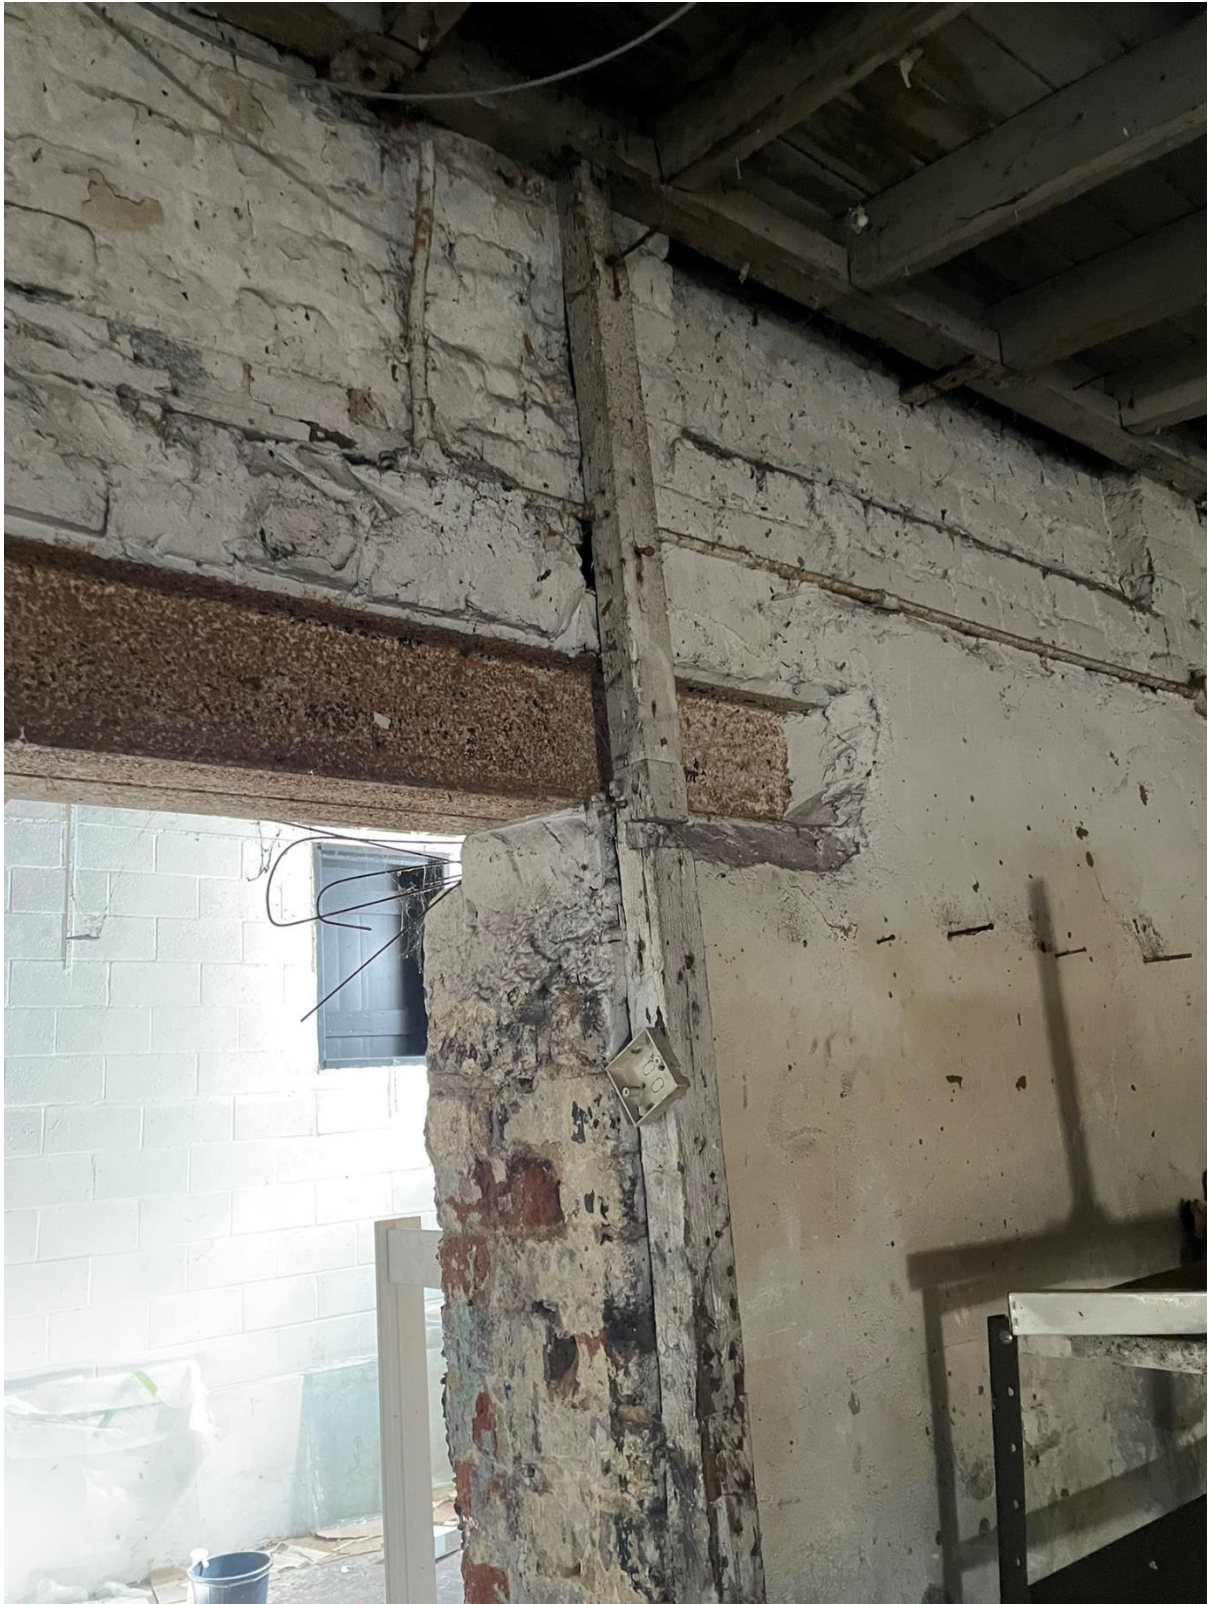
4.23 The steel structures supporting the openings are corroded and full of rust. While they may be able to be salvaged and restored, testing must be done to ensure that they can support the loads intended. The padstones also do not seem to be compliant and must be cast properly. The condition of the masonry pier would need to be assessed with the missing bricks and damaged bricks.

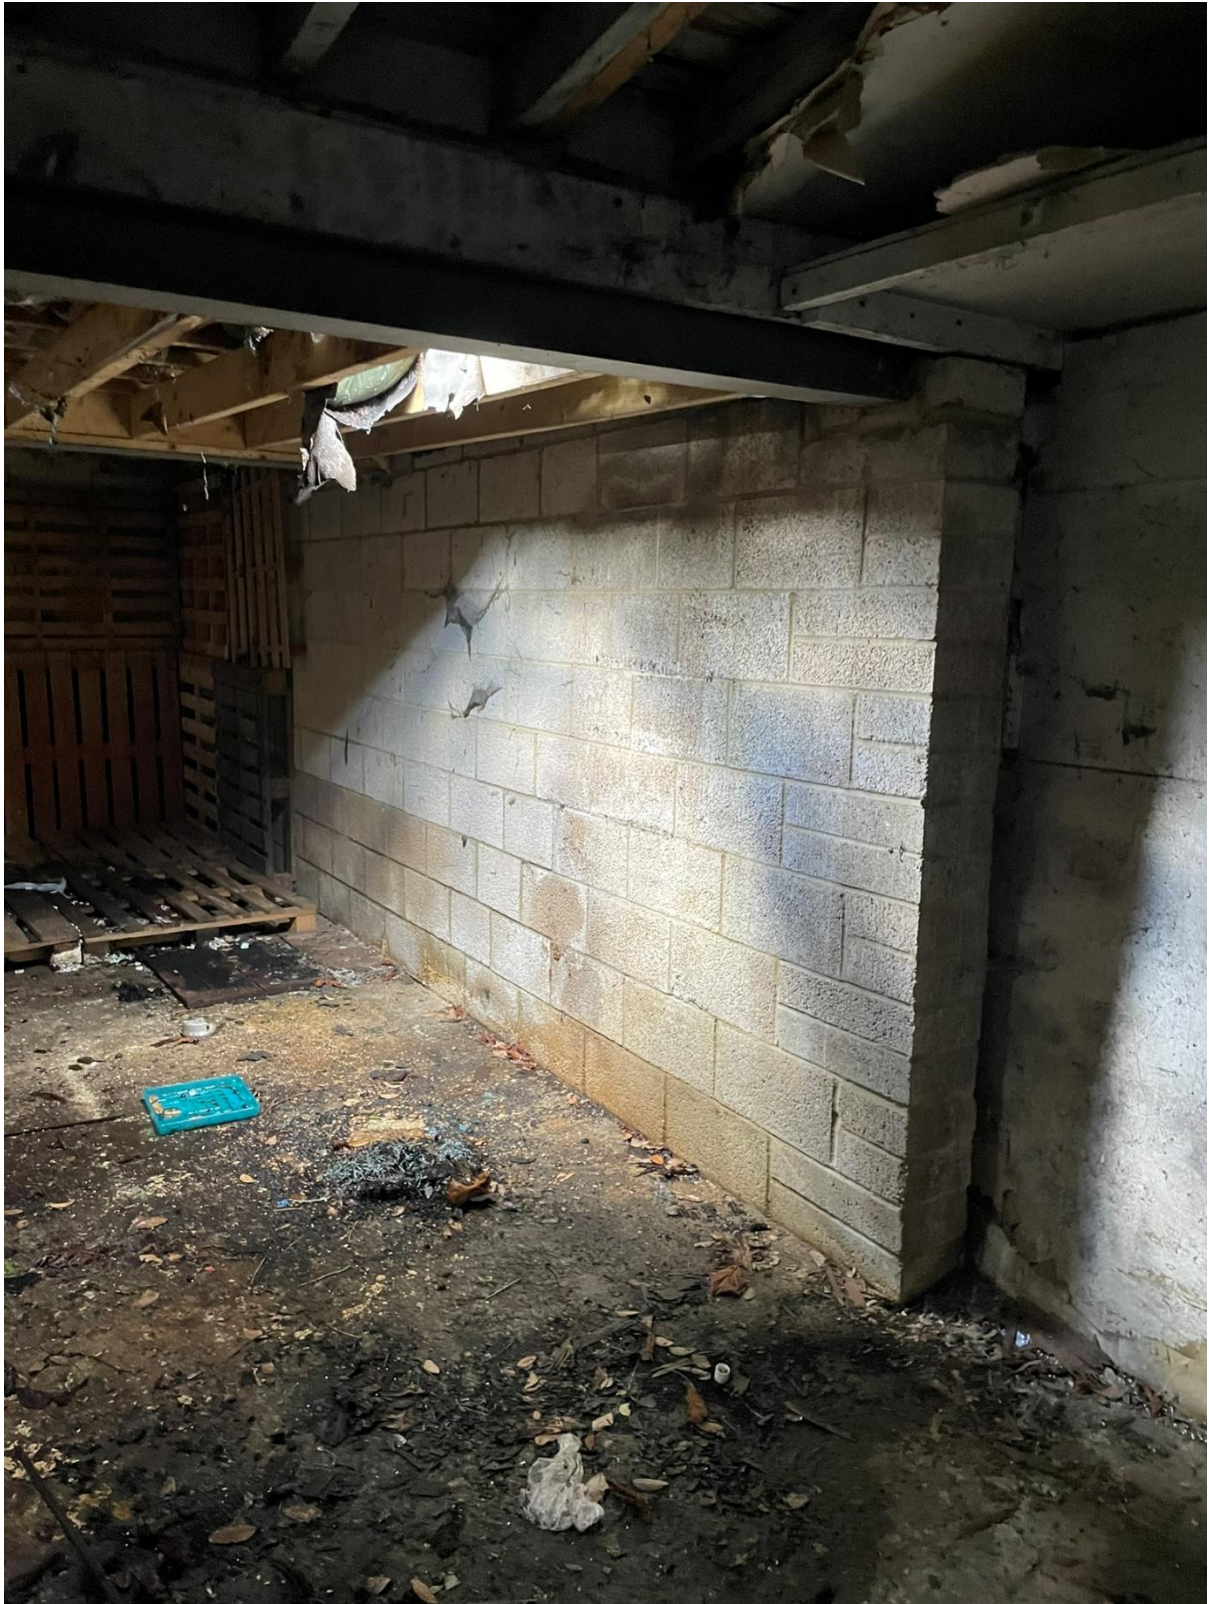
4.24 Highlighting the poor condition of the floor and the roof. There is a new masonry wall in blockwork that has been constructed. It may be supporting a wall that is failing and that should be investigated.

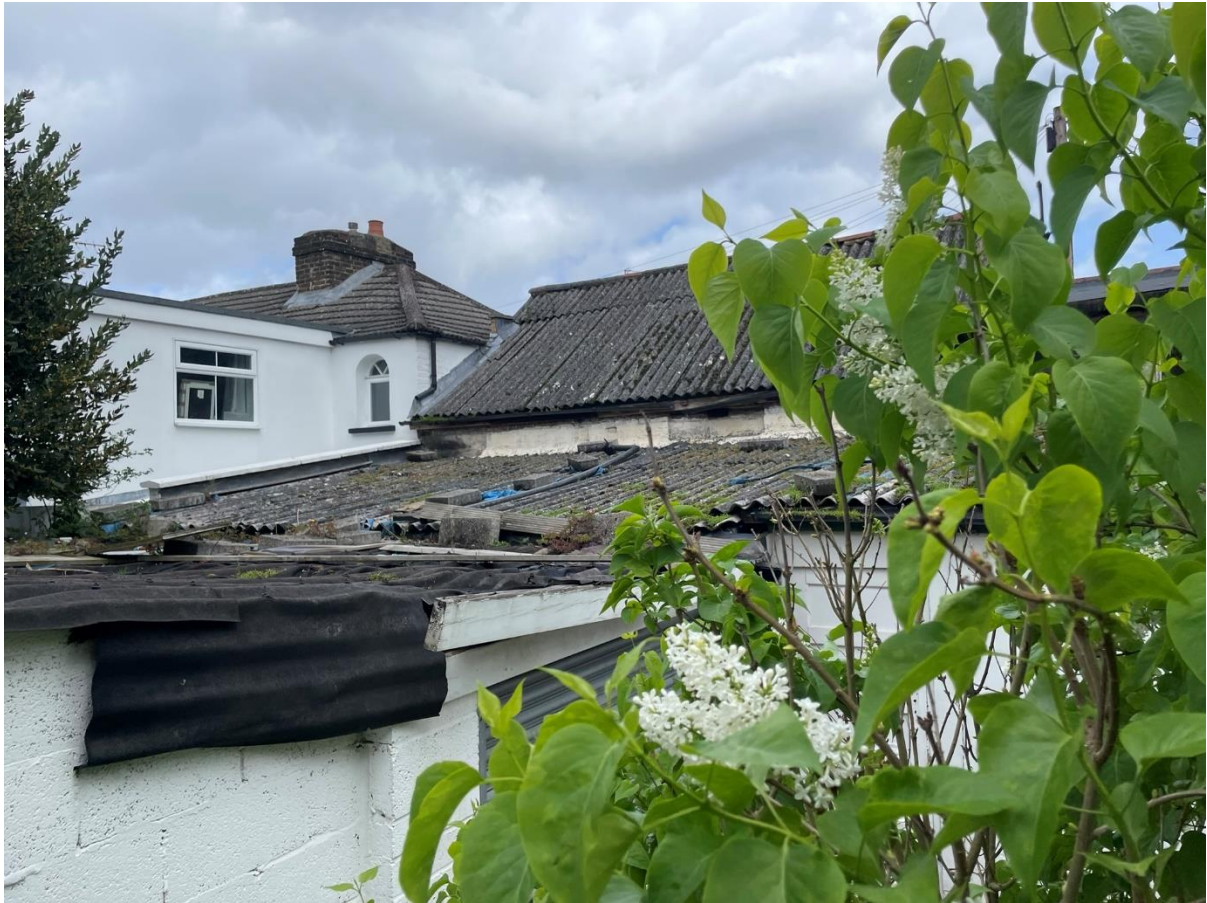
4.25 The view of the makeshift roofs from the top are also of structural concern. They appear to be undulating and sinking in several areas. The mechanisms to keep moisture and damp out are failing. They are full of debris and many of the roofing materials contain asbestos which need to be removed. It would be our recommendation that the entire roof is demolished and replaced.
