Tree Hazard Assessment / Tree Condition Survey

252 Kingston Road
London
TW11 9JQ

Survey Date: 22nd August 2024
Report Date: 5th September 2024
Project no: 2342

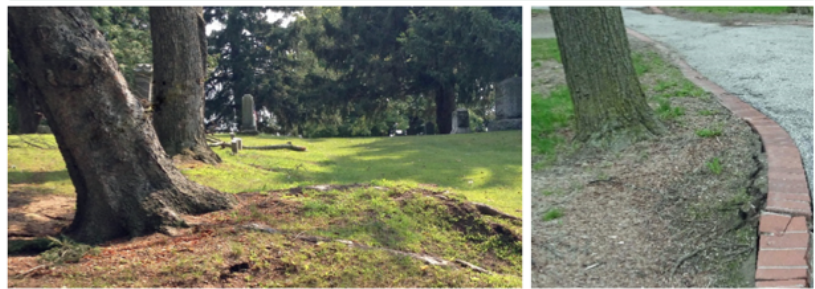
2.1 Root failure

9
Storms can break tree roots without blowing them over
Signs to look out for are
Change in angle of the trunk
Large cracks in the soil
Hump in the ground on one side

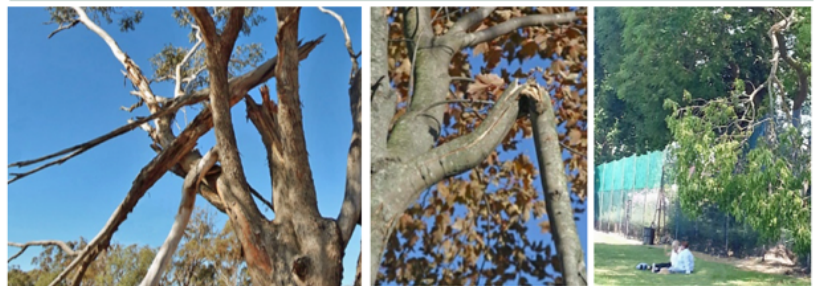
2.2 Hanging branches

10
Don't forget to look up
Branches can break during storms and still hang on
Sometimes they can get stuck up there for quite a while

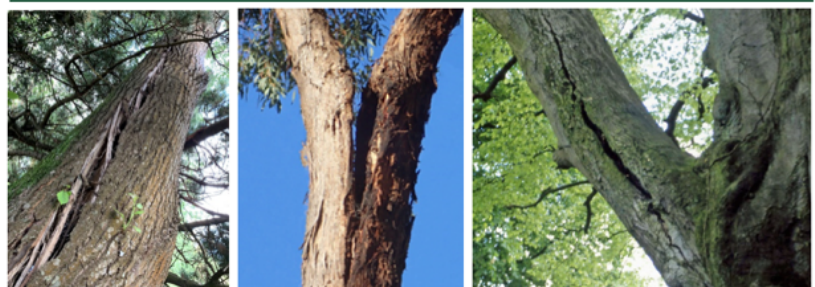
2.3 A crack or split into the wood, beyond the bark

11
When trees bend and twist in storms the wood can split and crack
Vertical cracks in the bark are just the tree growing well there's no need to worry

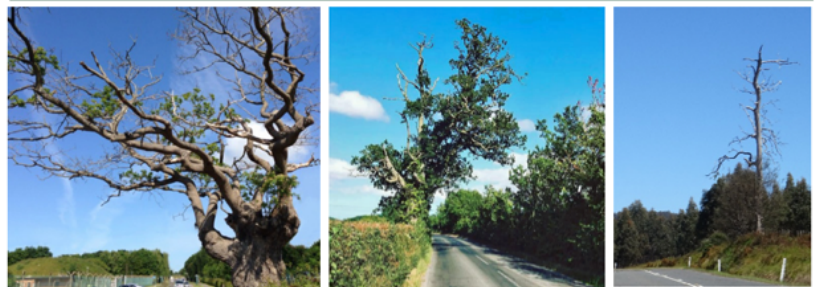
2.4 Decline & death

12
To stay healthy and strong trees need 'solar panel' leaves to make food
When trees suffer they often have much less leaf cover and many dead branches
Standing dead trees have great habitat benefits but need checking

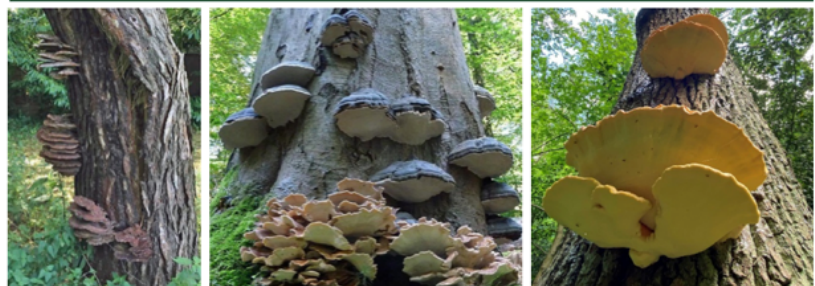
2.5 Decay fungi fruiting bodies

13
To decay fungi these 'fruits' are like apples to an apple tree
Decay fungi and trees mostly live happily together creating essential habitat for wildlife
Fungi can sometimes 'eat' too much wood and weaken the tree

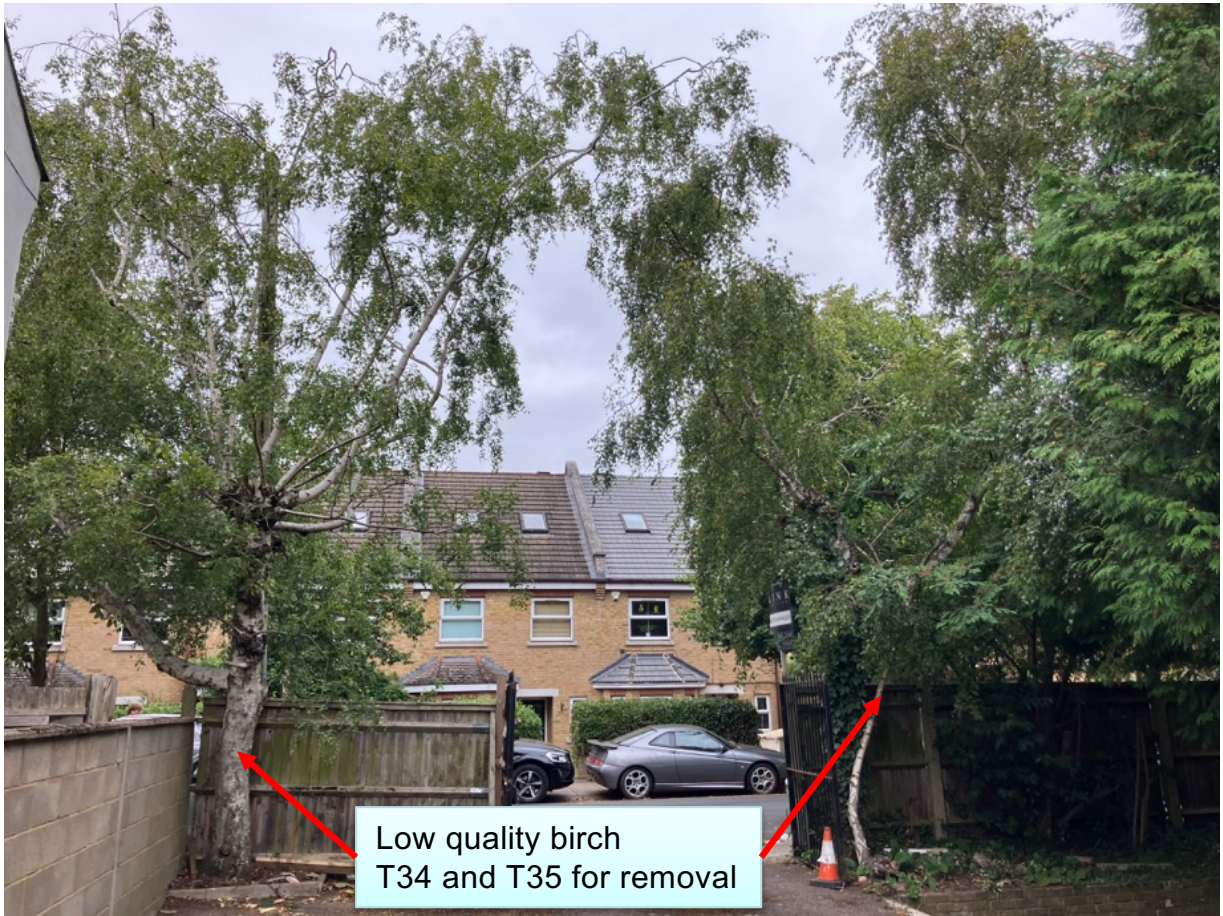
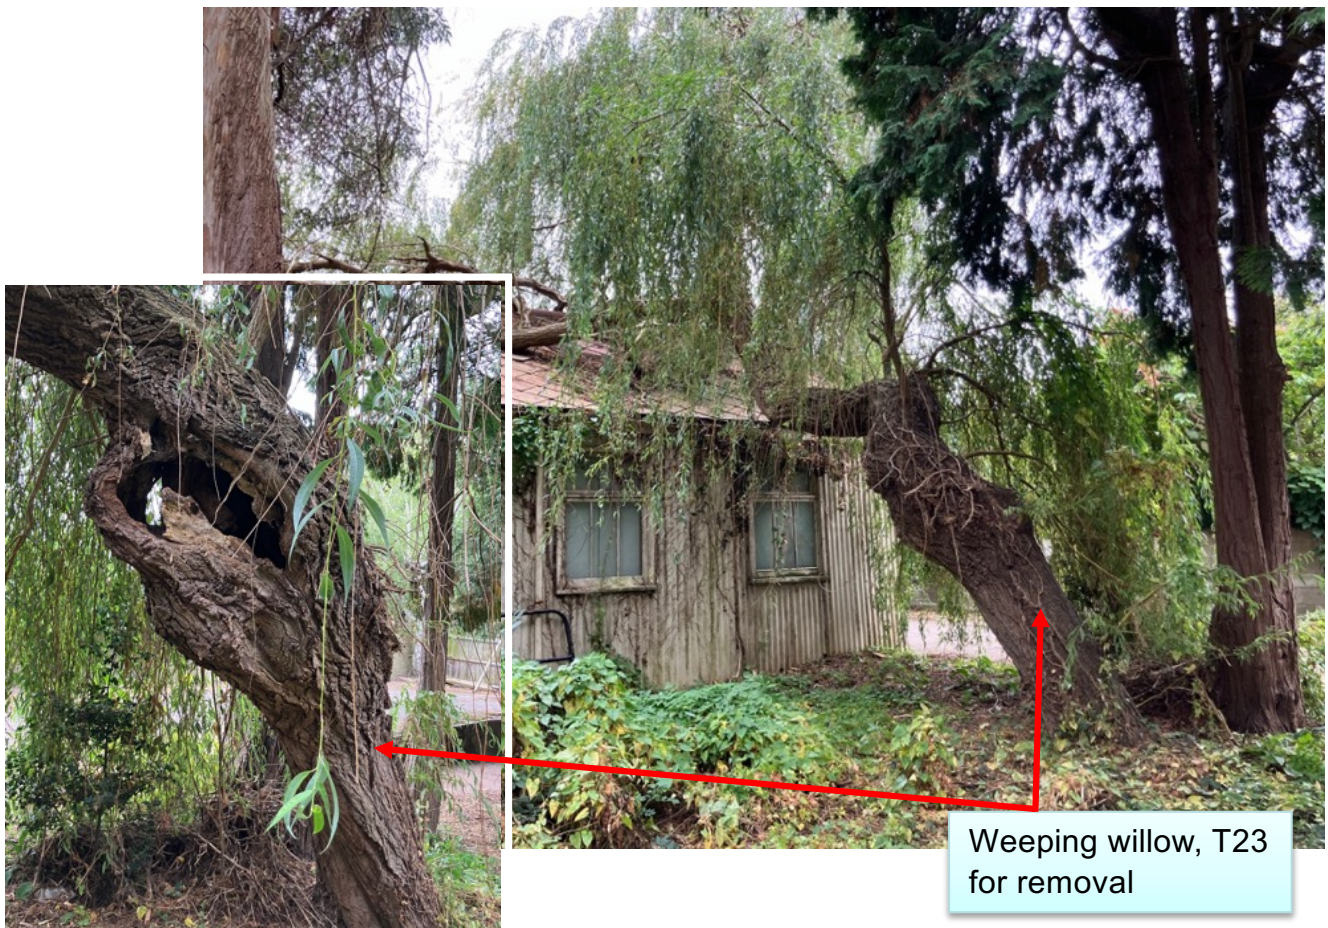
- 4.2.1 The only trees recommended for removal are:-
- Two low quality birch, T18 and T19, which are competing with the mature lime street tree.
 - A collapsing weeping willow, T23, shown in the photo in Appendix Fi).

- Two low quality birch, T34 and T35, growing either side of the rear entrance and shown in the photo in Appendix Fi).
- 4.2.2 The only work assessed as High Priority is the removal of the willow, T23, since the building is understood to be dangerous and unusable with the tree resting on the roof. The willow should be removed as soon as possible. The majority of tree work is Medium Priority, for completion within 6 months ie. by the end of March 2025.

T23	Weeping willow	12.5	570	0.5	8	6	2	0	Mature	Leaning to south east, with major limbs growing into roof of out building. Main stem completely hollow. Weight supported by roof. See photos in Apx Fi)	Remove.
T34	Birch	9	280	4	3	3	5	1.6	Mature	Repeatedly pollarded in past - with decay in pollard points. Declining vigour. Canopy against adjacent property and growing through utility lines. Stems likely to breakout.	Remove.
T35	Birch	7	280	3	2	3	2	2	Mature	Moderate vigour. Sections have broken out in past - further sections likely to follow.	Remove.
G36	4 no. Birch	13 - 17.5	100 - 200	0	0	0	0	0.7	Early mature	Foliage within 1m of building. Two smaller trees are multistem.	Remove self sown sycamore (3.5m) from group.

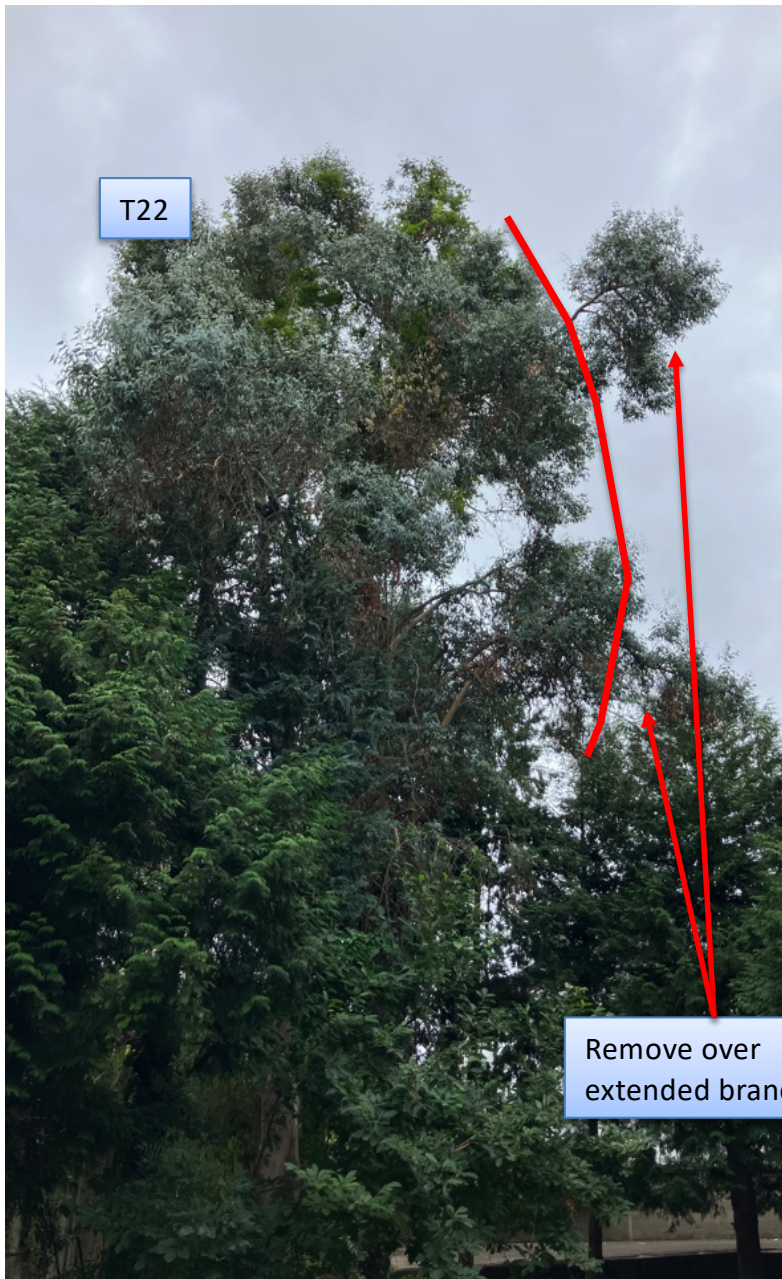
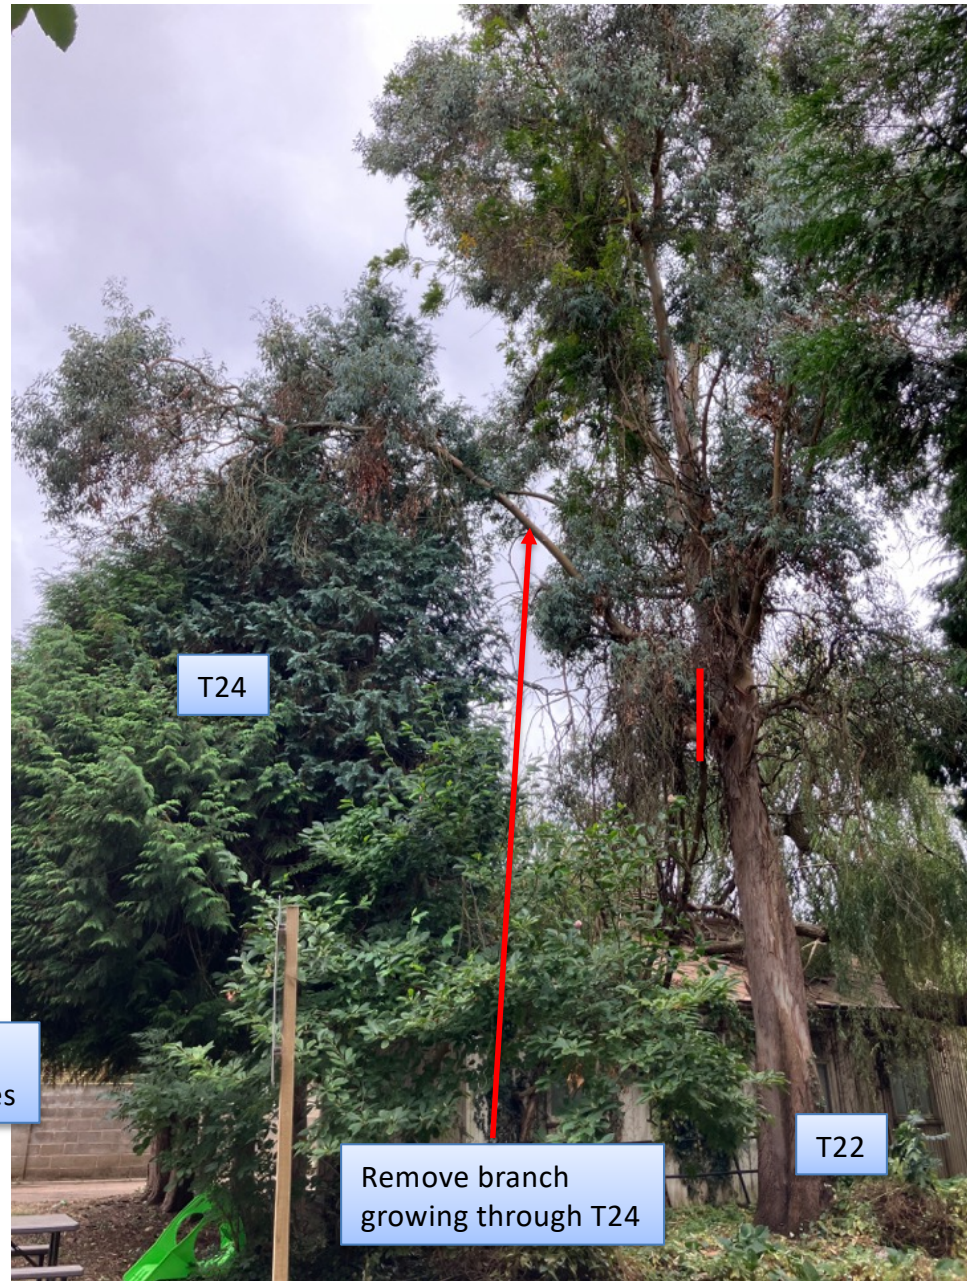
T11	Holly	8	320	2	3	2	2	0.9	Early mature	4 stems - avg 160mm. Reasonable vigour.	Remove low branches to provide 2m clearance to path.
T12	Lawson cypress	16	340	2	2	2	2	1.6	Mature	Twin leaders. Good vigour. Surface root lifting to tarmac path, creating trip hazard.	Remove low branches to provide 2m clearance over path.
T13	Sycamore	13.5	390	7	4	5	5	1.7	Early mature	Reduced to various points in the past. Canopy within 0.5m of building. Dead branch (110mm diameter) to south.	Remove deadwood, together with low branches in front of 1st floor windows.
T18	Birch	18	240	2	5	3	2	2	Mature	Only moderate vigour. Dense ivy to upper canopy.	Remove
T19	Birch	11	220	2.5	2.5	2.5	2.5	1.8	Mature	Poor structure. Dense ivy. Suppressed by adjacent trees.	Remove to allow surrounding trees to develop.
T22	Eucalyptus	20.5	790	7.5	7	5	4	4.5	Mature	Low dead branches. Heavy wisteria growth - now almost entirely dead. Upper canopy showing good vigour. Possible risk of branch breakout.	Remove dead branches and wisteria. Reduce over extended branches to north. Remove low branch to east growing through T24 to reduce risk of breakout. As per photos in Apx Fii).
