STRUCTURAL IMPACT ASSESSMENT

59 PETERSHAM ROAD, RICHMOND TW10 6UT

**PROPOSED SINGLE STOREY REAR EXTENSION AT GARDEN LEVEL WITH
UPPER POD TO LOWER GROUND FLOOR, AND PROPOSED FRONT
LIGHTWELL AND STEPS (PLUS ASSOCIATED ALTERATIONS)**

**Job No: G1100
18th September 2024**

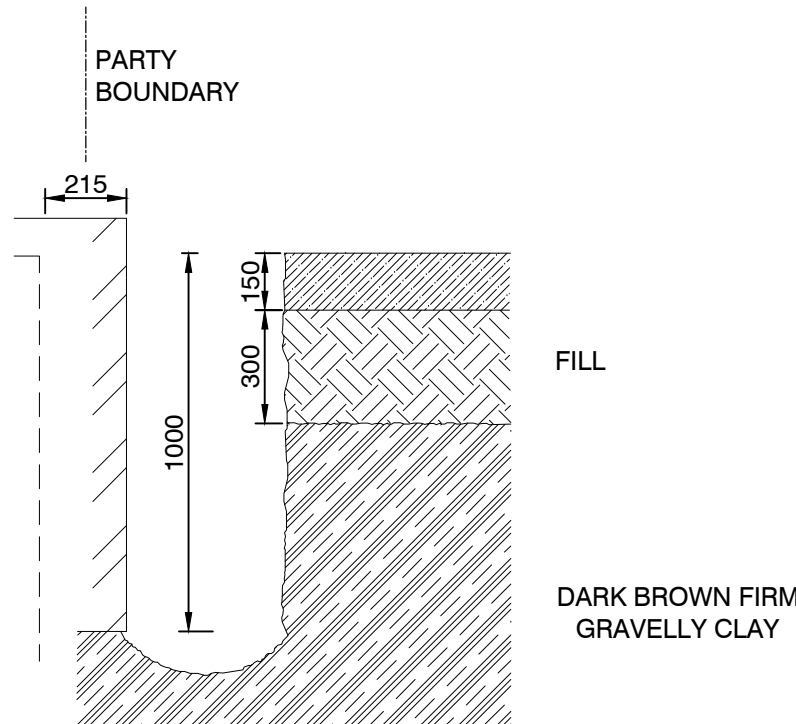
Trial Pit Locations
(Scale 1:50 @ A1)

- 3.3 To further understand the substructure of the building and adjacent walls a series of trial pits were carried out. These are recorded in Appendix A.

- 3.4 They consistently show the walls to be founded in firm dark brown gravelly clay. No ground water was encountered.
- 3.5 The rear wall was founded at a depth of 1.8m below garden level with the adjacent boundary walls founded at a depth of 1m (No 57) and 450mm (No 61). To the front of the building the footings were 250mm below this level. No corbelling of the brickwork at their bases was found.

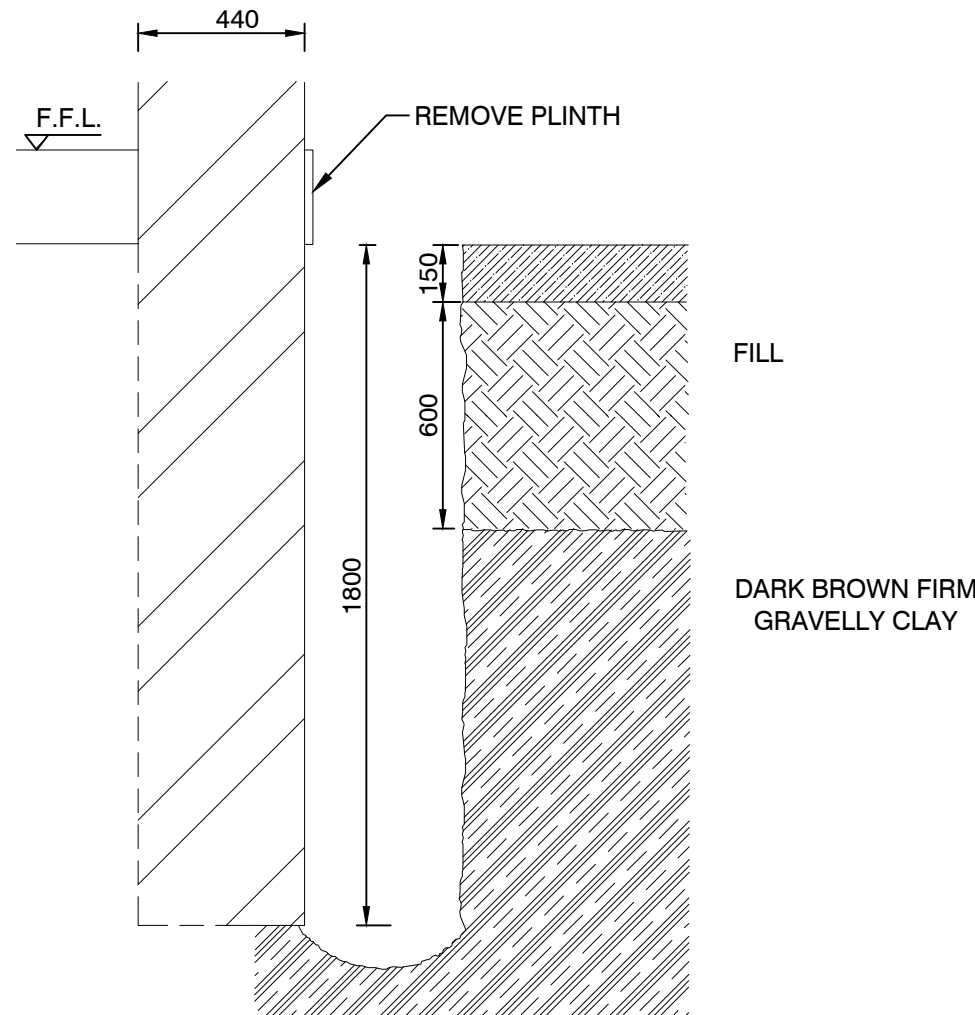
TP01
(SCALE 1:20 @ A1)

Reference to the trial pits carried out (Appendix B) shows the brick walls to the rear are founded relatively deeply at 1.8m onto the underlying gravelly clay. No corbelling at the base of the wall was found.

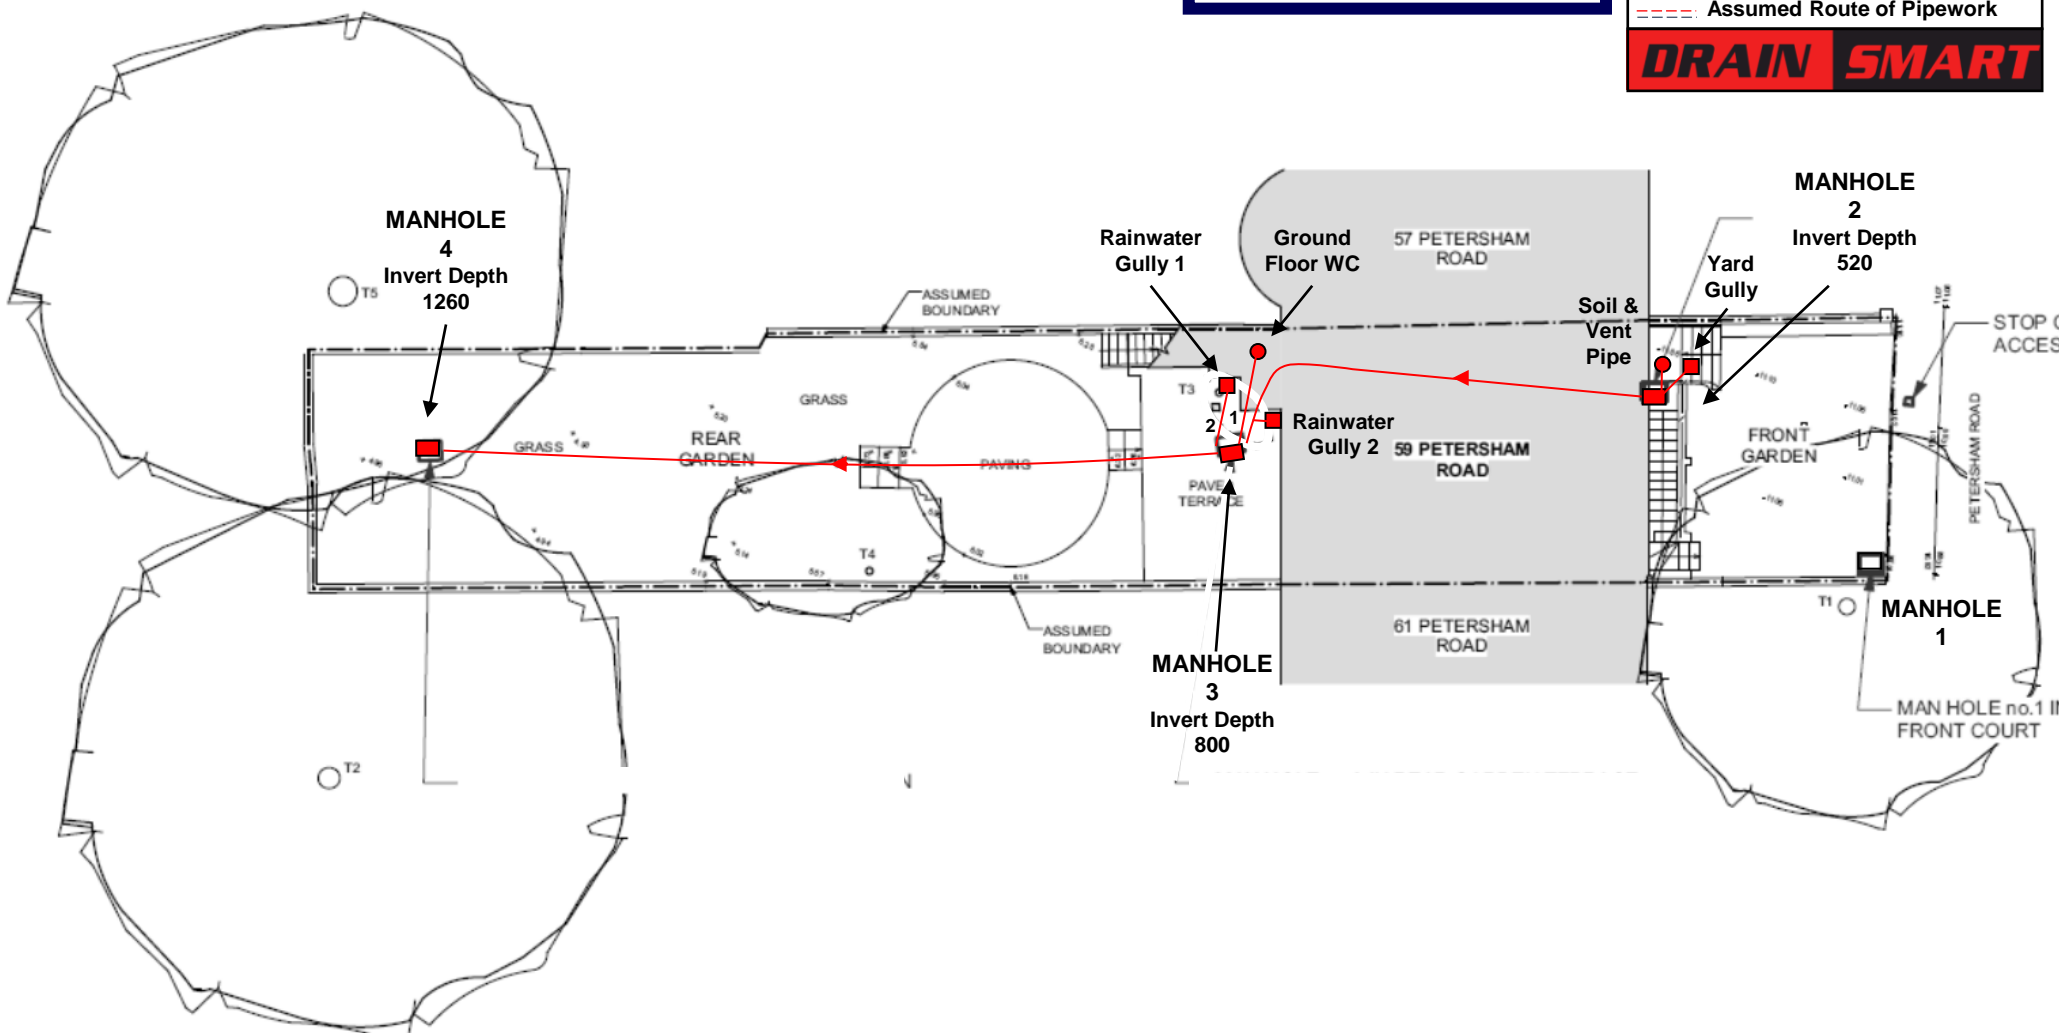
- 3.6 The results of a CCTV survey of the below ground drainage is summarised in Appendix B. This shows a combined system draining from front to back – presumably to the public sewer running parallel with the river.

- 3.7 Their summary concludes the drainage system is not in a satisfactory structural condition having multiple fracturing on the verge of collapse and heavy root penetration. There are also heavy debris deposits with cement intrusion which is affecting the free flow of waste. It is all confirmed as private and not under the ownership of Thames Water.

It was apparent from the CCTV camera inspection that the accessible private drainage system is not in a satisfactory structural condition having multiple fracturing on the verge of collapse and heavy root penetration which will be allowing the loss of water into the surrounding ground area. Please note that the root mass in Manhole 4 prevented a survey downstream of this chamber.

Whilst the damage discovered in the private system should be repaired, it may be that some of the affected drainage will be replaced as part of the proposed building works or made redundant. Should you require an estimate for any of the necessary repair or cleaning works in the pipework to be retained we will be pleased to provide this upon request.

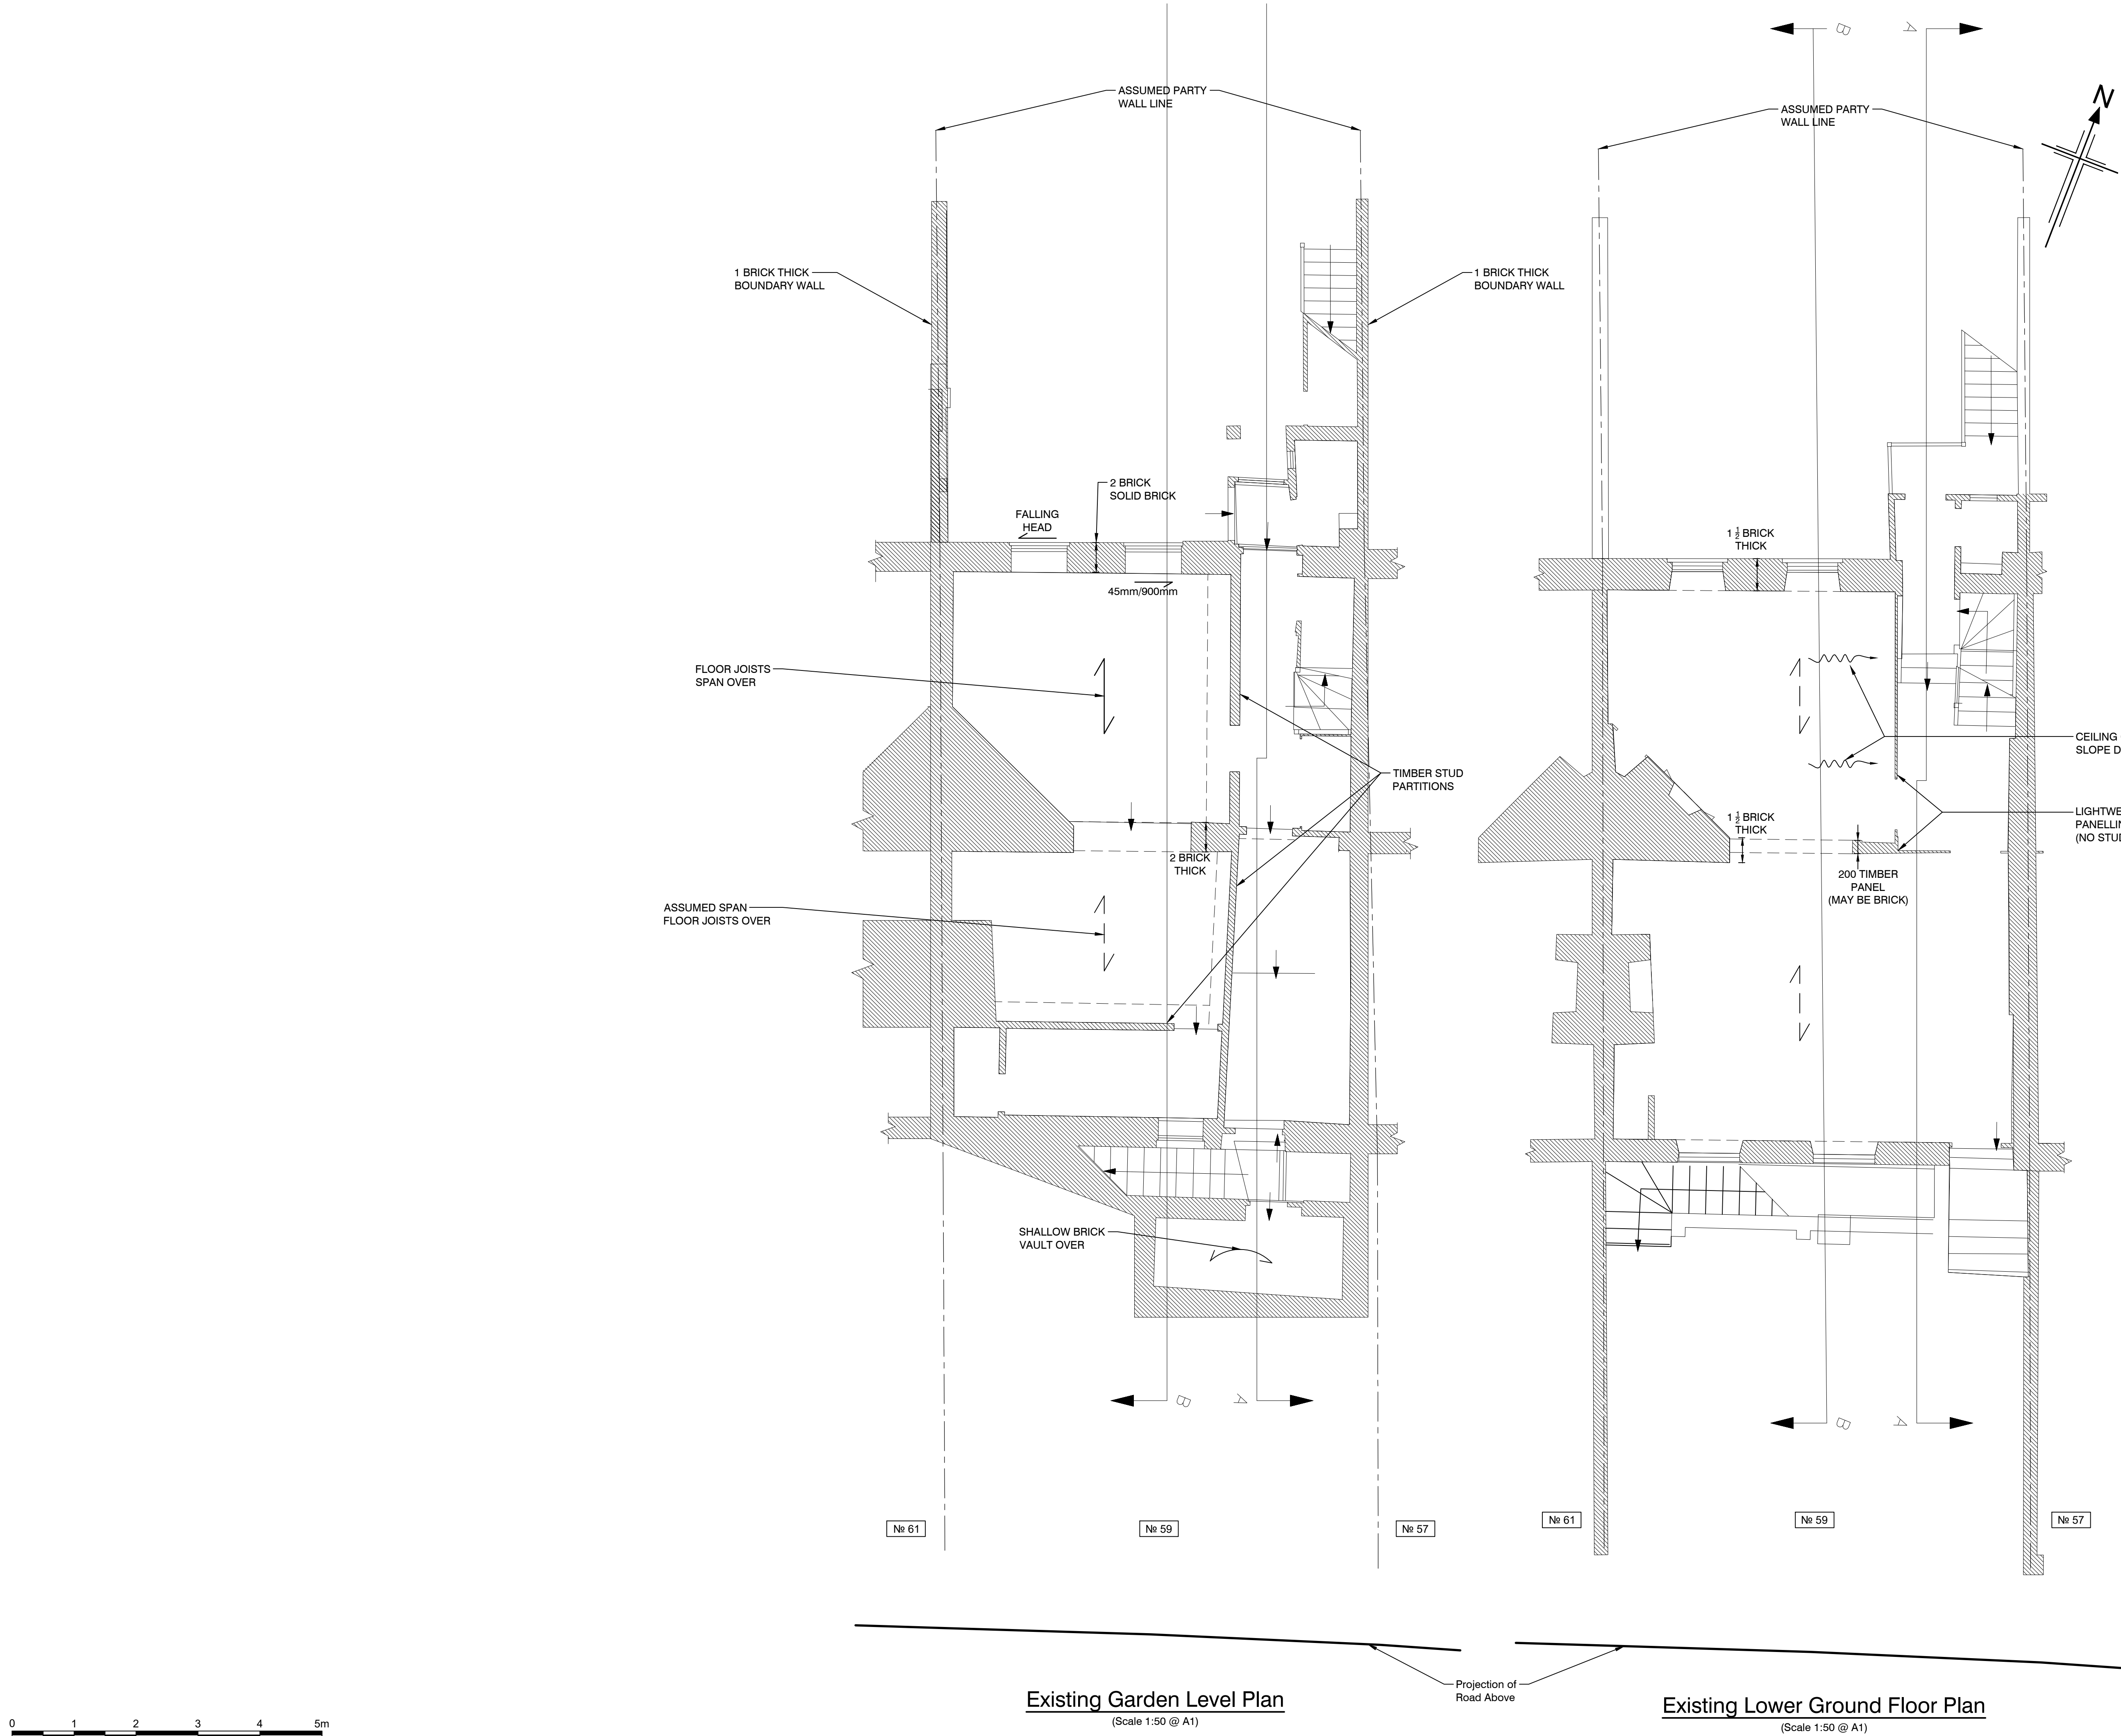
Scale:	As Shown @A1	Do not scale from drawing
Drawing Number:	G1100-1600-001	Rev:

Reference should be made to drawings G1100-001 to 005 (Appendix C) where these observations are recorded. Many of the rooms are clad in panelling – concealing the underlying condition of the structure.

The rear wall is in fair condition. It is apparent that the central pier between the two windows has settled relative to the two sides. The heads of the windows also slope down. No significant cracks were identified and the movement appears longstanding.

The rear wall is founded at a depth of 1.8m in to clay and has settled differentially along its length. This movement appears longstanding and is likely due to changes in moisture content of the clay (due to ground water runoff down the slope of the hill or damaged below ground drainage) resulting in cycles of swelling and shrinkage. The CCTV survey report of the below ground drainage confirmed it is in very poor condition and should be replaced.

The settlement that has occurred has not compromised the stability of the walls and where damaged localised repairs to the brickwork can be carried out.

The original masonry construction would have used a lime mortar which is able to accommodate the movement that has occurred. It is important that any repairs are carried out using similar lime based mortars such that any future movements do not cause brittle fracturing of the masonry
