STRUCTURAL IMPACT ASSESSMENT

59 PETERSHAM ROAD, RICHMOND TW10 6UT

**PROPOSED SINGLE STOREY REAR EXTENSION AT GARDEN LEVEL WITH
TERRACE OVER, AND PROPOSED FRONT LIGHTWELL AND STEPS (PLUS
ASSOCIATED ALTERATIONS)**

**Job No: G1100
18th September 2024**

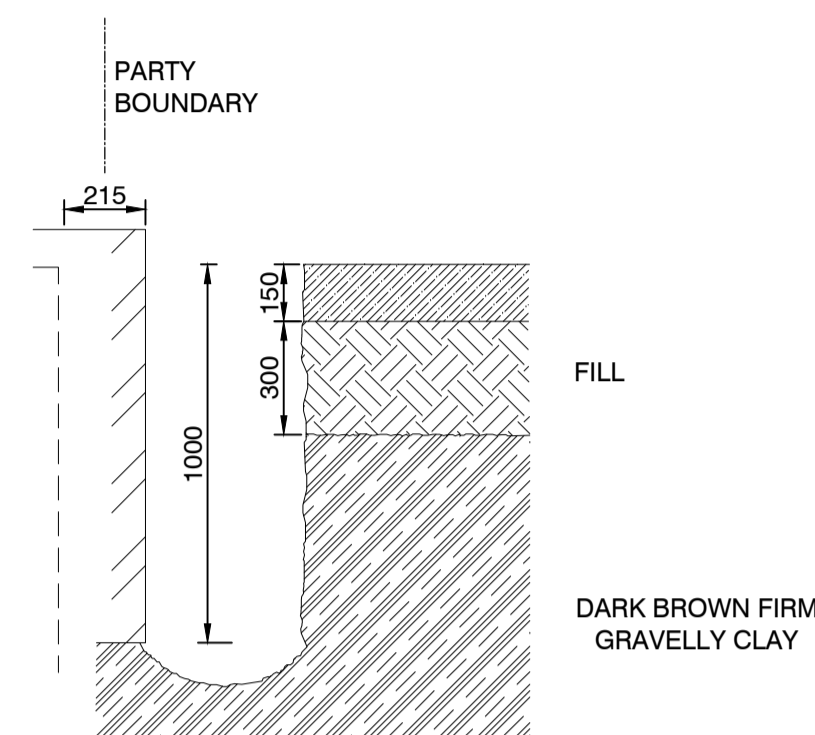
TP01
(SCALE 1:20 @ A1)

- 3.4 They consistently show the walls to be founded in firm dark brown gravelly clay. No ground water was encountered.
- 3.5 The rear wall was founded at a depth of 1.8m below garden level with the adjacent boundary walls founded at a depth of 1m (No 57) and 450mm (No 61). To the front of the building the footings were 250mm below this level. No corbelling of the brickwork at their bases was found.

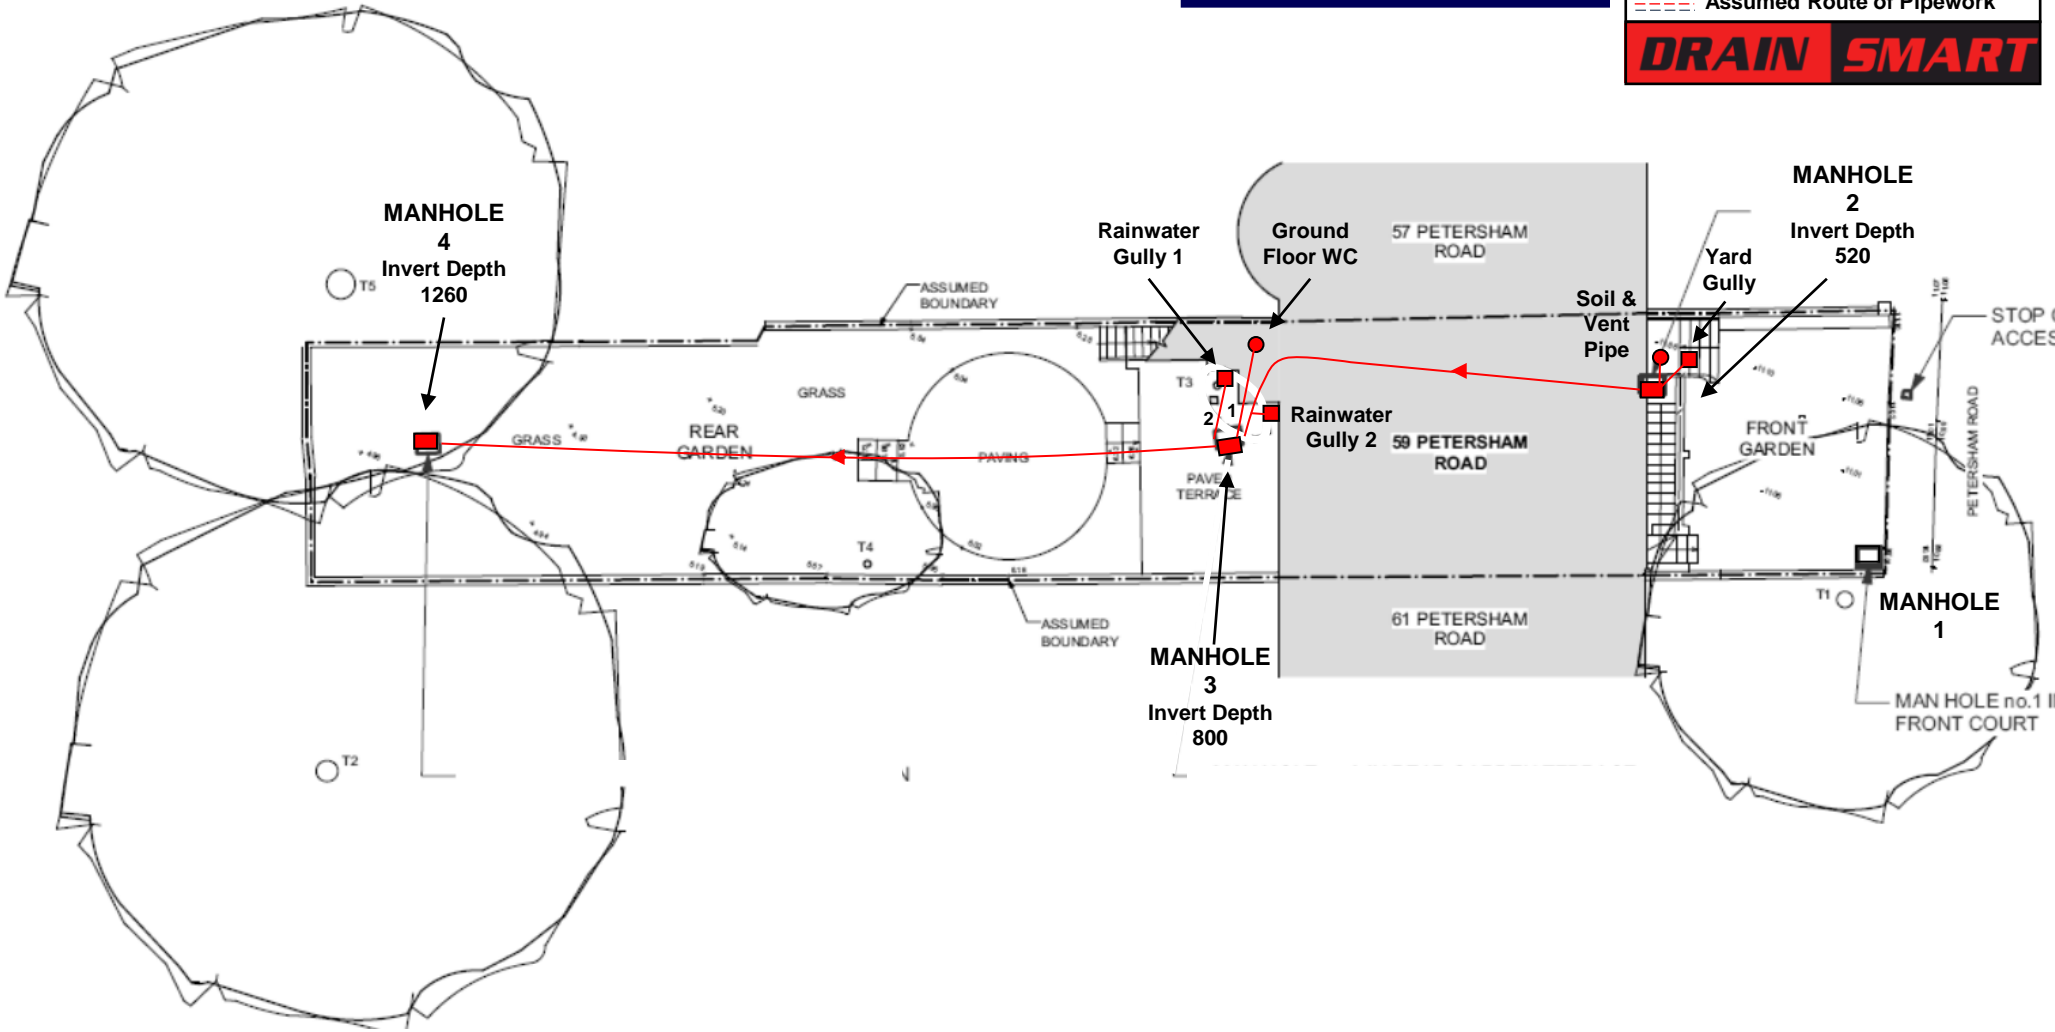
It was apparent from the CCTV camera inspection that the accessible private drainage system is not in a satisfactory structural condition having multiple fracturing on the verge of collapse and heavy root penetration which will be allowing the loss of water into the surrounding ground area. Please note that the root mass in Manhole 4 prevented a survey downstream of this chamber.

Whilst the damage discovered in the private system should be repaired, it may be that some of the affected drainage will be replaced as part of the proposed building works or made redundant. Should you require an estimate for any of the necessary repair or cleaning works in the pipework to be retained we will be pleased to provide this upon request.
