A Tree Condition Report carried out at:

53 Wensleydale Road Hampton TW12 2LP

Prepared for Simon Kippin

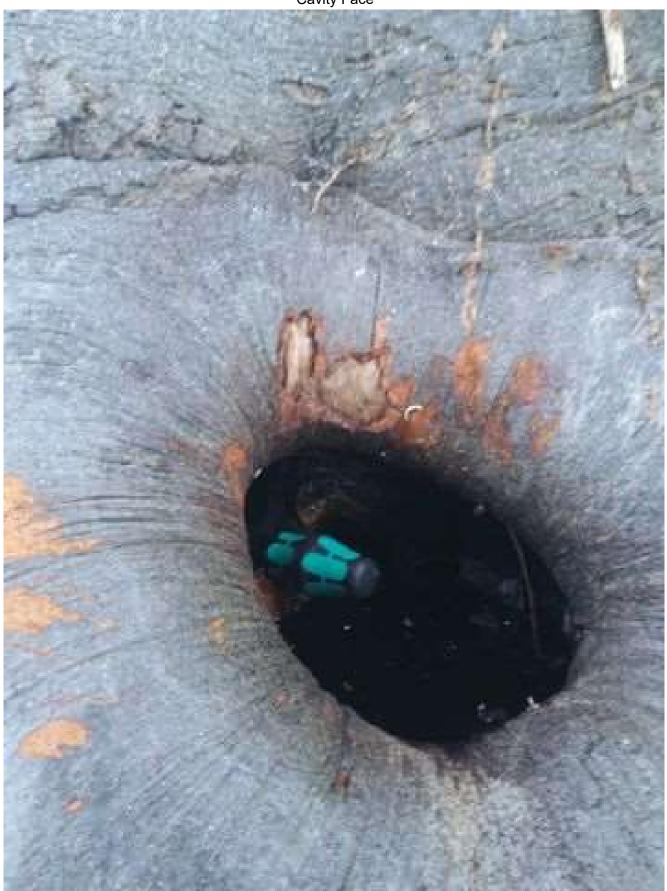
Photo 2
Cavity Face

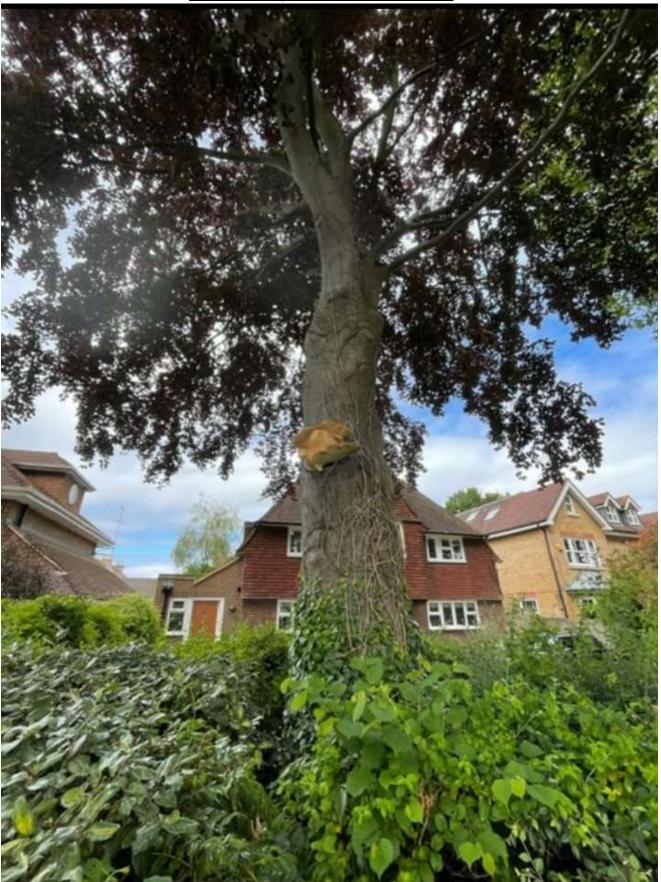
Photo 4 (Fungi in tree from Mr Kippin)

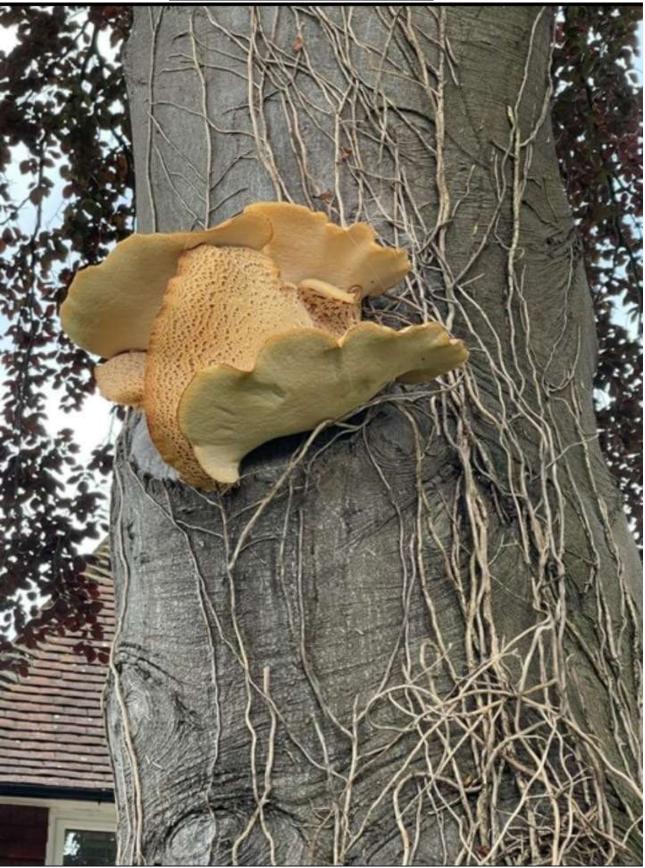
Photo 5 (Fungi in tree from Mr Kippin)

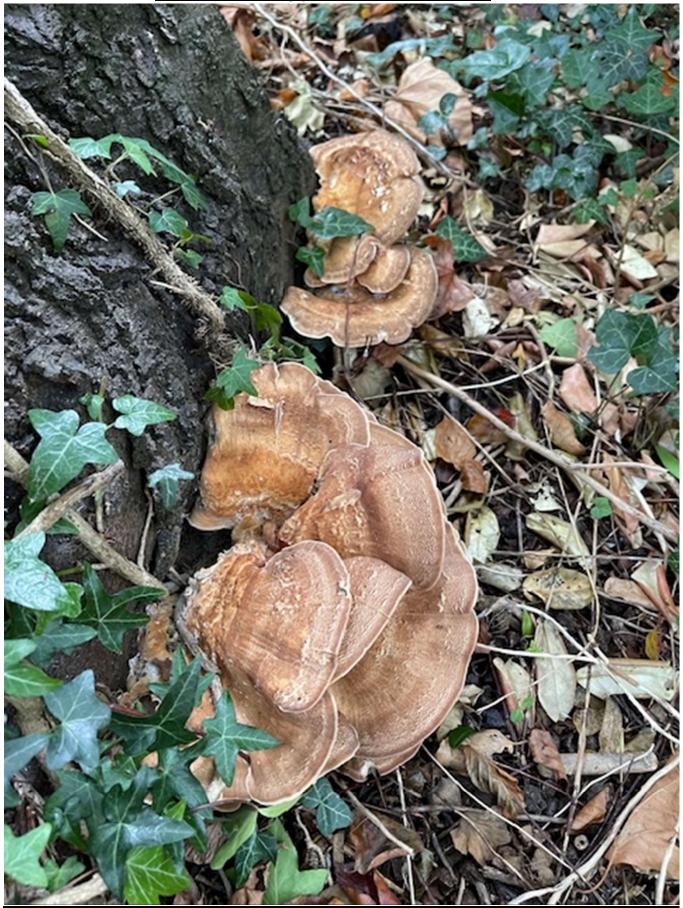
Photo 7 (Meripilus giganteus identified 14/10/24)

Appendix 1: Further photos were supplied by Mr Kippin on 13/10/24 (Photos 7, 8 & 9) which I have identified as *Meripilus giganteus*. This is recognised root decay fungi. Due to the extensive decay in the main stem along with the indication of the roots decaying, in my opinion there is only one option available which is to fell the tree.

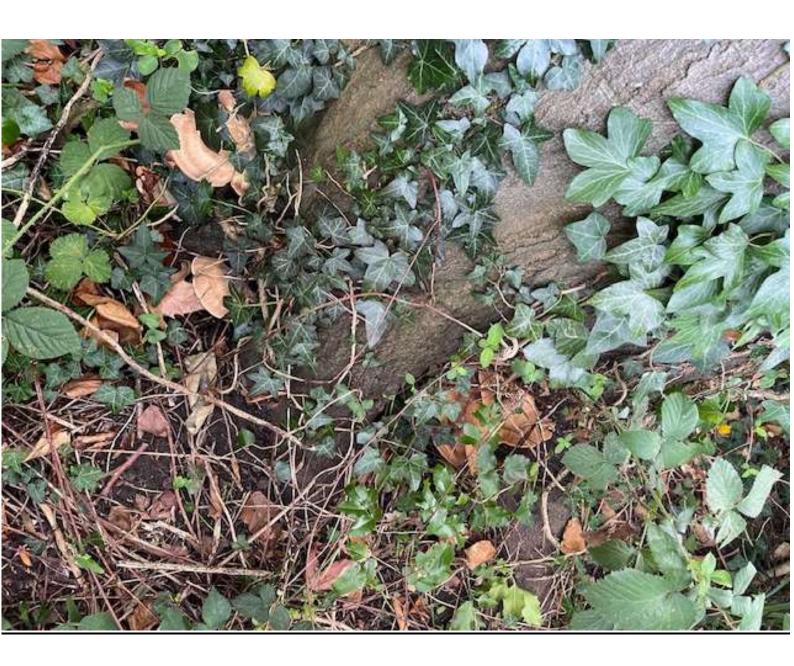
Photo 8 (Meripilus giganteus identified 14/10/24)

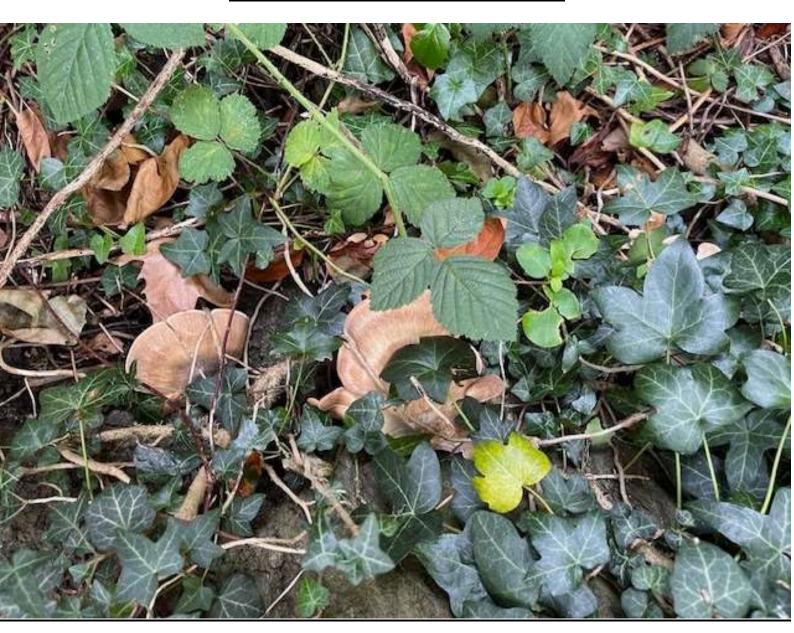
Photo 9 (Meripilus giganteus identified 14/10/24)

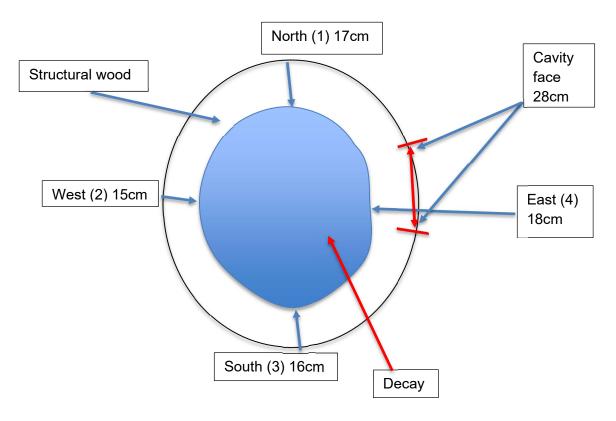
Interpretation (estimated extent of decay based on results not to scale)

94cm Diameter at 3m

- 1. Due to the extensive decay/cavity found at 3m, my recommendation is to fell the tree to ground level. It is likely that the tree will decline in vitality as a result of the fungal infection (*Cerioporous squamosus*) and therefore preventing the tree from producing sufficient reaction wood to support the crown.

- 3. Mathecks theory on hollow trees as described in (The Body Language of Trees, 2015) is that hollow trees with full crowns and single enclosed hollows are increasingly likely to fail if the residual wall is less than 30%. Given this calculation, that would equate to a hollow stem with 94cm diameter would ideally have a critical wall thickness of 47cm x 0.3 which equals 14.1cm. However, this theory of a 30% ratio does cannot be applied here due to the open cavity identified at 3m but is a good indicator that there is insufficient remaining functional wood to support the canopy. All drill tests performed on the stem of T1 are on the borderline of acceptable remaining residual wood. This is considered as an acceptable tolerance for "Normal" weather conditions but would be the likely place of failure in extreme weather events. With an aggressive pathogen such as this one this is likely to become worse and go beyond the acceptable threshold which is what I am basing my recommendation on.

T001- Fell to ground level

Timescale: Within 3 months of receiving report
