Report

Ingenium Building, Grey Court School, Ham
Street, Richmond

Inspection carried out 23 November 2021

Re: Ingenium Building, Grey Court School, Ham Street, Richmond

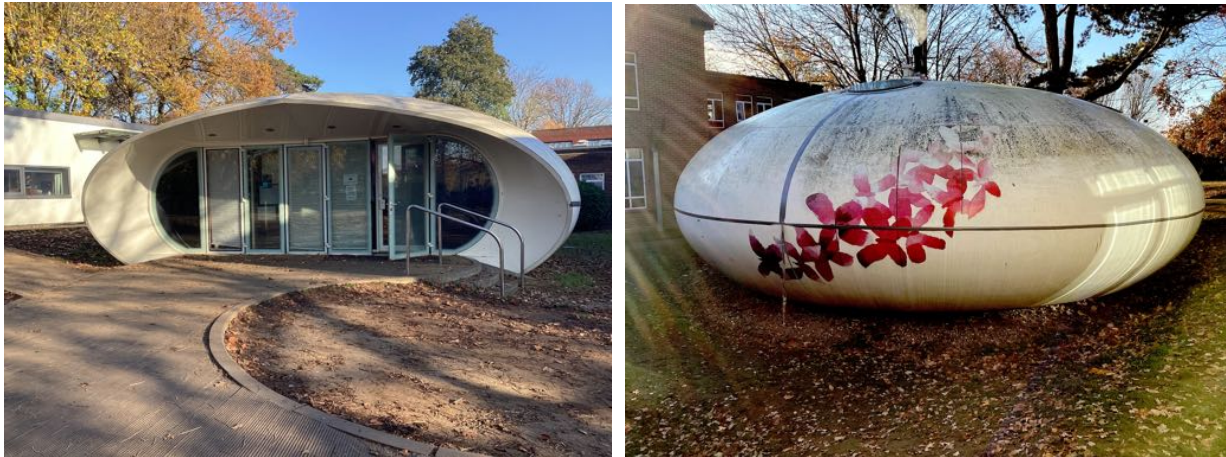
This report has been requested further to severe leaking of rainwater and partial collapse of the timber suspended floor towards the rear of the unit, and no other areas of the property have been examined or reported upon.

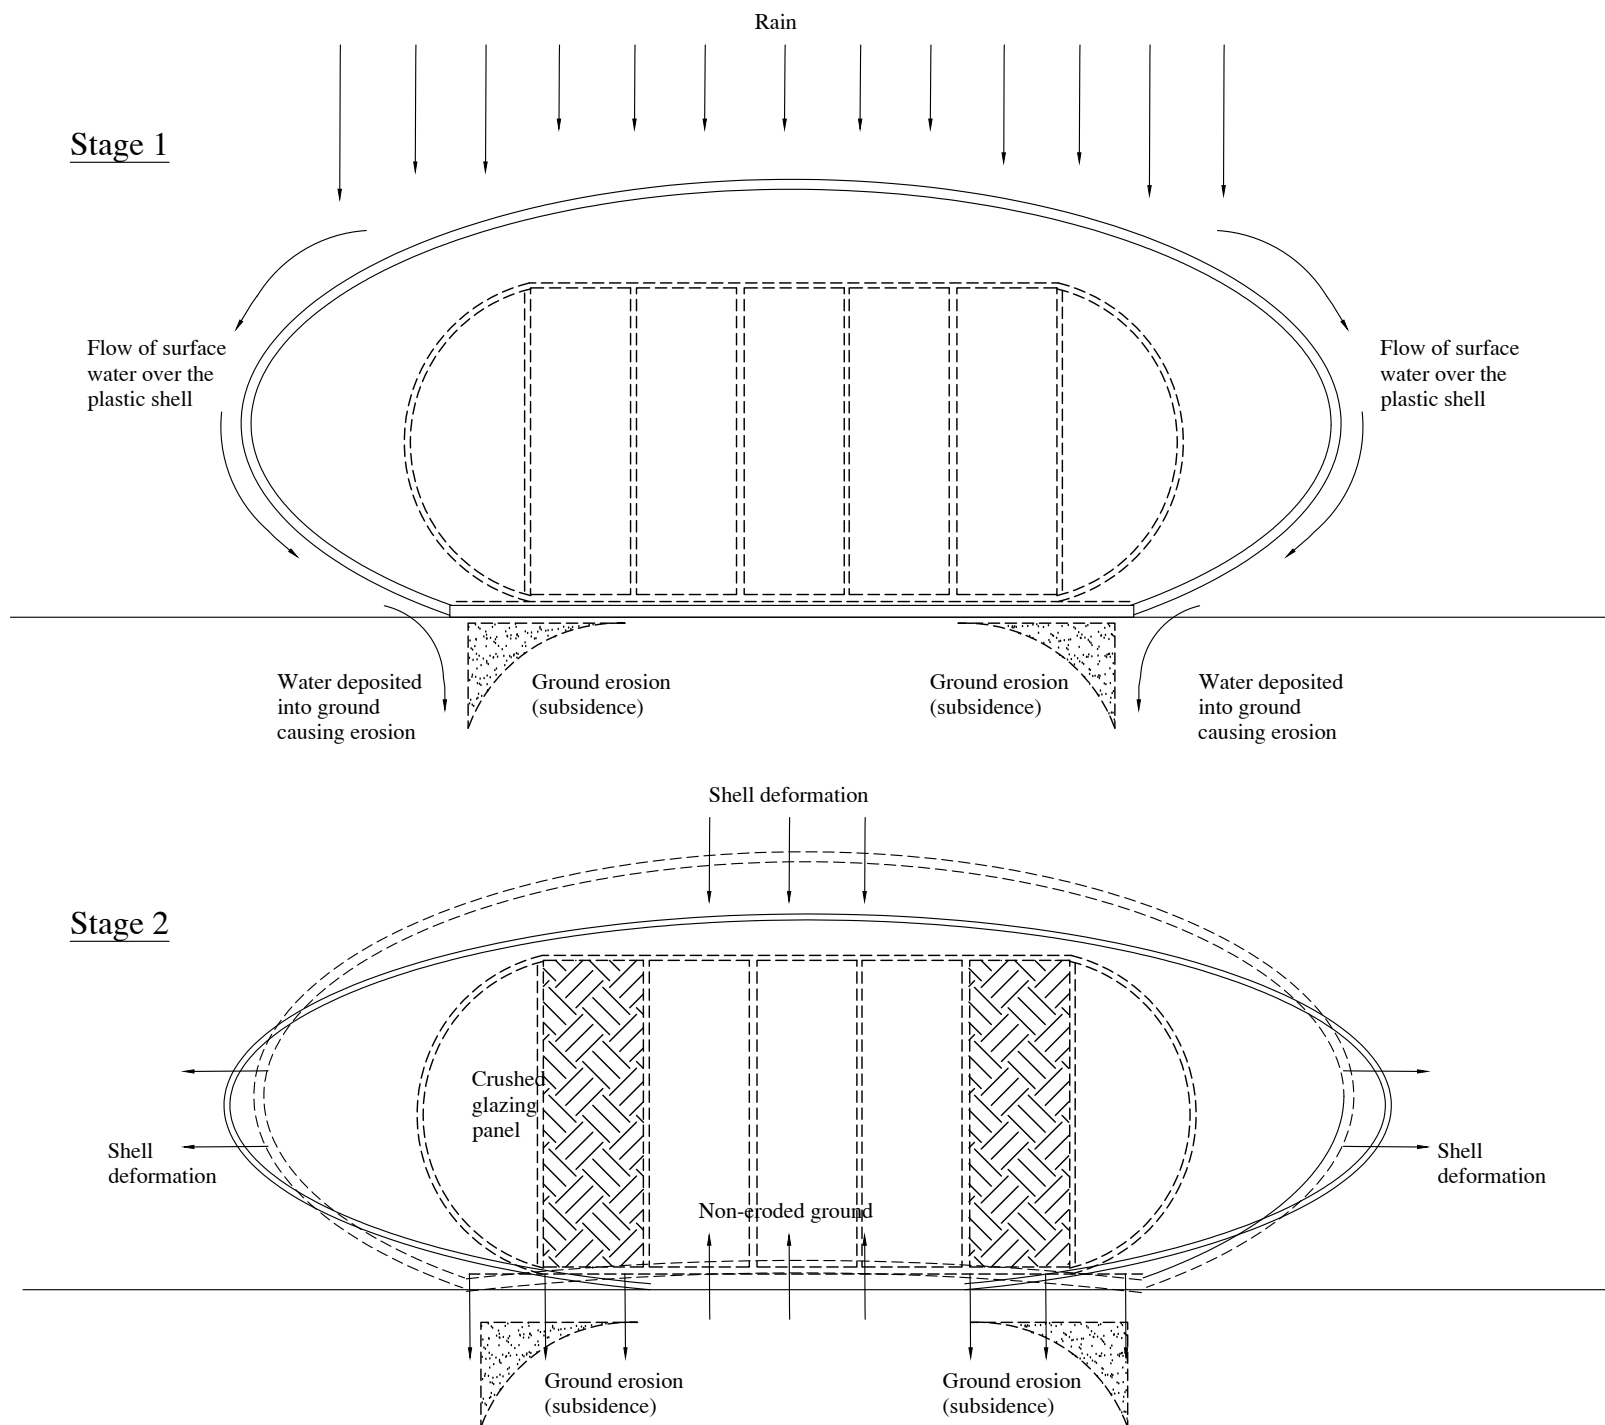
5823 01

Now that the ground is subsiding around the perimeter, the shell is stretching as it pulls apart at the welded seams, and breaking its back over the non-eroded ground at the centre of the floor space.
(ref drawing 5823 01)

The shell being plastic or fibreglass, there is no possible accommodation for tension in the skin, and so the plastic welded seams of the shell are simply pulled apart. The distortion to the shell also causes the rooflight inserts to no longer fit the apertures, and therefore the rooflights now leak. The distortion across the width of the glazed entrance doors is easily visible at the door cill, and I understand that one glass panel imploded due to compression of the shell structure onto a glazed unit.

Cause of dilapidation

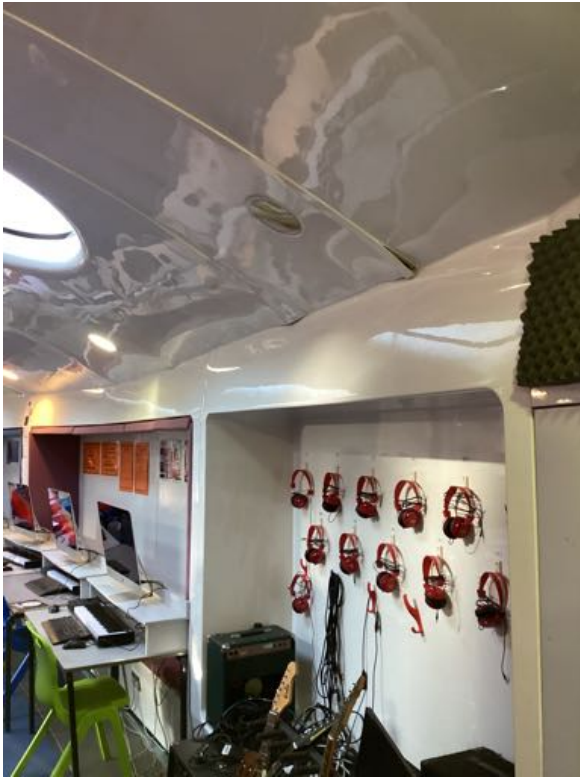
Internally, it can now be seen that the lining panels no longer fit the interior shape of the pod correctly, and much of the shell externally has been duct-taped in an attempt to hold the shell together at the positions of the opening welded seams.

Ill-fitting internal wall lining panels due to overall distortion of the shell

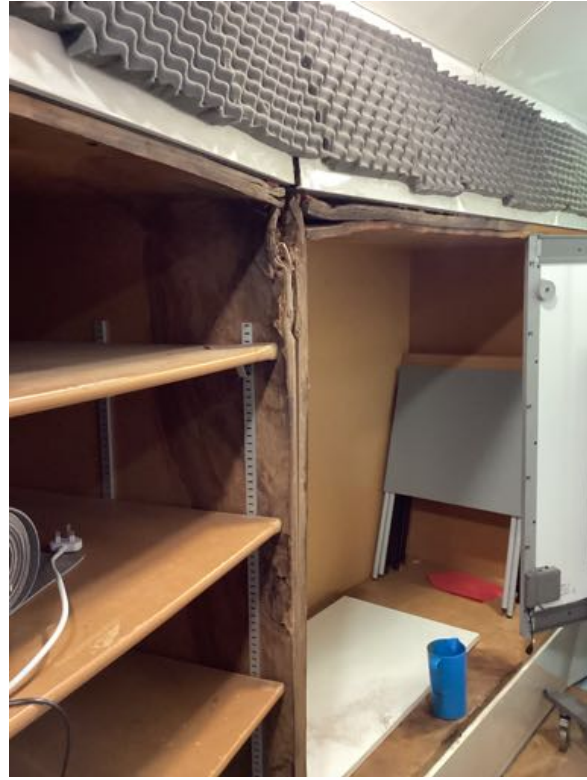
The rainwater now entering the outer shell now falls upon the internal panels and leaks onto shelves and equipment through the panel joints.

Water damaged shelving at the rear of the Ingenium Pod
