Our Ref: SME/CM/224260

Re: 32 The Green, Richmond, TW9 1LX

Conservation Accredited Engineer: Structural Overview of the roof and floor structures, foundation and basement floor.

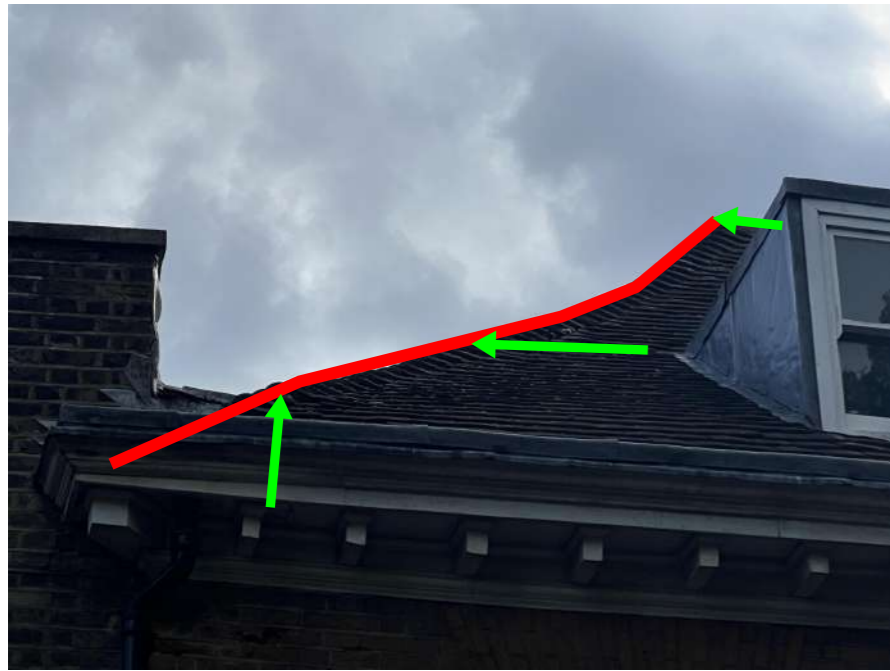
As part of the detailed inspection of the roof structure, it was noted that the two hip corners had dropped and were pushing outwards around the junction between the purlin and the hip member. The movement at this position was deemed to be excessive. A visualisation of this can be better seen on MNP sketches 9 and 10 appended.

Deflected shape of HIP and interior supports

With regards to the outward movement and dropping of the hip members, it is recommended that a triform of steel work is installed on the underside of the hip member with legs along the top of the wall heads. This will stabilise the hip member and provide propping at the position of the bearing of the purlin. The legs on the wall head will carry the compression force to the wall heads and the intervention of vertical strapping down the inside face of the wall to a steel channel section embedded into the wall will provide restraint to the overturning induced by the downwards force at the purlin junction.

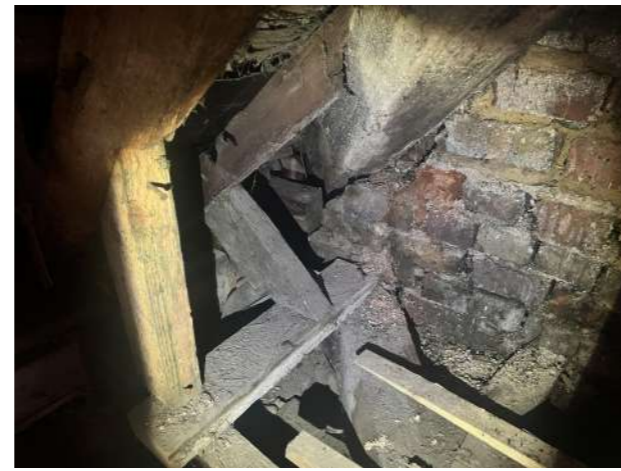
End of hip extending at corner, connection to end of diagonal floor beam / not seen.

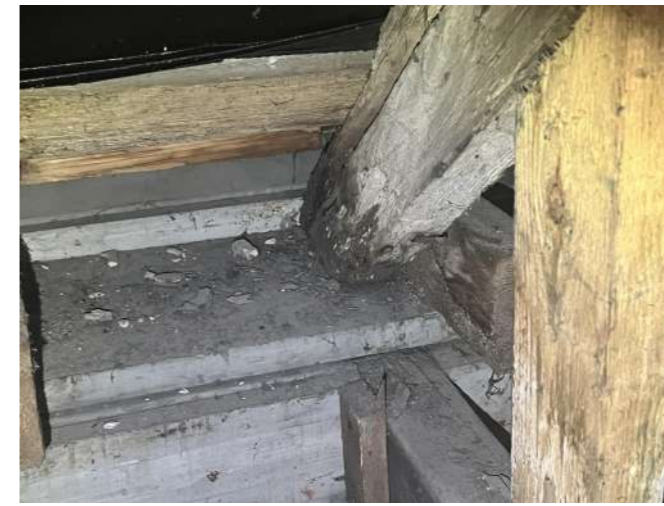
Interior view of cornice. Note grey colour, suggests replaced. Due to outward movement? Also Note decayed Rafter foot.

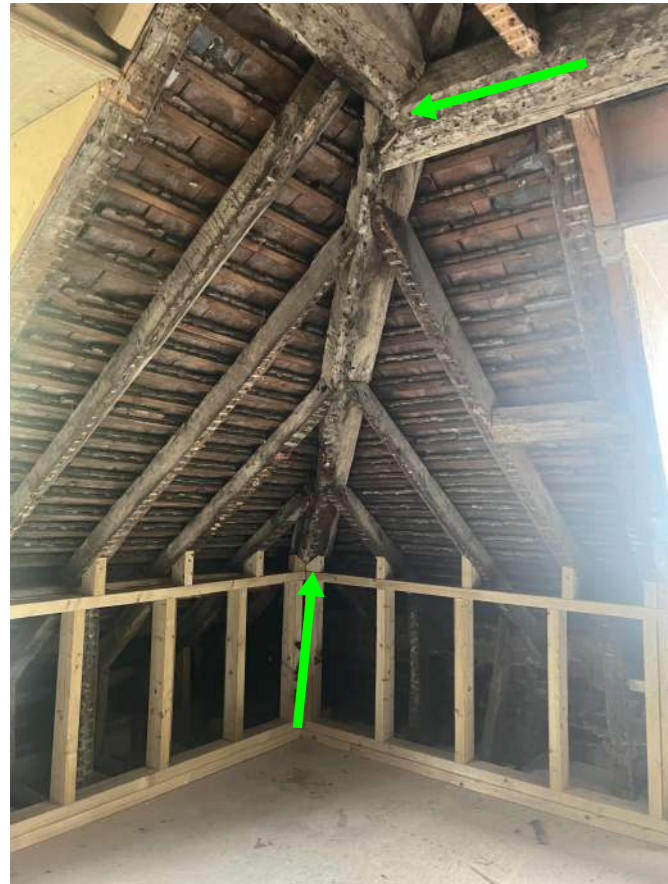
Interior view of sidewall support (vertical) and purlin prop (horizontal)

Note: original side wall is leaning out.

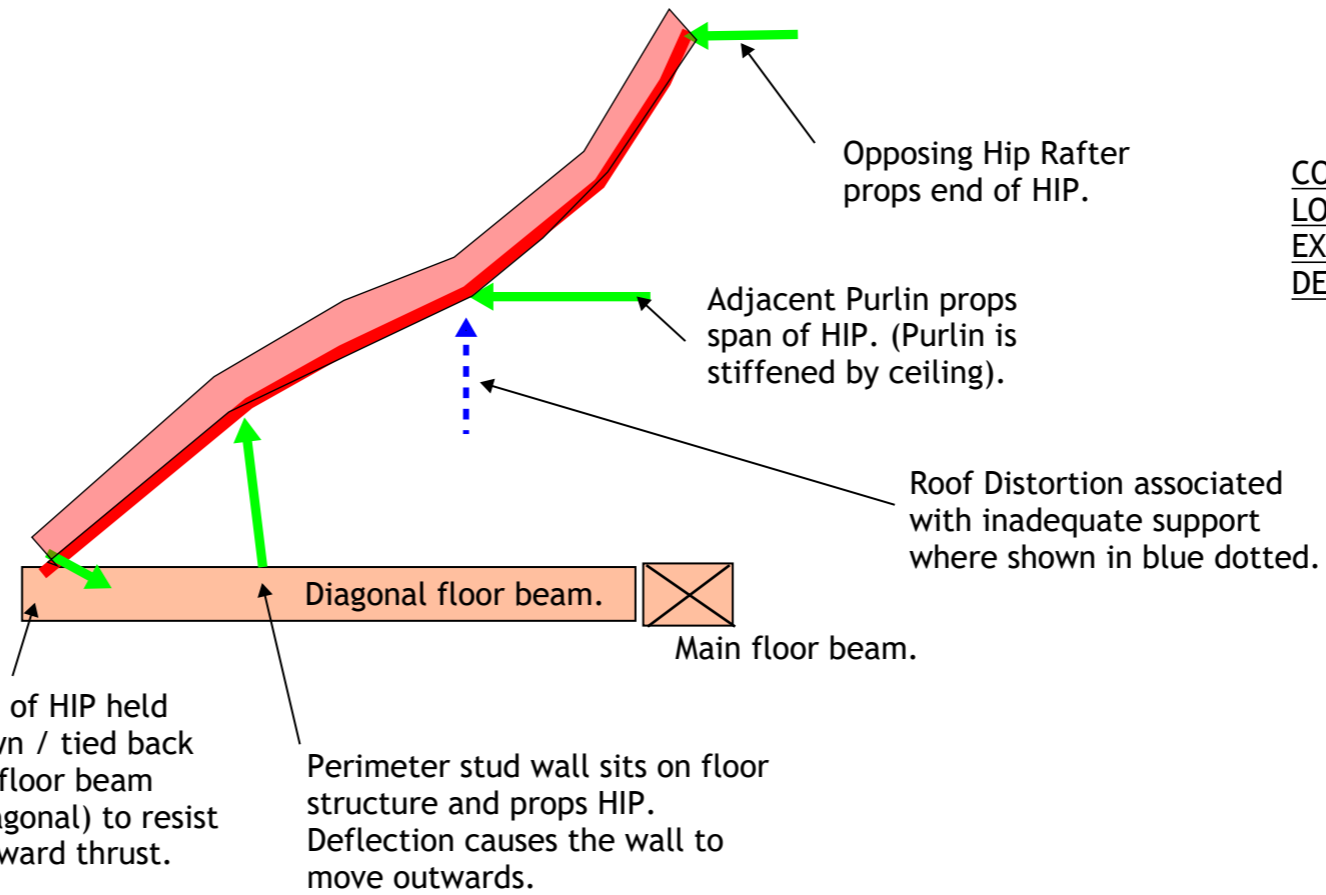
CONCERN THAT ADDING LOAD TO ROOF WILL EXAGGERATE THIS DEFLECTION PATTERN

SCHMATIC ELEVATION showing supports to HIP RAFTER (similar movement pattern associated with purlin deflection)

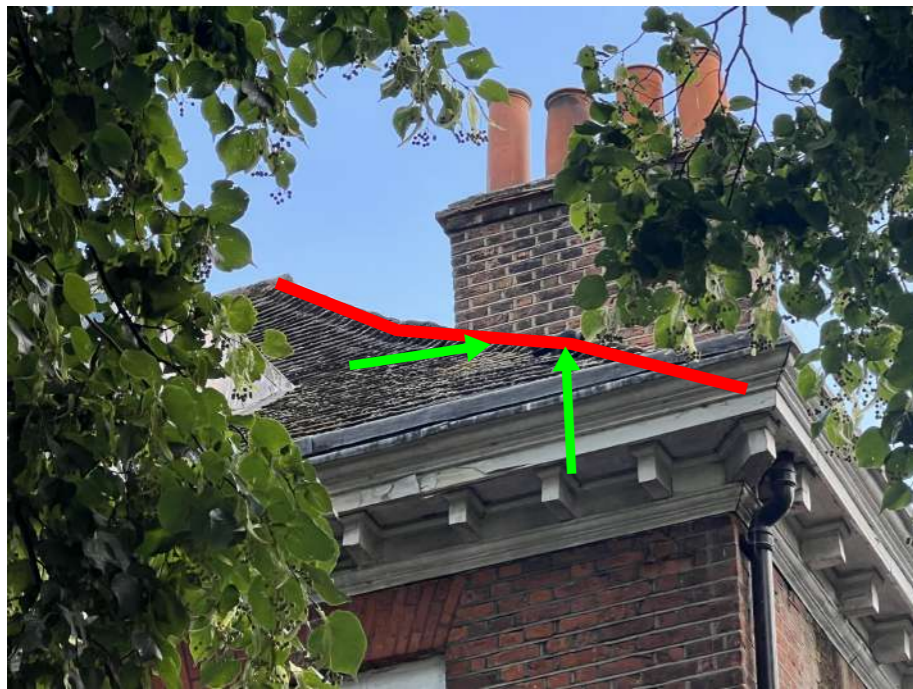
Deflected shape of HIP and interior supports

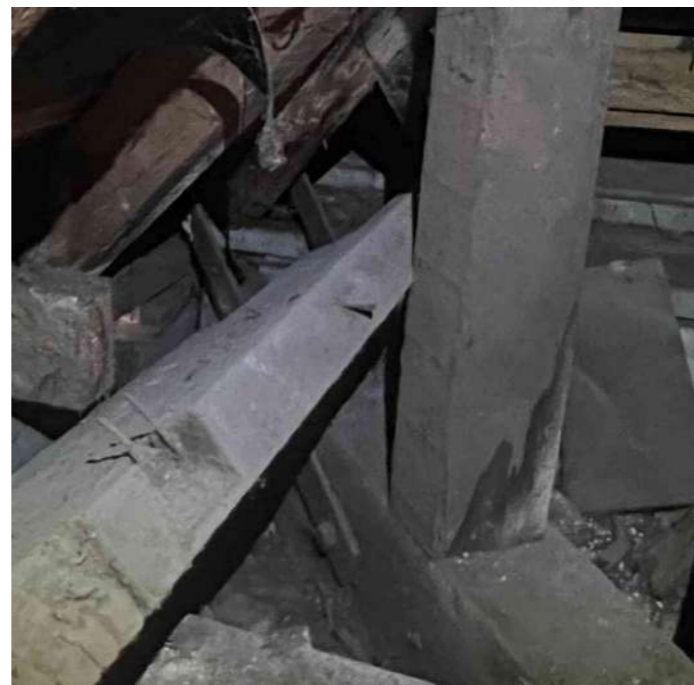
End of hip extending at corner, metal strap connection to end of diagonal floor beam holds the hip down and resists outwards thrust.

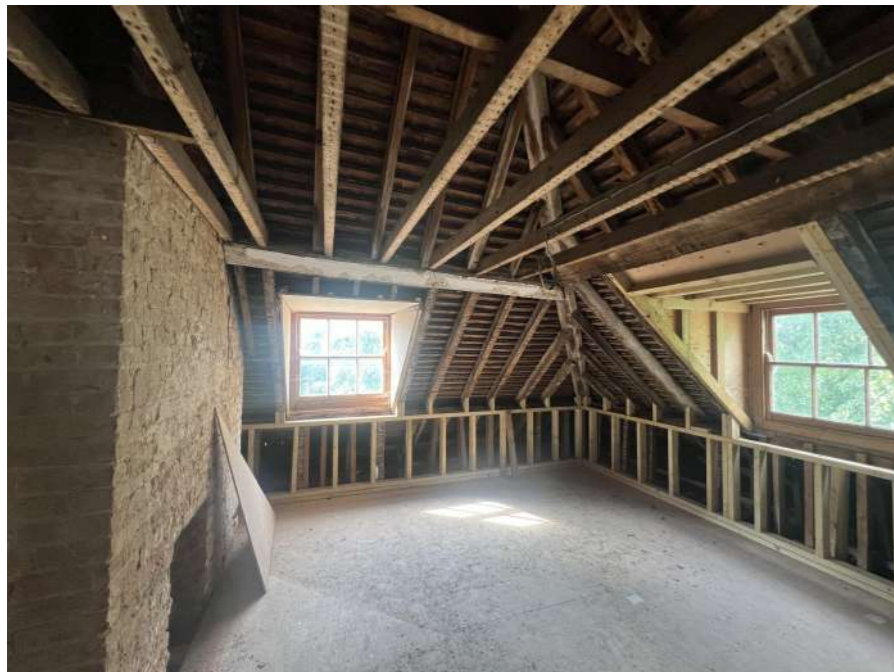
Interior view of sidewall support (vertical) and purlin prop (horizontal)

Note: original side wall is leaning out.

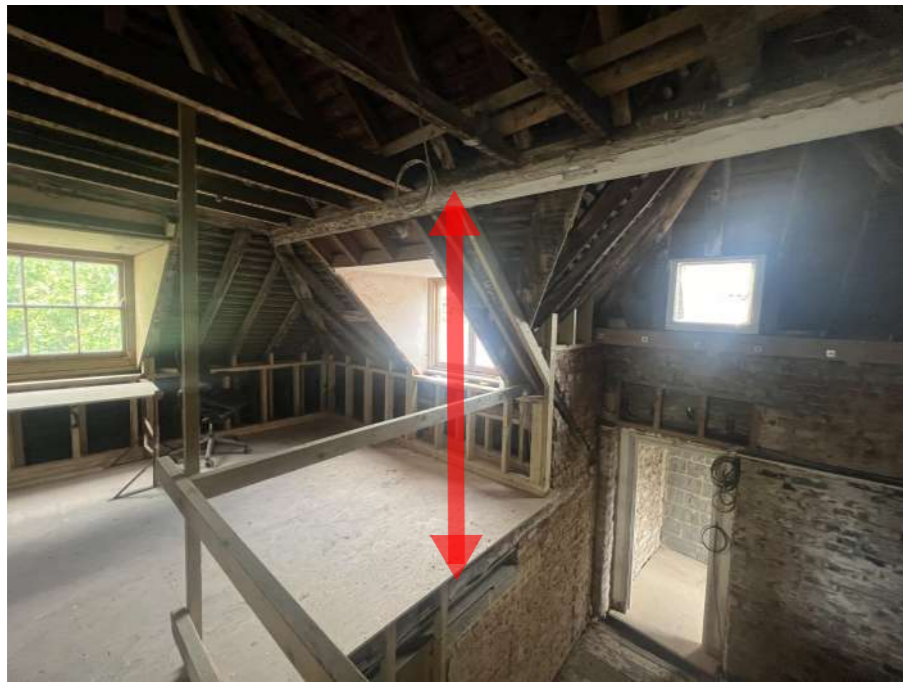
Furthermore, it was noted that the purlin above the stairs, which spans onto the corner hip member, is too long for its size and has dropped with the hip member. A further examination of this structural issue can be seen on MNP sketch 11 appended.

The purlin's span is too great for its size.

A vertical steel post should be installed beneath the over spanning purlin above the staircase to provide additional strength to the purlin and to reduce the load on the hip member at this location.

To prevent future deflection a mid span support is recommended. This might take the form of a post or a stair wall.

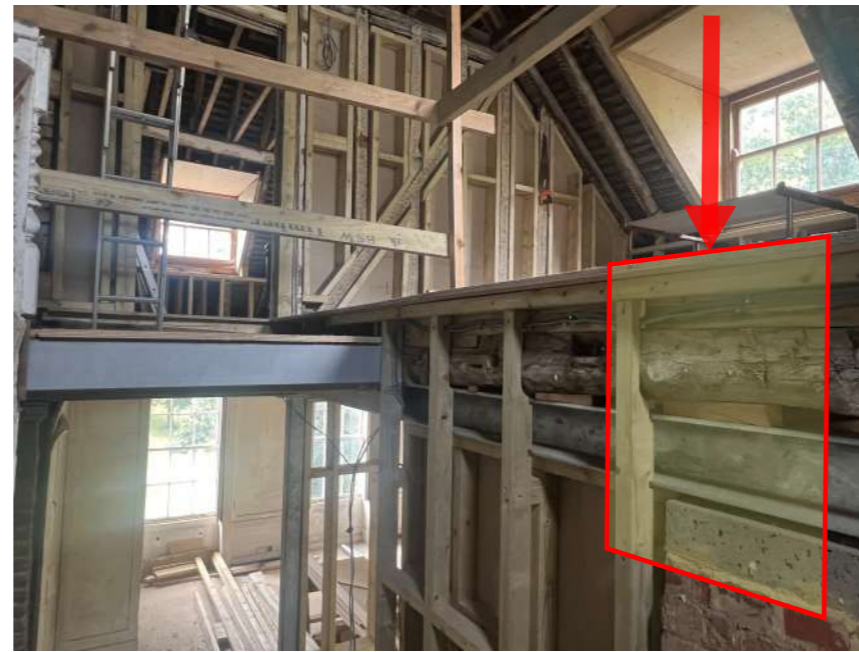
The stair wall immediately below where support is required.
