Twickenham Riverside

Tree Establishment Failure

Investigation Report

Project No.: ALP001-008

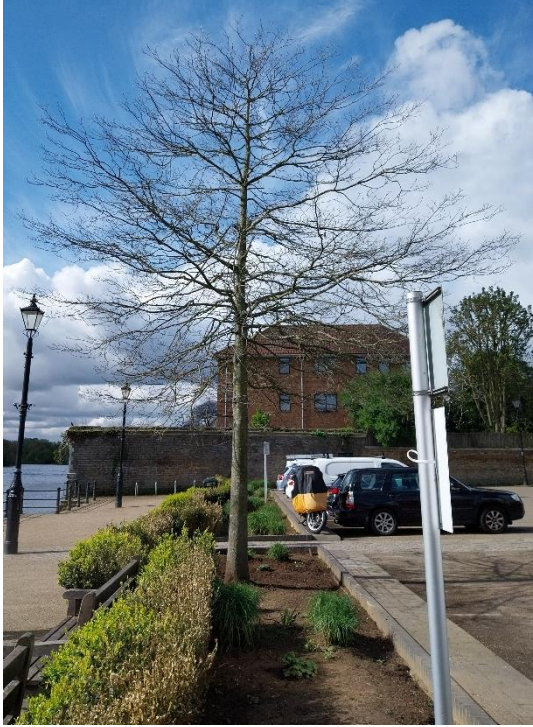
<p>T58 located at the western end of the car park</p>

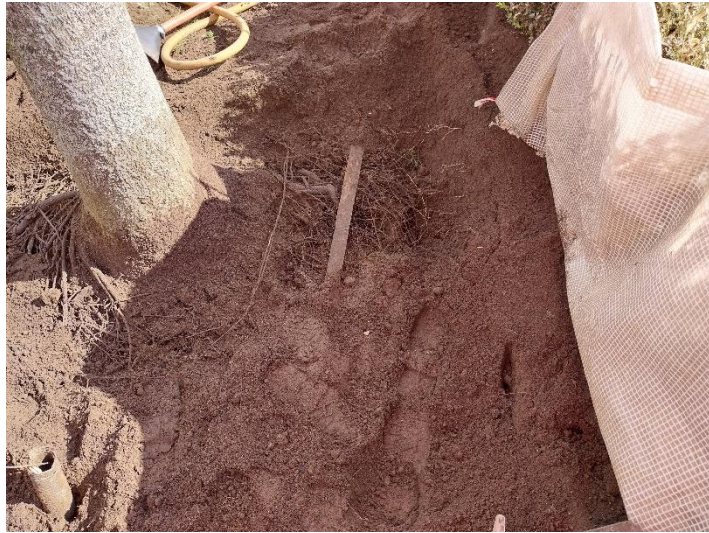
4.1.1 No structural roots were found outside the Burlap. Fibrous roots had grown out of the hessian wrapping on the north side of T58 but hit the car park edge wall and grown back towards the root ball but during the excavation roots were brittle so broke off when soil was being removed from the trench. On the southern side of the stem there is a mass of fibrous roots which are largely contained around the edge of the root ball and have not extended south to the strata cells. Roots also appear to have girdled around the base of the stem. Roots had not fully grown out of root ball and had not even made it to the strata cells, to the south. The soil was bone dry around the base, and that was after very recent flooding in the area, so it's expected the soil in the planting pit would be extremely dry in the summer.

View of south side of rooting area

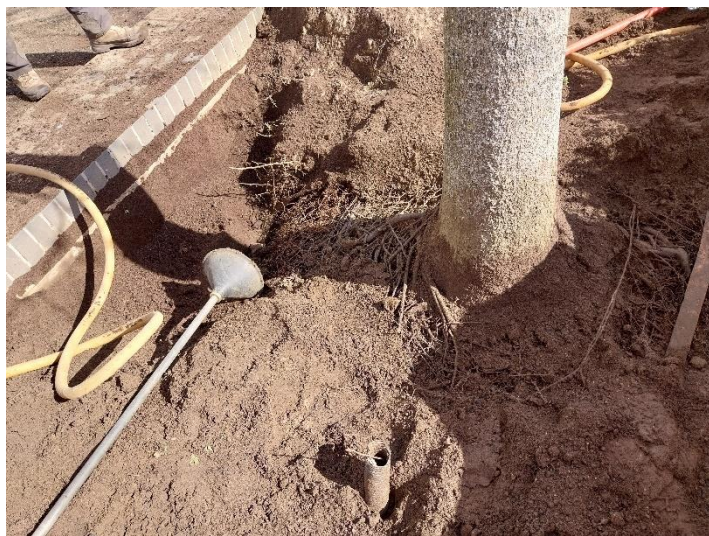
View mainly of north side of rooting area

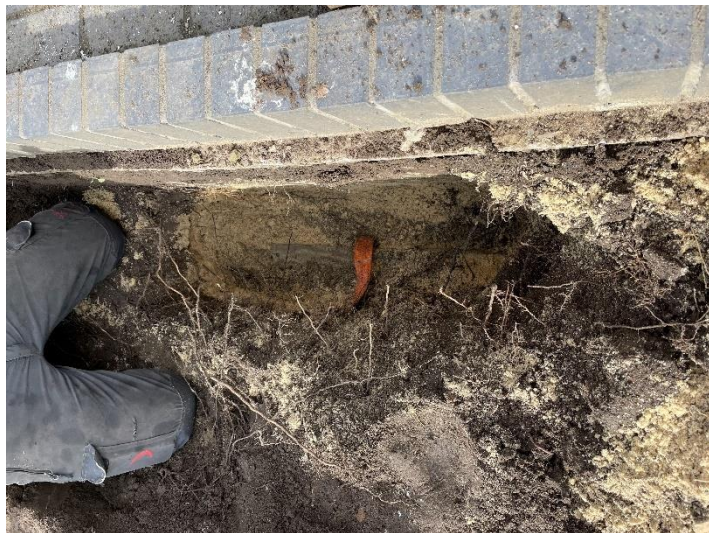
View of the north site of the rooting area showing roots growing towards the wall within the sand but not dense and dry and brittle

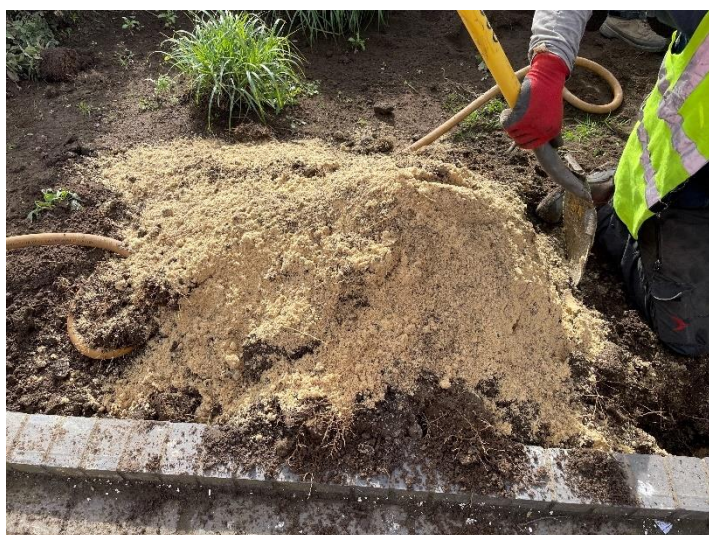
4.1.2 During the investigation measurements were taken within the depth of the excavation along the edge of the car park. The top 0.4m contained soil and the next c.0.2m contained sand before reaching a concrete block.

Image of the amount of sand mixed in with the soil within the planting pit

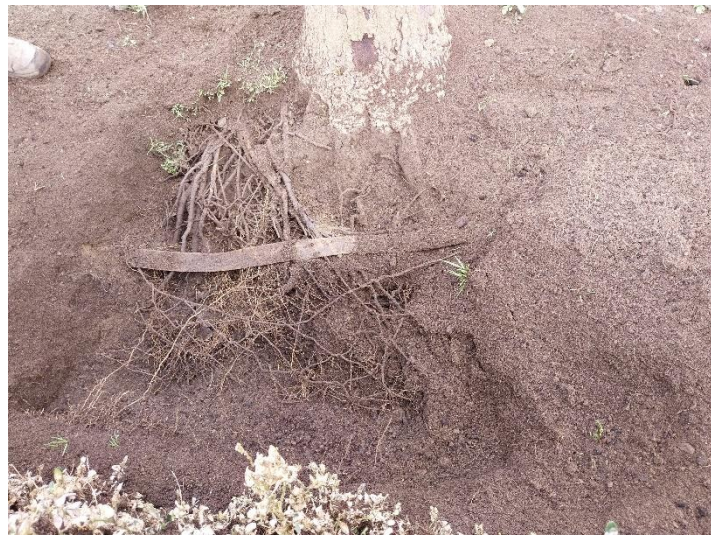
4.2.1 The root growth for T60 is very similar to T58, with larger structural root establishment around the base but not outside the burlap, and slightly more girdling around the base. A mass of fibrous roots was found around the burlap but not extending out past the sack. The soil was also bone dry around the base.

View of the root ball on the south side where it has not grown out towards the hedge

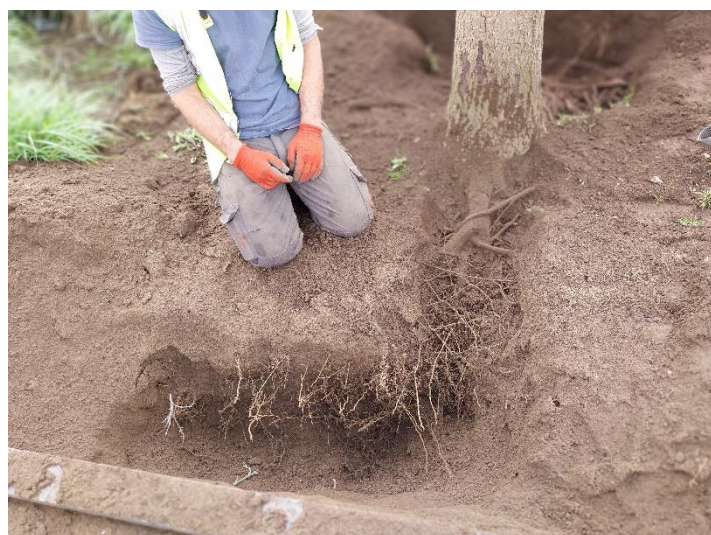
View of the root ball on the north side where it has not grown out towards the hard standing

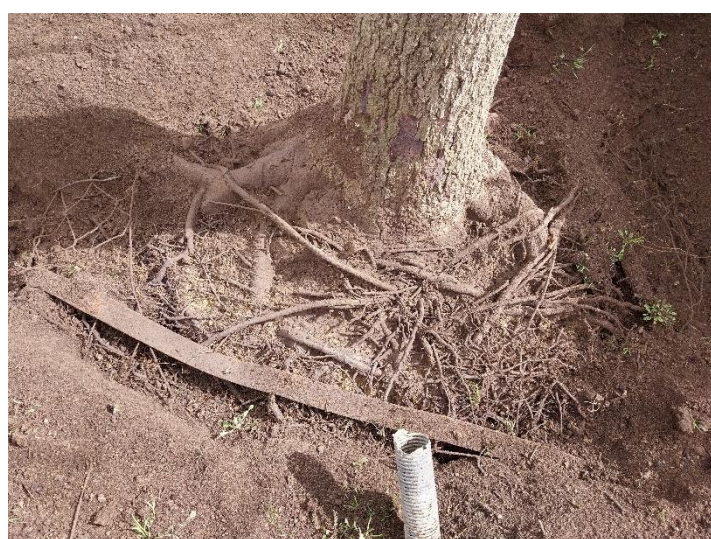
View of the root ball on the west side where it has girdled

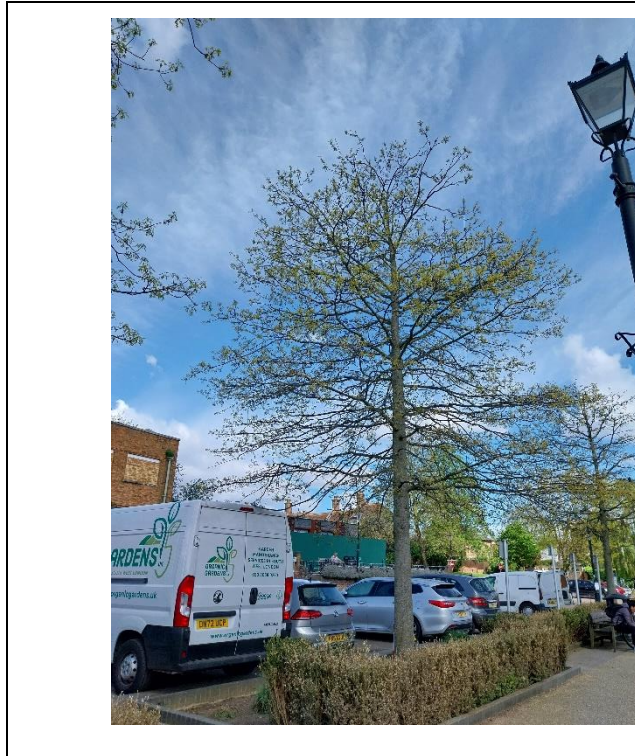
4.3.1 T63 is a lot healthier than the previous two trees investigated and coming into leaf at the time of the investigation. There were more dense fibrous roots growing towards the car park to the north, with less sand, and the roots have grown out of the Burlap sack on the south side underneath the hedge towards the strata cells. There were two slightly larger roots, at a diameter of c.0.2m and 0.15m below the surface on the southwest side. The soil was wetter and denser in the planting pit compared to being bone dry in first two.

T63 located at the central section of the car park, near to the footbridge and looking healthier than the previous two trees

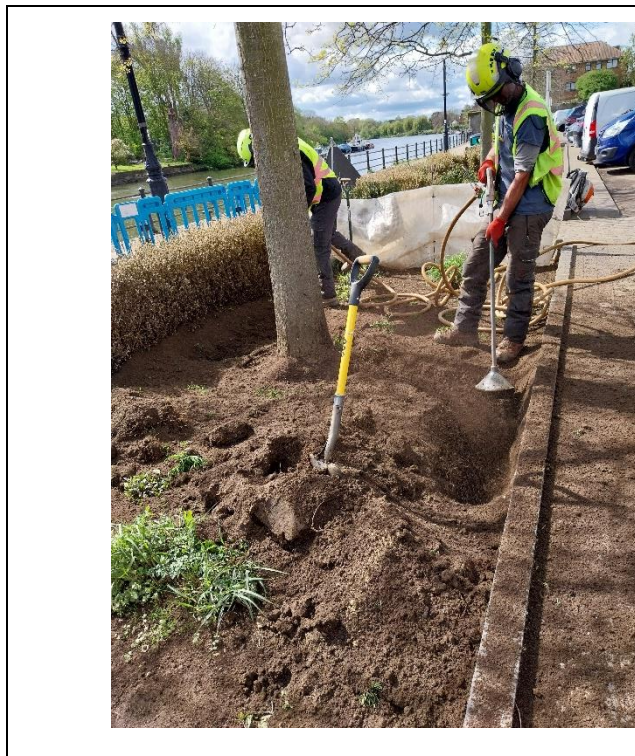
View of trial pits on the north and south side of the stem

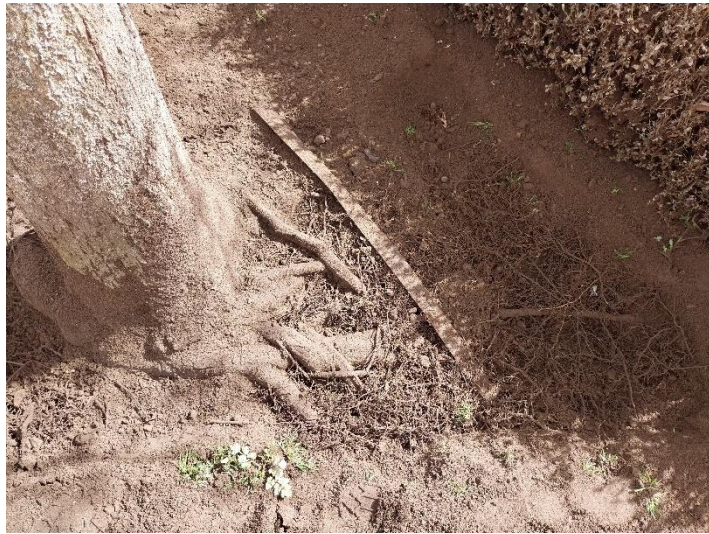
View of trial pits on the south side of the stem with visibly more roots and a dense mass close to the hedge and one of the larger roots found on the southwest side

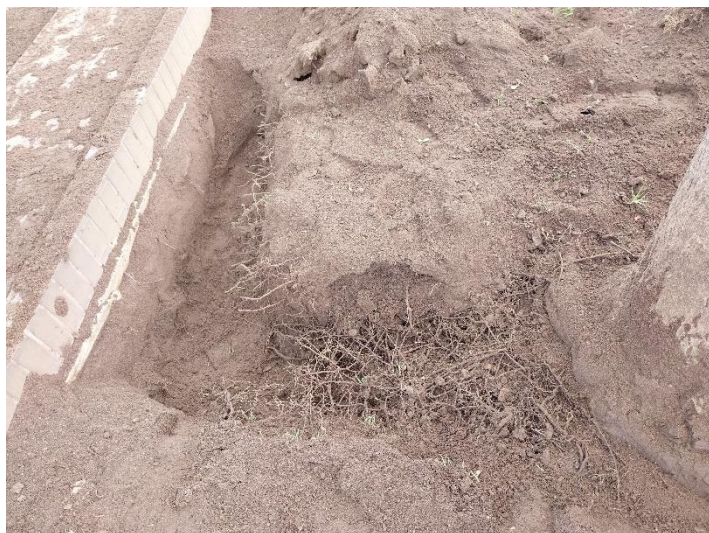
View of trial pits on the north side of the stem with visibly more roots but still no roots close to the hard standing
