# Appendix A

## **GROUND PENETRATING RADAR (GPR) SURVEY**

**PROJECT TITLE**  
 Kew Transfer Tunnel  
 TW9 4BZ

**2D Line, Level and Condition Survey**

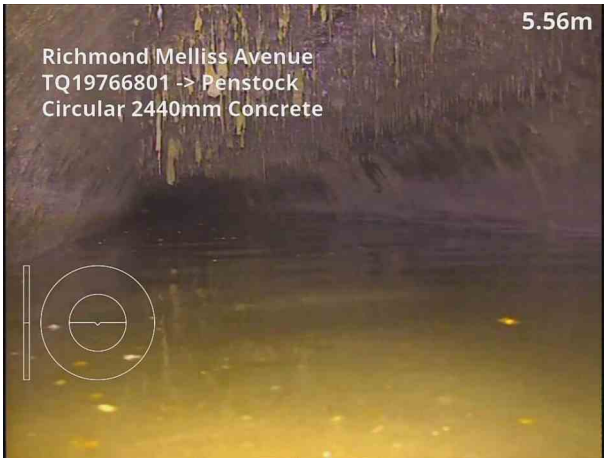
TQ19766801\_D\_241028\_095218\_49480\_2.jpg, 00:01:23, 5.56 m

</div>								0.00		MH	Start node, manhole, reference: TQ19766801	00:00:00				0.00		WL	Water level, 50% of the vertical dimension	00:00:02				5.56	S01	DEF	Attached deposits, fouling from 10 o'clock to 2 o'clock, 15% cross-sectional area loss, start	00:01:23	TQ197668 01_D_241 028_0952			10.05		GP	General photograph taken at this point: Condition photo	00:02:46	TQ197668 01_D_241 028_0952			20.16		GP	General photograph taken at this point: Condition photo	00:04:06	TQ197668 01_D_241 028_0952			30.36		GP	General photograph taken at this point: Condition photo	00:05:15	TQ197668 01_D_241 028_0952			40.27		GP	General photograph taken at this point: Condition photo	00:05:52	TQ197668 01_D_241 028_0952			47.56	F01	DEF	Attached deposits, fouling from 10 o'clock to 2 o'clock, 15% cross-sectional area loss, finish	00:06:28			3	50.43		GP	General photograph taken at this point: Condition photo	00:06:32	TQ197668 01_D_241 028_0952			70.22		GP	General photograph taken at this point: Condition photo	00:07:41	TQ197668 01_D_241 028_0952			80.07		GP	General photograph taken at this point: Condition photo	00:08:42	TQ197668 01_D_241 028_0952			87.26		SA	Survey abandoned: Unable to continue float grounded out of silt / Slow flows	00:39:46				100.00			End of pipe				
0.00		MH	Start node, manhole, reference: TQ19766801	00:00:00																																																																																																											
0.00		WL	Water level, 50% of the vertical dimension	00:00:02																																																																																																											
5.56	S01	DEF	Attached deposits, fouling from 10 o'clock to 2 o'clock, 15% cross-sectional area loss, start	00:01:23	TQ197668 01_D_241 028_0952																																																																																																										
10.05		GP	General photograph taken at this point: Condition photo	00:02:46	TQ197668 01_D_241 028_0952																																																																																																										
20.16		GP	General photograph taken at this point: Condition photo	00:04:06	TQ197668 01_D_241 028_0952																																																																																																										
30.36		GP	General photograph taken at this point: Condition photo	00:05:15	TQ197668 01_D_241 028_0952																																																																																																										
40.27		GP	General photograph taken at this point: Condition photo	00:05:52	TQ197668 01_D_241 028_0952																																																																																																										
47.56	F01	DEF	Attached deposits, fouling from 10 o'clock to 2 o'clock, 15% cross-sectional area loss, finish	00:06:28			3																																																																																																								
50.43		GP	General photograph taken at this point: Condition photo	00:06:32	TQ197668 01_D_241 028_0952																																																																																																										
70.22		GP	General photograph taken at this point: Condition photo	00:07:41	TQ197668 01_D_241 028_0952																																																																																																										
80.07		GP	General photograph taken at this point: Condition photo	00:08:42	TQ197668 01_D_241 028_0952																																																																																																										
87.26		SA	Survey abandoned: Unable to continue float grounded out of silt / Slow flows	00:39:46																																																																																																											
100.00			End of pipe

Attached deposits, fouling from 10 o'clock to 2 o'clock, 15%

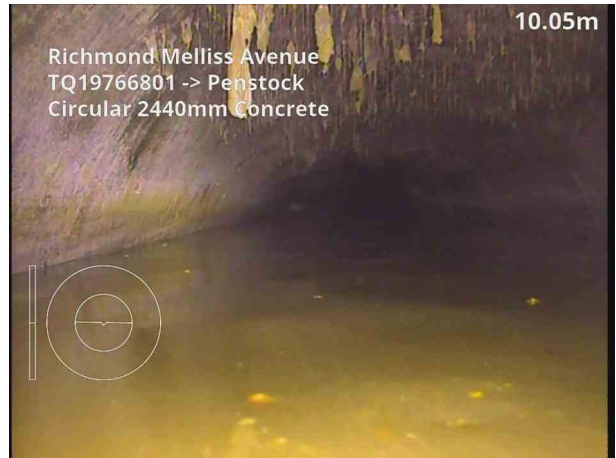
TQ19766801\_D\_241028\_095218\_49480\_3.jpg, 00:02:46, 10.05 m

General photograph taken at this point, Condition photo

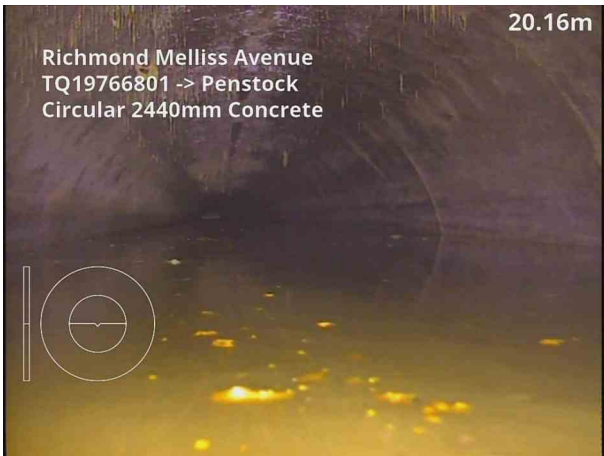
TQ19766801\_D\_241028\_095218\_49480\_4.jpg, 00:04:06, 20.16 m

General photograph taken at this point, Condition photo

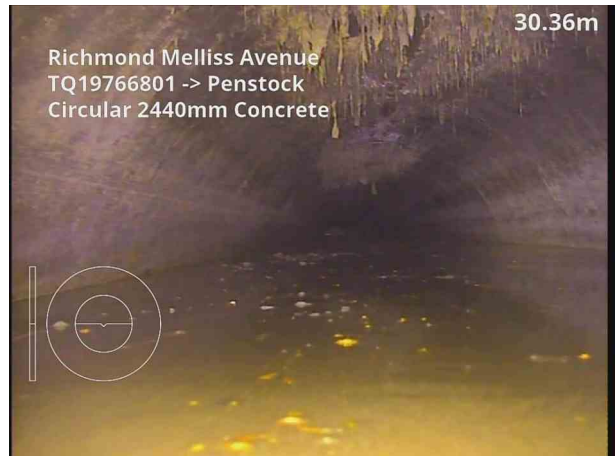
TQ19766801\_D\_241028\_095218\_49480\_5.jpg, 00:05:15, 30.36 m

General photograph taken at this point, Condition photo

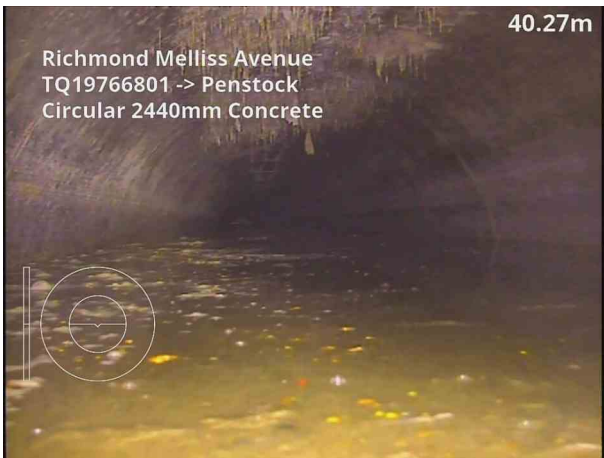
TQ19766801\_D\_241028\_095218\_49480\_6.jpg, 00:05:52, 40.27 m

General photograph taken at this point, Condition photo

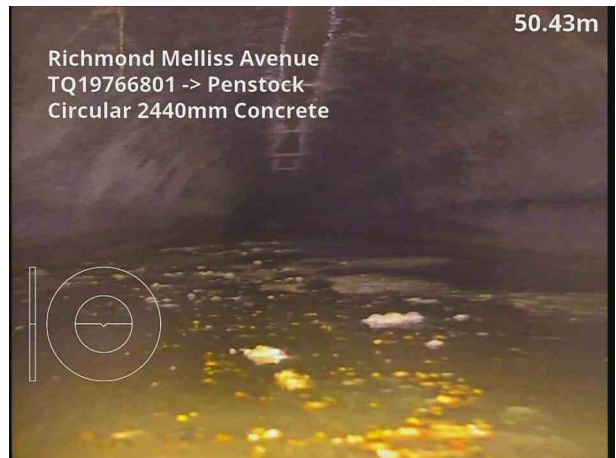
TQ19766801\_D\_241028\_095218\_49480\_7.jpg, 00:06:32, 50.43 m

General photograph taken at this point, Condition photo
