Gale Tree Consultancy

Tree Condition Report

Grosvenor Court, TW11 9BT

Ref: TCR/556/24

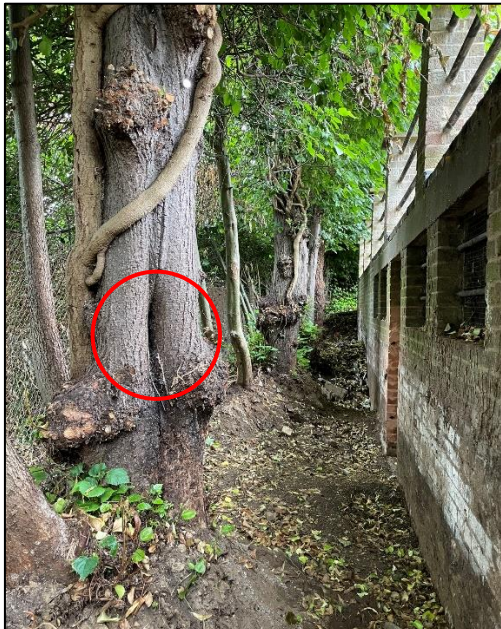
Tree No	Tag No.	Species	Stem Diameter	Height	Crown Spread	Age Class	Phy. Cond.	Comments	Action Required	Priority
T1	941	Common lime	351-550	10-15	0-5	EM	FAIR	Area around tree cleared of debris and soil levels appear lowered Cavity on east side of stem starting at c.40cm above root flare Thick ivy throughout crown Deadwood/stem section in upper crown	Sever ivy at ground level and again at 1m removing the severed band Remove deadwood/stem section back to sound wood	HS3
T2	942	Common lime	351-550	10-15	5-10	EM	FAIR	Tree not tagged Unable to assess buttress roots and lower of the tree due to dense basal sucker growth - physiological condition assessed only Dead tertiary stem section	Clear basal sucker growth Remove dead tertiary stem section	HS3
T3	943	Horse chestnut	551-750	15-20	5-10	EM	FAIR	Basal growth restricts assessment of western buttress roots Two bark wounds on SE side of the stem, wound wood forming Deadwood greater than 25mm in diameter over lawn area	Clear basal growth Remove deadwood greater than 25mm in diameter over the lawn area	HS3

- The ground along the rear of the car park, and the location of T1/941 Common lime, has been cleared and in places, lowered. It is not clear how much soil was removed, or whether the material removed was rubbish, but although no obvious root damage was noted, in the event surface roots were severed, decline of the trees may ensue

T1/941 Common lime - note the soil level change and cavity - circled red

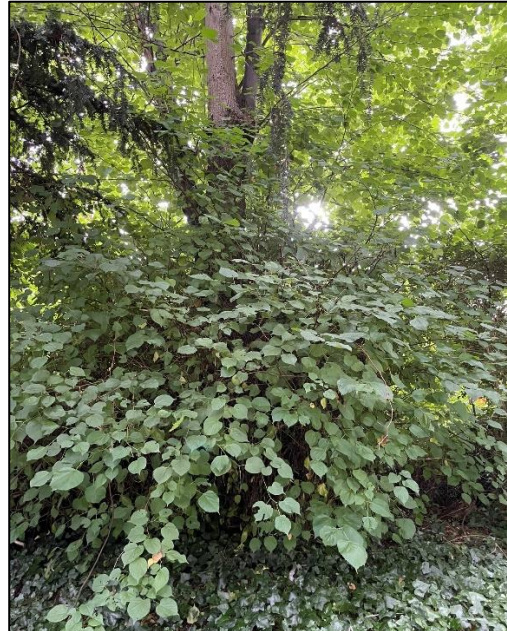
- Basal sucker was another feature recorded. Where it restricted a thorough assessment of the buttress roots and lower stem area of the tree, and in the case of T2/942 Common lime, the sucker growth was so thick that it was not possible to attach a tree tag

T2/942 Common lime - note the dense basal sucker growth

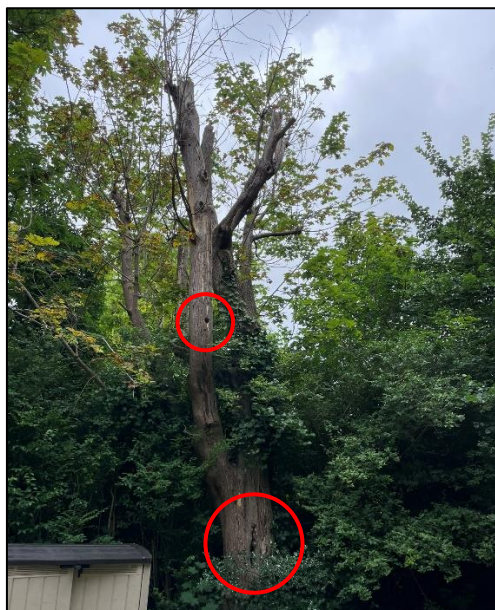
Tree No	Tag No.	Species	Stem Diameter	Height	Crown Spread	Age Class	Phy. Cond.	Comments	Action Required	Priority
T5	945	Norway maple	751-1000	5-10	5-10	M	MOR	Extensive decay and cavity present on lower stem Stem forks at c.2.2m into 3-4 stem sections two of which are dead Woodpecker holes present Remaining leaf material is poor with brown margins Previously heavily reduced	Fell to ground level OR Reduce to leave a finished height of c.3m to leave a habitat stem	HS3
T6	946	Sweet chestnut	1000+	15-20	10-15	M	GOOD	Mature basal sucker growth restricts thorough assessment of buttress roots and lower stem	Remove basal sucker growth	HS4
T7	947	Copper beech	551-750	15-20	5-10	EM	GOOD	Cavity forming on west side of stem at ground level, <i>Kretzschmaria deusta</i> fruiting bodies noted in face of cavity Further bark wound above Stem bias east Stem forks at c.6m, unions appear good Cavities noted at previous pruning wounds	Detailed decay evaluation of lower stem employing the use of PiCUS sonic and/or electrical tomography, plus Resi PD400 microdrill	HS2

- Where recommended, the sucker growth should be removed so the tree can be assessed thoroughly
- T5/945 Norway maple has extensive decay in the stem and upper crown. its removal has been recommended; alternatively, it could be reduced to leave a finished height of c.3m to retain a habitat for wildlife

T5/945 Norway maple - extensive decay in lower stem and main stem sections - circled red

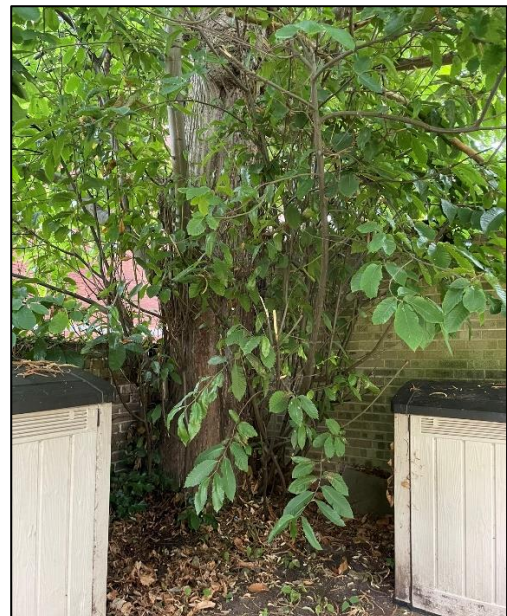
T6/946 Sweet chestnut - basal growth restricts thorough assessment of buttress roots and lower stem

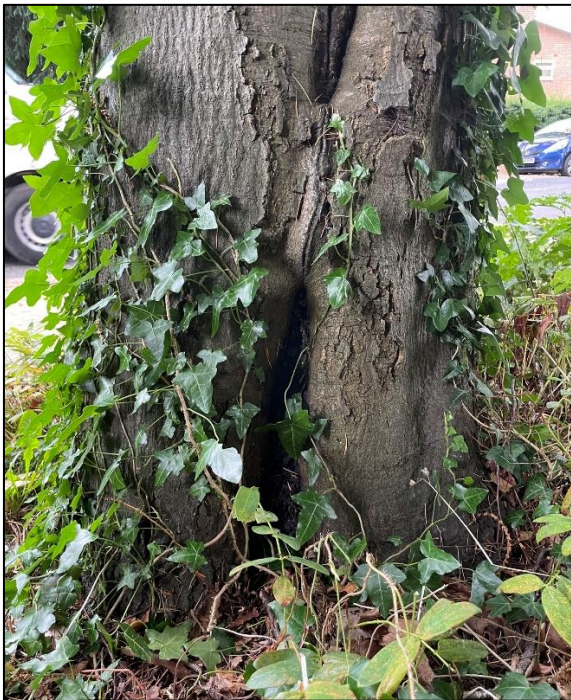
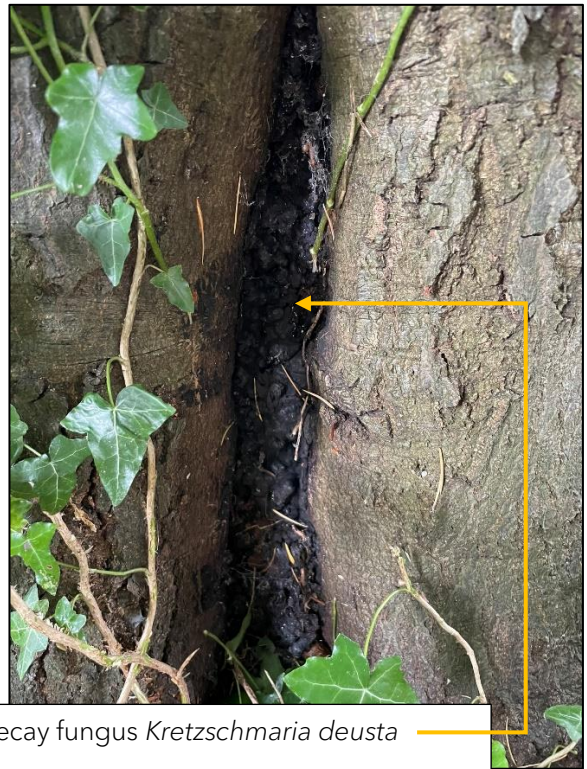
- The assessment of this area of the tree is important as many decay fungi can originate from around the buttress root and lower stem area
- One such fungi is *Kretzschmaria deusta* (Brittle Cinder fungus) which affects the lower stem and principal roots of the host tree. It forms a soft rot in its early stage which eventually makes the wood brittle, a white rot can form in the latter stages which in advanced stages, can lead to catastrophic failure

- T7/947 Copper beech has an open bark wound on the west side of the stem which is home to fructifications of the decay fungus *Kretzschmaria deusta* - see previous comments

T7/947 Copper beech - fructifications of the decay fungus *Kretzschmaria deusta* emanating on the face of the open wound

- A recommendation has been made for a detailed decay evaluation employing the use of PiCUS sonic and electrical tomography, along with resistance drilling in the form of a Resi PD400 microdrill, to ascertain the extent of any decay that may be forming

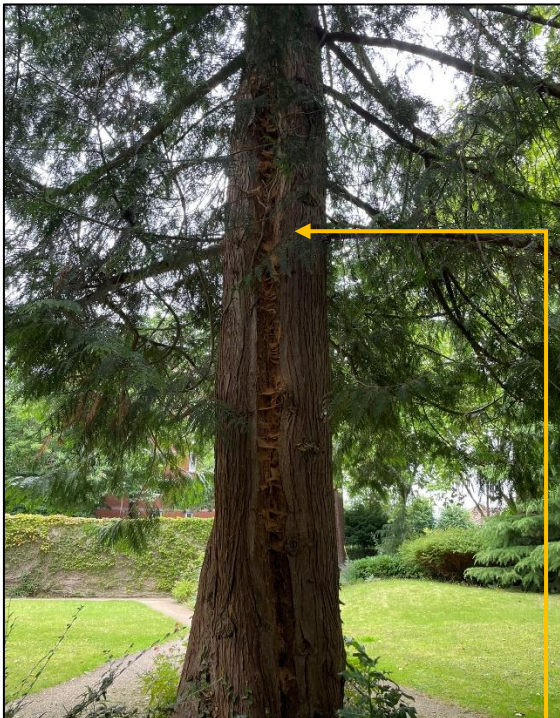
T8	948	Western Red cedar	551-750	15-20	5-10	EM	FAIR	Vertical open wound on SE side of stem from ground level up to c.5m, wood dust noted caught in spiders webs along the length of the wound Crown becoming sparse, needle debris on the floor - parakeets seen in upper crown	Detailed decay evaluation of lower stem employing the use of a Resi PD400 microdrill	HS3

T8/948 Western Red cedar - note the vertical wound and wood dust caught in the spiders web

- Further detailed decay evaluations should be undertaken on T8/948 Western Red cedar and T11/951 False acacia due to features noted

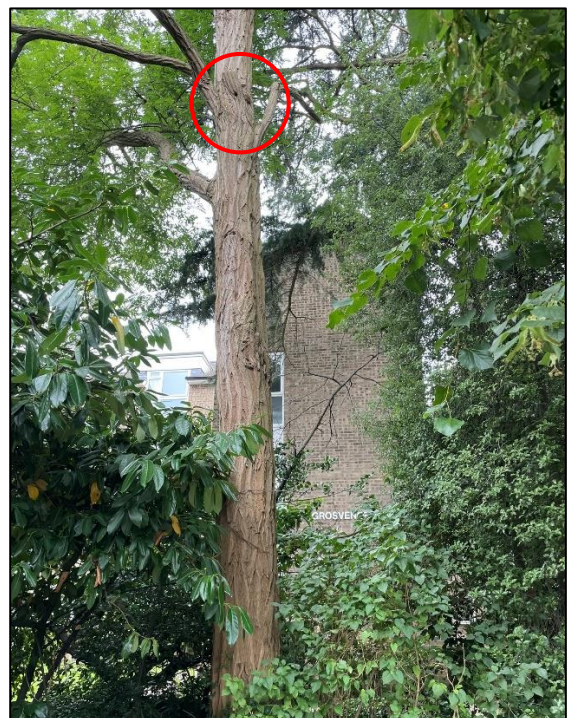
T11/951 False acacia - desiccated fungal fruiting body adjacent to a woodpecker hole - circled red
