**Tree Tag:** G0756

**Species:** Cedrus deodara

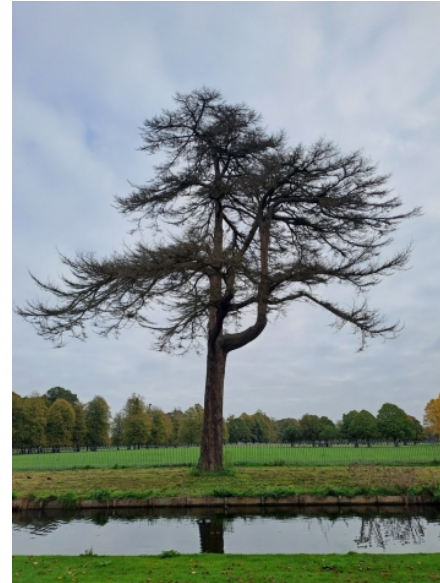
**Conditions:** Damaged branches - hanging branch  
Deadwood Major above 50mm - nothing over access areas  
Deadwood Minor less than 50mm  
Heavily end weighted branches  
Truncated branches / pruning stubs  
Bats - high risk / evident - bat box  
Bifurcated / co-dominant stems  
Compression fork / included bark - main bifurcation  
Decay in pruning wound  
Hazard beam  
Numerous pruning wounds in the same region - spread over main stem  
Resin bleed - main stem 2m, 10m new aspect  
Woodpecker holes - south western aspect 14m

**Size Clas:** Large

**Tree Cond:** Dead

**Recommendations:** Fell Tree - Dismantle and replant

**Priority:** 3 Months
