**Arboricultural report for
A horse chestnut tree
(*Aesculus hippocastanum*)
at
Mandalay
Willoughby Road
Twickenham
TW1 2QG**

**Client: Dominik and Katya Horn
Mandalay
Willoughby Road
Twickenham
TW1 2QG**

19/11/2024

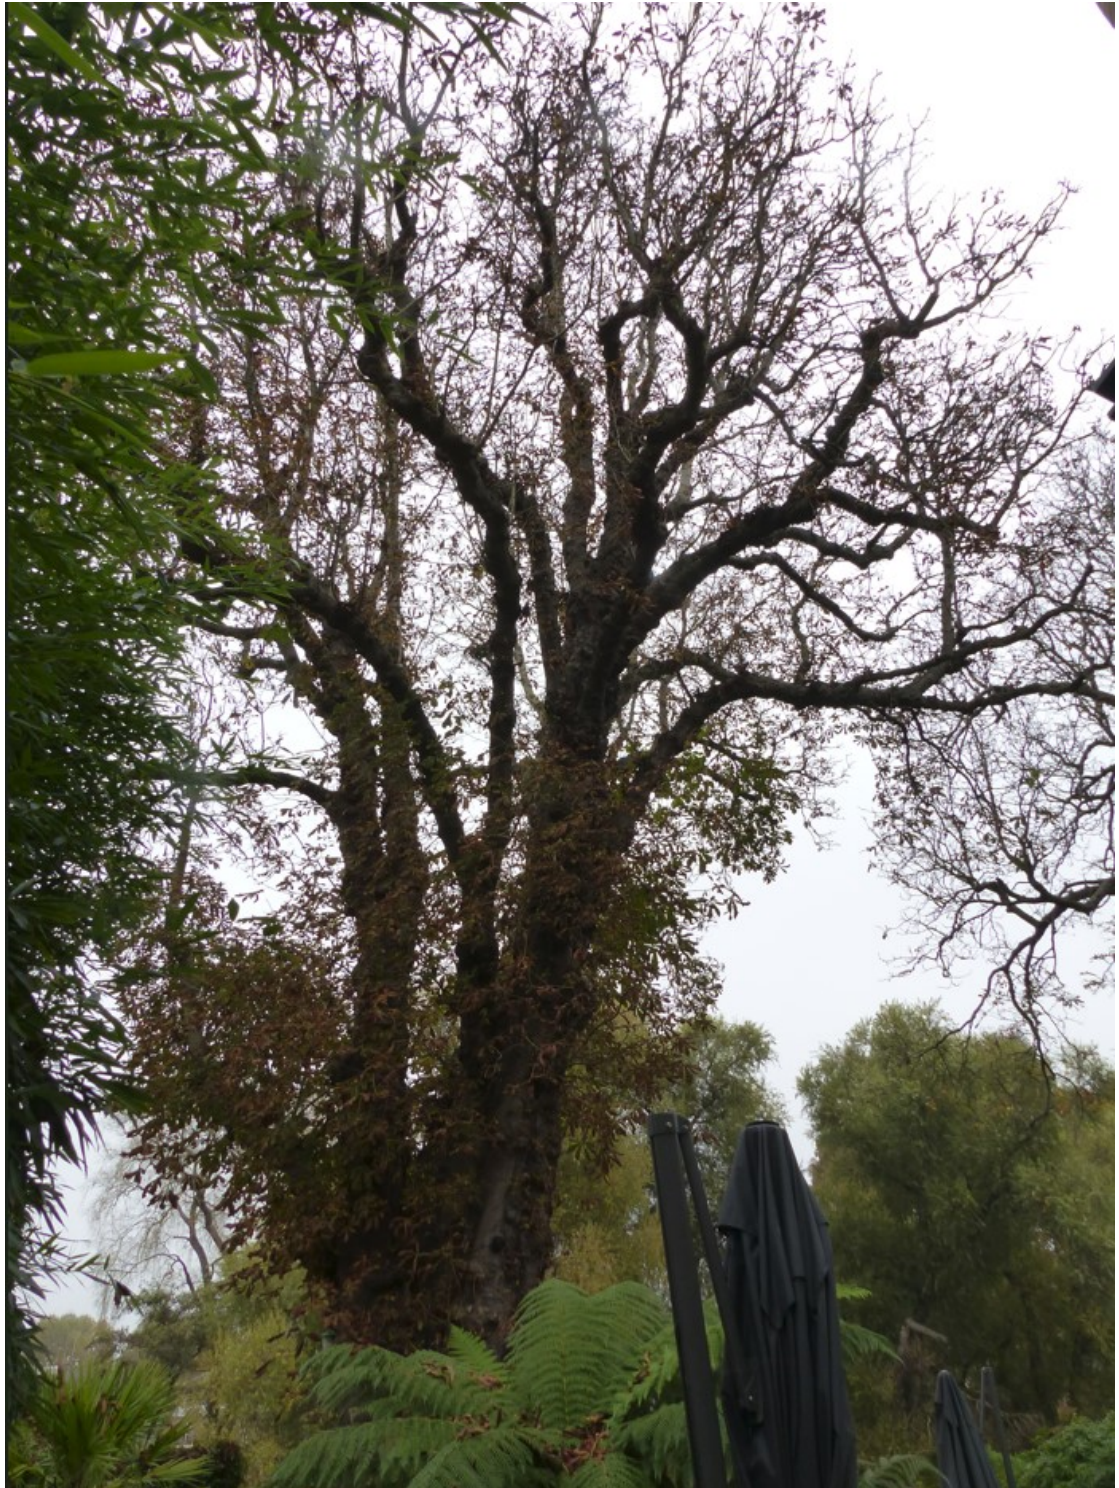
- 2.13 The subject horse chestnut (*Aesculus hippocastanum*) is an overmature tree located in the back garden of Mandalay 10m to the north of the house. It is 20m high with a crown spread extending for 6m N; 7m S; 7.5m E; 6m W. The tree has a stem diameter measured at a height of 1.5m of 141cm.
- 2.14 The tree is growing in open, but landscaped ground. The surrounds include pathways, decking, artificial (permeable) turf and shallow ponds to the south and east.
- 2.15 The horse chestnut is a useful feature in the local landscape (Pic.1), one of several fully mature horse chestnuts in the back gardens of the properties fronting the river here.

Pic. 1. The horse chestnut viewed from the southwest looking northeast

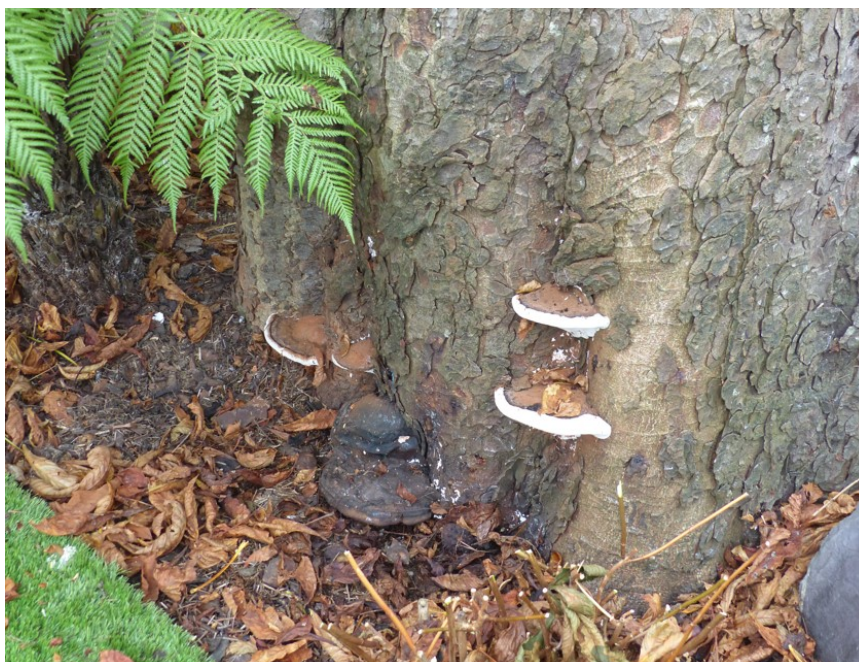
- 3.3 The lower stem has several brackets of *Ganoderma applanatum* attached to the lower stem on the east side. These include one aged bracket and four newer ones (more recent activity) with some reaction wood adjacent to the brackets (pic. 2).

Pic. 2. The fungal brackets (*Ganoderma applanatum*) seen on the lower east stem with newer reaction wood seen to the right of the brackets

- 4.6 The presence of the fungal brackets on the east side along with the ERT readings and the drill investigation between points 10 and 11 confirm that here the lower stem is extensively decayed, such that there is an inadequate thickness of the remaining sound wood on the outer edge of the stem.

- 7.1 Option 1 would be to remove this tree. In the light of the findings of the investigations it is clear that decay is becoming advanced and that a failure is a predictable and increasingly probable event. The tree is at the end of its safe useful life expectancy and removing it now and providing a replacement tree of a suitable stature would represent positive arboricultural management. This would be my strongest recommendation.

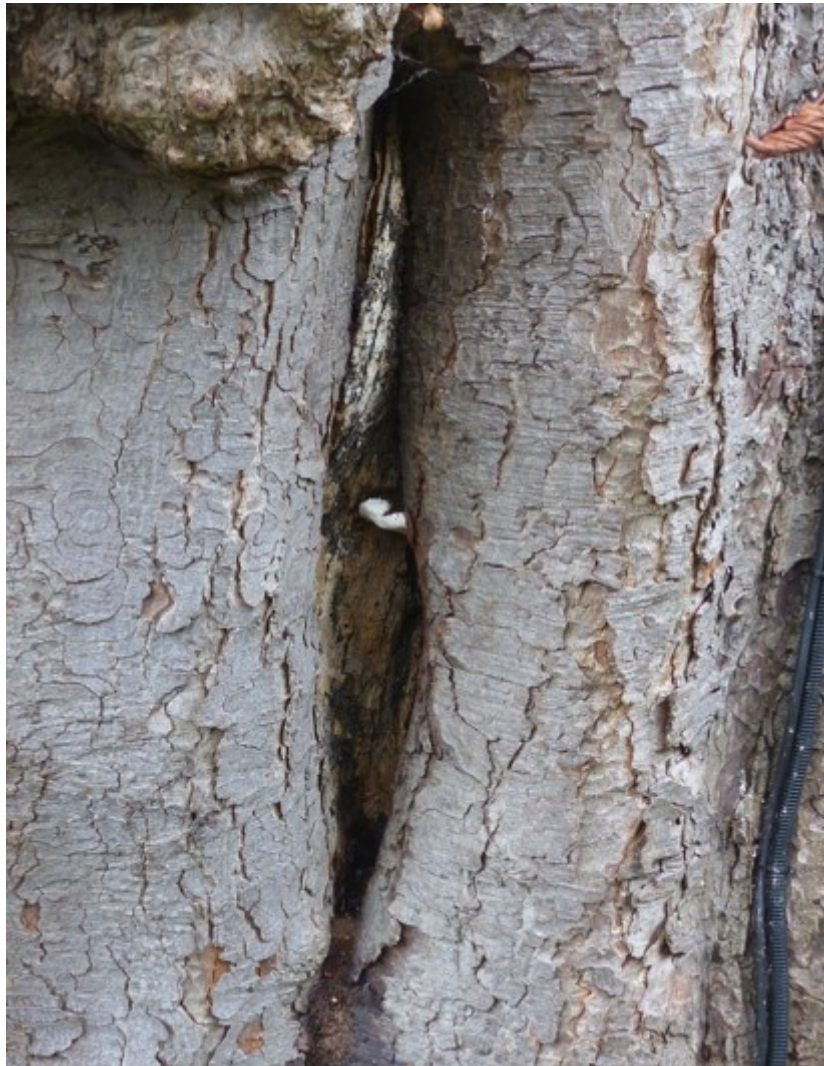
Pic. 3. The open wound on the west side with the small fungal bracket visible

- 3.7 The open cavity is flanked by reaction wood, callousing around the exposed wood, and there is a small amount of exudation at the base of the wound.
- 3.8 An Electrical Resistance Tomograph (ERT) reading was taken at a height of 15cm above ground level (fig.1). This has been used in conjunction with the drill readings using the IML Resistograph PD400 micro drill (see appendix 1)

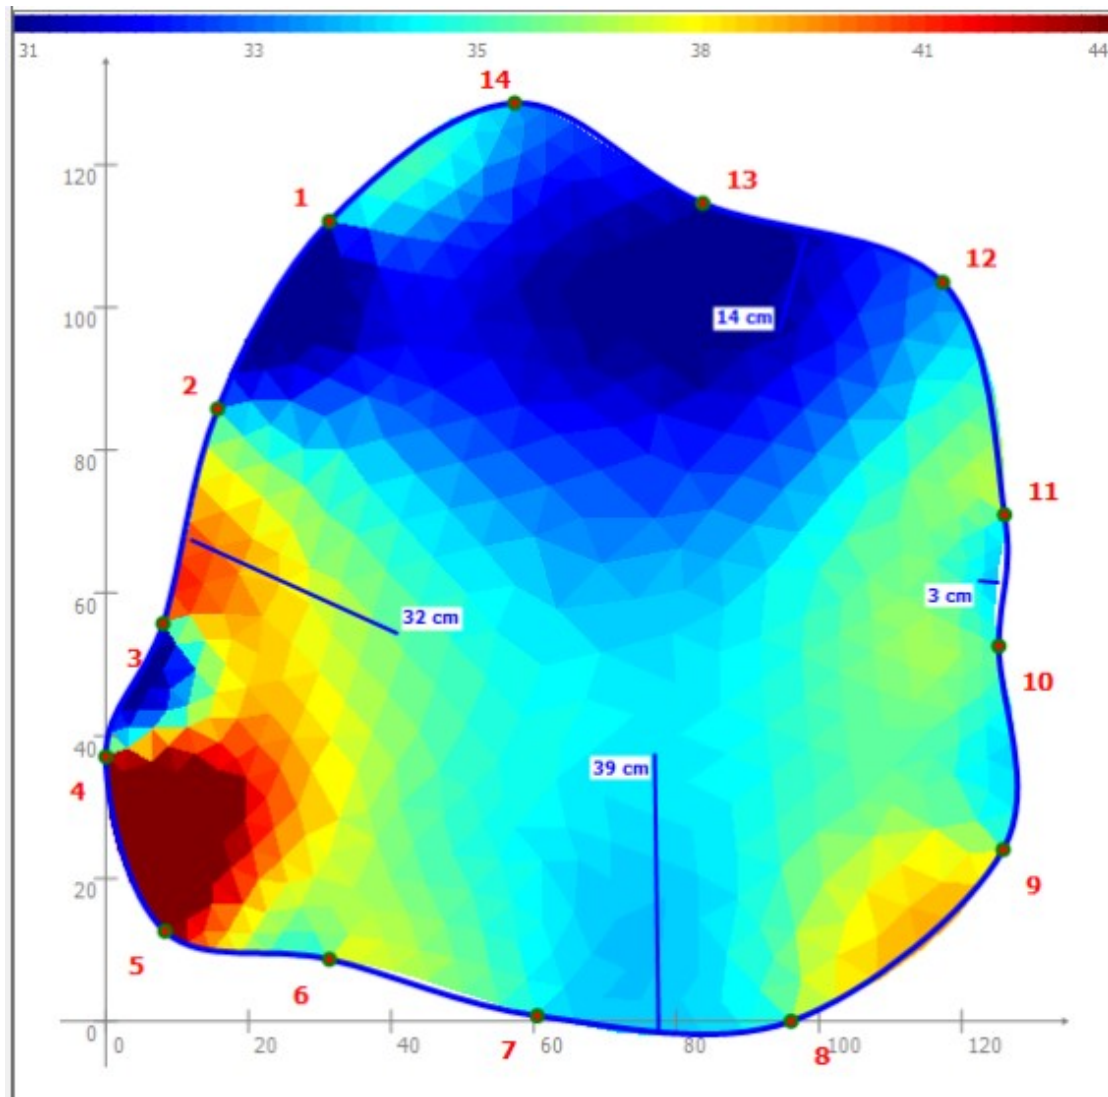
Fig 1. The ERT reading taken at 15cm where point 1 is north. The blue lines indicate the drill readings taken which are terminated where decay has been picked up. The key features here include the dark red at points 4-5, where the open cavity is, and the light blue green areas. These specifically appear behind the open cavity and behind points 10 – 11 where the fungal brackets have appeared

- 4.8 The ERT reveals decayed or degraded wood to the south east and the south west sides of the stem at 15cm, although it has also picked up a strip to the south where the wood is showing more resistance.

- 4.10 The overall picture of the lower stem is one of spreading decay with the main areas being towards the east, the centre and to the south.
- 4.11 The ERT and drill readings taken at 1m show that the stem higher up is much less decayed, other than some decay behind the open wound. This is consistent with the visual observations that included the presence of a small fungal bracket there.

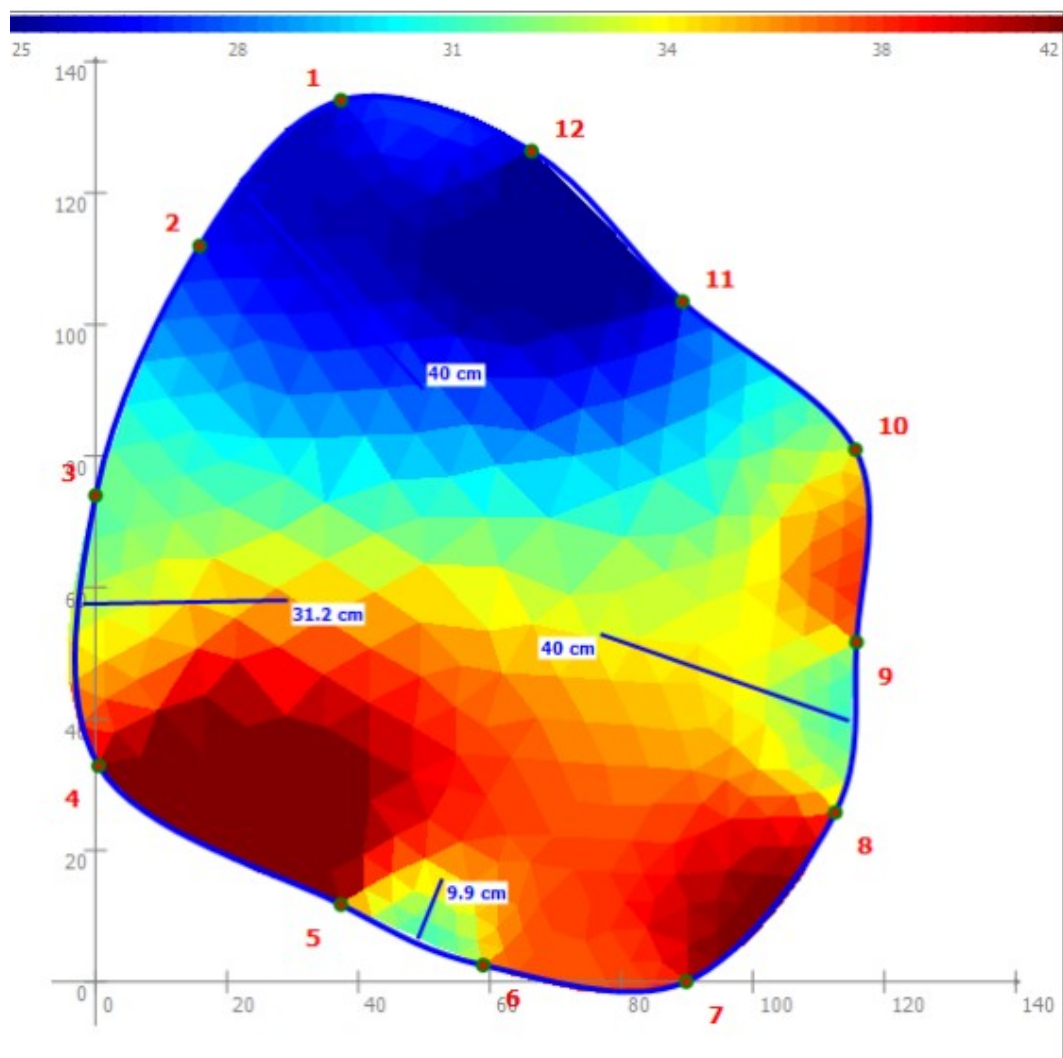
Fig 1. The ERT reading taken at 100cm where point 1 is north. The blue lines indicate the drill readings taken which are terminated where decay has been picked up. The key features here include the dark red at points 4-5, where the open cavity is. In general the indication is that decay is less extensive than lower down the stem.

- 4.12 The two sets of readings at 15cm and 100cm respectively show a pattern of decay that is progressing conically up the stem from the base, consistent with the growth strategy of several buttress decay pathogens including *Ganoderma*. These pathogens usually attack the root plate as well and symptomatic of this is the appearance of deadwood in the upper crown along with a general loss of vitality

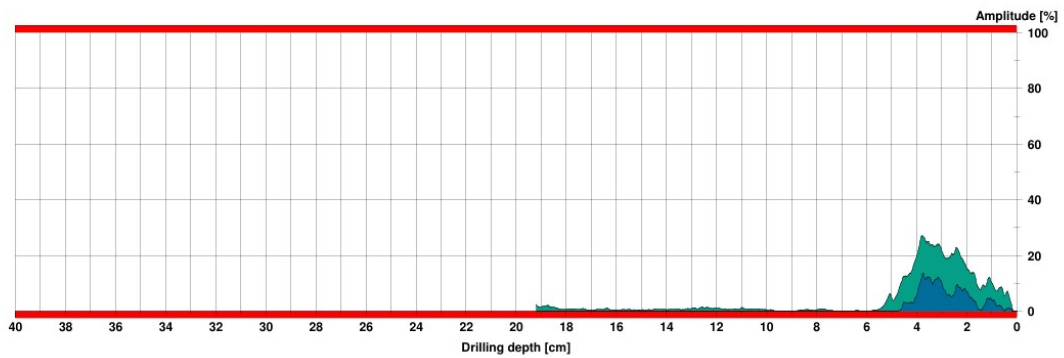
■ From 0,00 cm to 40,00 cm : Decay

This part of the stem is entirely decayed

Measurement 1 taken at 15cm on the west side of the stem where the fungal fruit bodies are present.
The wood behind the fungal brackets is entirely decayed.

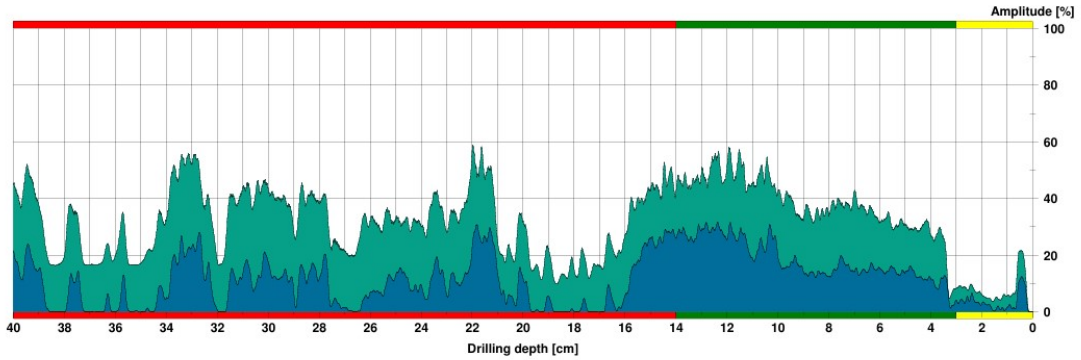
- 4.7 Similarly, the drill reading taken between points 12 and 13 indicate internal decay at 14cm, leaving an inadequate thickness of the remaining sound wood on the outer edge of the stem.

Yellow	From 0,00 cm to 3,00 cm	: Bark
Green	From 3,00 cm to 14,00 cm	: Sound wood
Red	From 14,00 cm to 40,00 cm	: Decay

Extensive decay detected in this part of the stem

Measurement 2 taken at 15cm on the north west side towards the centre of the stem. This reveals the wood on the outer edge is initially reacting to the decay, trying to resist further spread, but that after 14cm the resistance collapses and the wood has become decayed.

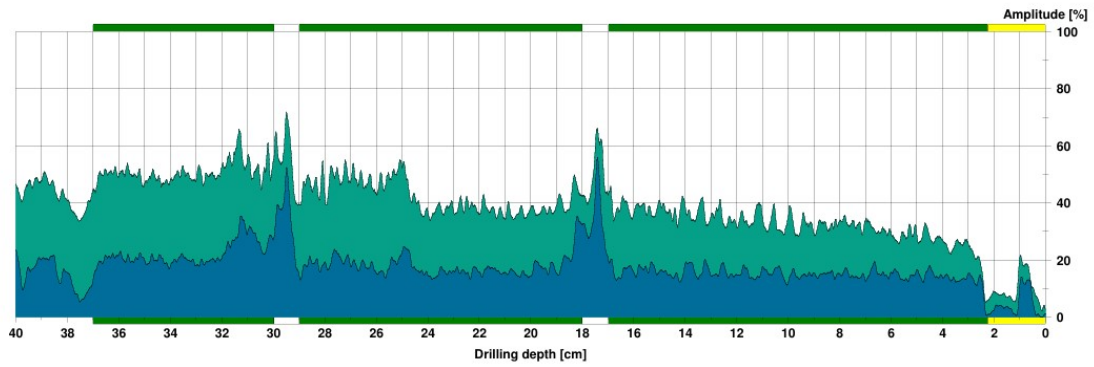
- 4.9 The drill reading taken between points 7 and 8 did show a couple of spikes which could be knots, or possibly barrier walls resisting the spread of decay. The reading did pick up decayed wood deeper in towards the centre.

From 0,00 cm to 2,25 cm	: Bark
From 2,25 cm to 17,00 cm	: Sound wood
From 17,00 cm to 18,00 cm	: Knot
From 18,00 cm to 29,00 cm	: Sound wood
From 29,00 cm to 30,00 cm	: Knot
From 30,00 cm to 37,00 cm	: Sound wood

A couple of knots in the wood have been picked up here. Towards the end of the drill (after 37cm) the quality of the wood degenerates indicating decay

Measurement 3 was taken at 15cm on the south side towards the centre of the stem. The reading shows sound wood in this part of the stem with a couple of spikes suggesting possible knots (or similar obstruction) in the wood. Deeper in, near 40cm the quality of the wood appears to degrade with a late drop in the needle reading. This would correspond with the area of decay on the west side.

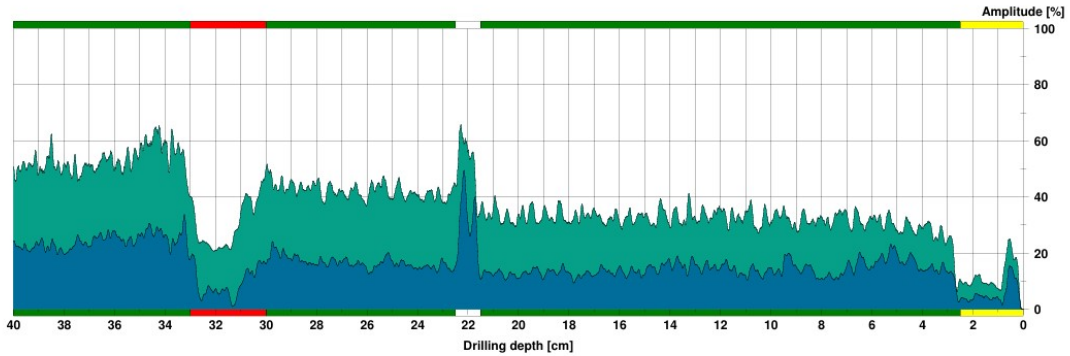
From	0,00 cm	to	2,50 cm	:	Bark
From	2,50 cm	to	21,50 cm	:	Sound wood
From	21,50 cm	to	22,50 cm	:	Knot
From	22,50 cm	to	30,00 cm	:	Sound wood
From	30,00 cm	to	33,00 cm	:	Decay
From	33,00 cm	to	40,00 cm	:	Sound wood

The spike in the reading is probably a knot or similar in the wood. A small pocket of decay has been picked up.

Measurement 4 was taken on the east side at 15cm towards the centre of the stem. The sound wood is punctuated by the presence of a knot (or similar obstruction) before encountering a small pocket of decay. The steep incline of the drill reading deeper into the stem shows a strong resistant barrier wall.

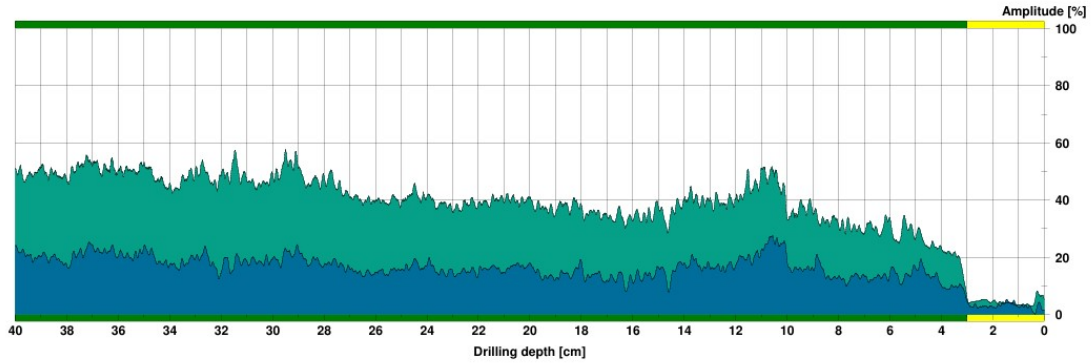
From 0.00 cm to	3.00 cm	: Bark
From 3.00 cm to	40.00 cm	: Sound wood

Measurement 5 was taken at 100cm from the west side towards the centre of the stem. Whilst this is above the fungal brackets, there is no evidence of active decay here, suggesting that if decay is travelling up the stem, it has developed a conical shape in doing so. This is typical of a *Ganoderma* development pattern.

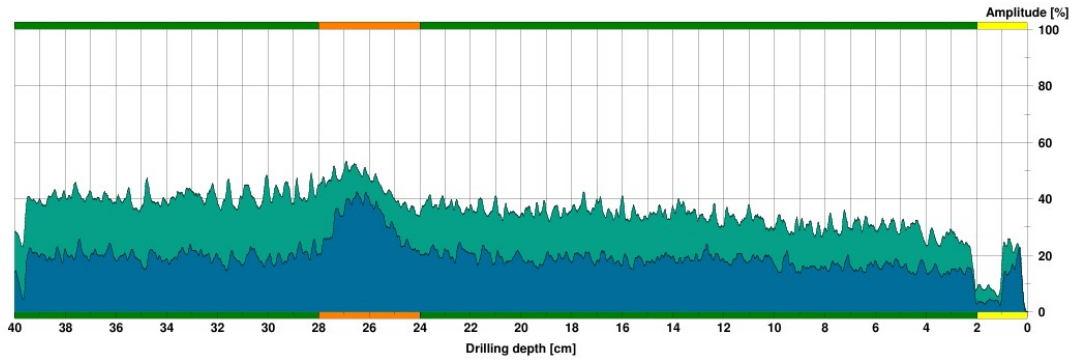
From	0,00 cm to	2,00 cm	: Bark
From	2,00 cm to	24,00 cm	: Sound wood
From	24,00 cm to	28,00 cm	: Reaction wood
From	28,00 cm to	40,00 cm	: Sound wood

Measurement 6 was taken at 100cm on the north side of the stem towards the centre. Another reading of sound wood confirming that decay has not developed higher up in the stem. The unusual bulge in the reading indicates more resistant wood, a reaction to something not accounted for.

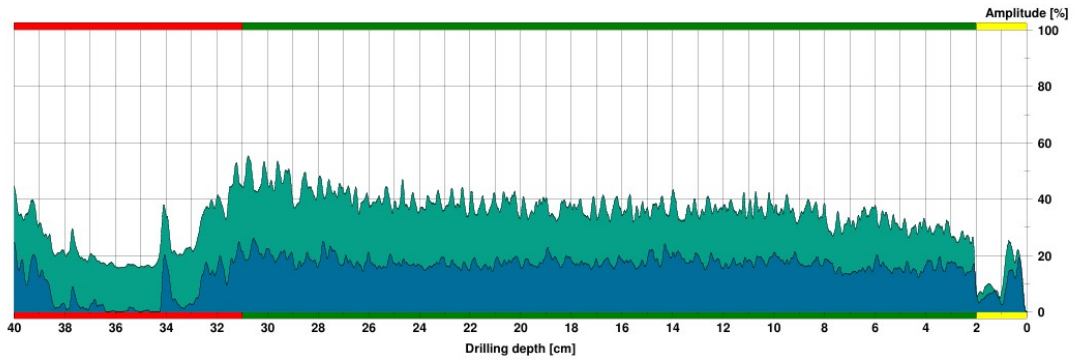
From 0,00 cm to 2,00 cm :	Bark
From 2,00 cm to 31,00 cm :	Sound wood
From 31,00 cm to 40,00 cm :	Decay

Decay found deeper toward the interior of the stem

Measurement 7 was taken at 100cm from the north east side towards the centre. This crosses the area of decay on the east side of the stem with the open wound between 0.7 – 1.7m. Decay, likely linked to the wound is picked up after 31cm.

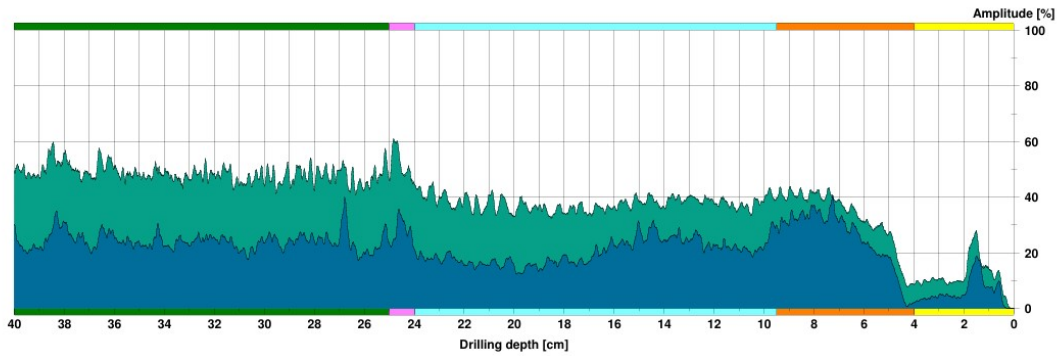
From 0,00 cm to 4,00 cm :	Bark
From 4,00 cm to 9,50 cm :	Reaction wood
From 9,50 cm to 24,00 cm :	Degraded wood
From 24,00 cm to 25,00 cm :	Barrier wall
From 25,00 cm to 40,00 cm :	Sound wood

The wood is resisting the spread of decay on the outside, but internally the quality of the wood is gradually being lost. A further barrier wall at 24cm seems to be the point where decay is being arrested for the time being

Measurement 8 was taken at 100cm from the south side towards the centre of the stem. There appears to be a loss of quality of the wood between 10 – 24cm, possibly an indication of early stage decay. This is supported by the presence of slightly resistant reaction wood (a higher resistance to the drill) just before the area of degraded wood and a barrier wall at 25cm.
