**SCHEMATIC SECTION OF AFFECTED PART OF ROOF.**

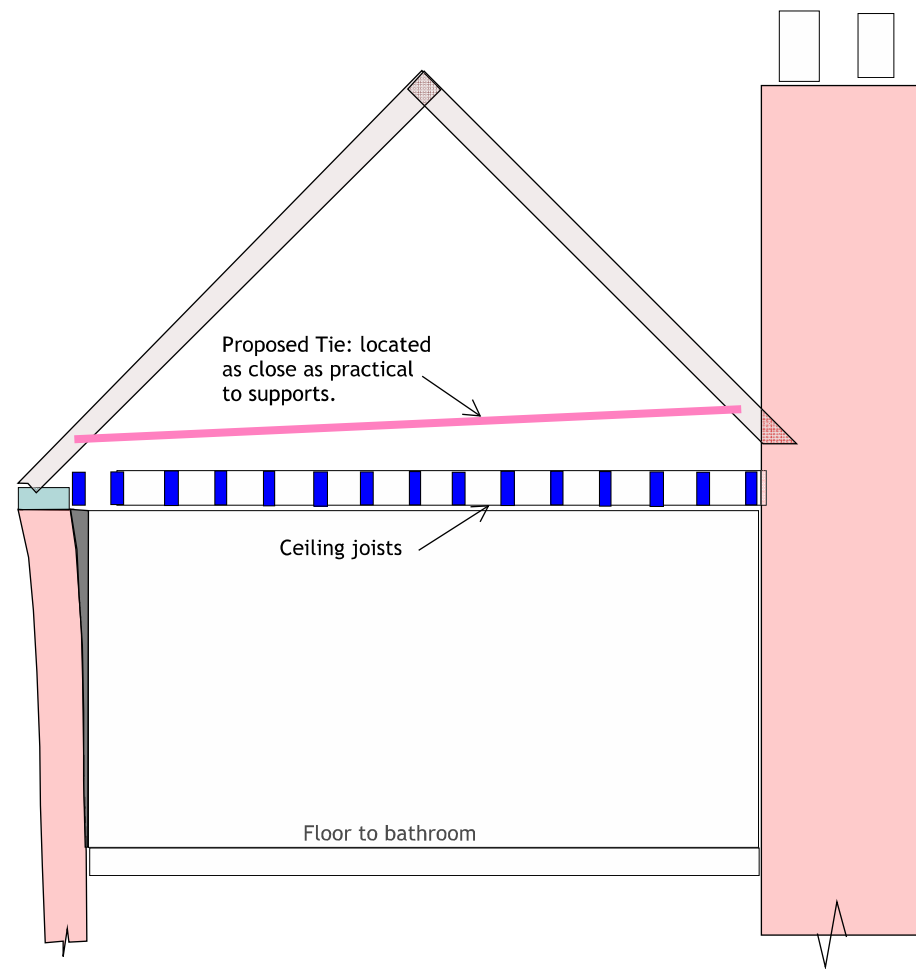
**Problem:**  
 Historic absence of any eaves level tie in chimney zone has allowed the opposing rafters to push out at their supports.

**Proposed Solution:**  
 Add an eaves level tie to each rafter supported on the chimney stack
