Japanese Gateway, Royal Botanic Gardens,  
Kew, London

Results of Architectural Paint Research

28/03/2024

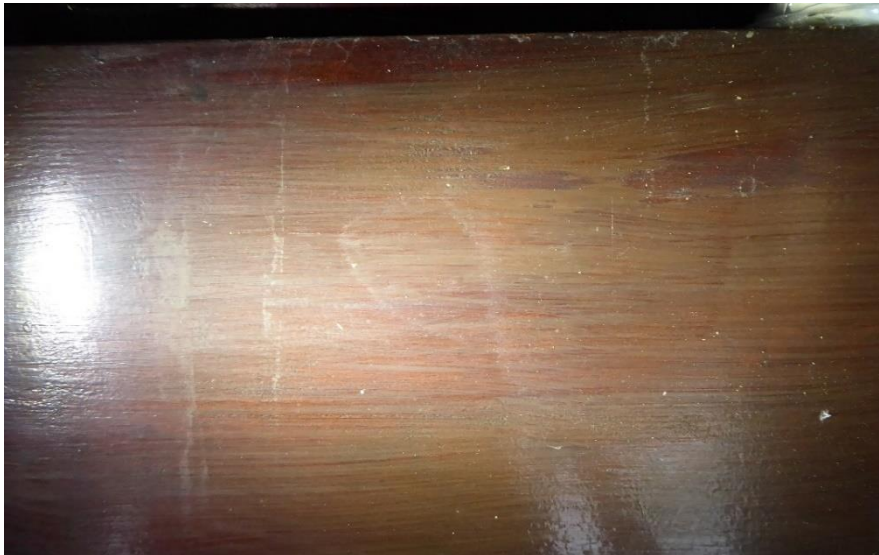
There are notable areas all around the gateway of differing colour finishes to the wood. For example, in the roof space on the south elevation, the surface of a beam appears to have been treated in a different manner to much of the rest of the structure. This may suggest a variation in workmanship and what appears to be a later coating (possibly a polyurethane varnish) that has been applied to the surfaces. This has discoloured and brush strokes are visible (Figure 6) suggesting this is likely to be part of a later intervention and not in line with the known methods of traditional lacquering.

*Figure 6: Image showing the brush strokes in possible later protective coating.*

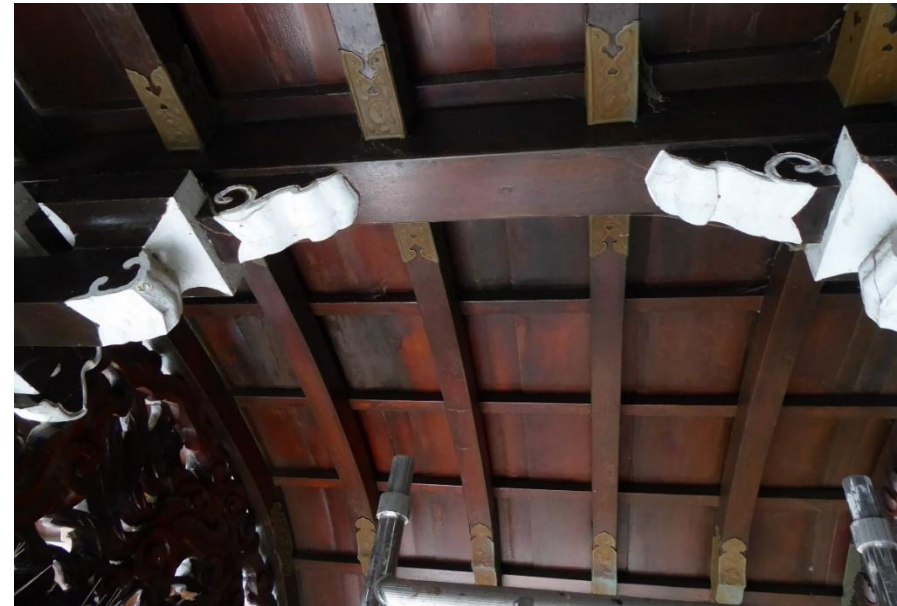
Further inspection of the structure revealed that there were also some areas of darker films, suggesting the remains of an earlier scheme that may have been removed. The interior ceiling timbers on the south side appear to have an uneven colour (Figure 7), this could be the result of partial removal of earlier schemes. It was also noted that the existing

colour of this area has more of a red appearance with the previous scheme appearing as darker patches. Unfortunately, safe access to this area was not possible from the scaffold tower provided.

*Figure 7: Image showing the ceiling timbers on the south side of the structure.*

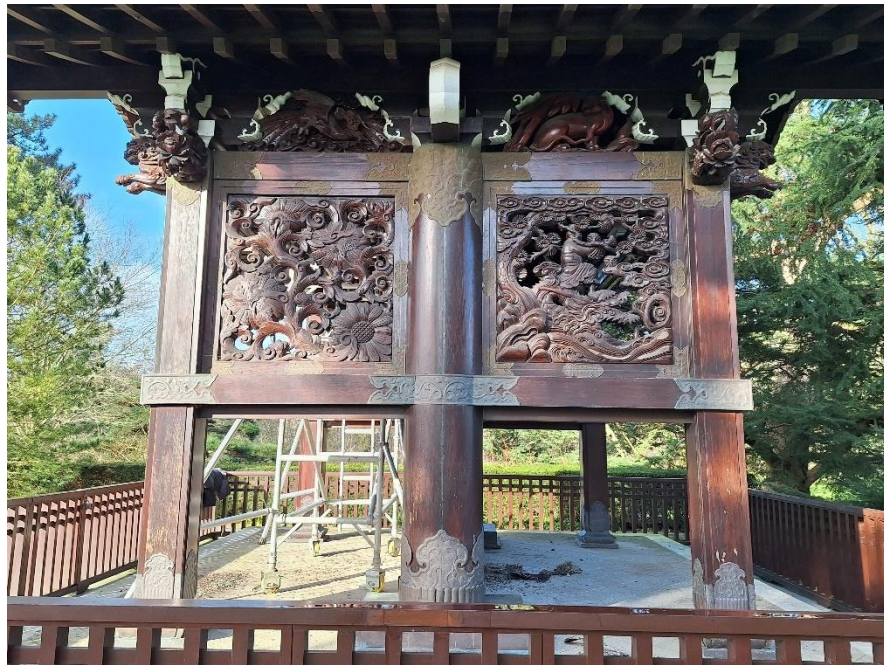
Discolouration and deteriorating paint films were observed in all elevations, although facets on the south elevation, which is more open to weathering, appear to have been affected more (Figure 8).

Figure 8: East elevation, showing the increased deterioration of the painted surfaces to the south (left) compared to those on the north side (right).

A number of areas contained failing paint films and all areas of flaking paint should be removed prior to redecoration. Whilst every effort should be made to retain paint archaeology, suitable preparation is required to ensure appropriate bonding of the paint films, especially given the elevated nature of some of the facets and any future access limitations.

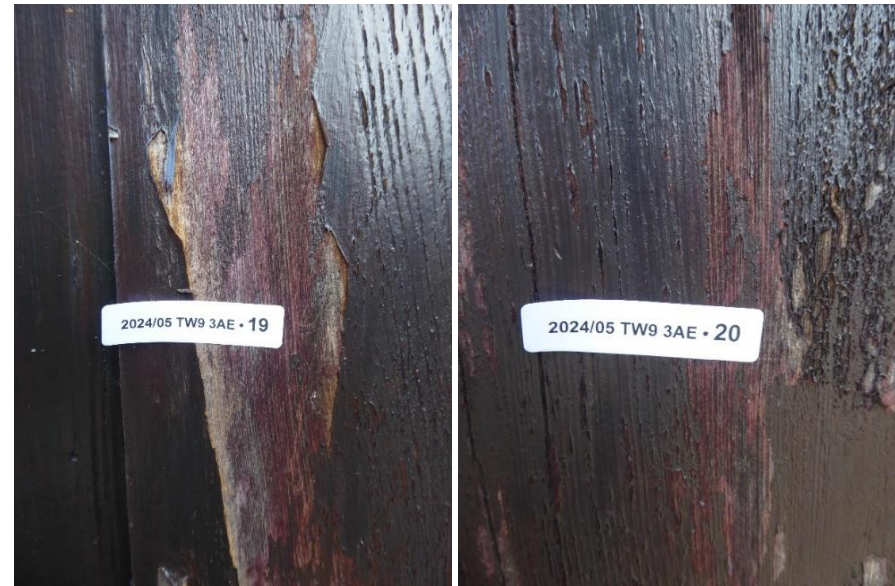
Two samples of applied decoration were removed from the south-western posts on the south side (Figure 9). The paint films to these posts were significantly degraded with many areas being exposed to the timber substrate and peeling or flaking paint, where an underlying red colour was noted. This had also been noted on the south-eastern post too.

Figure 9: Images showing the red colour beneath the peeling films on the south-western post.

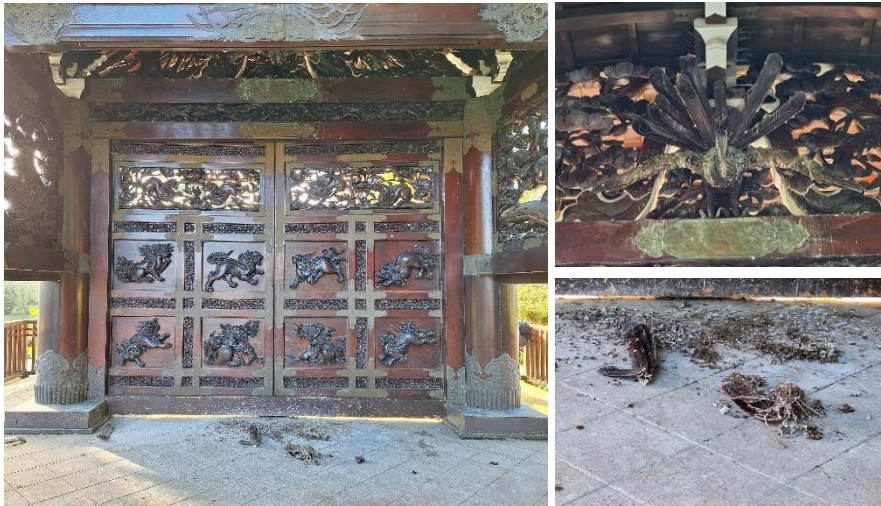
On the north elevation there is evidence of pigeon roosting to the upper levels above the doors. Bird 'spikes' have been installed but apparently to little effect; remains of a nest and guano were present. As a result, damage has been caused to the internal higher level decorative bird (crane); displacement of facets and losses to tail feathers has occurred, due to the nesting birds (see Figure 10). One of the smaller wooden decorative feathers<sup>4</sup> has been retained with the samples to aid any additional analysis. Bird droppings have fallen on the internal beams and doors, the corrosive nature of the guano will have caused damage to both the wood and the copper ornamentation.

*Figure 10: North elevation, showing the damaged decorative carvings and evidence of bird roosting.*

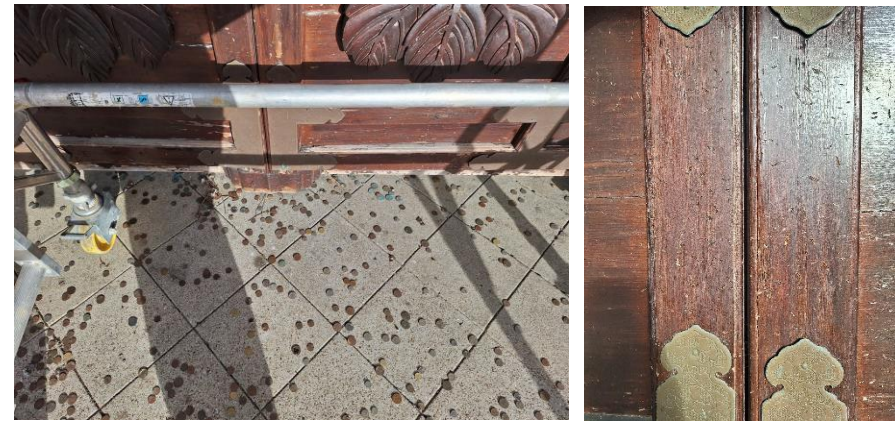
On both sides of the door there is deterioration to the wooden surfaces assumed to relate to the throwing of coins as offerings, where they have impacted on the wood there are a series of dents and nicks to not only the applied decoration but the wood itself (see Figure 11). This can be seen more prominently on the south elevation, where the coins still remain on the ground.

*Figure 11: Image of south elevation doors, showing the damaged caused by coin offerings.*

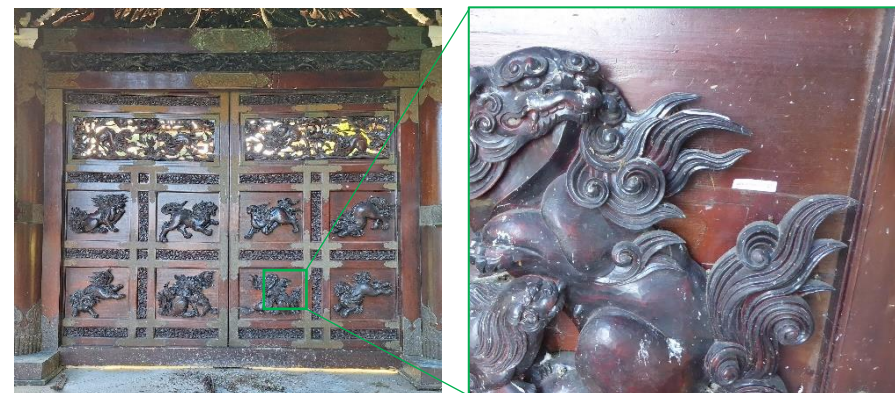
On closer inspection of the north side door beast carvings, traces of paint films and scarring or ghosting was observed, suggesting that they may have been in a different configuration at some point in the past (Figure 12).

*Figure 12: Close up of carved beast on north side of door, showing possible scarring of altered position.*

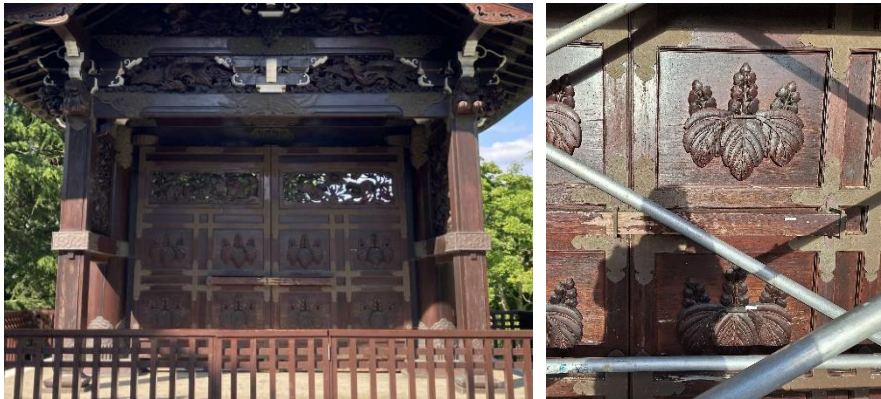
A locking bar is located on the south side of the doors, this is solid wood and square in profile. It is held in place with three metal bars, one centrally and one at each end. Damage has been caused through use, more so in the centre, where paint films have been worn away.

*Figure 13: South elevation, showing the doors and locking bar. (left image: © Clews Architects; right image: © Hirst Conservation Ltd.)*

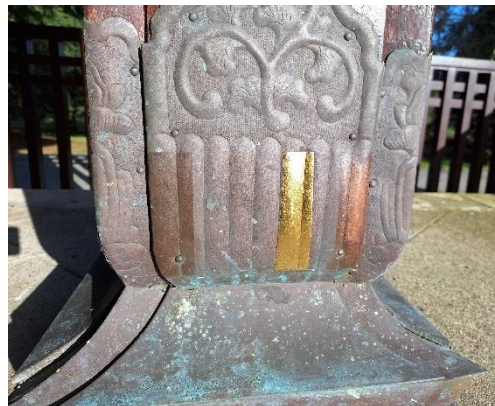
Whilst inspecting the Japanese Gateway, it was noted that there appeared to have been some recent testing to the copper ornamentation, this was located on the south side of the base of the north-eastern post (Figure 14).

*Figure 14: South side of north-eastern post, showing the copper ornamentation test areas.*

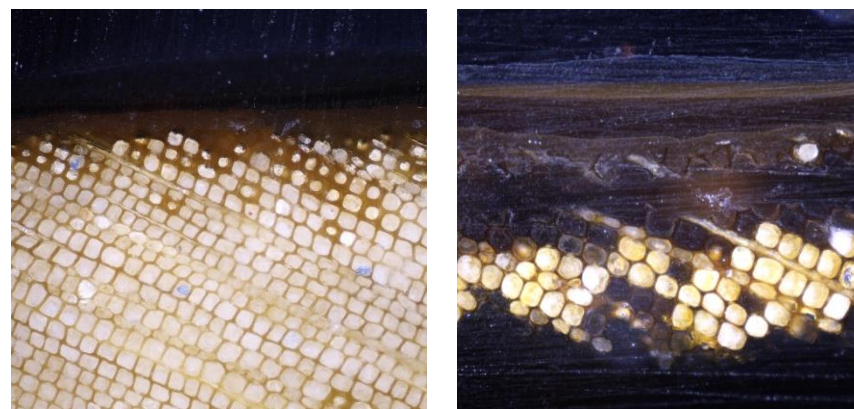
from the enrichment carving to gate to the north side has an even, regular cell structure (see Figure 15) however samples taken from other parts of the structure have a more irregular, lozenge shaped pore structure. There is also evidence of clean, fresh-looking timbers associated with areas of repair / replacement. Comparison of the timber substrate also reveals areas of possible compression or abrasion to the surface of facets with some samples revealing residues of past paint films embedded in the pores but no longer visible as a flat paint coating. Such evidence indicates likely losses possibly from exposure to the elements and possibly from removal prior to redecoration.

Figure 15: Sample 22 (left) and Sample 26 (right), photomicrographs showing the timber substrate differences in visible light taken at 200x magnification.

Further analysis of the underlying timbers may be of interest.

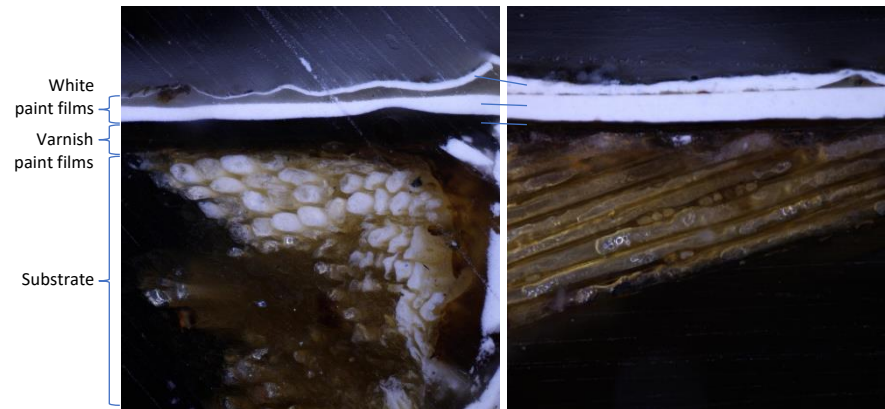
Sample 04 was taken from an underside position of the brace that is currently painted white. The cross section in Figure 17 (left), shows that the timbers look fresher/cleaner, than in other samples, which may suggest that this may be a later repair. Although, due to its position and function it a number of factors such as a variation in the use of timber, its protected position at the top of the inside of the Gateway, suggests it has not weathered in the same manner as other samples.

underlying paint residue in the cellular structure of the substrate. There is also evidence of an intermediary varnish film above this fragmented scheme. This would suggest that this chamfered section of the decorative brace may not always have been painted white. This is comparable to a similar chamfered facet found in Sample 08, seen in Figure 17 (right). This is also true of Sample 01, which was taken from the base of the ridge-piece. A single white paint film, similar to the first seen in the other comparable cross sections, was observed over approximately eight earlier varnish films.

*Figure 17: Sample 04 (left) and Sample 08 (right), photomicrographs showing the paint film differences in visible light taken at 200x magnification.*

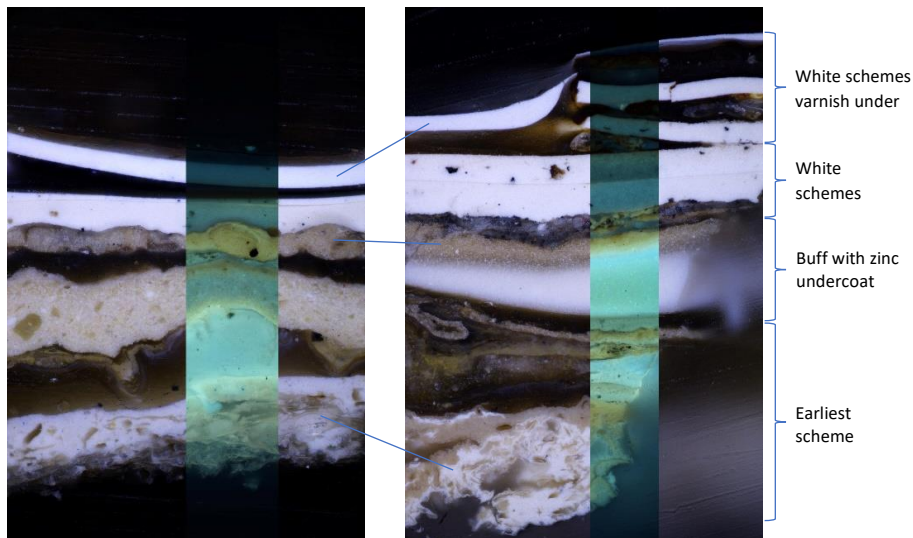
When looking at Sample 05 (Figure 18 - left), the earliest white paint film appears to be sat within the cellular structure of the thin section of timber substrate, this is also true of a similar earliest scheme seen in Sample 06 (Figure 18 right). This could mean that the surface was broken/roughed up when the paint film was applied, perhaps indicating this was done so over worn and weathered timber. This film reacts under

Sample 06i appears to be the most complete set of paint films of the white painted facets, with what appears to be approximately seven schemes of decoration, although it is not clear how this information fits into recorded history of the structure.

Figure 18: Sample 05 (left) and Sample 06i (right), photomicrographs showing the paint films in visible and UV (inset) light taken at 200x magnification.

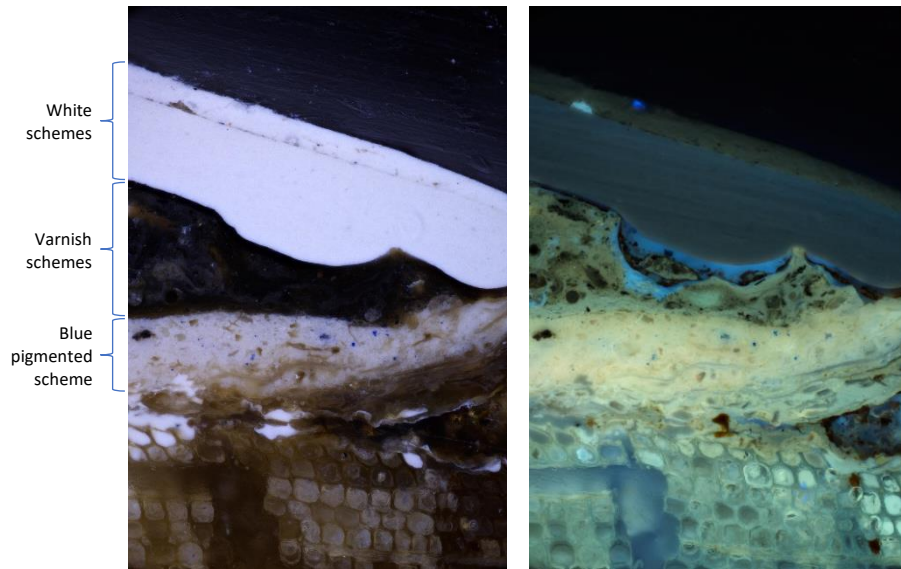
Sample 12 sees some similar schemes as those found in the other white paint sampled cross sections. We see a repeat of the earliest paint scheme, not shown in Figure 19, but appears in the cross section image in Section 6.

This is then followed by a buff paint film with the inclusion of a small number of blue pigments. Although their presence could suggest that there may have been some use of colour, it is believed that there would not have been enough to create a significant colour variation. A test was carried out with a mild acid (HCl) to Sample 12, a positive reaction was seen in the form of carbonation and bleaching of the blue pigment. The reaction indicates the likely use of French Ultramarine available from the mid-nineteenth century onwards.

Figure 19: Sample 12i, photomicrographs showing the paint films in visible (left) and UV light (right) taken at 200x magnification.

Uncovering and colour matching would be recommended to ascertain the original colour intended for the white facets. Was it a buff/cream, or perhaps a lighter shade as seen in Sample 12, with the blue pigmented paint film. However, there has been some losses in the area accessed and so a targeted strategy should be adopted.

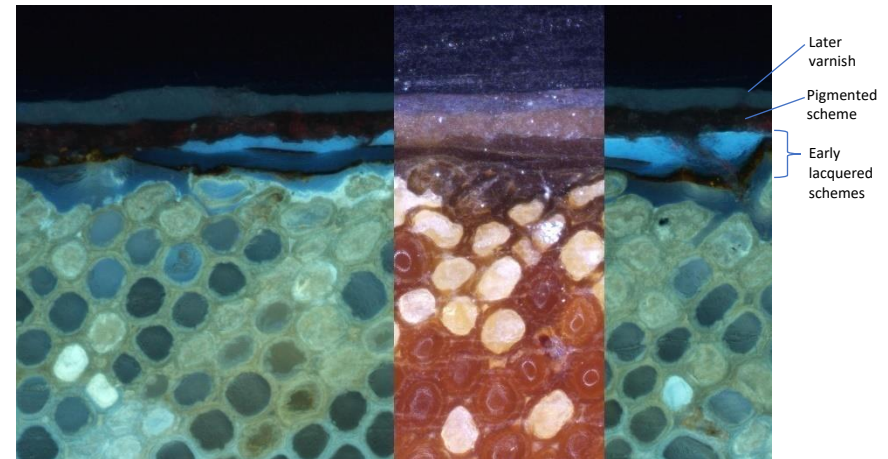
In sample 09 an initial film can be seen applied to timber substrate with a thin dark film visible over it (Figure 20). The appearance of this film under ultra-violet light indicates it is a modern coating. Above this is a broken scheme which has also suffered some losses through time, this is then followed by a brown pigmented scheme, the addition of a pigment could be to renew the appearance of discoloured wood, or the craftsmen employed different techniques than had been used before. There appear to be three or four schemes in this sample, which all indicate an intended lacquer appearance.

Figure 20: Sample 09, photomicrographs showing the paint films in visible (inset) and UV light taken at 200x magnification.

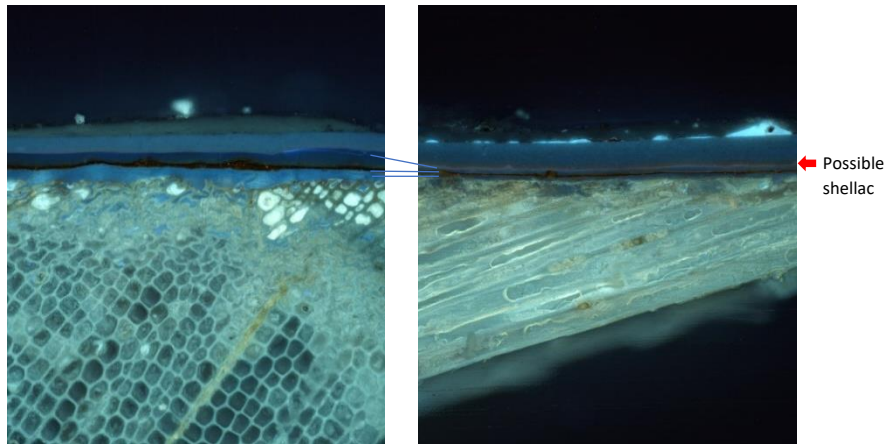
Again, these appear to be later interventions but the lack of this additional film in 06ii may suggest that there was a variation in appearance or that there has been a subsequent loss of film; due to the condition of the paint films.

Figure 21: Sample 06ii (left) and Sample 08 (right), photomicrographs showing the paint films in UV light taken at 200x magnification.

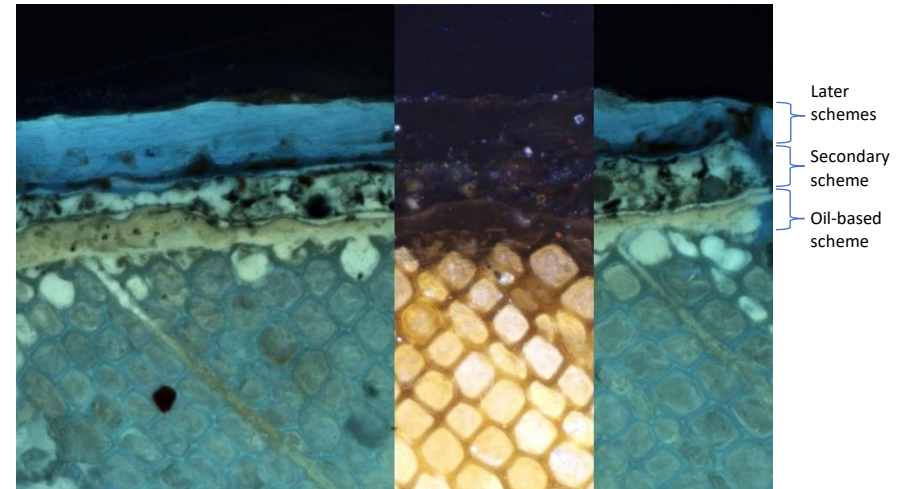
embedded within the paint film, or it was a poorer quality material containing impurities in the oil.

Figure 22: Sample 11, photomicrograph showing the paint films in UV and direct (inset) light taken at 200x magnification.

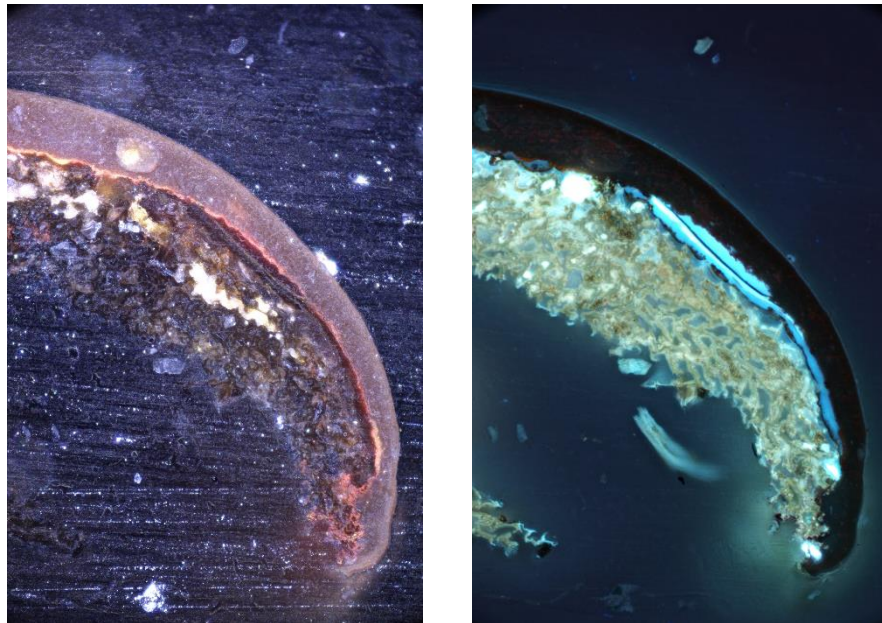
This dark red film was also noticed in cross section to Sample 16, from the south-east post, see Figure 23. The red film, seen clearest in direct light (left), lies under a brown pigmented varnish as one of the later coatings. Underneath these later films are the remains of fragmented earlier coatings similar to those seen in Sample 09, these may have been lost through damage or the restoration of the surfaces. It was noted that

these films also show an intended lacquered scheme. Evidence of earlier surviving schemes, although they also appear to be fragmented, can be seen in Sample 14 (see image in Section 6).

Figure 23: Sample 16ii, photomicrographs showing the paint films in direct (left) and UV (right) light taken at 200x magnification.

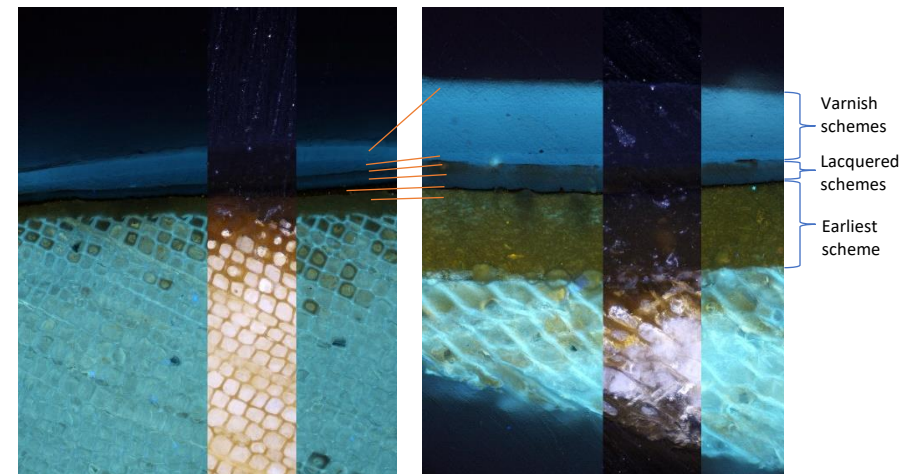
Samples 22, 28 and 29, all from the enrichment decorations on the north side of the doors, proved to be interesting and significantly different in their cross sections from those encountered on the rest of the structure (Figure 24). Samples 28 and 29 are similar, with the exception that Sample 28 shows broken additional earlier lacquered films, that are similar to those seen in Samples 06, 08 and 09.

the decorative elements, which may help to understand why some areas have had different treatment in regard to coatings. It appears to be a well prepared surface for the earliest scheme to be applied to. The yellow/orange fluorescence seen here would suggest the use of a shellac coating (Webb, 2007, pp. 157-9).

Figure 24: Sample 22 (left) and Sample 29 (right), photomicrographs showing the paint films in UV and direct (inset) light taken at 200x magnification.

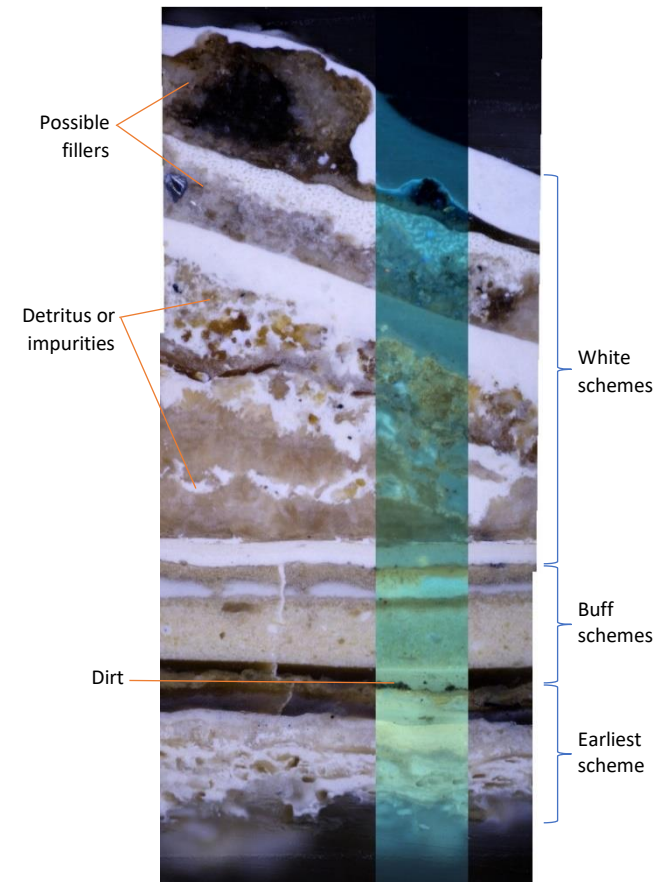
The later white undercoat, to a buff topcoat, is likely to be a white, zinc-based oil paint film; due to the fluorescence observed and the appearance of the barytes inclusions. This scheme is comparable to one found in Sample 13, from the high-level central strut on the south elevation. No reaction for lead was seen in the this white paint film when; however it could contain lithopone pigments, which were used from the 1870's as a substitute for lead carbonate (white lead), further analysis would be required to confirm this.

Figure 25: Sample 13, photomicrograph showing the paint films in direct and UV light (inset) light taken at 200x magnification.

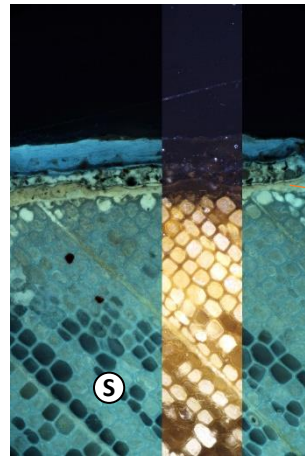
**Sample 11 (100x mag)** – South elevation, south side of central façade, top rail, above hinge plate, east, timber substrate.

- Early schemes seen at the base of Samples 11, 14 and 16, although in 14 they are broken.
- Sample 11 shows a secondary coating which contains debris which could mean that it wasn't a very well prepared layer, or that it did not fully cure.

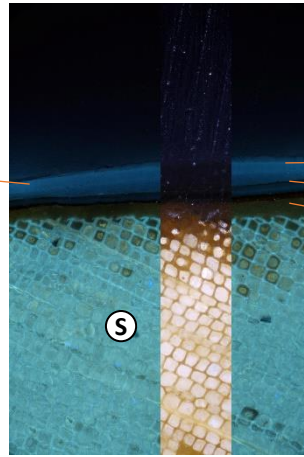
**Sample 22 (200x mag)** – North elevation, doorway, right door, bottom left panel, wood enrichment, top of mane, timber substrate.

- The substrate for the enrichment carvings seems to be different for Sample 22, which appears to have a visibly smaller grain than the others.
- There is comparability between how the carvings on the south side of the door, Samples 25 & 26, have been treated. This also applies to those found on the north side of the door, Samples 22, 28 & 29.
- The carvings on the north side of the door have an earlier possible shellac coating, which is absent in the carvings on the south side.
- In the secondary scheme of Sample 28, there have been earlier losses, this could be due to knocks or the preparation of surfaces.
- The most recent film looks to be a polyurethane varnish and is present on the samples from both sides.
